Deadwood Creek Tributary South

Culvert Scour Assessment

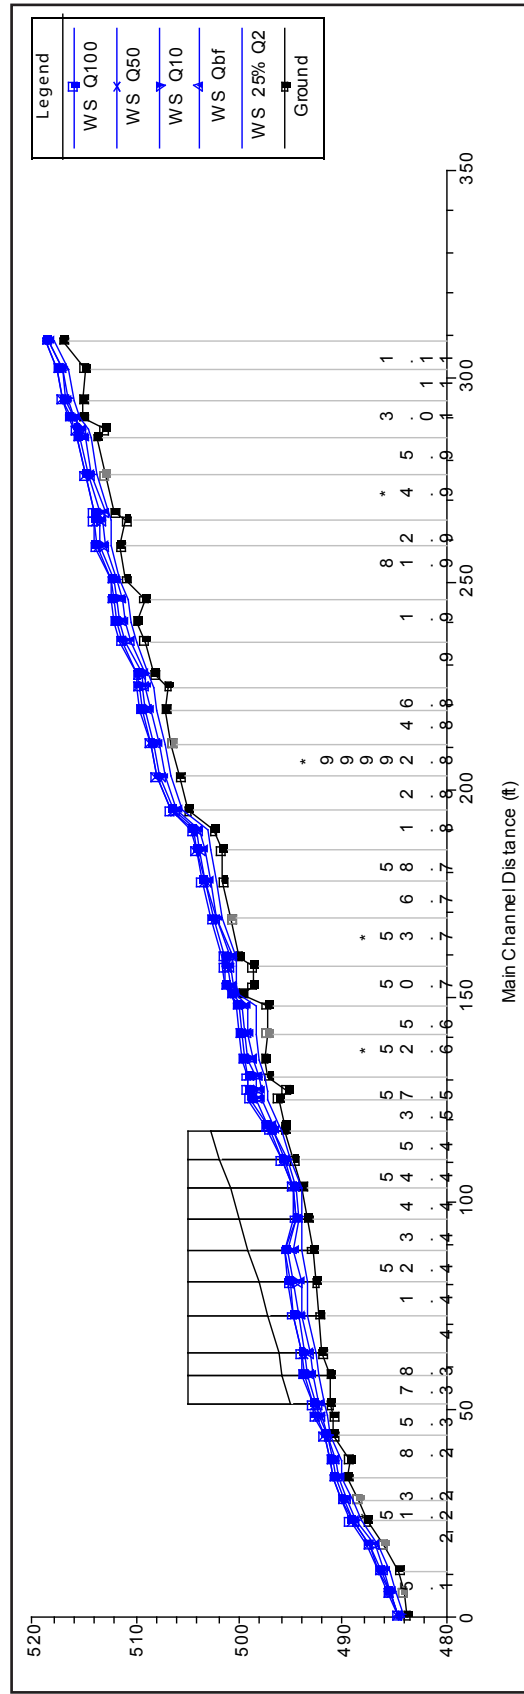
Figure 3—HEC-RAS profile.

This site has very high gradient (up to 12 percent) that likely pushes the limits of the HEC-RAS model; and so results need to be interpreted accordingly. However, the flow conditions modeled in the culvert at this site appear to match well the observations of flow conditions at the time of the survey with respect to the rapid shallow flow in the scoured portion of the pipe.

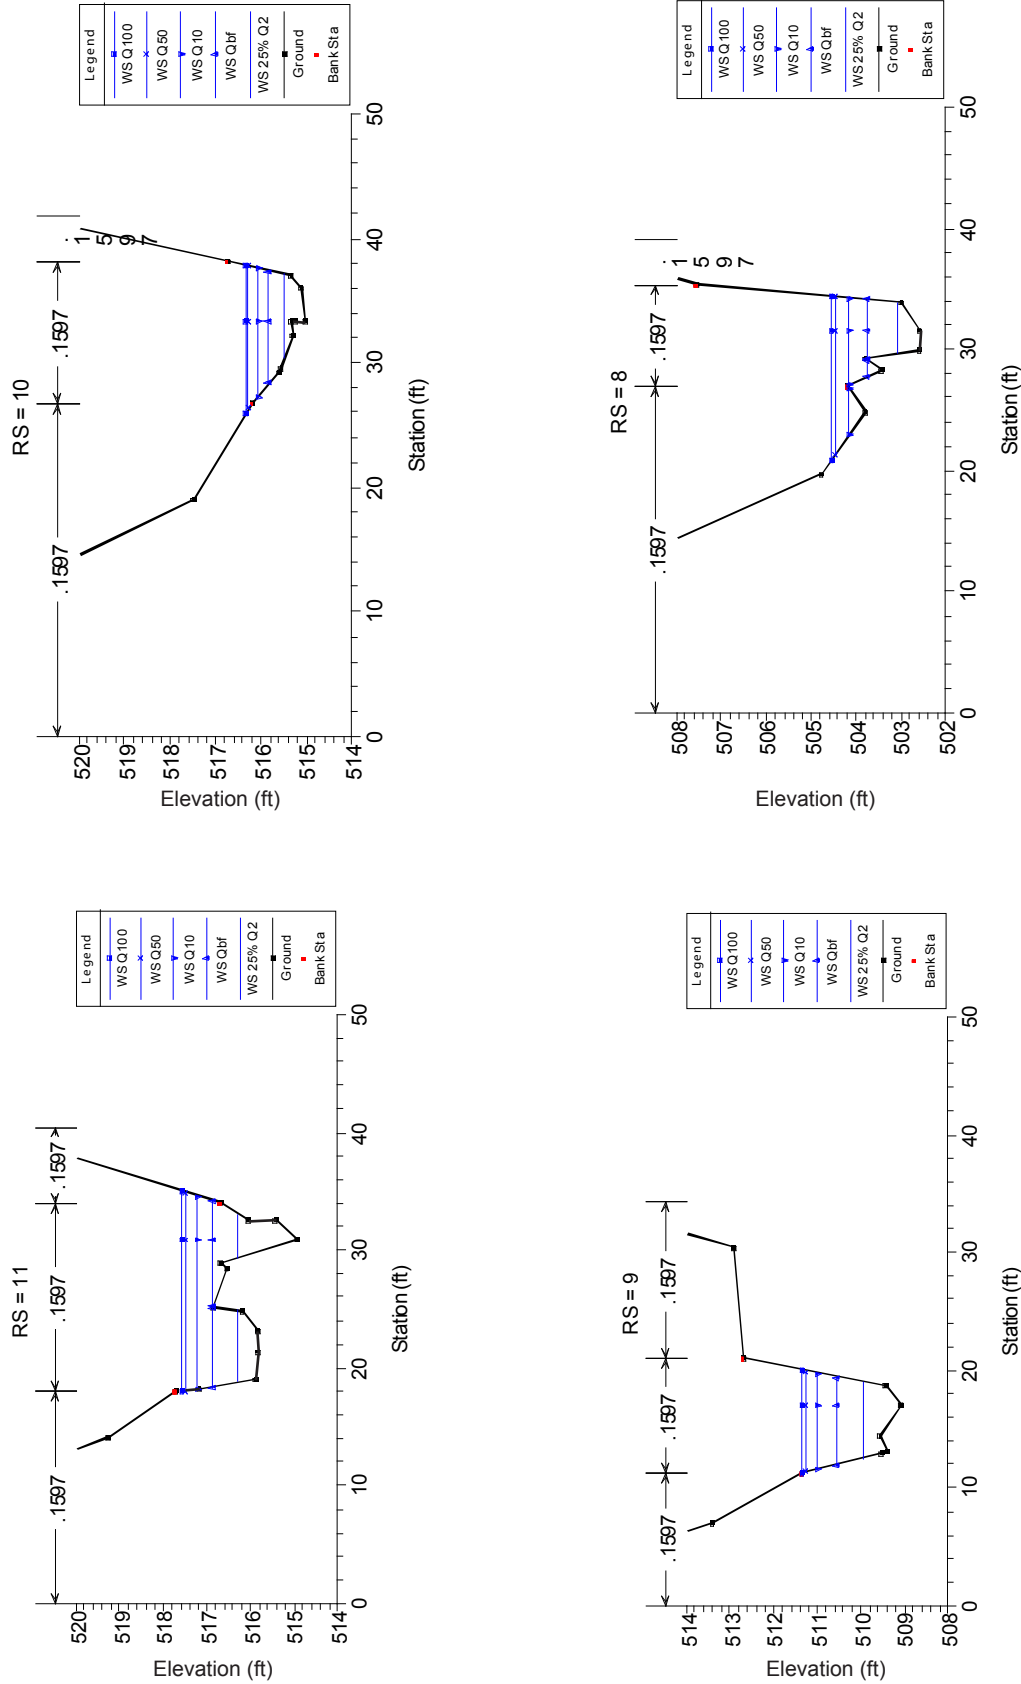
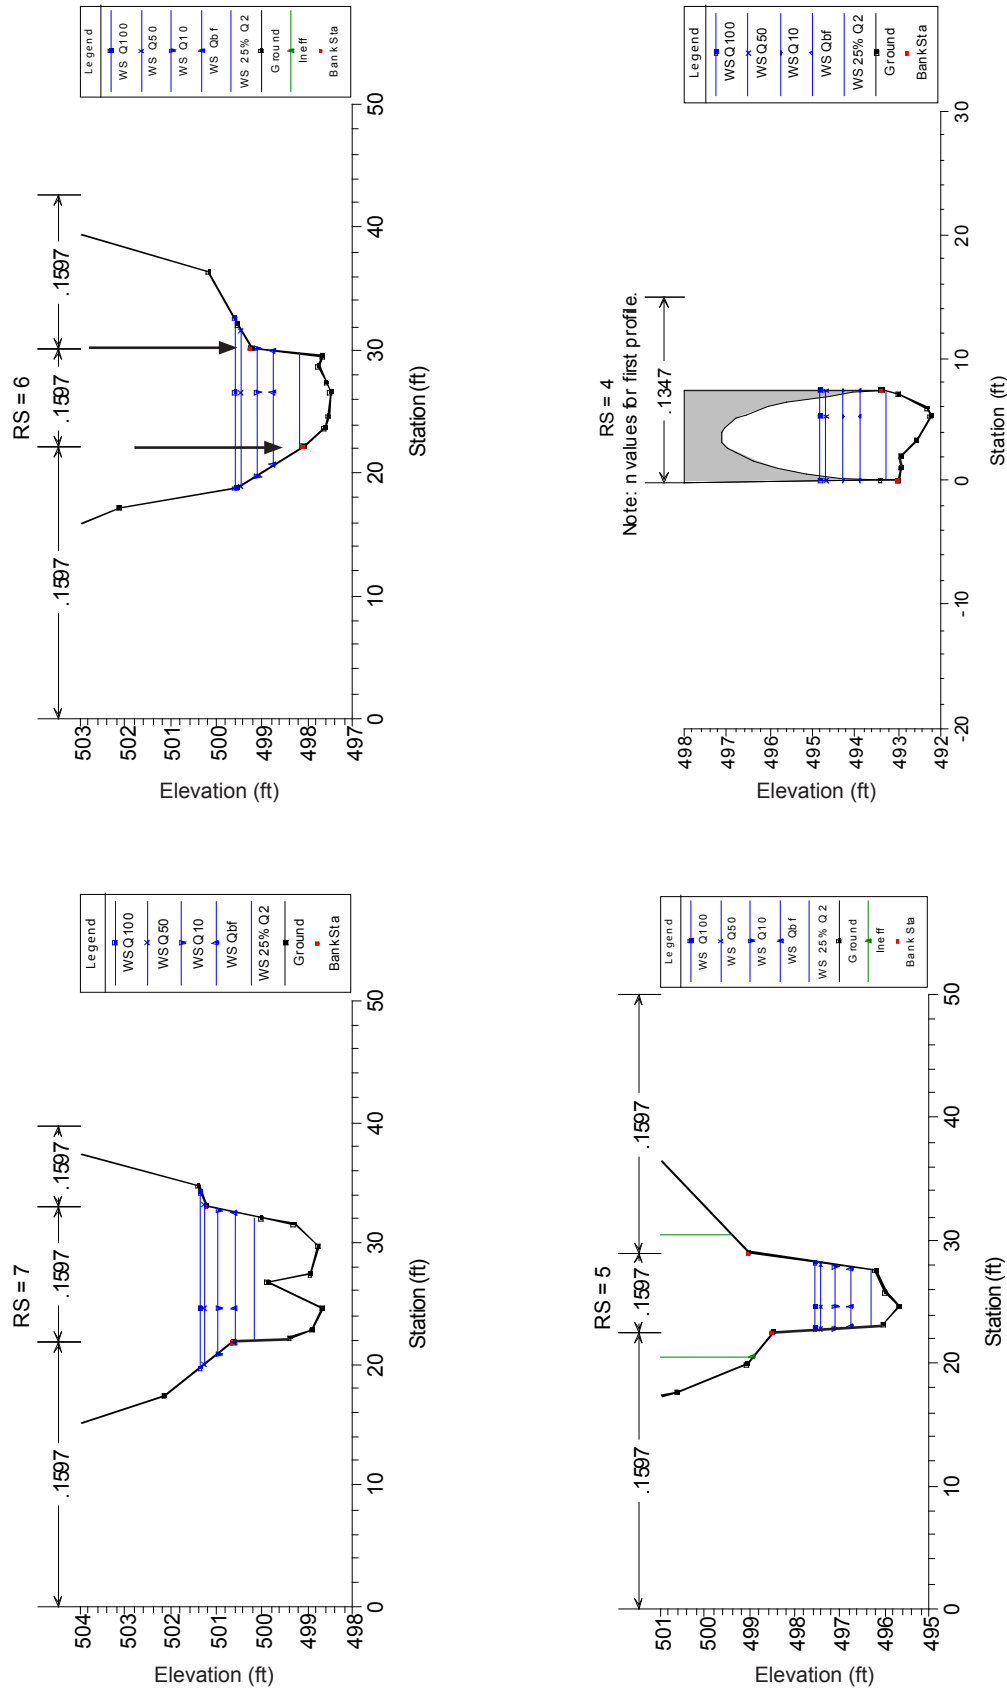
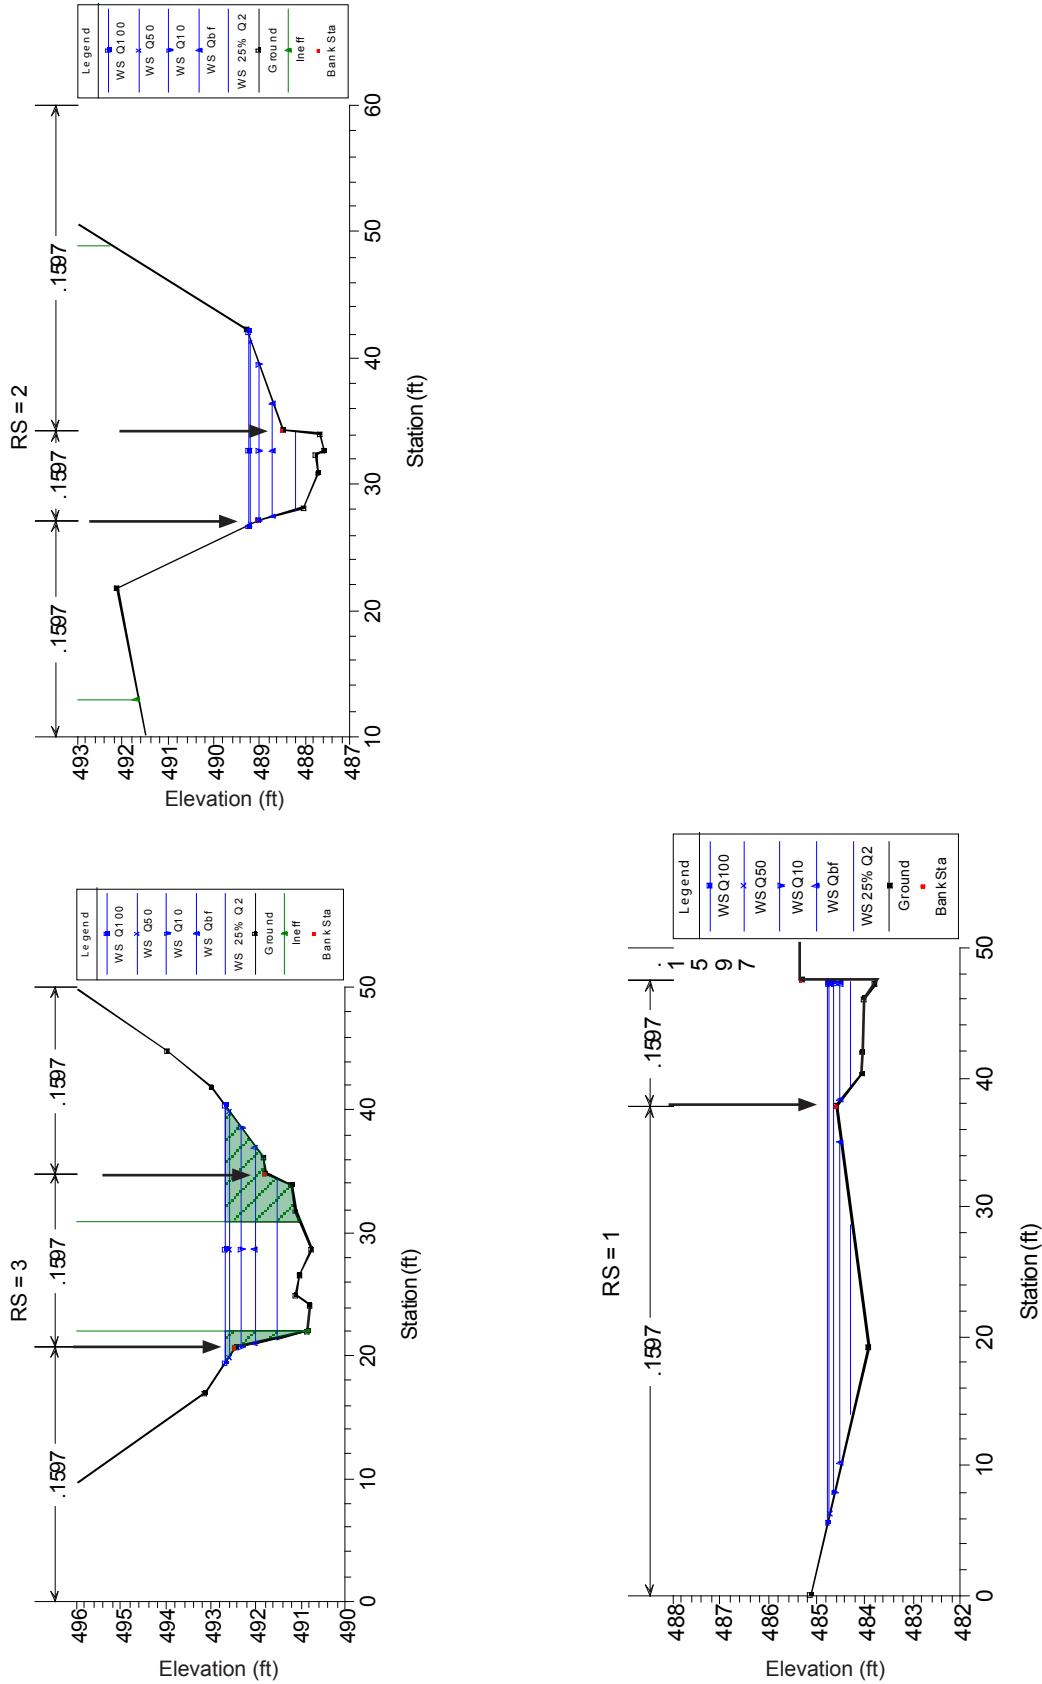
Cross-section characteristics – Cross-section characteristics in the culvert are very different in the upstream (scoured) portion of the culvert versus the downstream portion of the culvert (figures 5 through 9). In general, the upstream portion of the pipe has dramatically reduced flow area, wetted perimeter, hydraulic radius, top width, and maximum depth. The downstream portion has conditions that are more similar to the natural channel but generally have less variability. The box plots (figures 12 through 17) do not fully exhibit this pattern because the upstream profile segment in the culvert (F) extends downstream beyond the scoured portion of the pipe. The upstream transition segment has similar conditions to corresponding profile segments except for depth and hydraulic radius, which are greater in the transition segment. The downstream transition segments are mostly within the range of their natural counterparts except for top width, for which they have greater values.

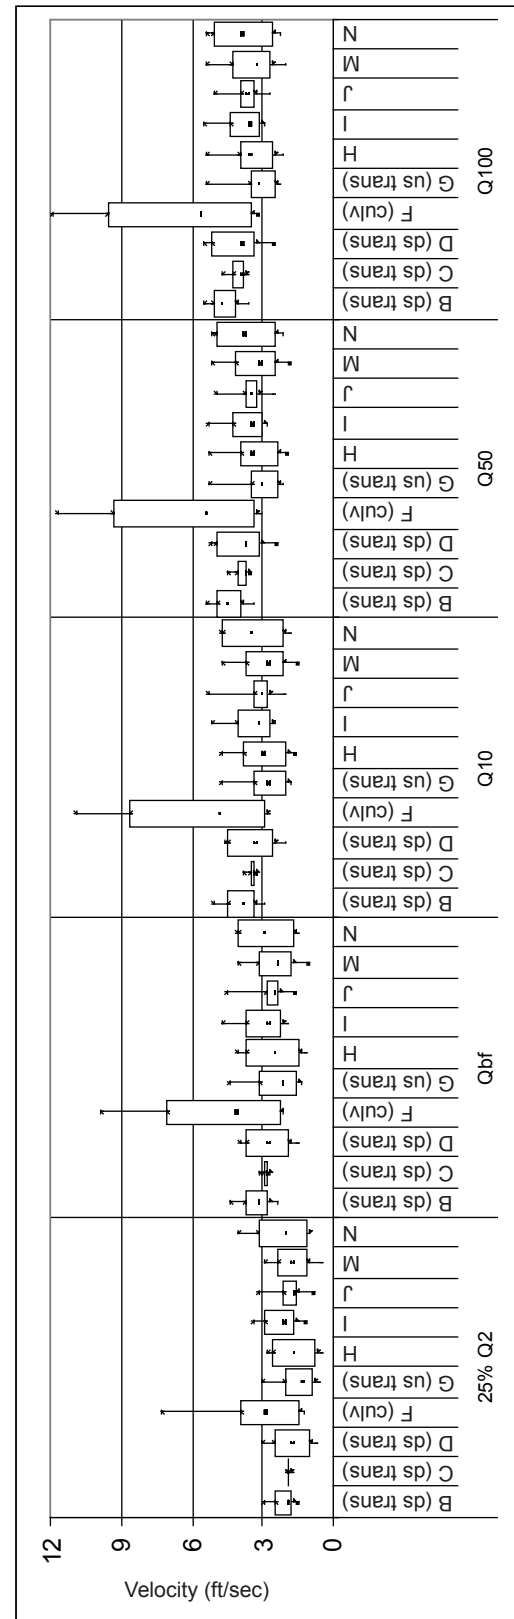
Figure 18—Velocity (channel).

Velocity – Velocity in the upper portion of the culvert is extremely high in relation to the natural channel (figure 11). The downstream portion of the culvert and the transition segments have velocities that are more in line with the channel outside the crossing.

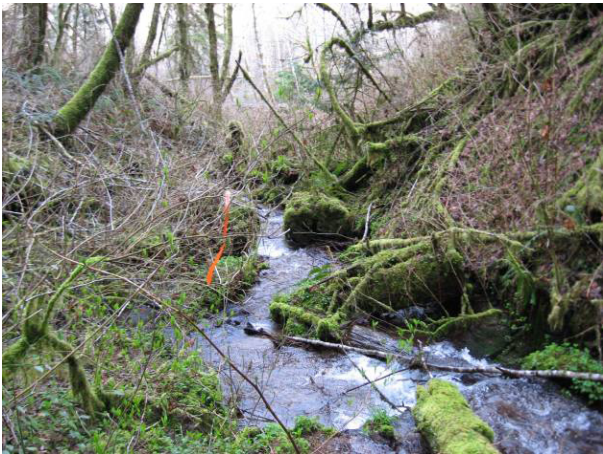
The upstream representative channel consisted of a high gradient step-pool channel with a narrow and low active flood-plain surface. The presence of large wood in the stream provides structure to the channel, making up the majority of the grade control. In addition to wood, large boulders also add to the structure of the steps. Plunge pools follow most steps and are interspersed by steep riffles.

View downstream from upstream end of upstream reference reach.

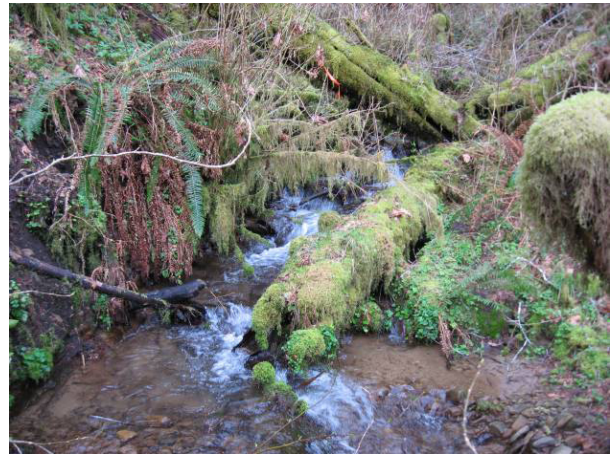
Upstream of the culvert, the step-pool channel has high complexity that is driven by the abundance of woody debris that forms the steps. If fish could pass the reach at the crossing, there is high quality and passable habitat upstream. In the current condition, fish passage would be blocked by the scour in the upstream portion of the pipe. The downstream riprap step is also likely to present a barrier to upstream fish migration. Even in the downstream portion of the pipe where material remains, the bed is fairly uniform, and lacks the step-pool character and complexity of the natural channel. There are also no channel banks in the culvert that would allow for terrestrial organism passage.

View upstream near downstream end of upstream reference reach.

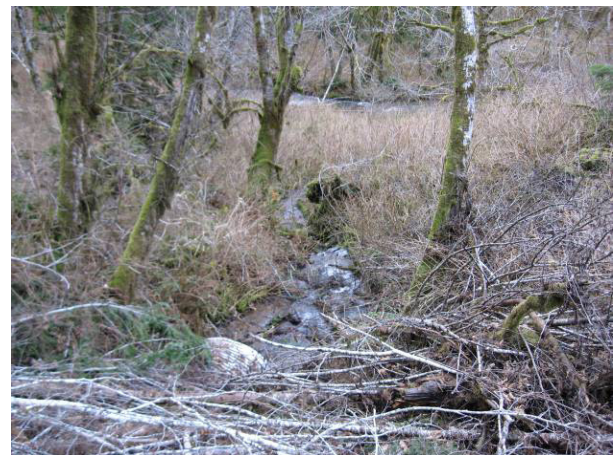
At the outlet to the culvert, the channel drops over a steep riffle. Downstream of the outlet there is a steep riprap step/cascade possibly built during or following construction to control the grade up to the outlet. After the step, the stream flattens out before entering the flood plain of Deadwood Creek. Large quantities of brush from roadside clearing were present downstream of the crossing.

View downstream from road.

Vegetation-clearing activities along the road should avoid depositing material in the inlet or outlet areas. This material can plug the culvert and can affect fish passage conditions.
