## Case Study 13. North Fork Consumnes River Tributaries Box Culvert Vented Fords

Central California. Eldorado National Forest, Placerville Ranger District. About 18 miles ESE of Placerville. North Fork Consumnes River basin. Meiss Cabin Road, Forest Road 52 upstream of Capps Crossing.

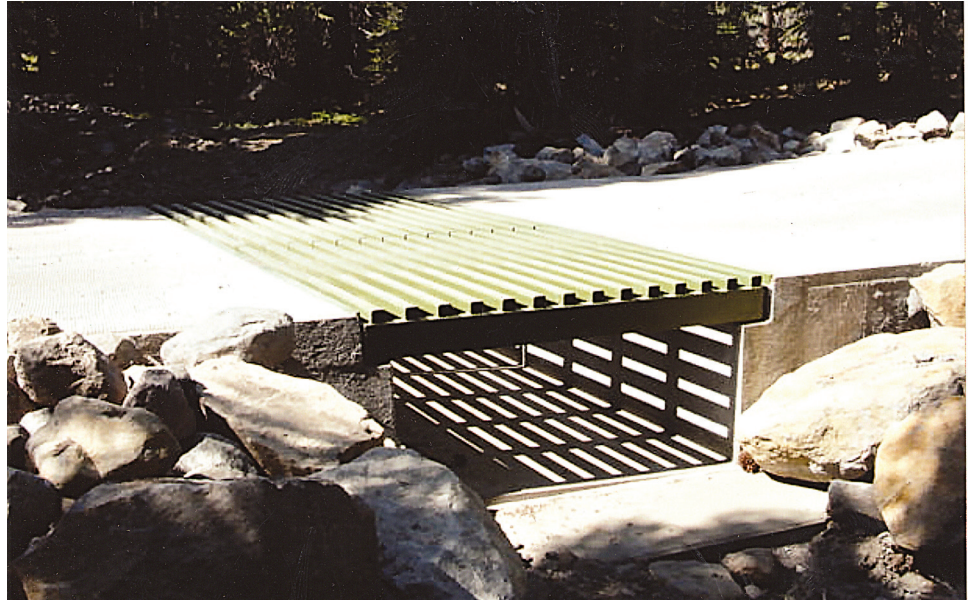
**Structure:** The structure is a small box culvert with an open top and cattleguard driving surface that can be removed for cleaning (figure A84). Concrete approaches dip into the ford, which has a total length of 75 feet (figure A85). The concrete box is 8 feet wide and 4 feet deep. The box floor slopes slightly perpendicular to the direction of flow to force low flow to concentrate in the trench at one side of the box. An upstream cutoff wall 9 inches deep runs the full length of the ford and is heavily riprapped.

Figure A84. Close up of grate-top vented ford.

All the vented fords functioned well during the large flood in January 2006, an estimated 85-year flow. They were overtopped, but not blocked or damaged, and flow was not diverted away from the stream channels. For durability and ease of maintenance, these structures appear to be very appropriate in these difficult depositional settings.

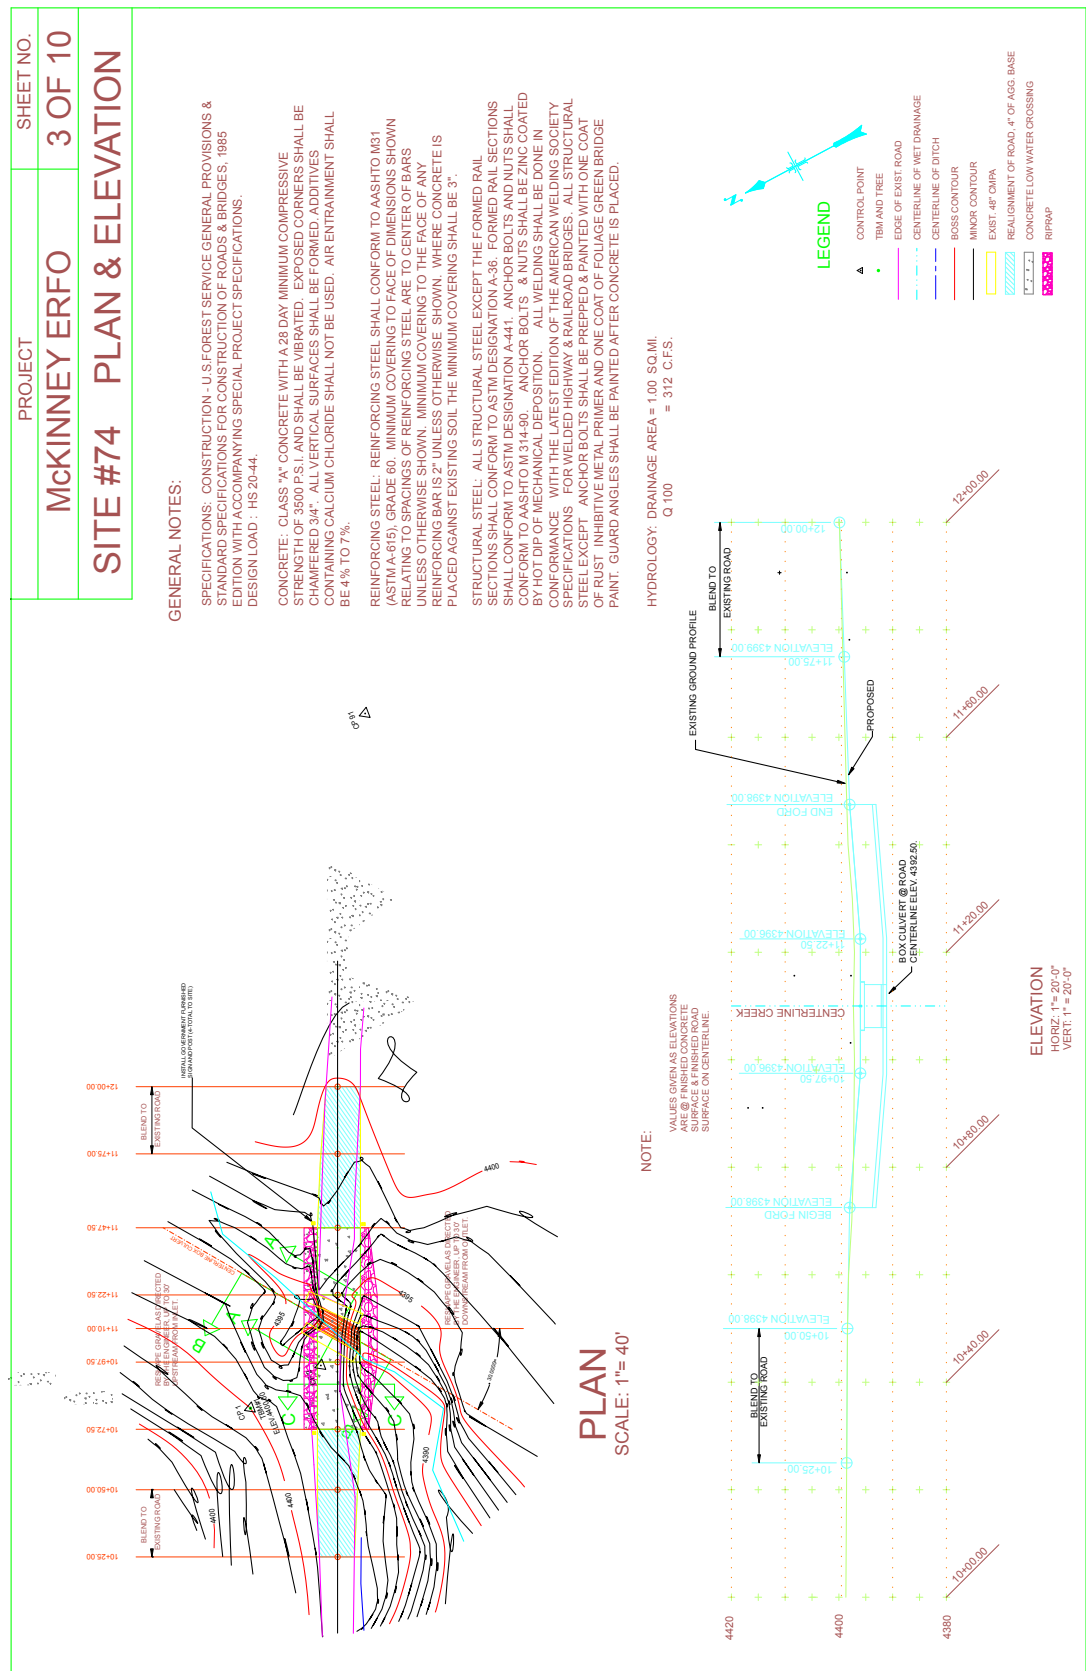
Figure A85—Site plan for McKinney Creek crossing, similar to Meiss Cabin Road box culverts but without the tilted floor. A full size drawing may be found on the CD included in the back of this publication.
