## Case Study 19. Mill Creek Embedded Box Culvert Vented Ford

Southeast Missouri. Mark Twain National Forest; Houston-Rolla Ranger District. Southeast of Rolla, south of Interstate 44, off of State Road P: Forest Road 1576. Mill Creek, tributary of Little Piney Cr, Gasconade River basin.

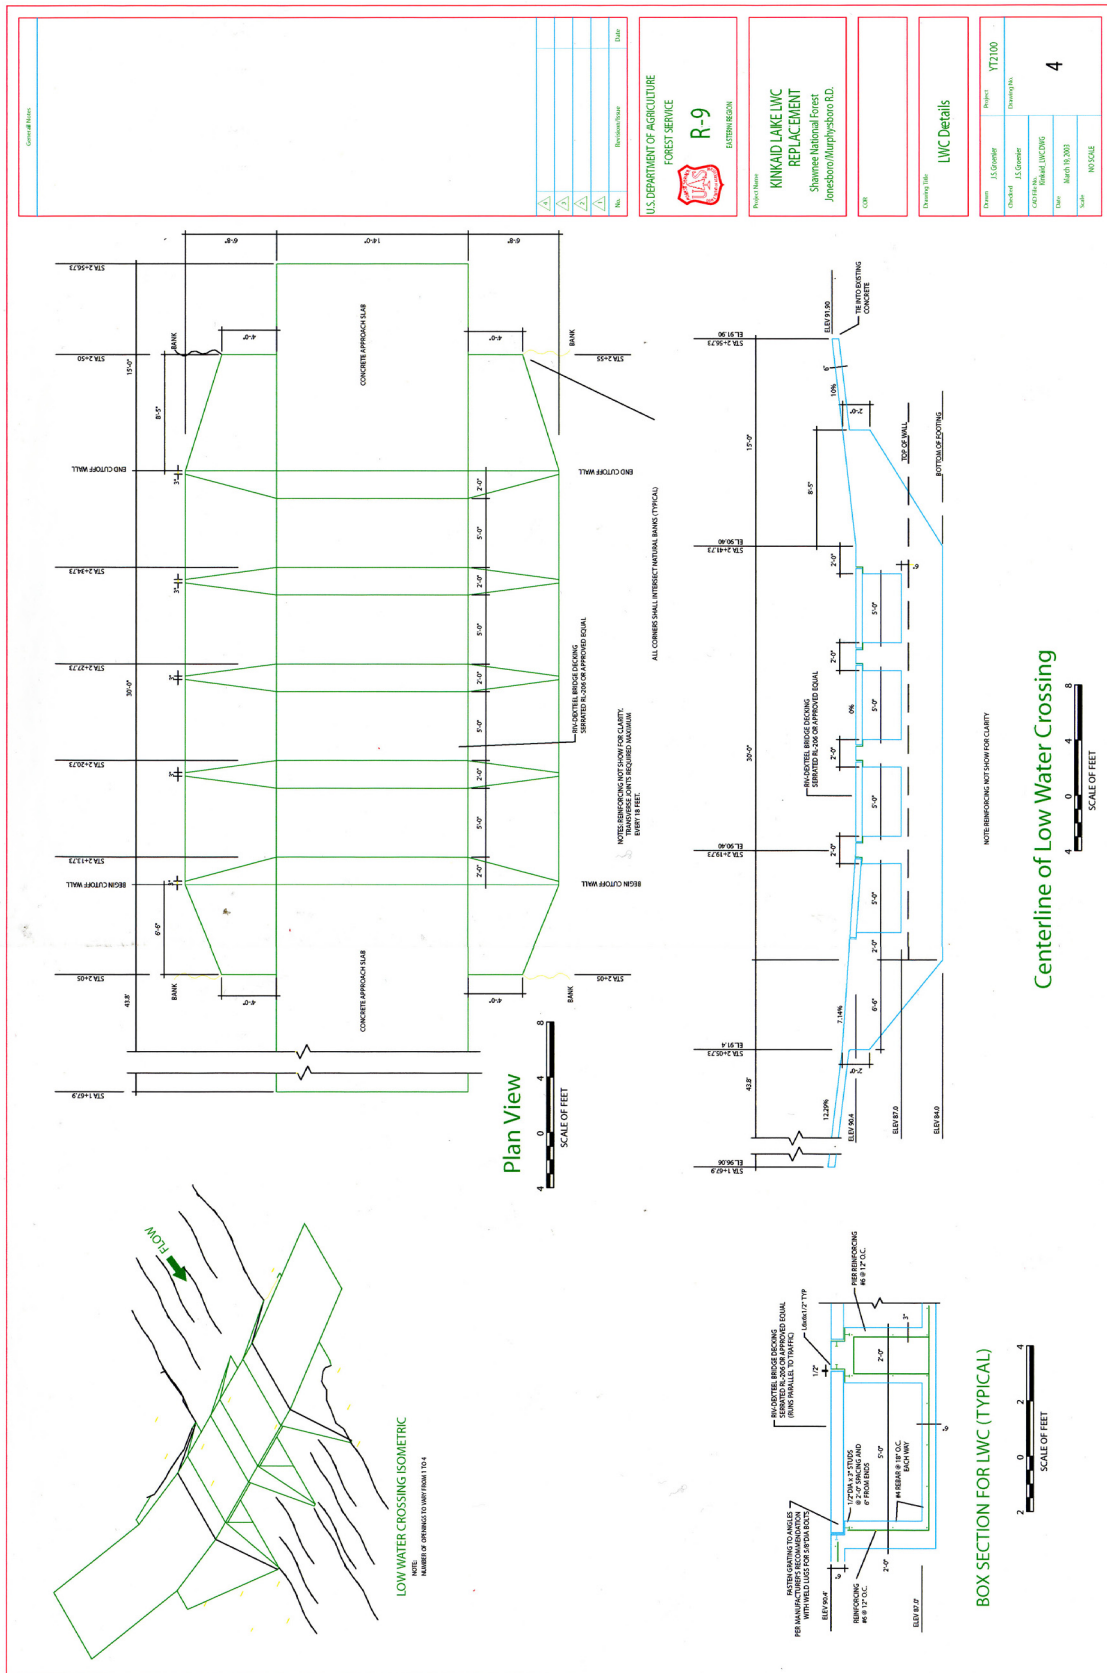
Figure A127—Plans for Kinkaid low water crossing replacement, 2001. A full size drawing may be found on the CD included in the back of this publication.

Sustained concentrated rainfalls of several inches per day cause peak flows in this area, and peaks on Little Kinkaid Creek are very flashy. Since traffic use is low and would be interrupted only a few hours during any one runoff event, a low-water crossing was a desirable and cost-effective solution here. However, the design had to account for the unstable, erodible banks and tendency for debris and bedload plugging. The designer selected a very low-profile structure to encourage woody debris to go over the top and to avoid large changes in flow width that would put pressure on the banks at bankfull and higher flows. The structure is a set of four 5-foot-wide concrete boxes with metal-grate decking that can be removed to clear the boxes. The box walls slant out and down, as at Mill Creek, to help debris slide over the top (figures A126 and A127).

The 3-foot-high boxes are embedded about 1 foot into the streambed for fish passage (figure A126a). The boxes were allowed to fill naturally with streambed material, and in this case the streambed was mobile enough (medium to coarse gravel) and the sediment supply high enough that no headcut resulted. The streambed in the boxes has maintained itself successfully through two approximately normal rainfall years.
