## Case Study 8. Agua Fria River Concrete Slab Ford

North Central Arizona. U.S. Department of the Interior Bureau of Land Management Agua Fria National Monument, near Horseshoe Ranch. Approximately 15 miles North of Black Canyon City, AZ, and 3.1 miles south of Cordes Junction, Bloody Basin Road, east of I-17. Forest Road 269.

This ford was constructed in 1994 on a perennial to intermittent fish-bearing stream. It is a reinforced-concrete slab with concrete approaches. The surface is slightly raised above the streambed surface, but it allows fish passage when the structure is submerged.

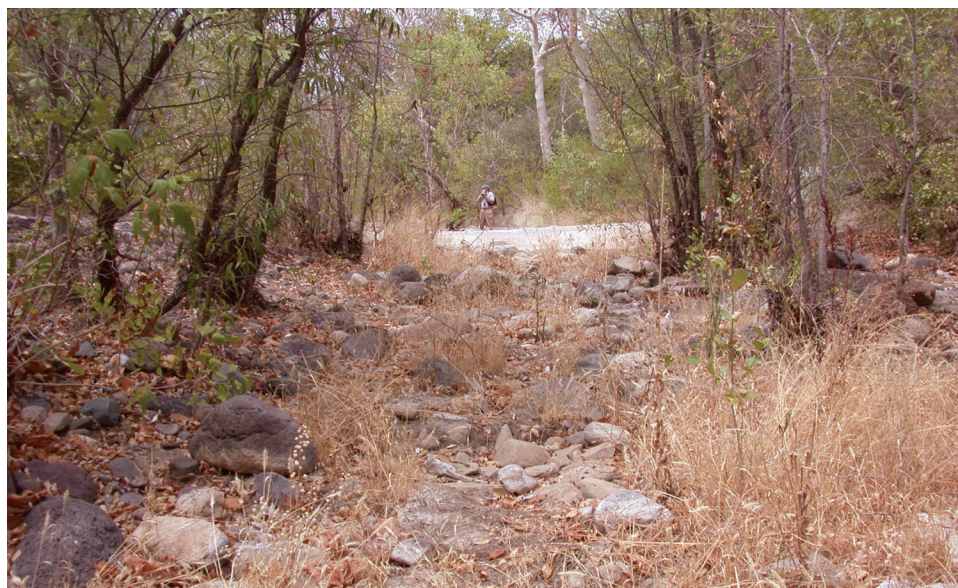
Figure A49. Cave Creek looking downstream toward the ford.

The ford is 50-years old. It has been through many desert floods, including the major 100-year-flood event of 1993. Its concrete surface is battered and has been repaired or extended on both ends. Flows have partially outflanked it at some times in the past, so grouted riprap and pieces of concrete and rock have been placed along the approaches to control scour (figure A51). Downstream scour occurred at some point in its history, leading to the construction of the concrete apron, which currently provides adequate protection against scour. The ford has not received any maintenance since the late 1980s. The structure is appropriate to this high-energy site since it provides for free passage of debris and rock during high flows and there are no aquatic animal issues.
