FHWA-FPL-93-004

July 1994

Project Report for Launched Soil Nails— 1992 Demonstration Project

Volume 2

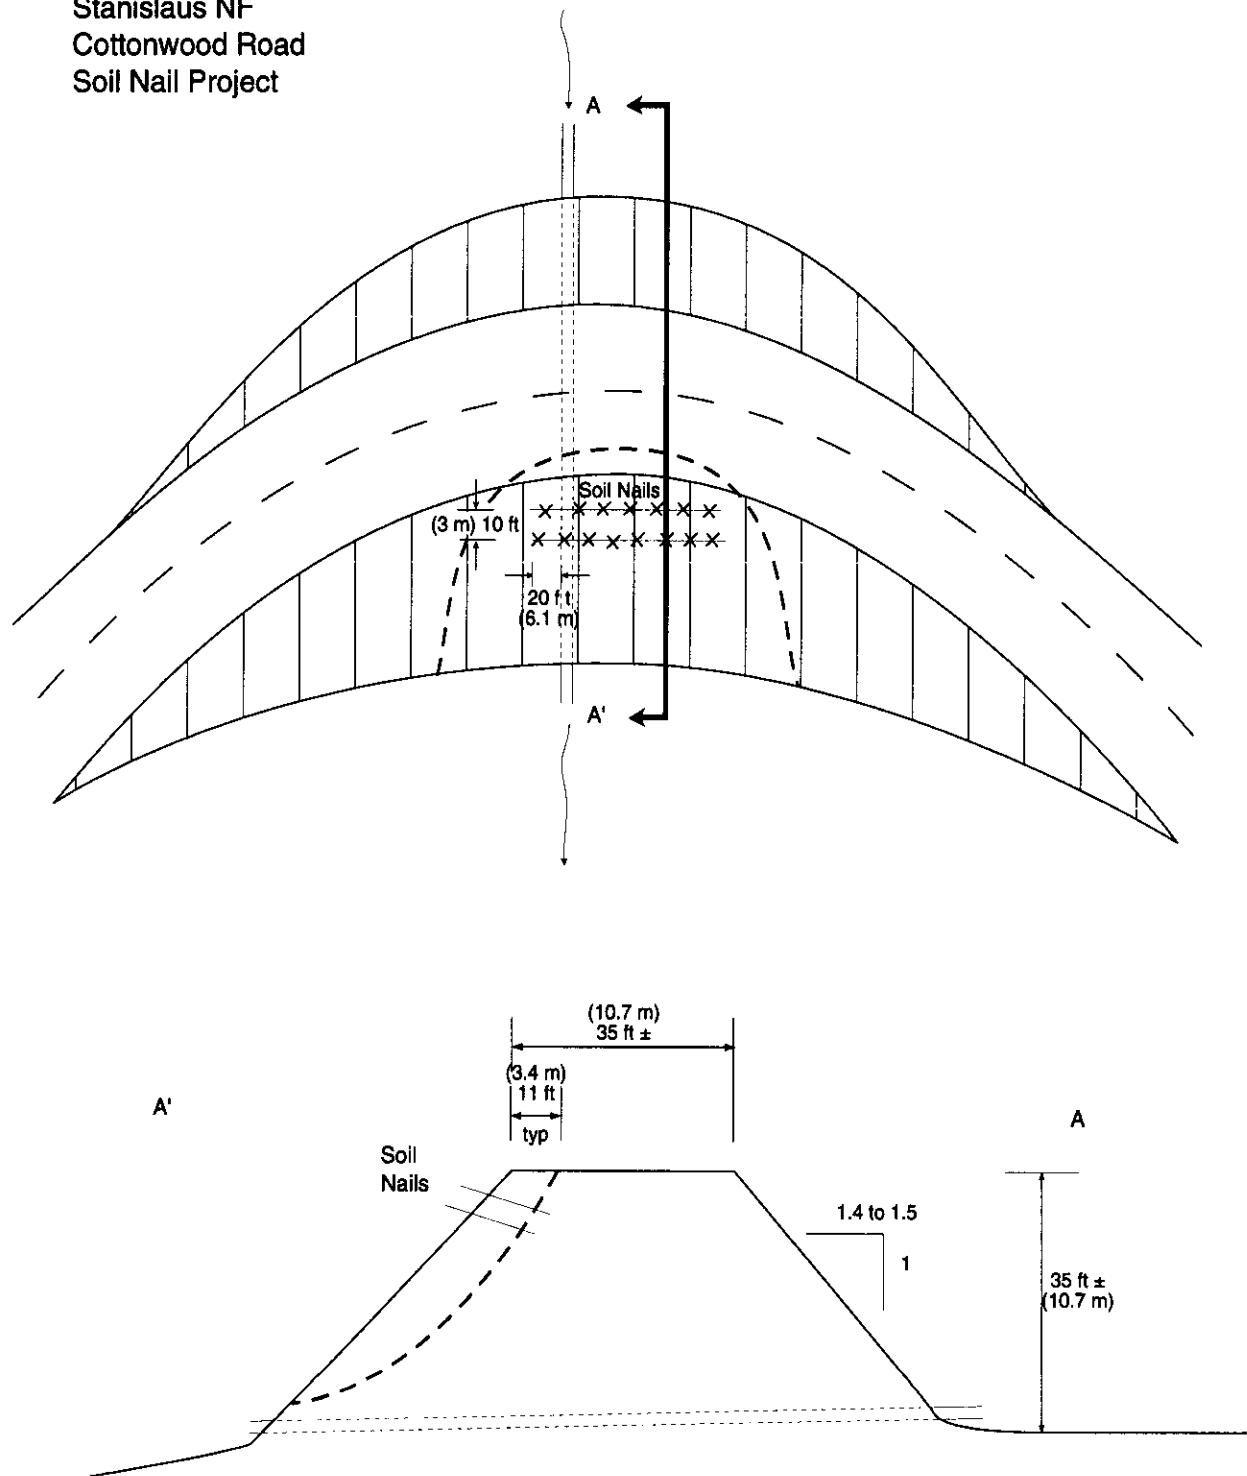
Site 4, Sketch 1

Site 4	Stanislaus National Forest Cottonwood Road Sonora, California
Site Type	Fill Slope Stabilization
Site Description	This site is a through fill constructed of silty to clayey soil about 35 feet high on a double-lane paved road (site 4, sketch 1). The area had failed in previous years. In 1991, an underdrain costing about \$30,000 was installed in the embankment to remove water seepage noted in an earlier failure. The area continued to slide after the drainage system was installed.
Demonstration Description	Two rows of soil nails on about 20 foot (6.1 m) centers along the road were installed in 100 foot (30.5 m) length of the embankment. About 15 nails were installed in two rows (see Site 4, sketch 1).
Results	There was no slippage of the nailed area during the 1992-93 winter and about a 1 inch (25 mm) drop during the 1993-1994 winter. The movement was much less than before nail installation. The launched soil nails appear to be a cost effective solution to this problem if movement is stopped over the long run. The Stanislaus NF representative, Richard Wisehart, indicated the nail solution would cost about one-third of the cost for the drainage attempt (at \$135/nail).

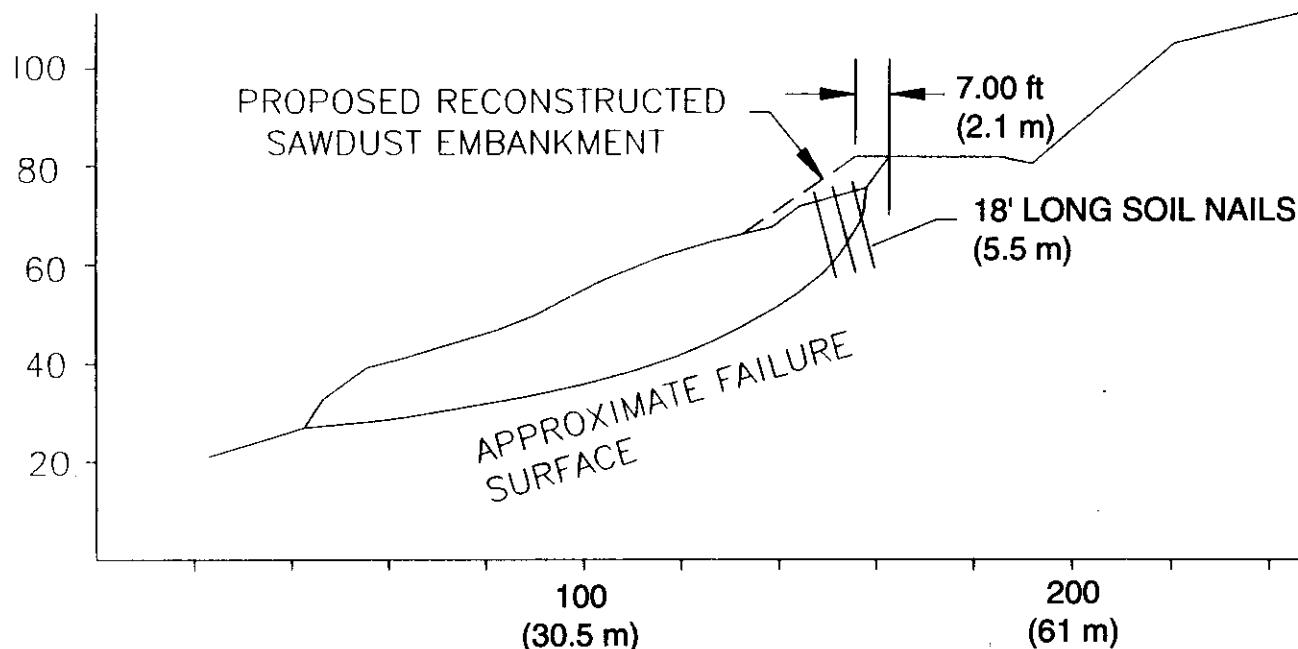
Site 6, Sketch 1

The slide is approximately 120 feet long and 150 feet wide (see the attached cross-section, site 6, sketch 1, and photo 19). Movement is rotational with a very steep 5-foot headscarp near the top and probably translational towards the bottom. The soils exposed on the headscarp and most of the slide's surface is stiff, moist medium-plasticity clays with some silt near the toe. There has been seepage from the headscarp and from the base of the blanket drain.

100 (30.5 m) 200 (61 m)
 SOILS: MAIN SACRP AND BODY OF SLIDE
 STIFF MOIST MEDIUM PLASTICITY CLAY (CL)

AT TOE OF SLIDE
 MOIST SILTS AND CLAYS (ML'S AND CL'S)

Proposed repairs for the site included intercepting the failure surface with about 50 soil nails in two or three rows over approximately 90 feet (27.5 m). The concept was to stabilize the top of the slump block as a base for a lightweight sawdust fill.

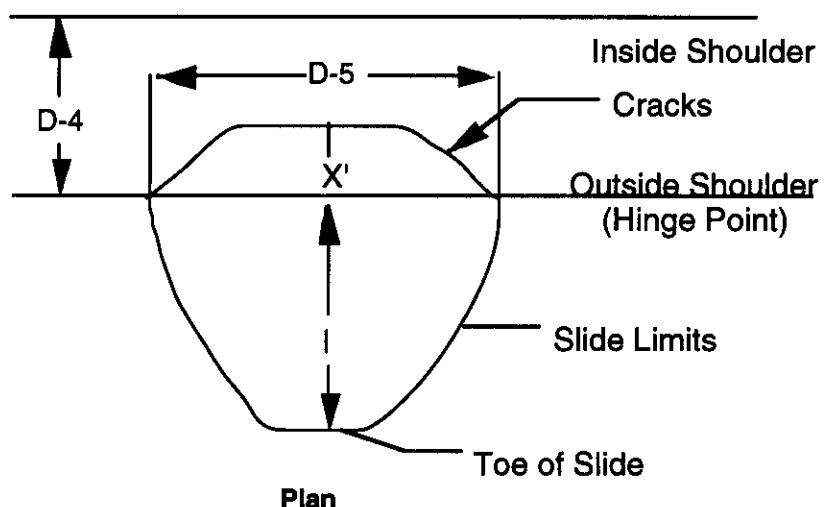
Site 8, Sketch 1

General Site Description: Pavement drops yearly an inch or more on fill slope side of road. Wet areas behind road and along ditch. Soils are sandy elastic silts.

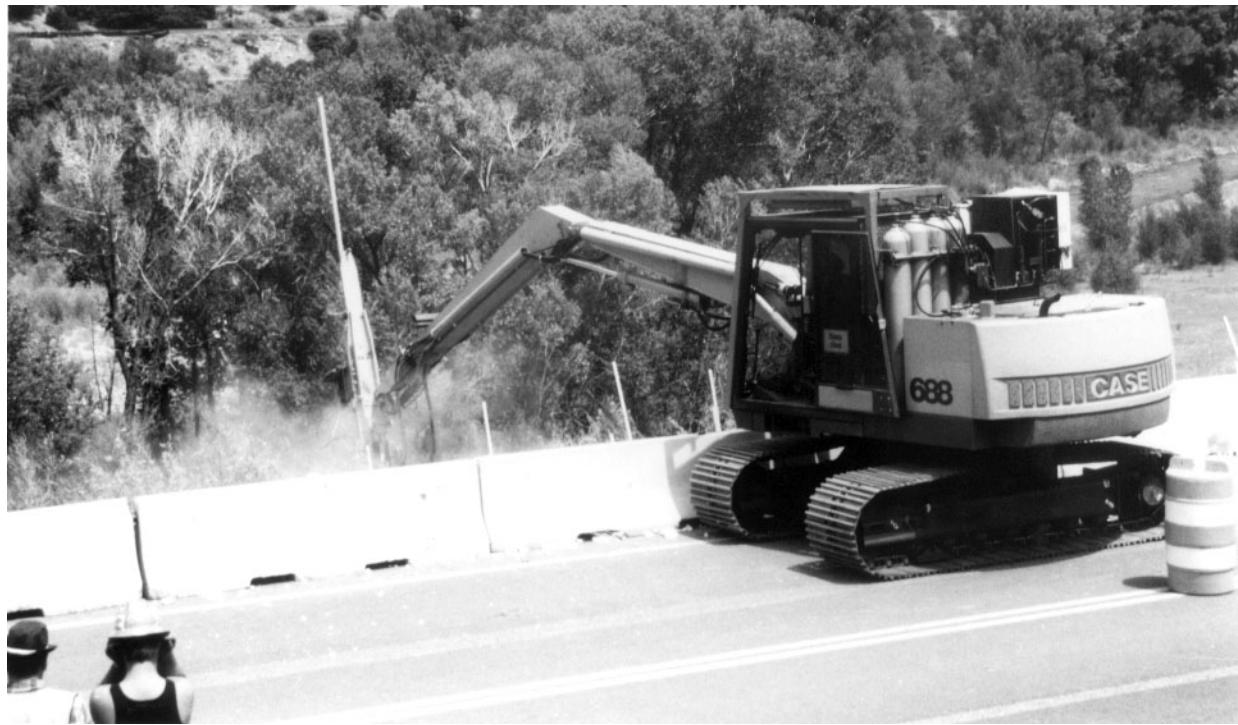
Photo 13. Reaching over a temporary guardrail to nail a failing slope in Colorado.

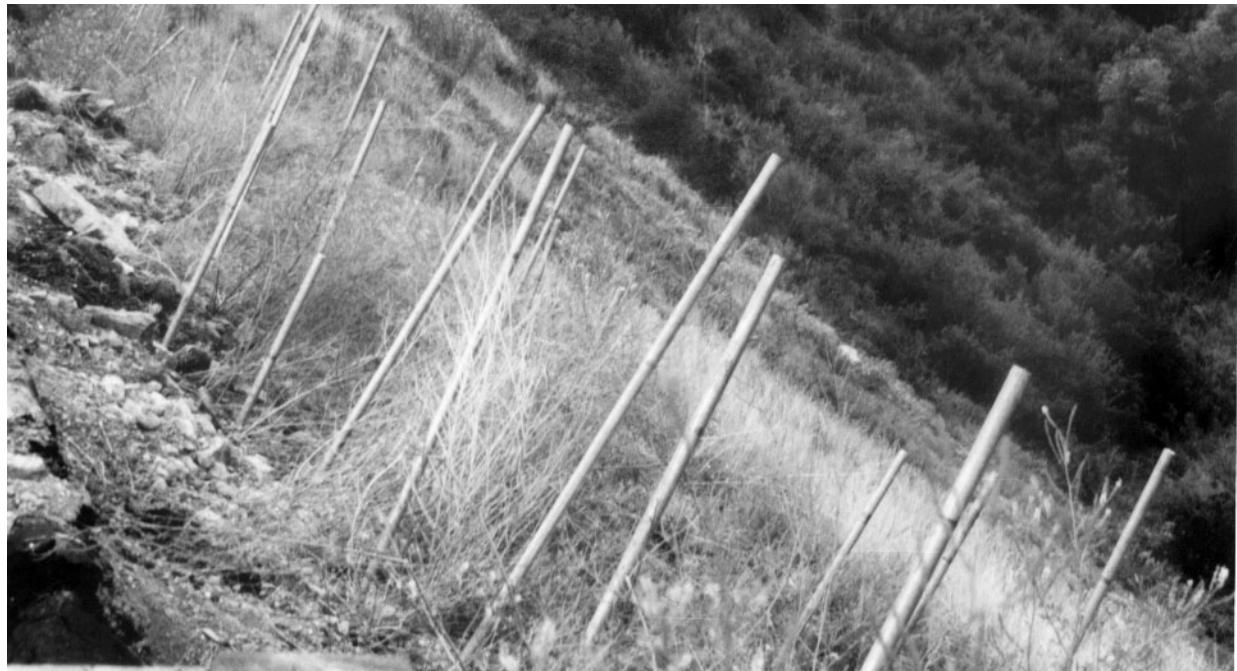
Photo 14. Three rows of launched soil nails in the slope in photo 13 before cut-off of the nails.

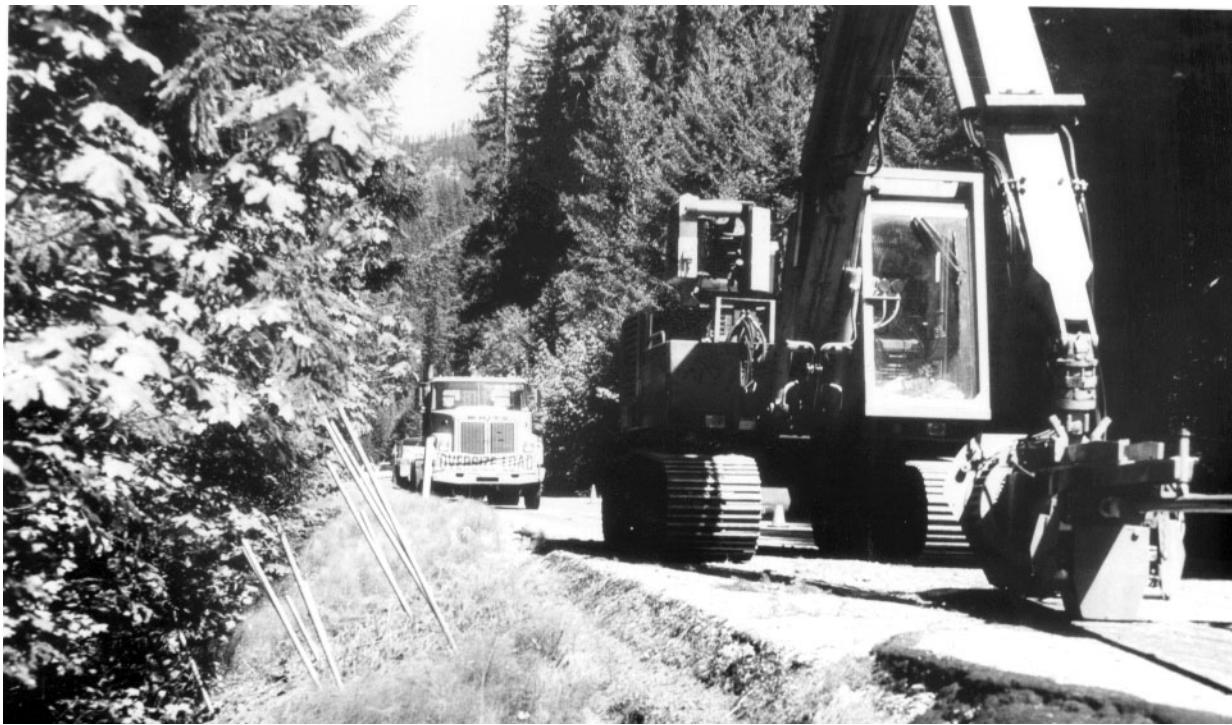
Photo 15. Excavator, launcher, and transport vehicle adjacent to installed nails. Note three rows of nails installed without disturbing the vegetation.

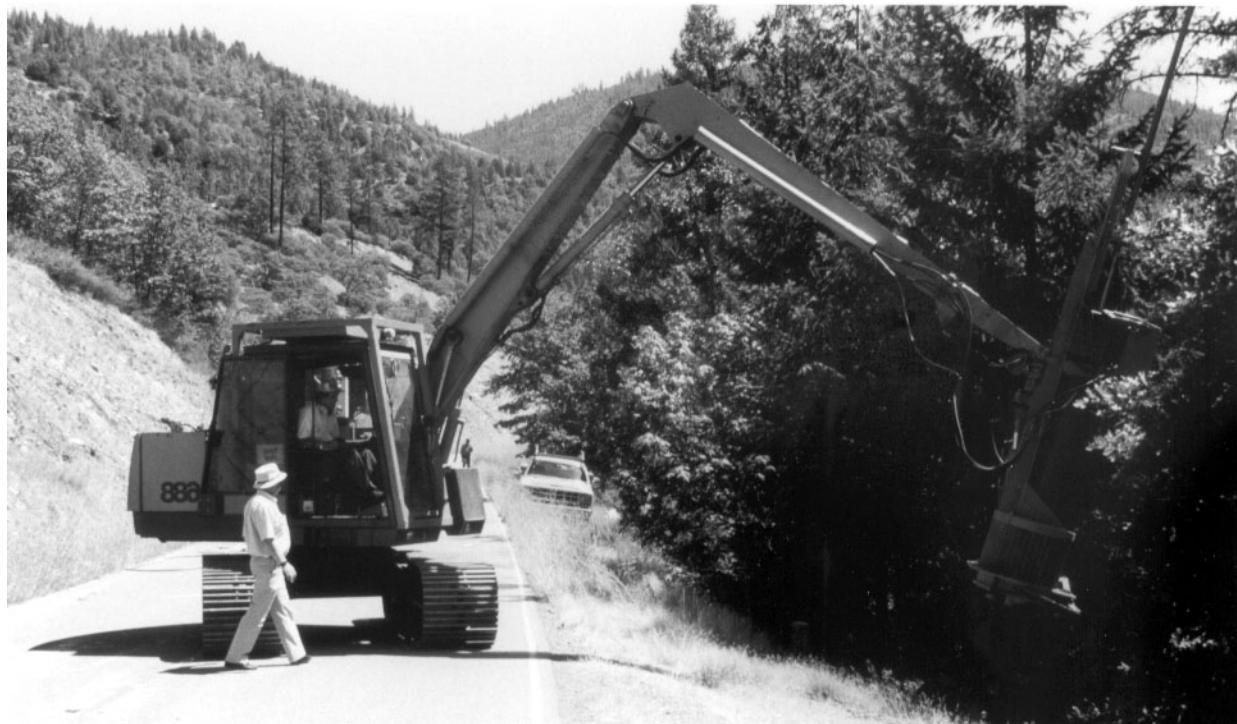
Photo 17. Positioning the soil nail launcher without removing roadside vegetation.

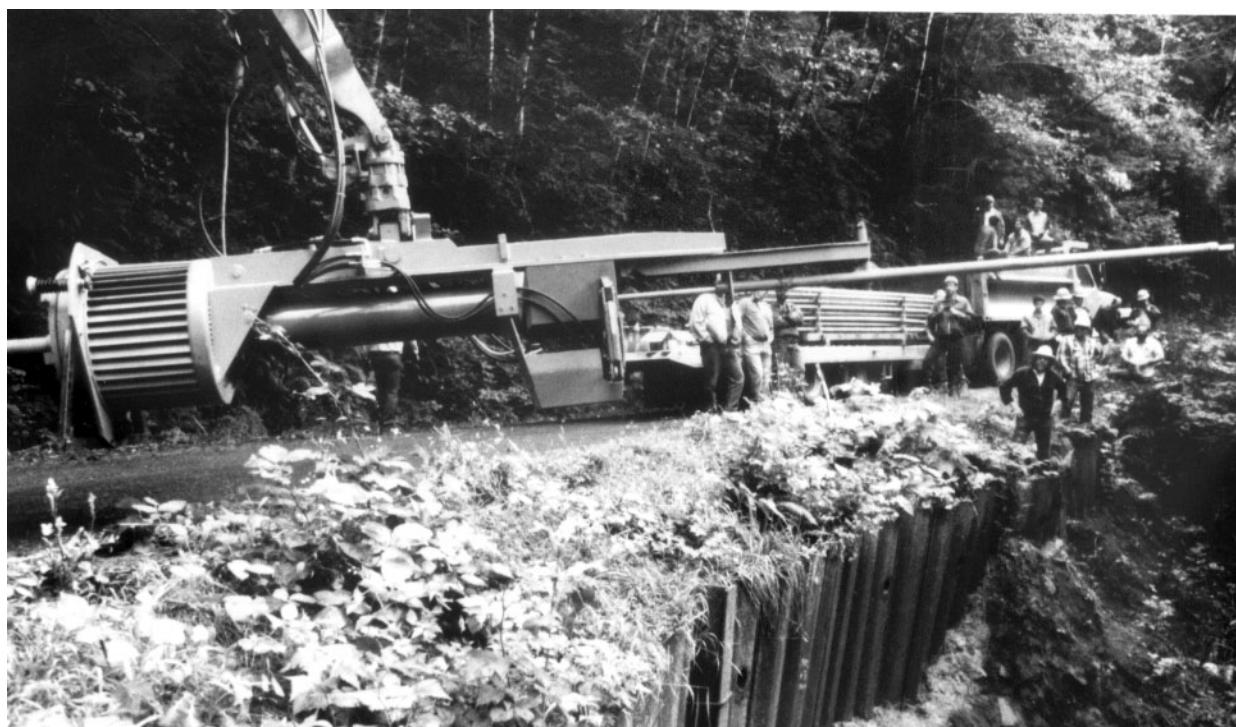
Photo 21. Positioning the launcher for installation of the soil nails.

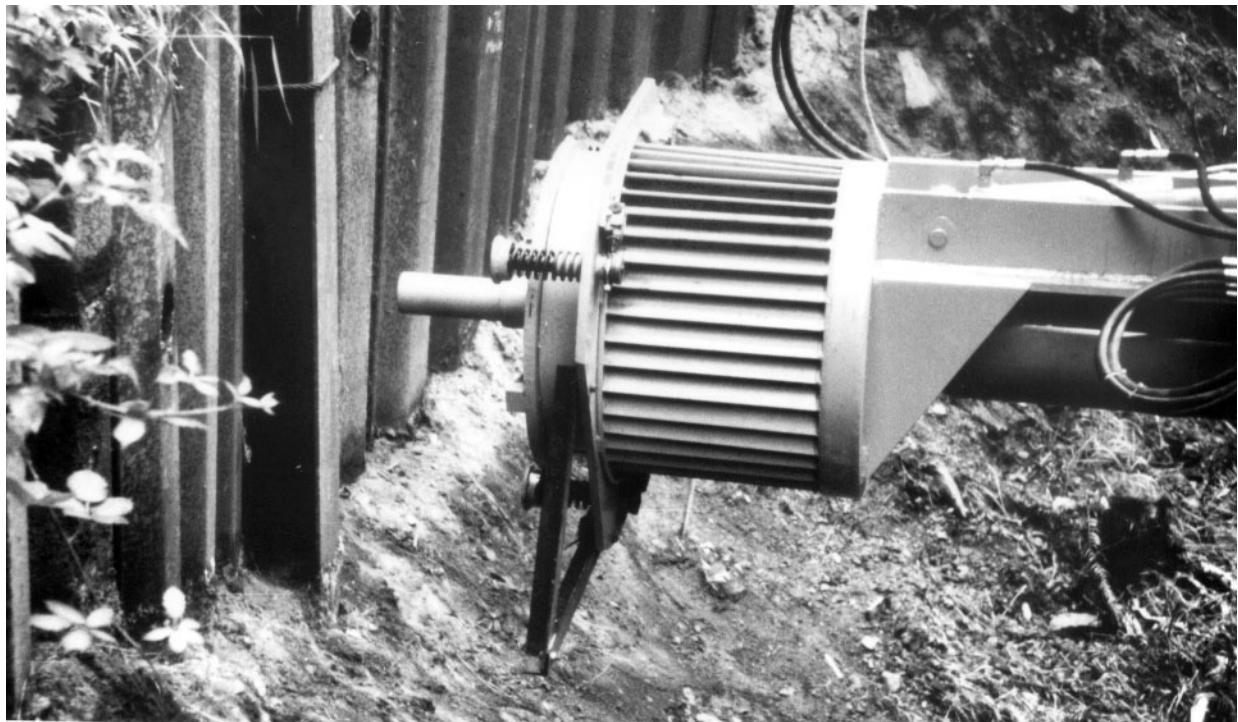
Photo 22. The launcher approaching the wall. Note the guide tube attached to the launcher to guide the nail into the hole.
