Fisheries Monitoring Results 2006-2009

Prepared by: J. Greenway, Fisheries Technician

Reviewed by: Caleb Zurstadt, West Zone Fisheries Biologist

December 17, 2009.

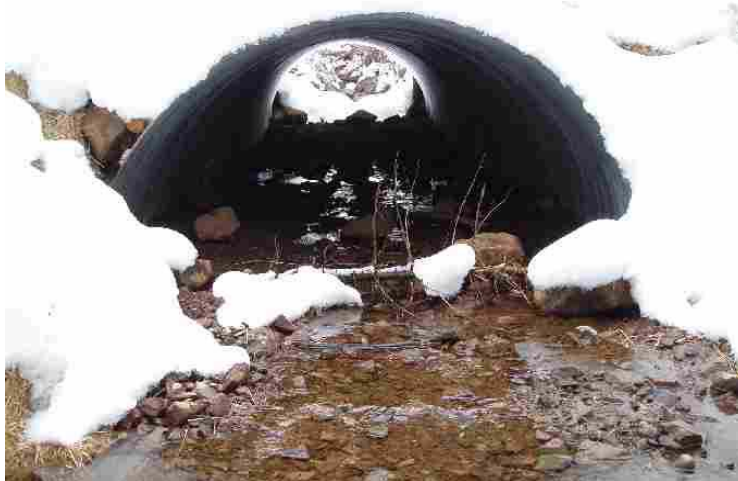
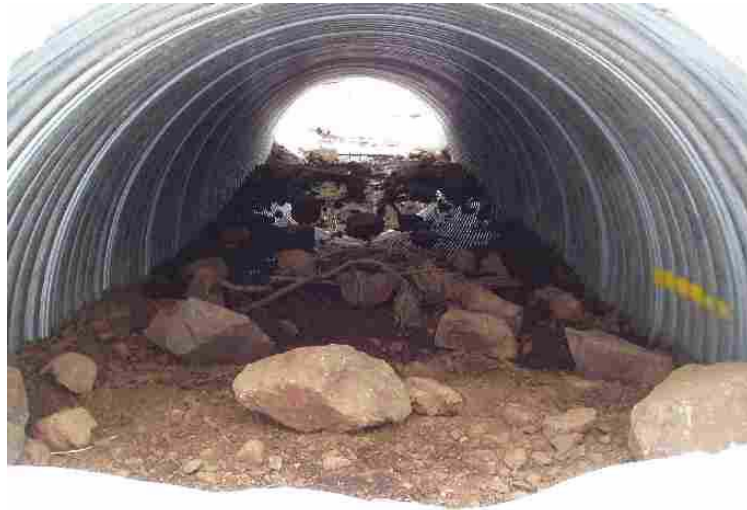
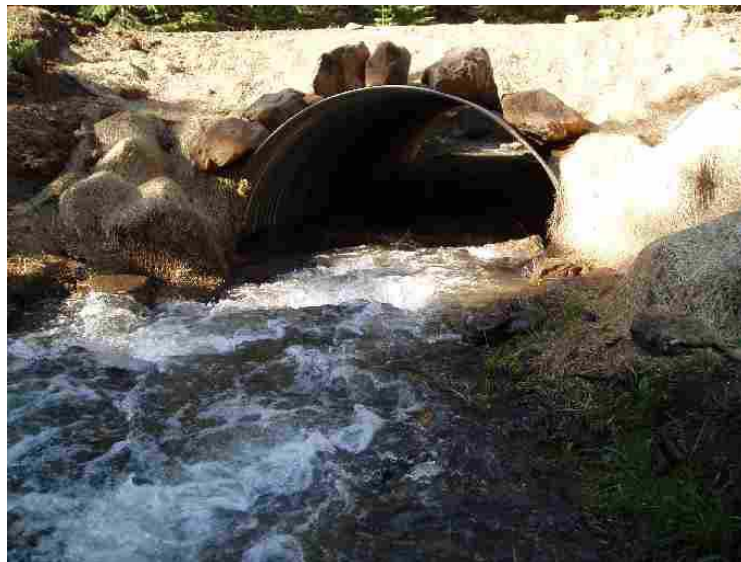
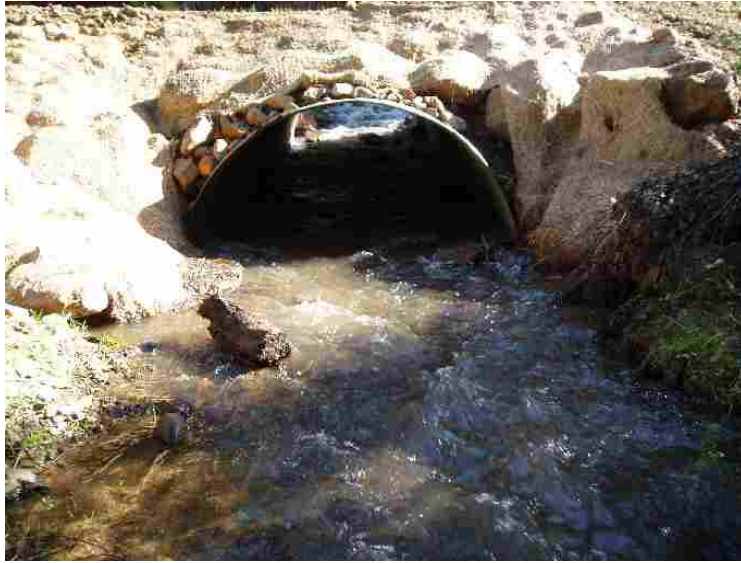
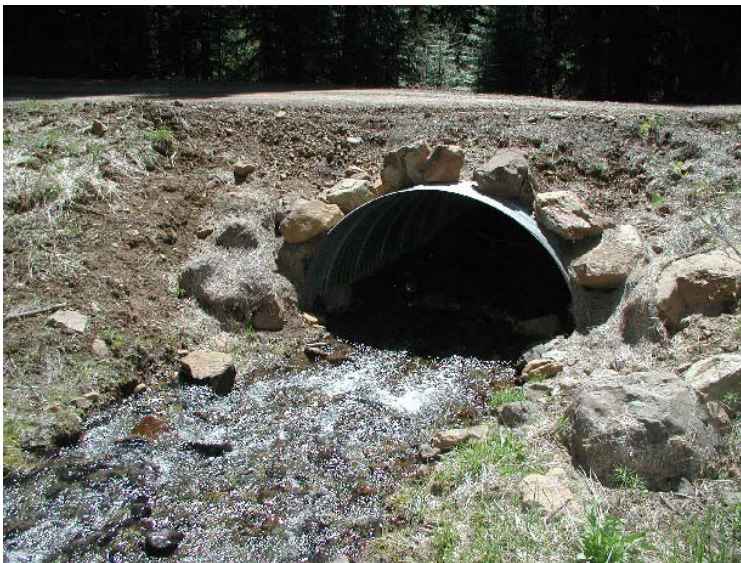
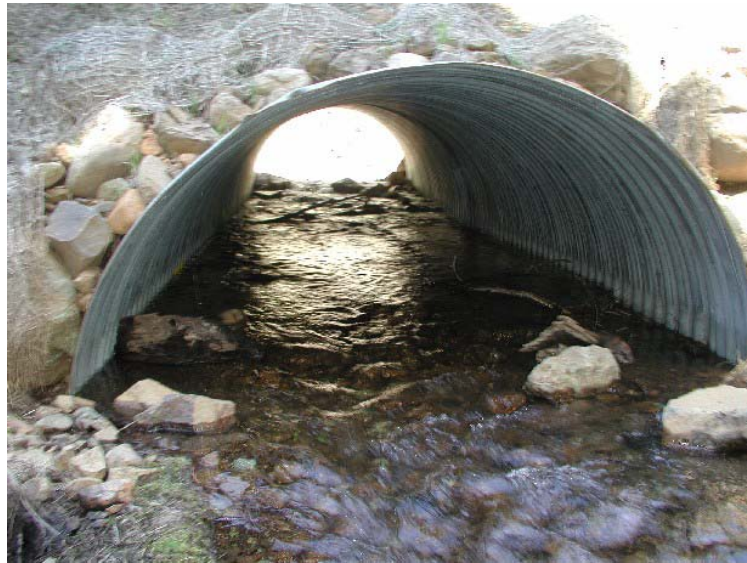
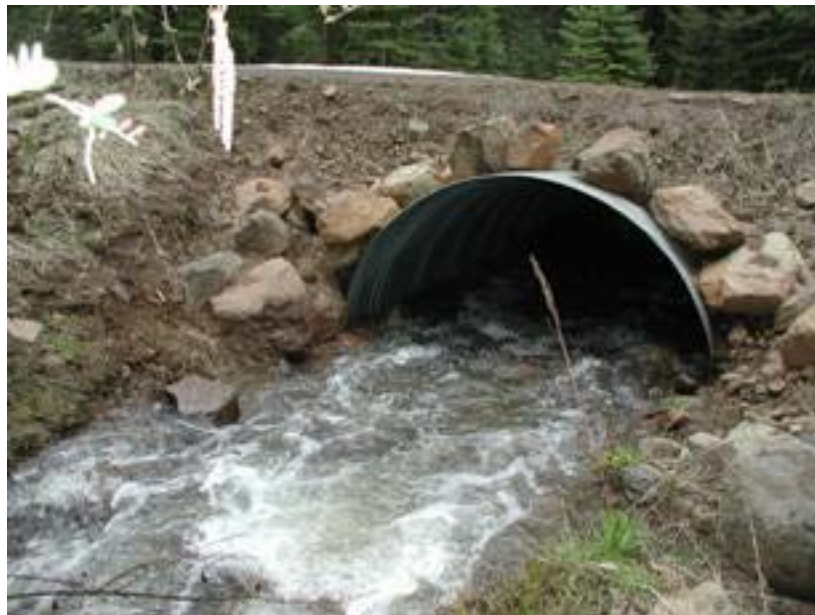
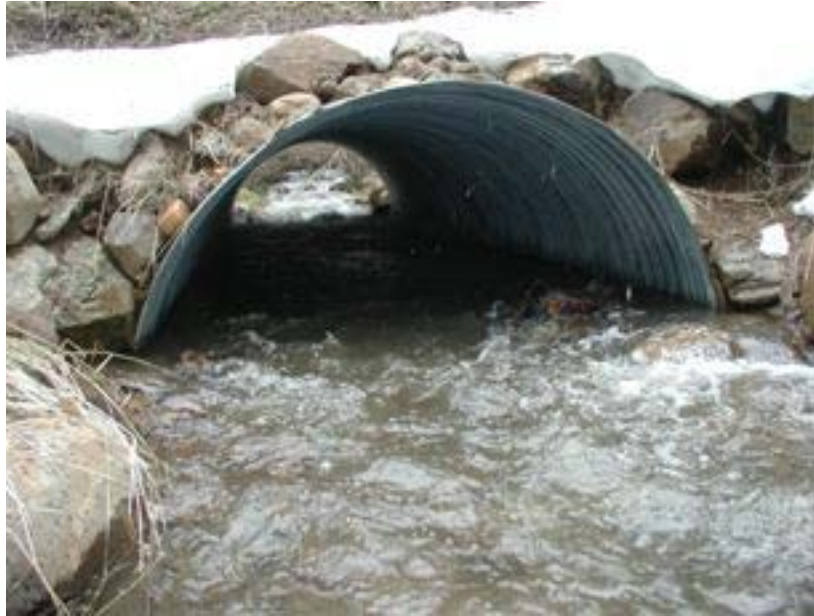
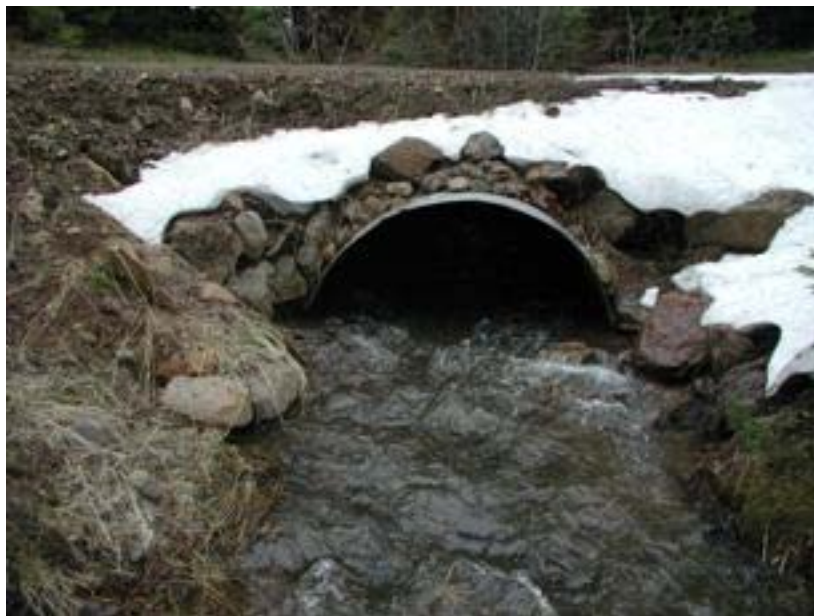
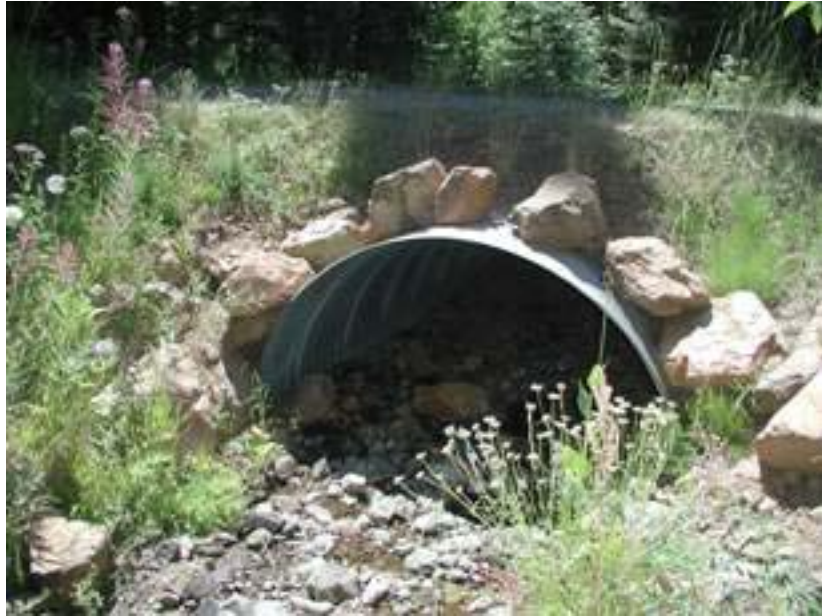
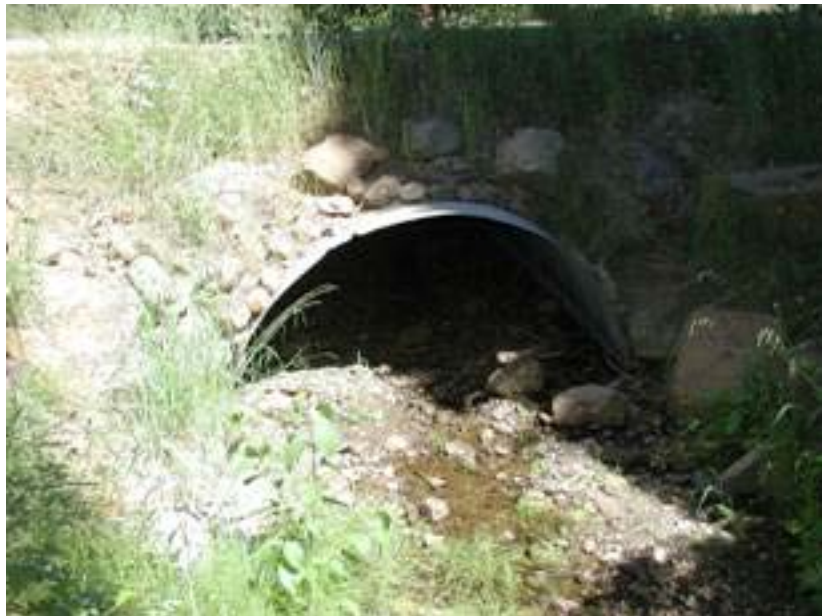
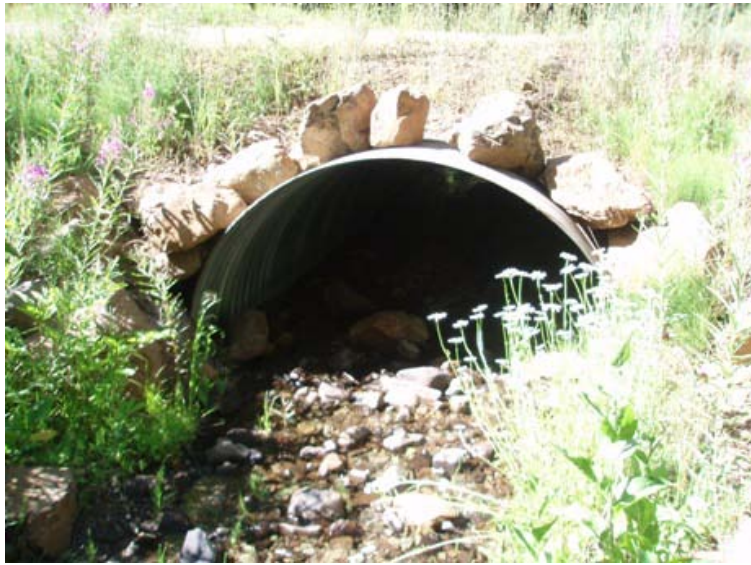
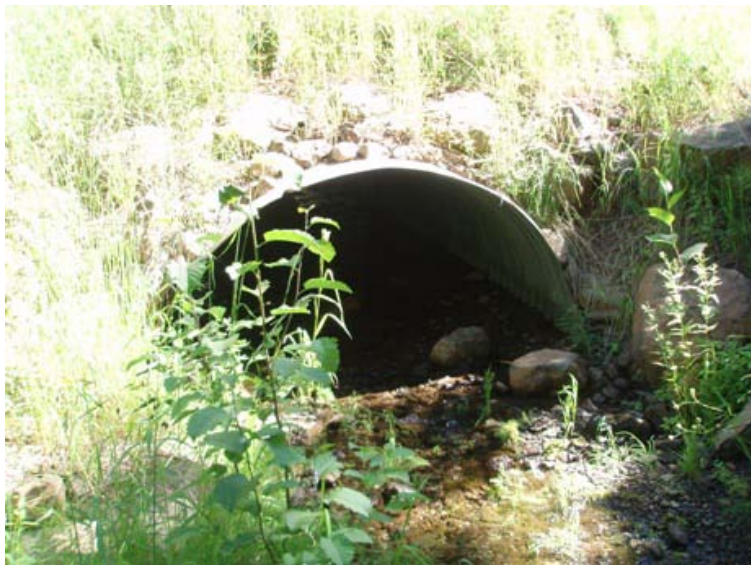
Two of five culverts identified in the Upper Bear EIS were replaced in 2005. The two culverts, one on Bessie Gulch (Bear Creek tributary)(FS Road 130) and the other on an unnamed north bank tributary of Bear Creek (FS Road 110) were visited by west zone fisheries personnel on multiple occasions. The Bessie Gulch culvert is located at UTM 0530893 4991965 and the unnamed tributary is located at UTM 0529676 4991815. Culverts were photographed once in November of 2005 after they were installed, in May of 2006 when streams were near bankfull flow and annually since. Photographs were taken at the inlets and outlets of both of the culverts.

Photos of the culverts replaced in 2005 are located in [Figures 9-39](#). During spring flows the culverts appeared to provide natural stream simulation. Some down cutting occurred at the inlet of the Bessie Gulch culvert ([Figure 25](#)). The stream channel headcut to a grade control created by a LWD jam. The inlet of the culvert has retained a substrate covered bottom, but the depth of substrate was less than when the culvert was placed, especially at the upstream end. The substrate retained in the culvert in 2009 was similar to 2008. All erosion control measures such as straw mats and bales were in place and appeared to be effective. The culvert on the unnamed tributary of Bear Creek (FS 110) appears to provide natural stream simulation under all flow conditions. Under low flow conditions in 2009, the stream channel was split and flowed along the edges of the culvert, but still provided adequate stream simulation. Vegetation has become established at both of the stream crossings.

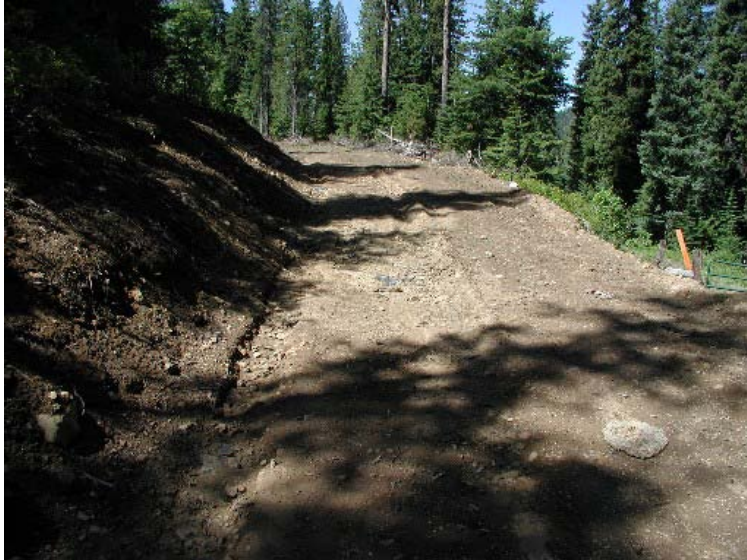
The one-half mile of new road construction (beginning at UTM 0533473 4994142) that occurred as part of the Upper Bear Vegetation Management Project was not visited in 2006, but a site visit was made in May of 2007 after spring runoff had occurred. The new road showed signs of erosion on the northeast end where it connected to an existing road. Water ran down the cut-slope side of the road and then across the road surface and off the downhill side of the road. Sediment was deposited in the riparian area of a small unnamed tributary of Bear Creek. It could not be determined if sediment entered the stream channel. [Figure 40](#) depicts the new road and erosion that took place in the spring of 2007. The new road was visited again in August 2008 and July 2009 ([Figures 41 and 42](#)). In 2008, it appeared that less erosion took place during spring runoff than had occurred the previous year. More vehicle traffic had also occurred there. In 2009, there

Figure 40. New road construction in the Upper Bear Vegetation Management Project Area, 2007. Note erosion on left side of picture.

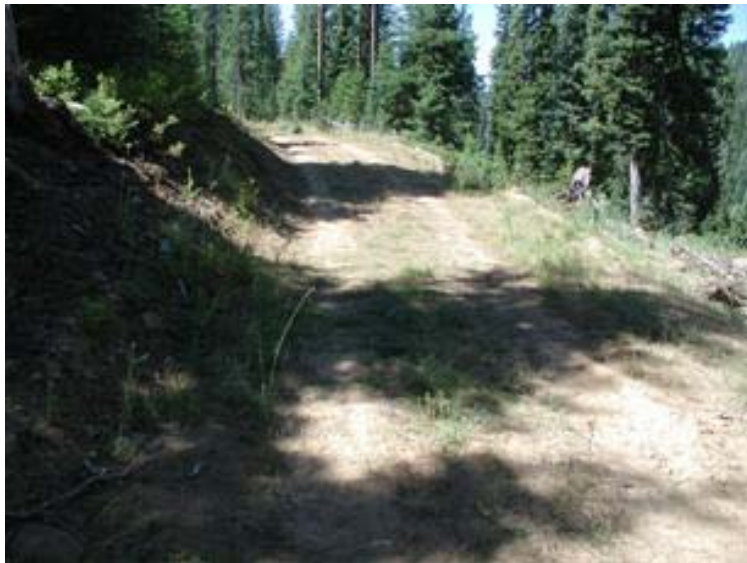
Figure 41. New road construction in the Upper Bear Vegetation Management Project Area, 2008.

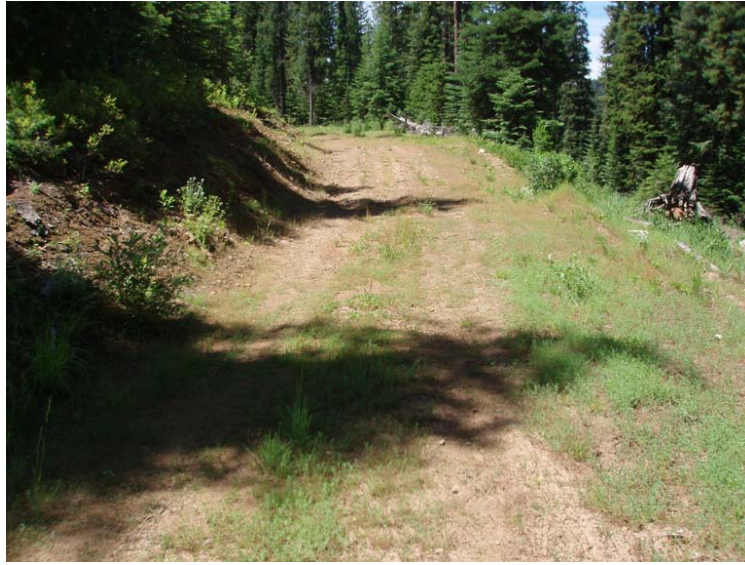
Figure 42. New road construction in the Upper Bear Vegetation Management Project Area, 2009.

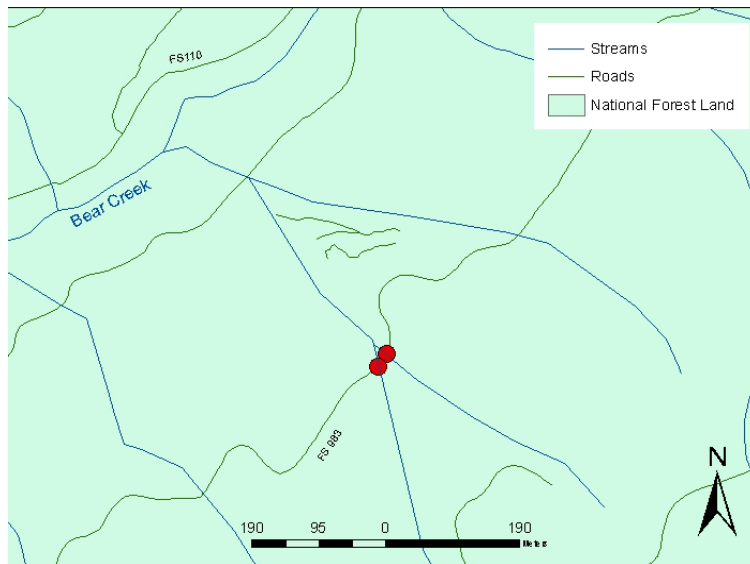
Two culverts on FS Road 983 were removed in 2007 when road decommissioning took place ([Figure 43](#)). Approximately 5 meters downstream of each of these culverts was snorkeled to determine if fish were present and may be harassed by culvert removal operations. Fish were not observed at either of these locations. Photos were taken at these 2 locations in 2008 and again in 2009 ([Figures 44-49](#)). Both of the reconstructed stream channels provide stream simulation and vegetation has begun to reestablish. One young-of-the-year (YOY) salmonid was observed in the larger of the two streams during the site visit in 2009.

Figure 43. Culvert removal locations in Upper Bear on FS Road 983.

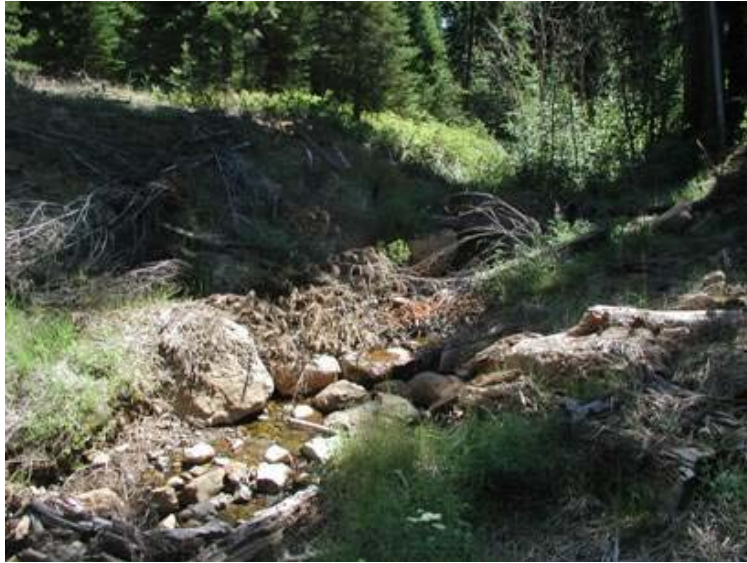
Figure 44. Culvert removal locations in Upper Bear on FS Road 983, 2008. Looking upstream at the northern crossing.

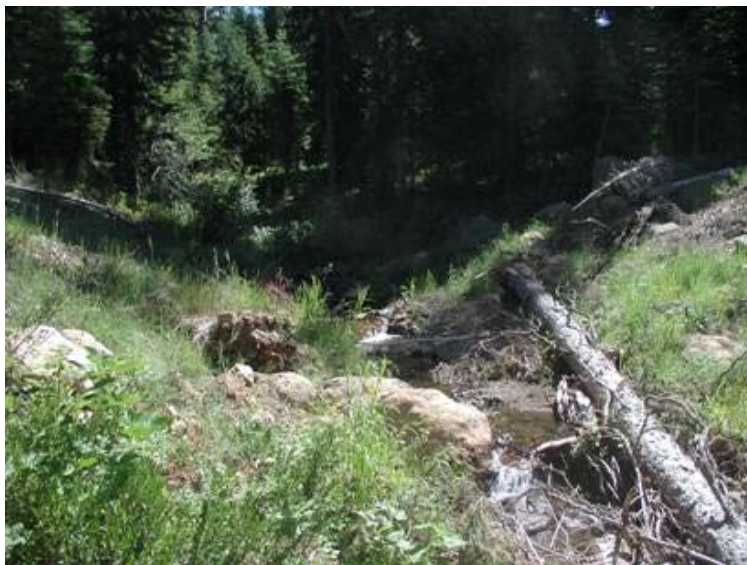
Figure 45. Culvert removal locations in Upper Bear on FS Road 983, 2008. Looking upstream at the southern crossing.

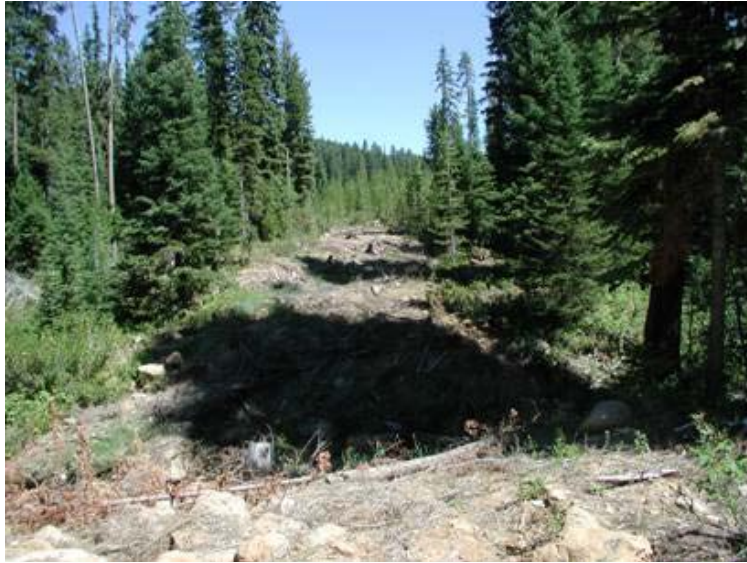
Figure 46. Culvert removal locations in Upper Bear on FS Road 983, 2008. Looking NE on FS 983 at both stream crossings.

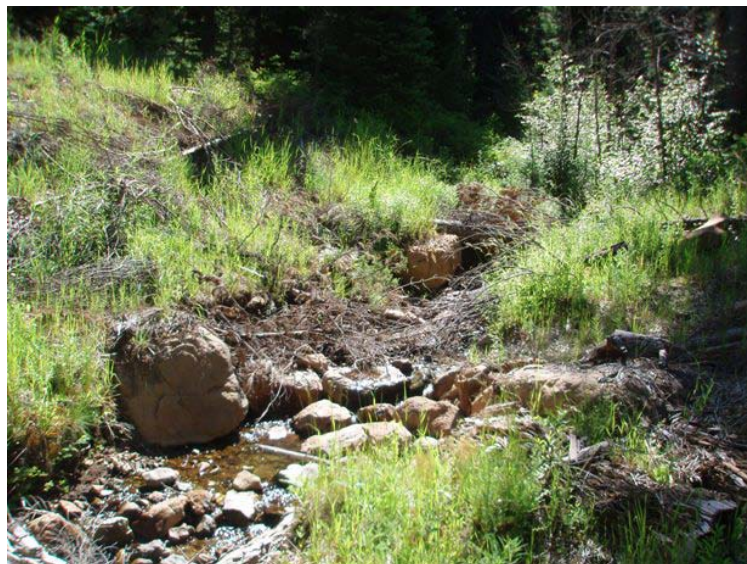
Figure 47. Culvert removal locations in Upper Bear on FS Road 983, 2009.

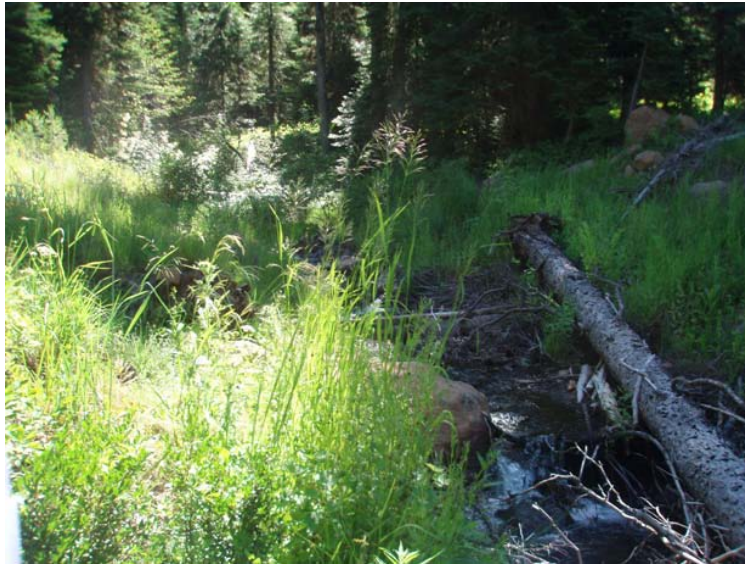
Figure 48. Culvert removal locations in Upper Bear on FS Road 983, 2009.

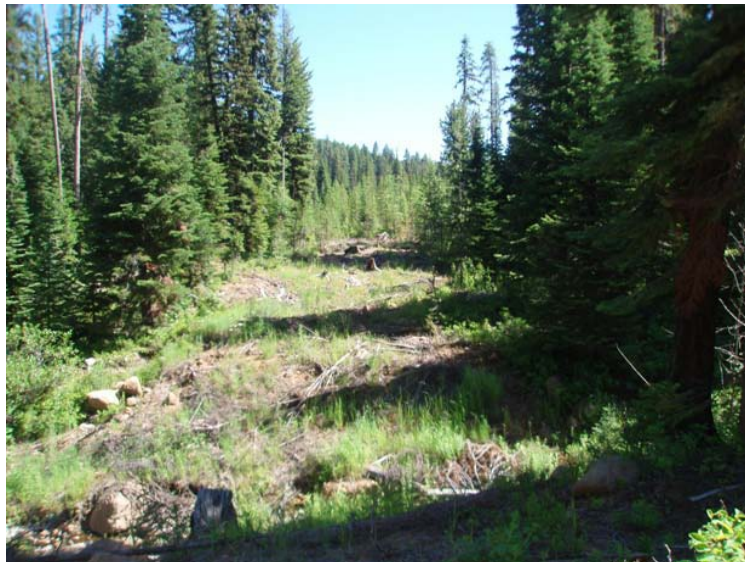
Figure 49. Culvert removal locations in Upper Bear on FS Road 983, 2009.

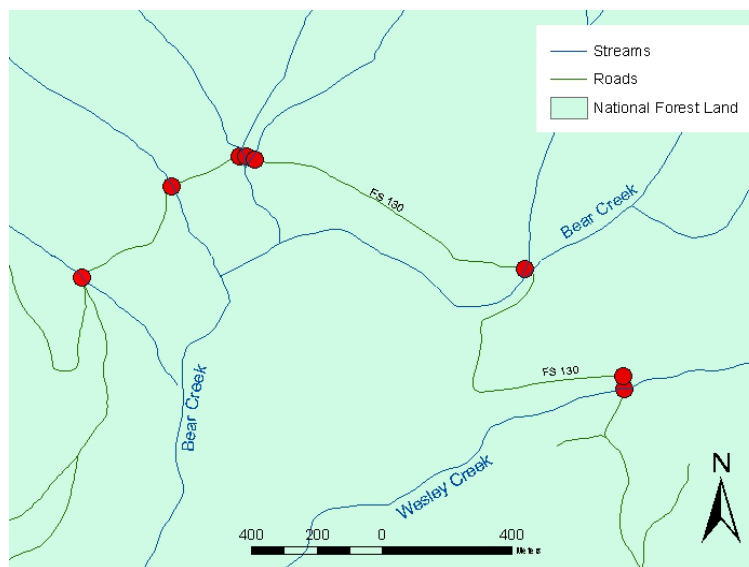
The Wesley Creek culvert proposed for replacement was instead removed, along with nine other culverts on tributaries of Bear Creek along FS Road 130 ([Figure 50](#)) (It should be noted that the crossing on Bear Creek is a box culvert with at natural stream bottom; therefore fish passage is not a concern where FS Road 130 crosses Bear Creek). Culvert removal took place in mid-August, 2007. Culvert removal work was approved by the

Figure 50. Culvert removal locations in Upper Bear on FS Road 130.

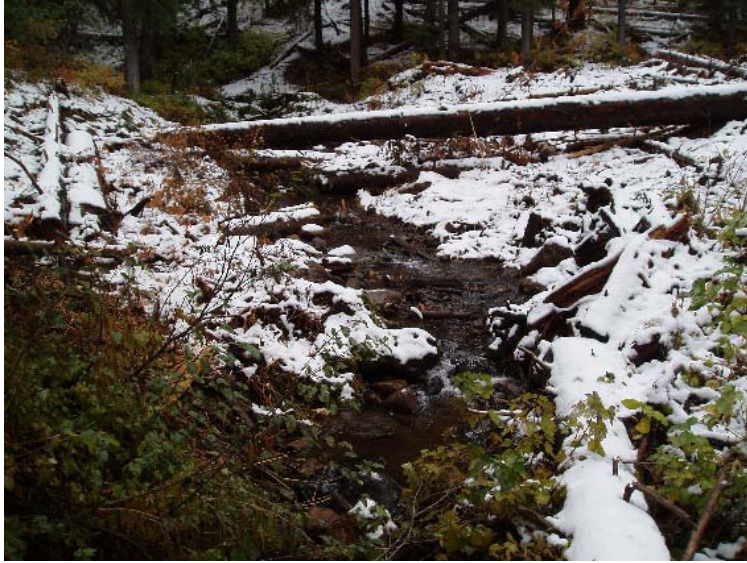
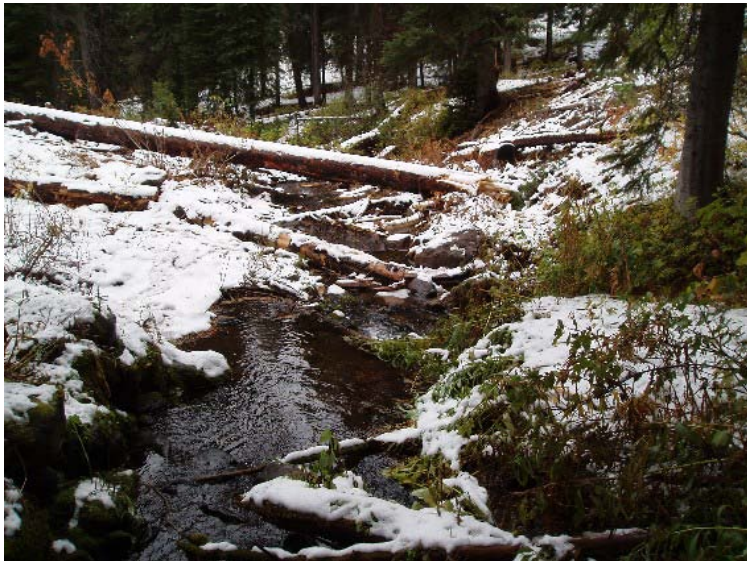
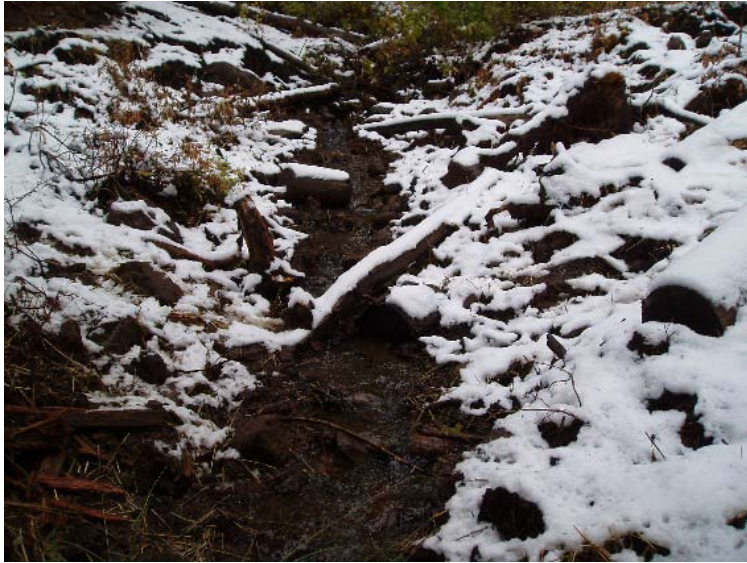
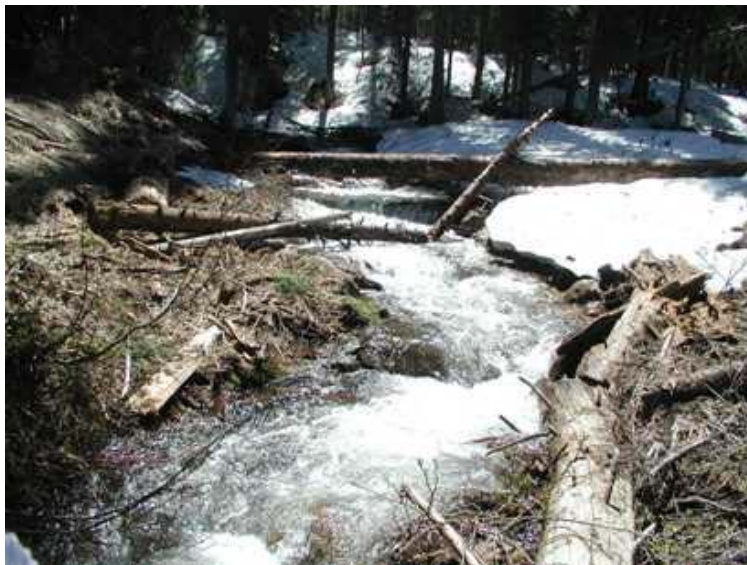
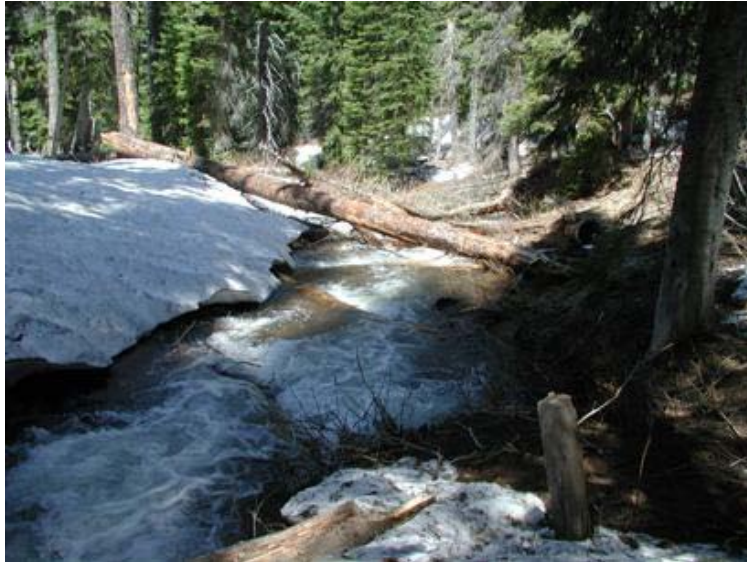
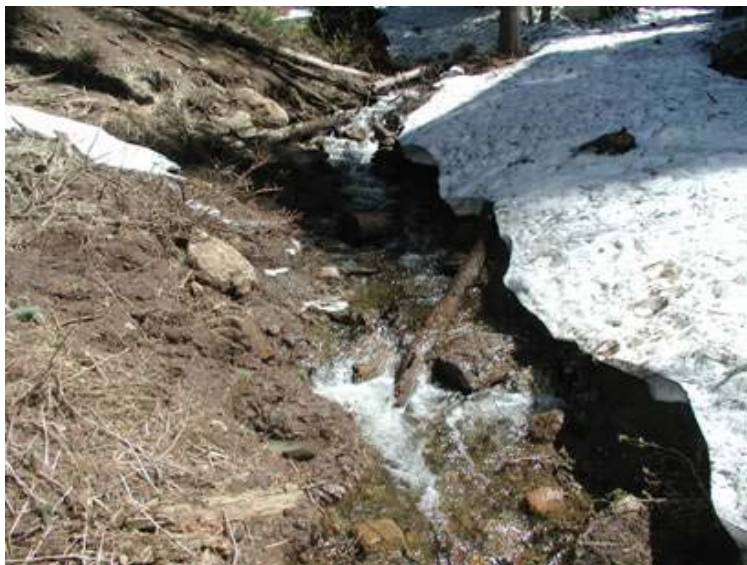
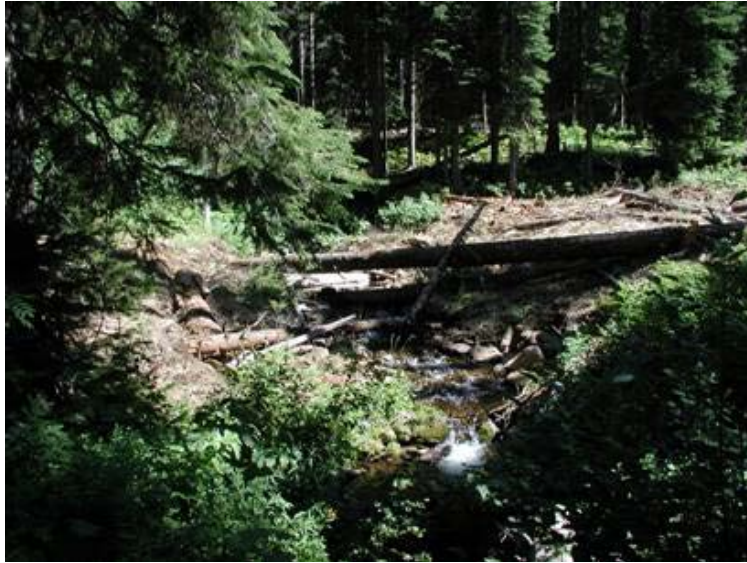
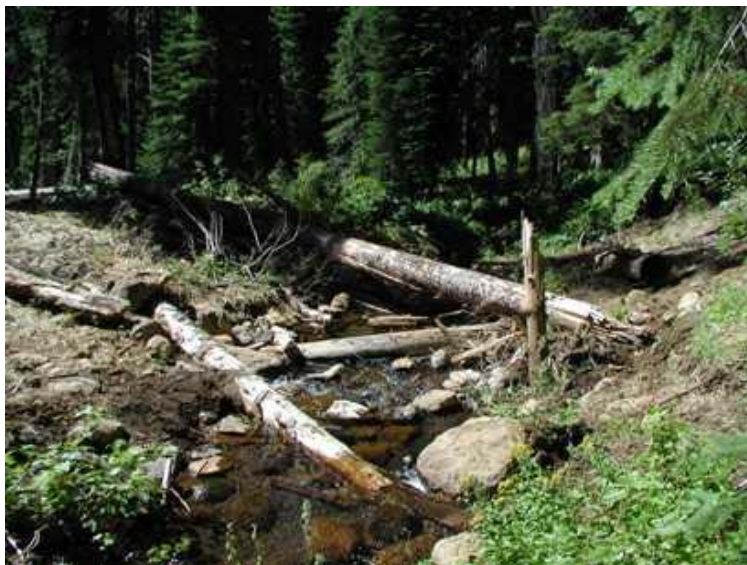
Photos were taken of the Wesley Creek and the unnamed tributary crossing in 2008 and 2009 (Figures 51-64). Photos were taken only of the Wesley Creek crossing in 2009. Snorkel surveys were conducted at both of these sites in 2008 and 2009. Fish were not observed either year in Wesley Creek. Bull trout were observed both years in the unnamed tributary of Bear Creek.

Figure 51. Culvert removal location on Wesley Creek on October 2, 2007. Looking upstream.

Figure 52. Culvert removal location on Wesley Creek on October 2, 2007. Looking downstream.

Figure 53. Culvert removal location on an unnamed tributary of Wesley Creek on October 2, 2007. Looking upstream.

Figure 54. Culvert removal location on Wesley Creek on June 18, 2008. Looking upstream.

Figure 55. Culvert removal location on Wesley Creek on June 18, 2008. Looking downstream.

Figure 56. Culvert removal location on an unnamed tributary of Wesley Creek on June 18, 2008. Looking upstream.

Figure 57. Culvert removal location on Wesley Creek on August 12, 2008. Looking upstream.

Figure 58. Culvert removal location on Wesley Creek on August 12, 2008. Looking downstream.

Bull trout have been observed in Wesley Creek (2002 data on file at the Council Ranger District), but not within approximately ¼ mile downstream of the culvert. No apparent passage barriers exist between known bull trout distribution and the culvert, making it possible for fish to exist up to the culvert outlet. Removing the culvert, and thus restoring fish passage, should allow fish to access an additional 220 meters of stream habitat upstream of FS Road 130. In 2006 a likely passage barrier was discovered during a stream habitat inventory approximately 220m upstream of FS Road 130. Fish have not been observed upstream of the culvert, but suitable fish habitat exists there. Prior to culvert removal operations, no bull trout (or any other fish) were observed near the outlet of the culvert on Wesley Creek. Fish have not yet been observed near or upstream of the culvert removal location on Wesley Creek.

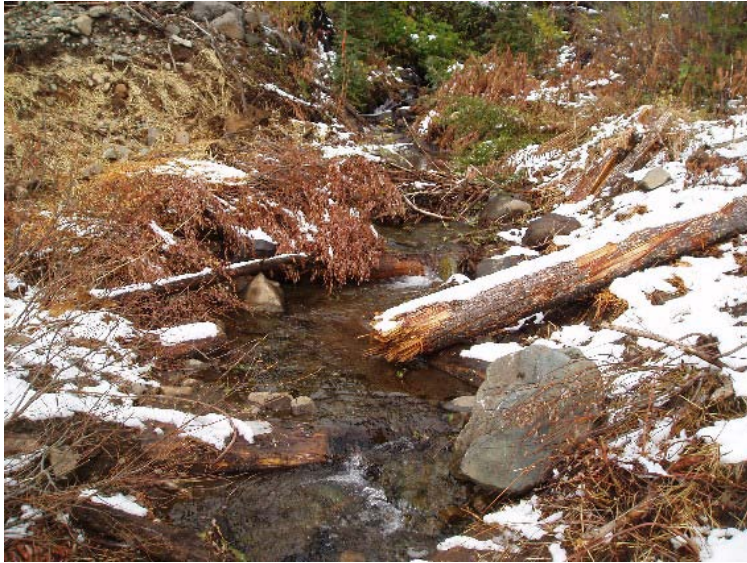
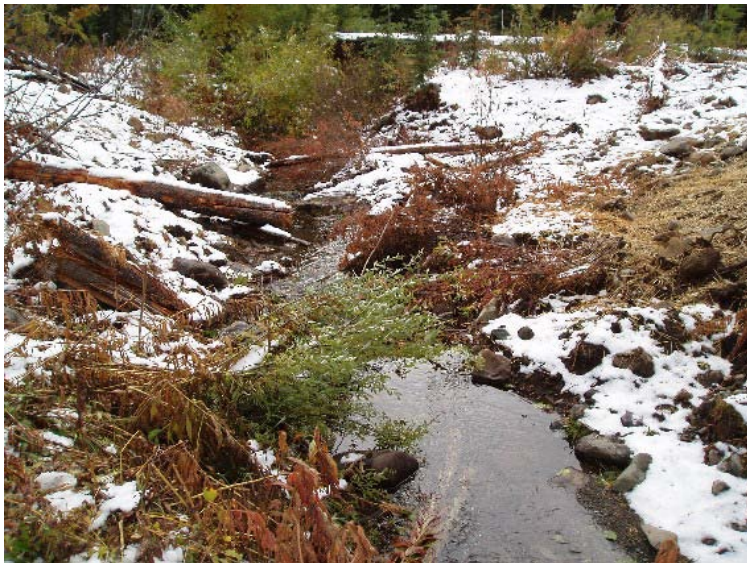
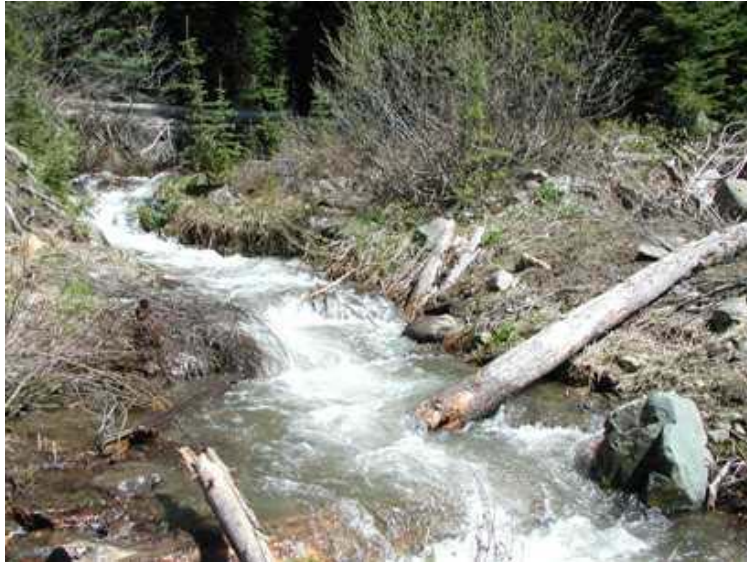
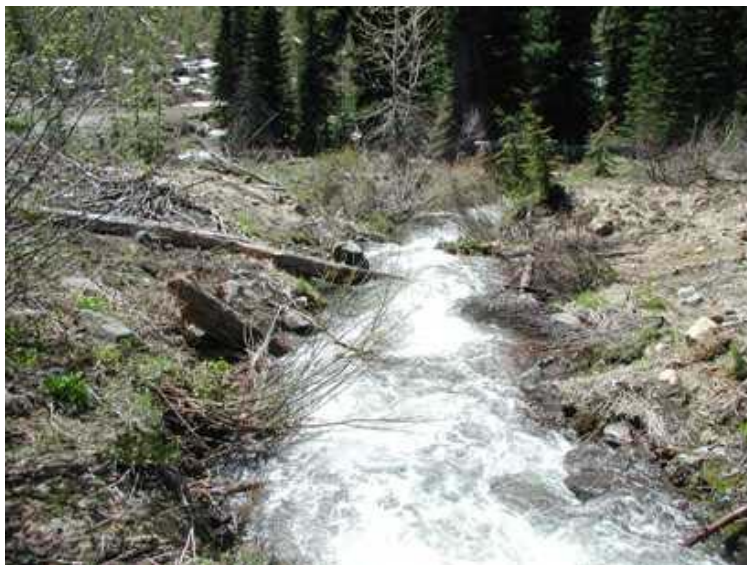
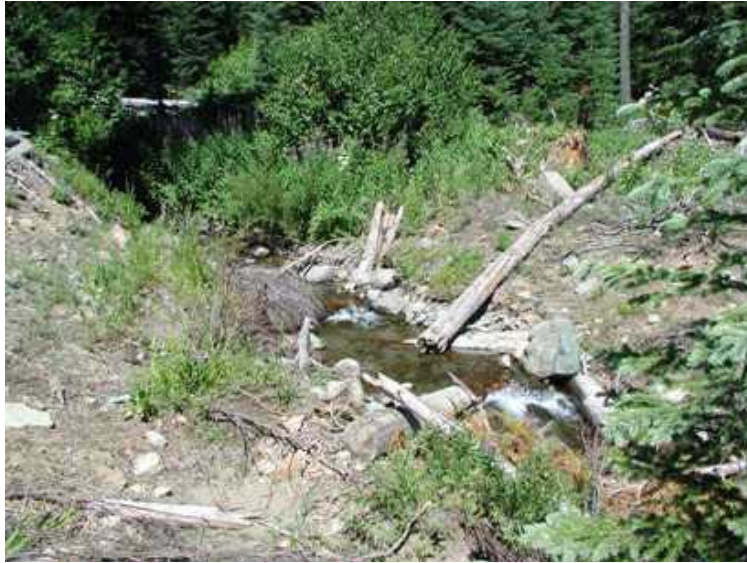
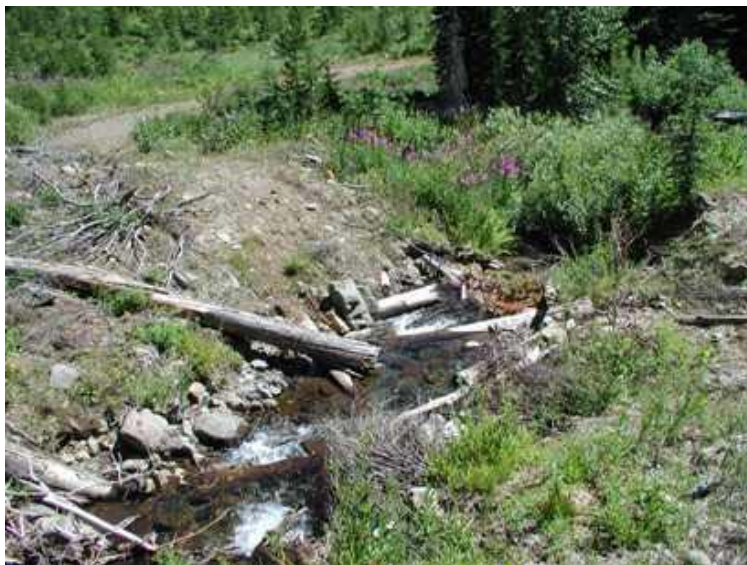
Figure 59. Culvert removal location on an unnamed tributary of Bear Creek on October 2, 2007. Looking upstream.

Figure 60. Culvert removal location on an unnamed tributary of Bear Creek on October 2, 2007. Looking downstream.

Figure 61. Culvert removal location on an unnamed tributary of Bear Creek on June 18, 2008. Looking downstream.

Figure 62. Culvert removal location on an unnamed tributary of Bear Creek on June 18, 2008. Looking downstream.

Figure 63. Culvert removal location on an unnamed tributary of Bear Creek on August 14, 2008. Looking downstream.

Figure 64. Culvert removal location on an unnamed tributary of Bear Creek on August 14, 2008. Looking downstream.

During a pre-removal snorkel survey, one bull trout was observed in the culvert outlet pool in an unnamed tributary of Bear Creek (immediately west of the 130 Road crossing on Bear Creek). A bull trout (presumably the same fish observed on July 30) was observed by the crew the day culvert removal began. Although this fish was present near the culvert it did not appear to be spawning and there was not a redd present within the culvert outlet pool. Care was taken during culvert removal to not disturb the pool with machinery or other materials placed into the stream. Due to the short duration and intensity of stream turbidity, and lack of physical harm to the fish, it is believed that there were no adverse effects. Bull trout were observed in this stream upstream of the culvert removal location in both 2008 and 2009. It appears that bull trout are using the unnamed tributary both in and upstream of the culvert removal site.

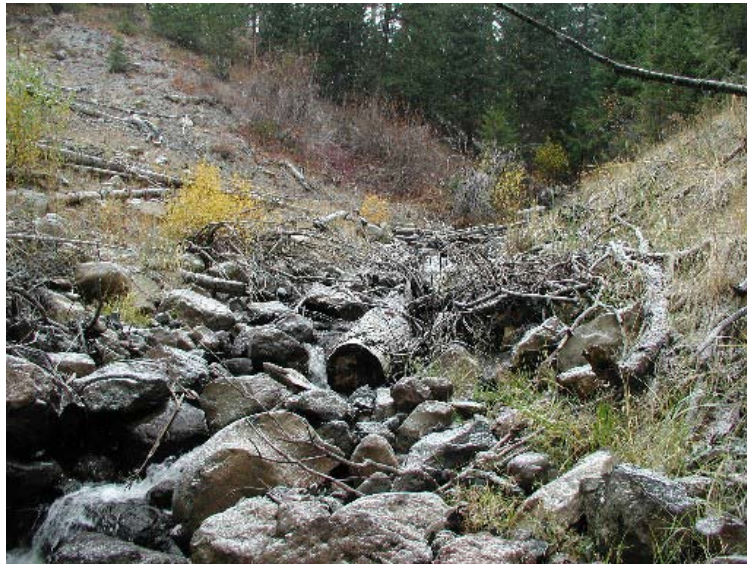
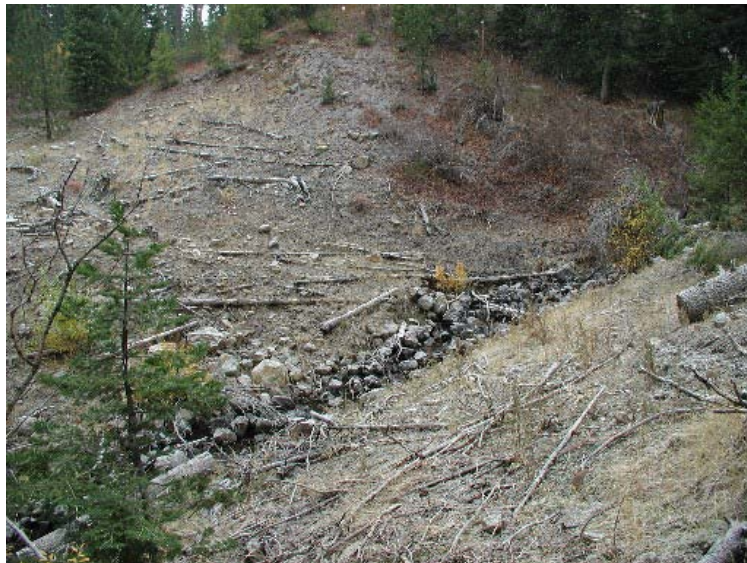
The culvert on Bull Corral Creek, which was identified in the Little Weiser Landscape Vegetation Management Project FEIS was removed when the Sheep Creek Road (FS Road 180) was decommissioned in 2003 ([Figure 65](#) and [Figure 66](#)). The culvert on Lost Fork Creek is still in use, and is slated for removal when timber harvest operations are complete. The remaining culverts identified in the FEIS will be removed or replaced as funding becomes available.

Figure 65. Culvert removal on Bull Corral Creek. Photograph is looking upstream at the culvert location in October of 2007.

Figure 66. Culvert removal on Bull Corral Creek. Photograph is looking upstream at the culvert location in October of 2007.

The culvert removal location on Bull Corral Creek was providing appropriate stream simulation ([Figure 66](#) and [Figure 67](#)). Vegetation is re-establishing on the banks and the stream gradient appeared to be consistent with that reach of Bull Corral Creek. The culverts associated with this project have not yet been replaced. When funding becomes available for replacement, a fisheries biologist should ensure that new culverts provide stream simulation.

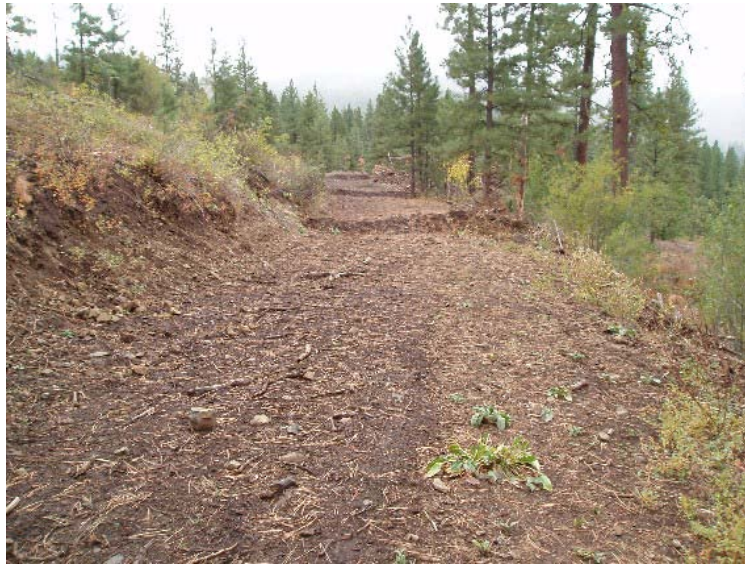
Figure 67. Temporary road that accesses Unit 207 in the Anderson Creek Timber Sale.

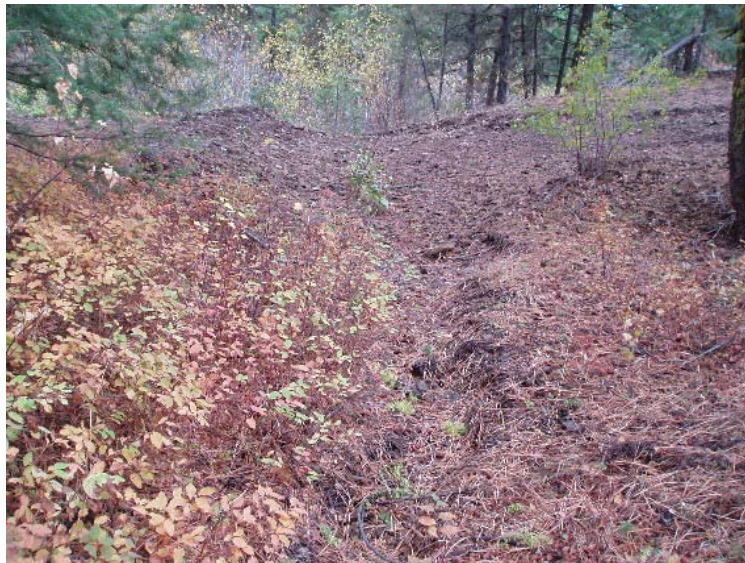
Figure 68. Channel crossing on a temporary road that accesses Unit 207 in the Anderson Creek Timber Sale.

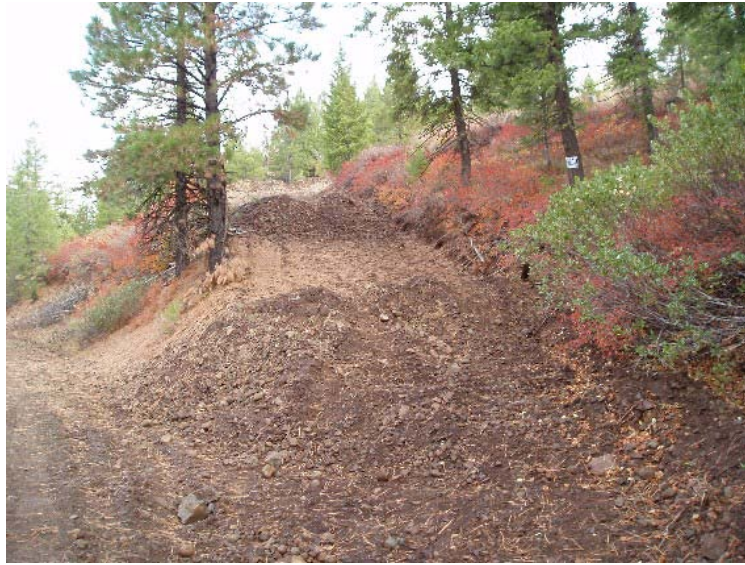
Figure 69. Temporary road that accesses Unit 214 in the Anderson Creek Timber Sale.

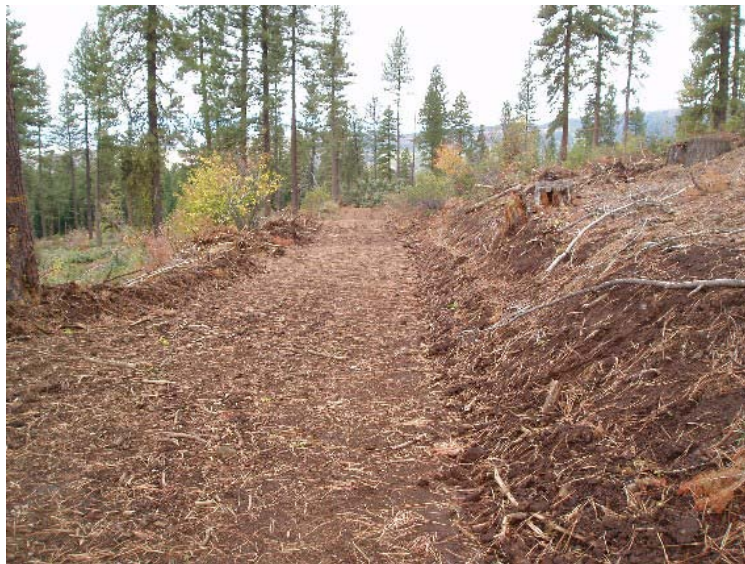
Figure 70. Temporary road within Unit 224 in the Anderson Creek Timber Sale.
