Fisheries Monitoring Results 2006-2009

Prepared by: J. Greenway, Fisheries Technician

Reviewed by: Caleb Zurstadt, West Zone Fisheries Biologist

December 17, 2009.

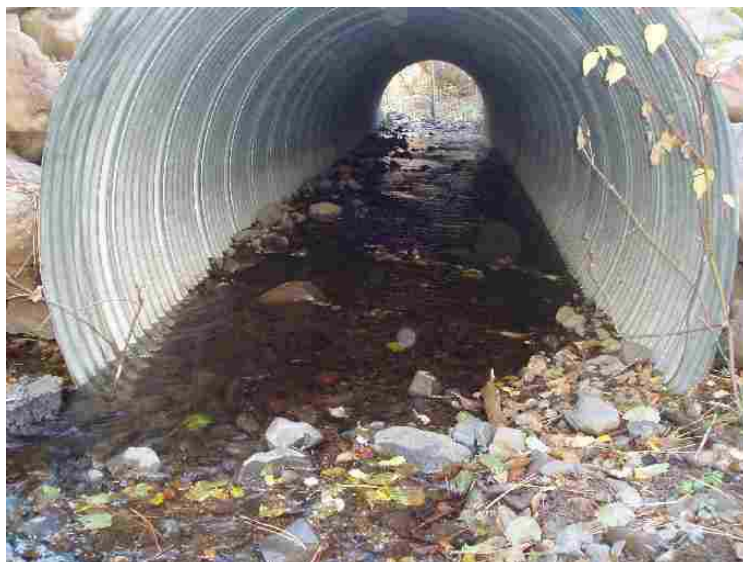
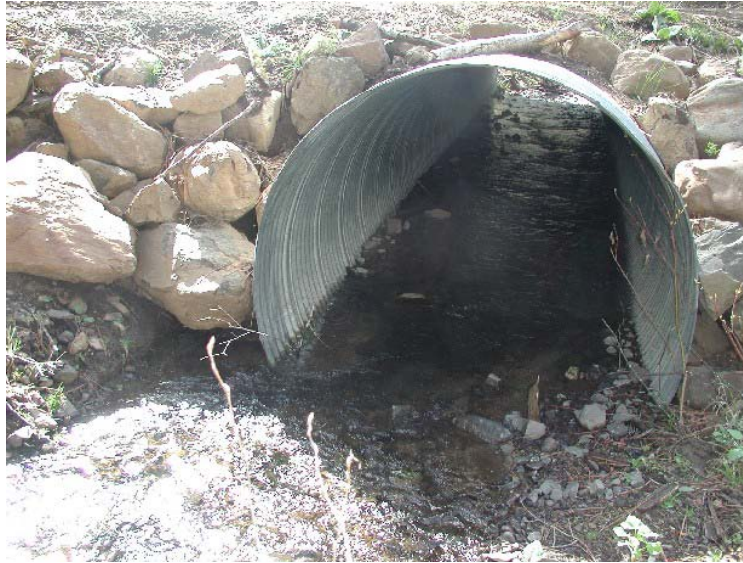
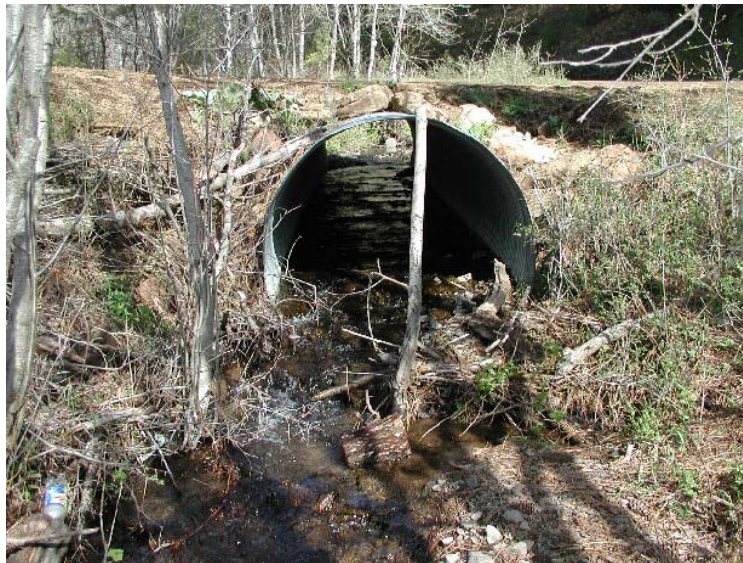
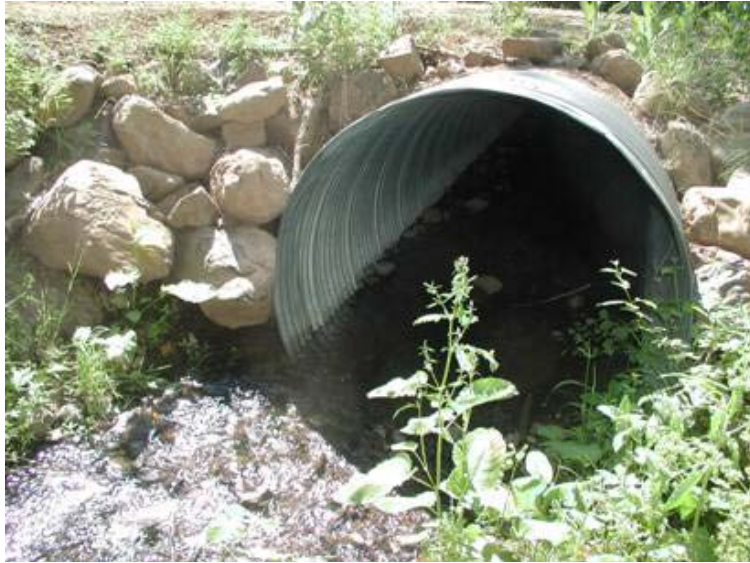
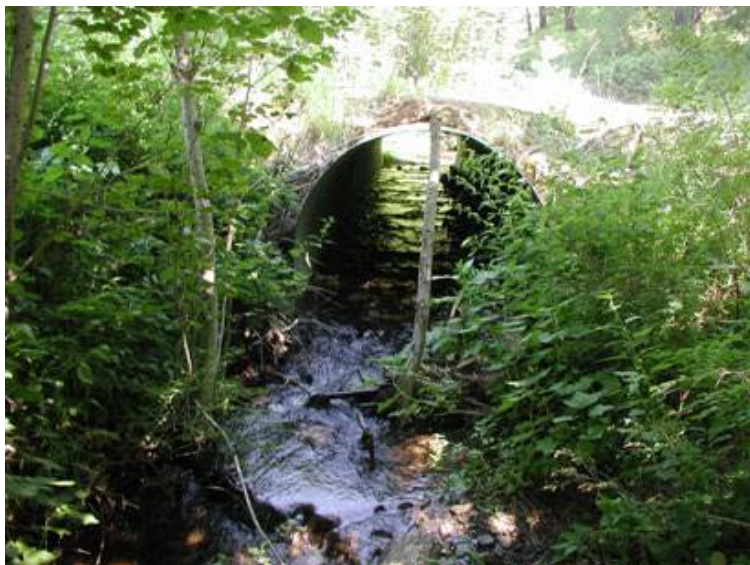
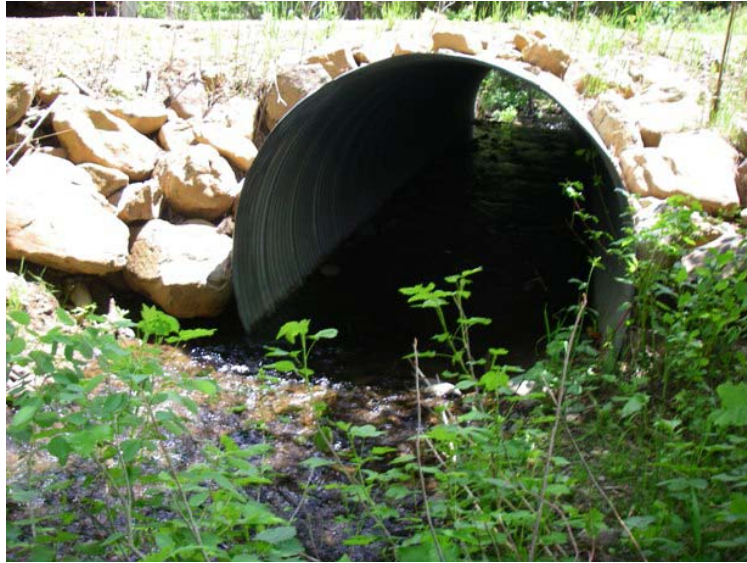
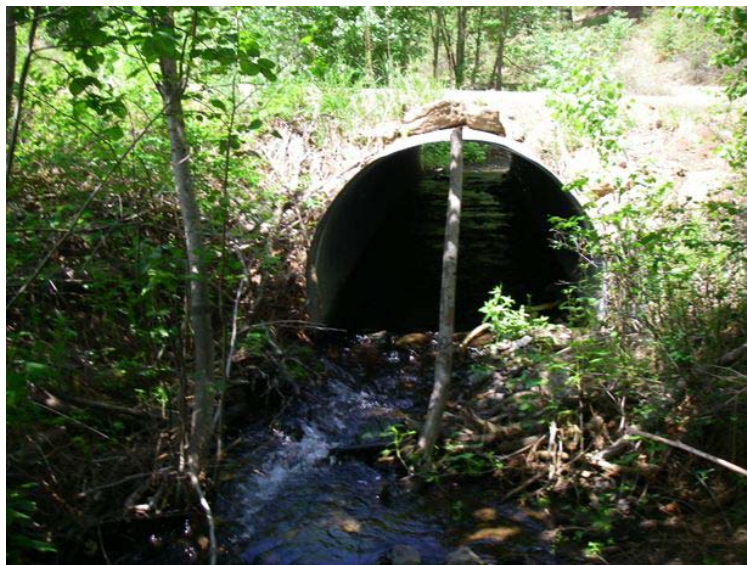
Figure 71. Culvert replaced on Adams Creek to allow fish passage. Photograph is looking downstream at the inlet of the culvert in the fall of 2006.

Figure 72. Culvert replaced on Adams Creek. Photograph is looking downstream at the inlet of the culvert in the spring of 2007.

Figure 73. Culvert replaced on Adams Creek. Photograph is looking upstream at the outlet of the culvert in the spring of 2007.

Figure 74. Culvert replaced on Adams Creek. Photograph is looking downstream at the inlet of the culvert in July 2008.

Figure 75. Culvert replaced on Adams Creek. Photograph is looking upstream at the outlet of the culvert in July 2008.

Figure 76. Culvert replaced on Adams Creek. Photograph is looking downstream at the inlet of the culvert in June 2009.

Figure 77. Culvert replaced on Adams Creek. Photograph is looking upstream at the outlet of the culvert in June 2009.

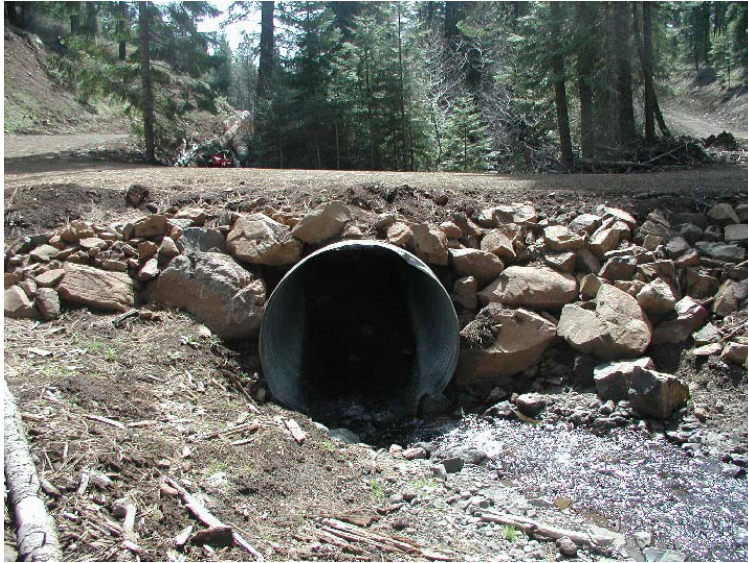
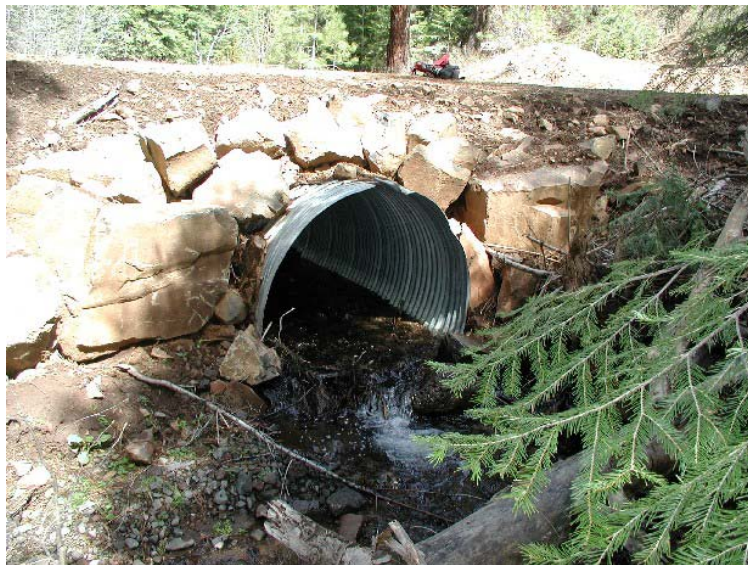
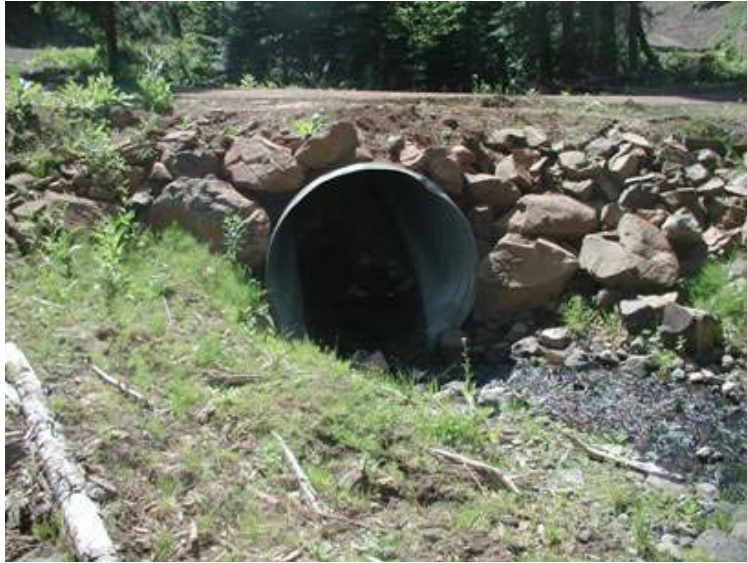
Figure 78. Culvert replaced on Stacey Creek. Photograph is looking downstream at the inlet of the culvert in the spring of 2007.

Figure 79. Culvert replaced on Stacey Creek. Photograph is looking upstream at the outlet of the culvert in the spring of 2007.

Figure 80. Culvert replaced on Stacey Creek. Photograph is looking downstream at the inlet of the culvert in the spring of 2008.

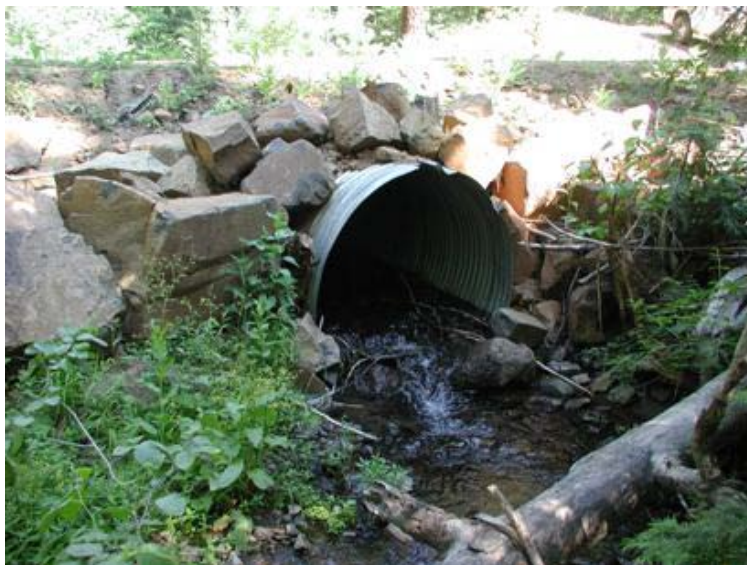
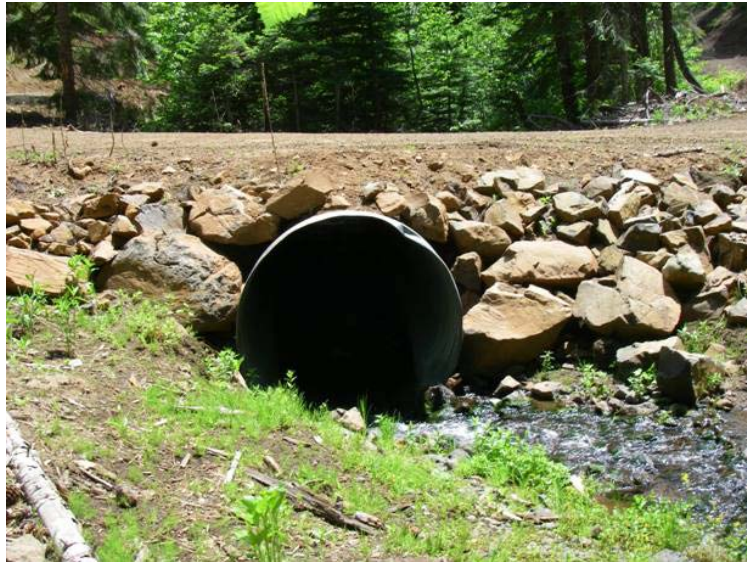
Figure 82. Culvert replaced on Stacey Creek. Photograph is looking downstream at the inlet of the culvert in the spring of 2009.

Some of the substrate at the inlet of the Stacey Creek culvert had moved downstream in 2008 due to the alignment of the culvert with the stream channel. The alignment has caused some lateral scouring within the pipe, removing some of the substrate. Some sloughing has also occurred on the left bank where the wetted channel approaches the culvert. Conditions within the pipe still provide fish passage and little change was

observed from 2008 to 2009, further monitoring at this site is not necessary unless significant changes take place.

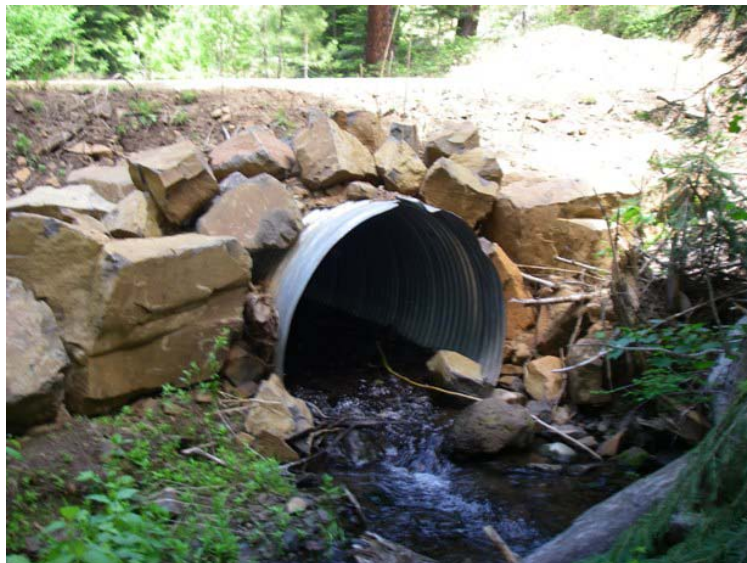
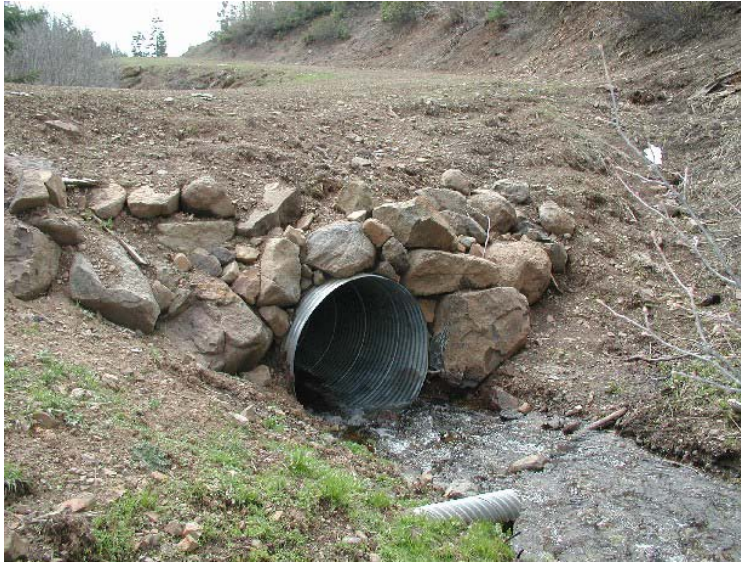
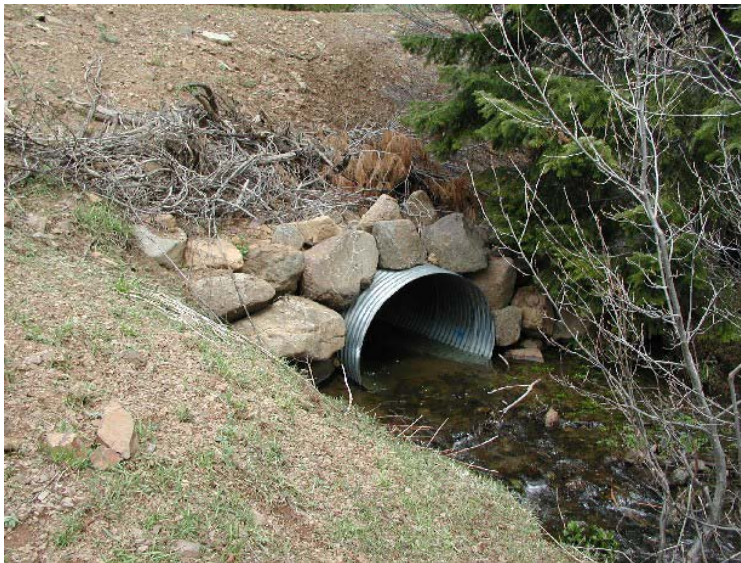
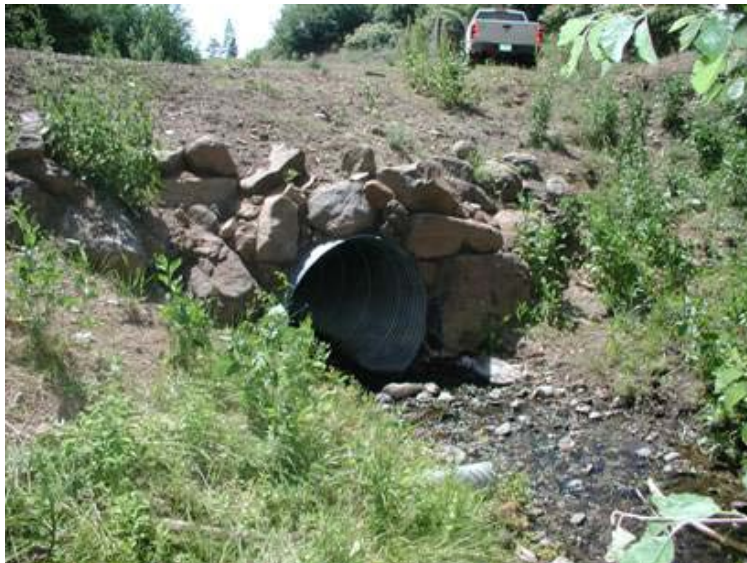
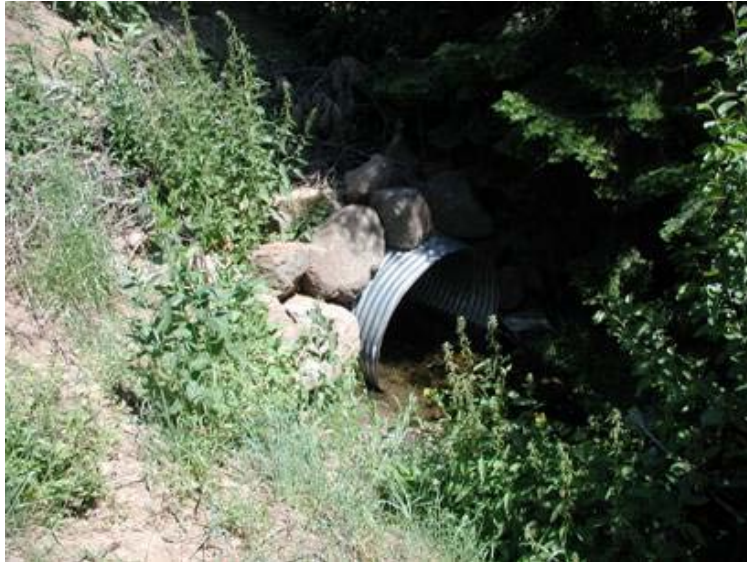
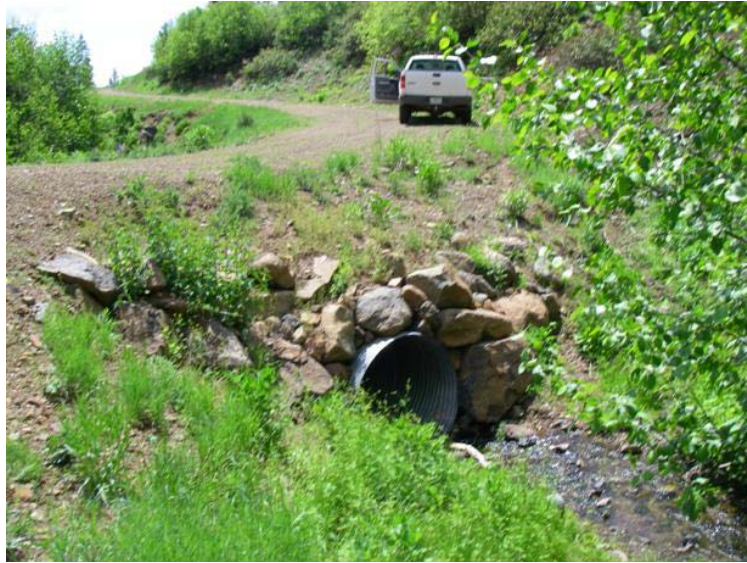
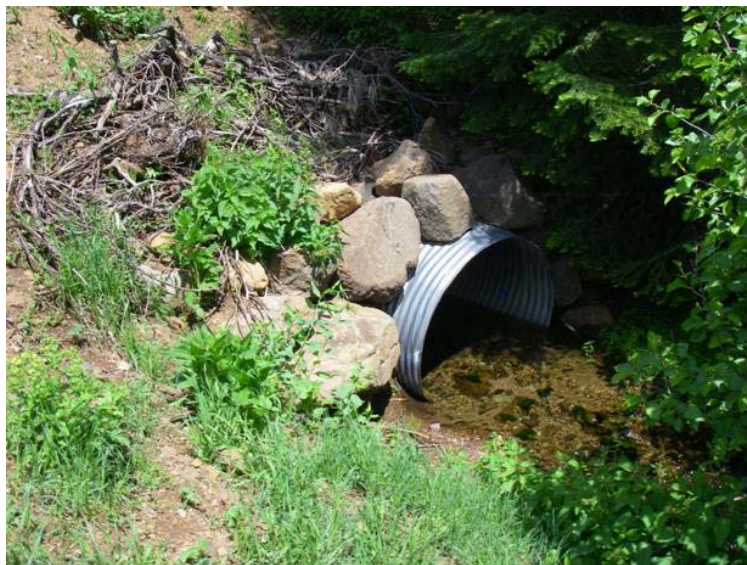
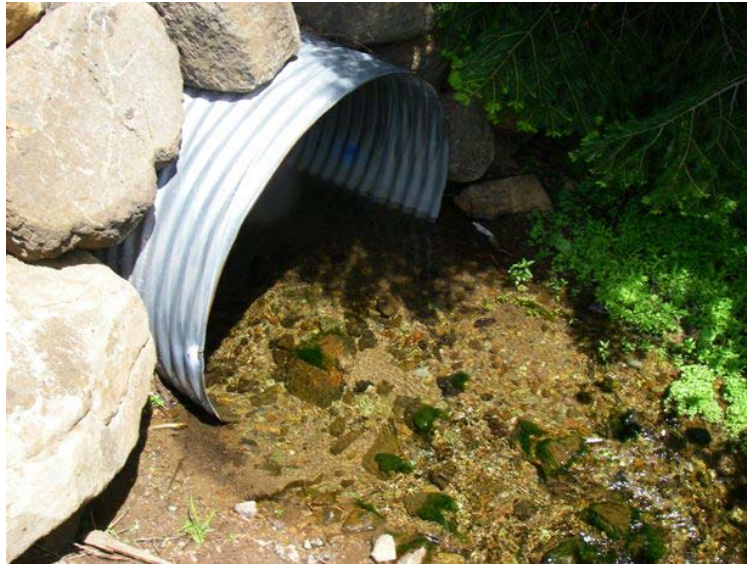
The culvert on Fourth of July Creek was visited in the spring of 2007(UTM 0499317 4935749) ([Figures 84-92](#)). The culvert was steep and the flow was fast. The culvert did not contain any substrate and did not appear to provide fish passage. Numerous fish (150-200mm) were observed in the pool at the culvert's outlet ([Figure 86](#)), but none were observed upstream. Similar results were observed in 2008 and again in 2009. The lower ½ of the culvert provides pool habitat, but the remainder of the culvert is steep and shallow with no substrate present, providing no stream simulation. This culvert is likely a fish passage barrier and it is not expected that conditions will improve over time. Further monitoring at this culvert is not recommended.

Figure 84. Culvert replaced on Fourth of July Creek. Photograph is looking downstream at the inlet of the culvert in the spring of 2007.

Figure 85. Culvert replaced on Fourth of July Creek. Photograph is looking upstream at the outlet from the left bank.

Figure 87. Culvert replaced on Fourth of July Creek. Photograph is looking downstream at the inlet of the culvert in July 2008.

Figure 88. Culvert replaced on Fourth of July Creek. Photograph is looking upstream at the outlet from the left bank in July 2008.

Figure 90. Culvert replaced on Fourth of July Creek. Photograph is looking downstream at the inlet of the culvert in June 2009.

Figure 91. Culvert replaced on Fourth of July Creek. Photograph is looking upstream at the outlet from the left bank in June 2009.

Figure 92. Culvert outlet on Fourth of July Creek. Photograph is looking at outlet pool in June 2009.

The culvert replaced on Fourth of July Creek did not appear to provide fish passage. Numerous fish were in the outlet pool of the culvert and none were observed in pool upstream of the culvert. The fish appeared to be redband trout and were likely attempting to move upstream to spawn. The gradient of the stream appears to be steep enough that providing fish passage with a closed-bottom culvert would be difficult, but a open-bottom arch may not be feasible in that location. Fish passage has not improved in the culvert on Fourth of July Creek.

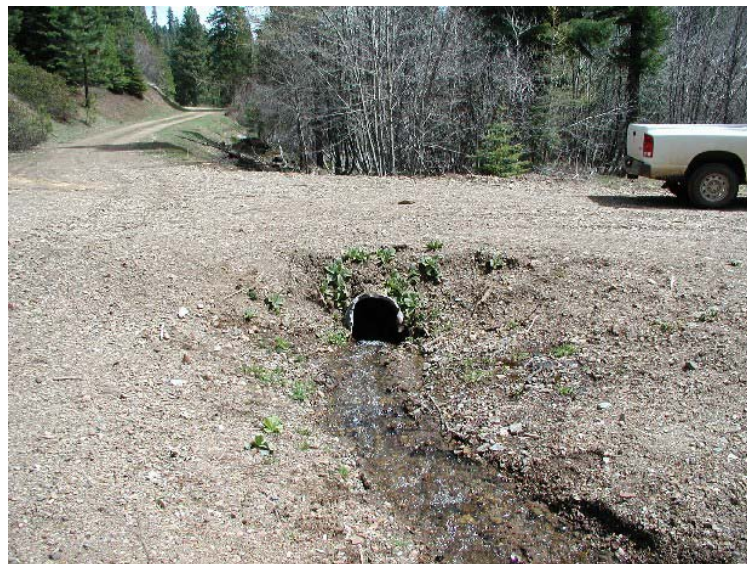
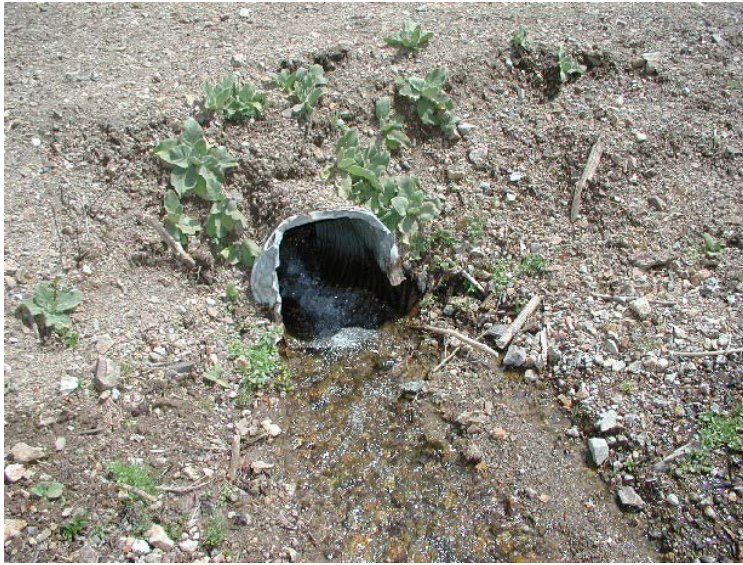
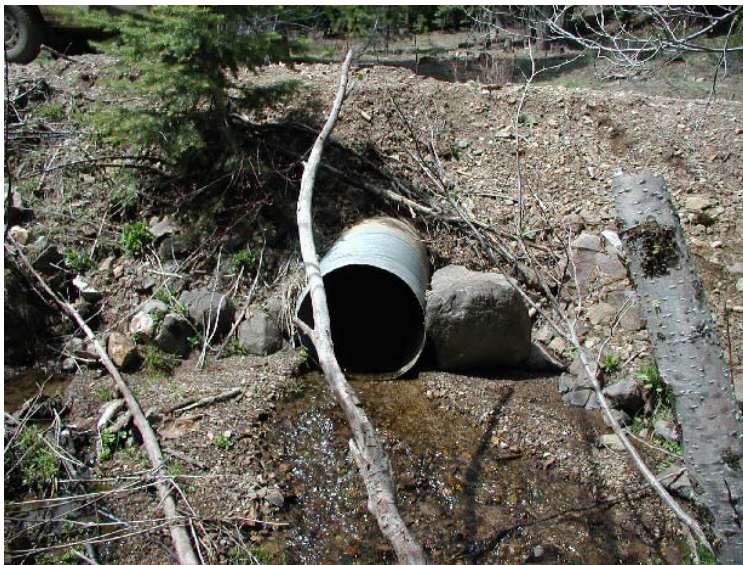
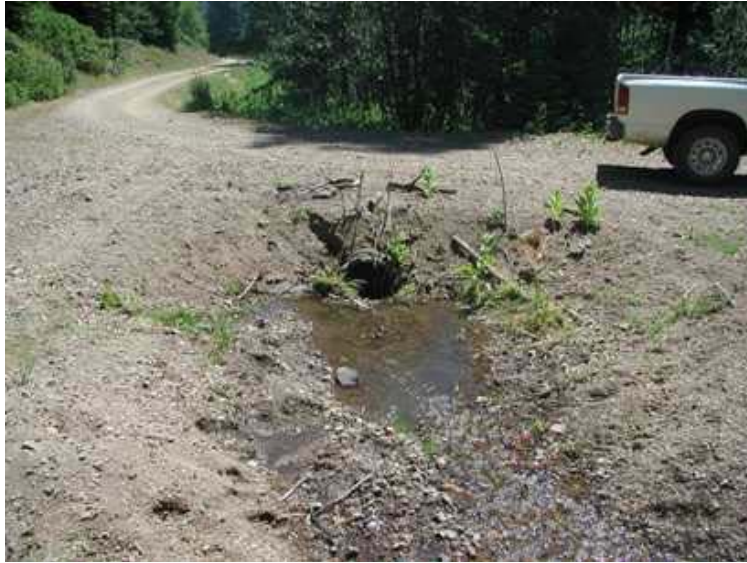
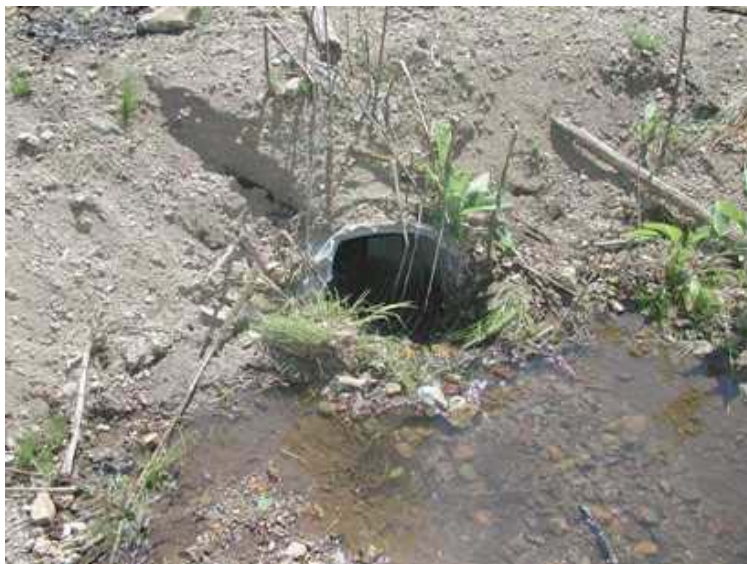
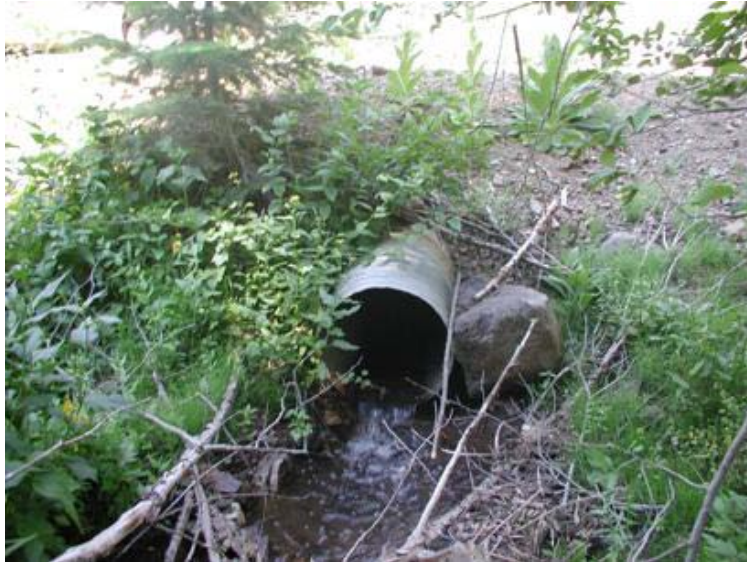
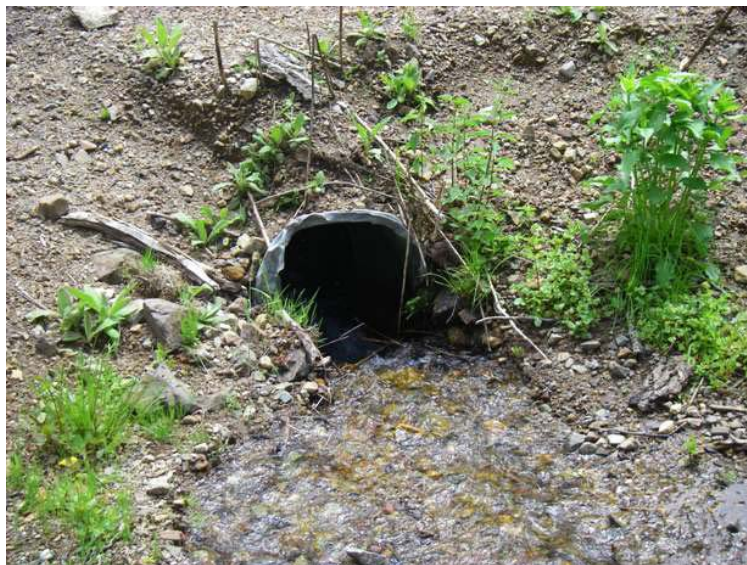
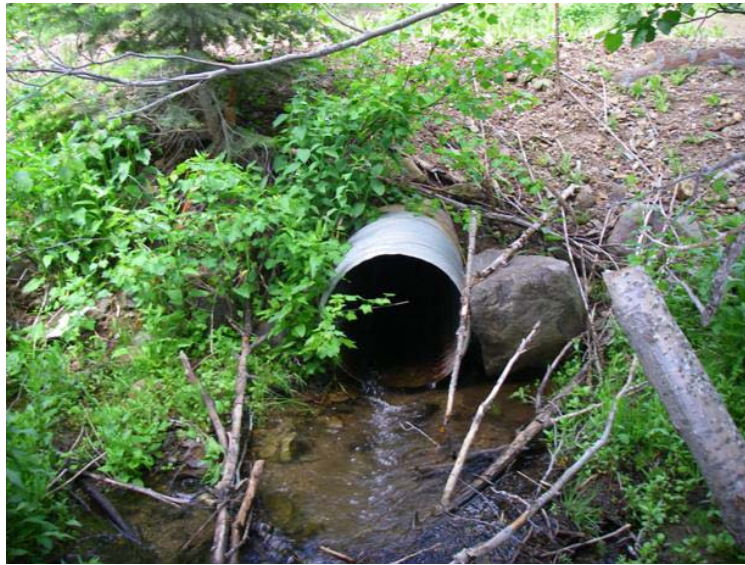
Figure 93. Culvert on Barton Gulch, looking downstream at the inlet in the spring of 2007.

Figure 94. Culvert on Barton Gulch, looking at the bent inlet in the spring of 2007.

Figure 95. Culvert on Barton Gulch, looking upstream at the outlet in the spring of 2007.

Figure 96. Culvert on Barton Gulch, looking downstream at the inlet in the spring of 2008.

Figure 97. Culvert on Barton Gulch, looking at the bent inlet in the spring of 2008.

Figure 98. Culvert on Barton Gulch, looking upstream at the outlet in the spring of 2008.

Figure 99. Culvert on Barton Gulch, looking downstream at the inlet in the spring of 2009.

Figure100. Culvert on Barton Gulch, looking upstream at the outlet in the spring of 2009.

Although the culvert at Barton Gulch was not replaced as part of the Mann Creek Vegetation Management and Watershed Restoration Project, consideration should be given to replace this culvert. It appears to be undersized and there is damage to the inlet, further reducing its capacity.

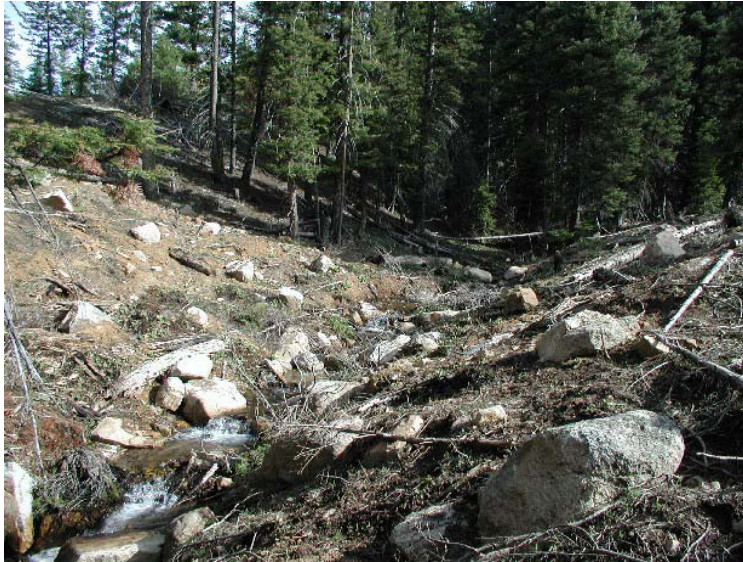
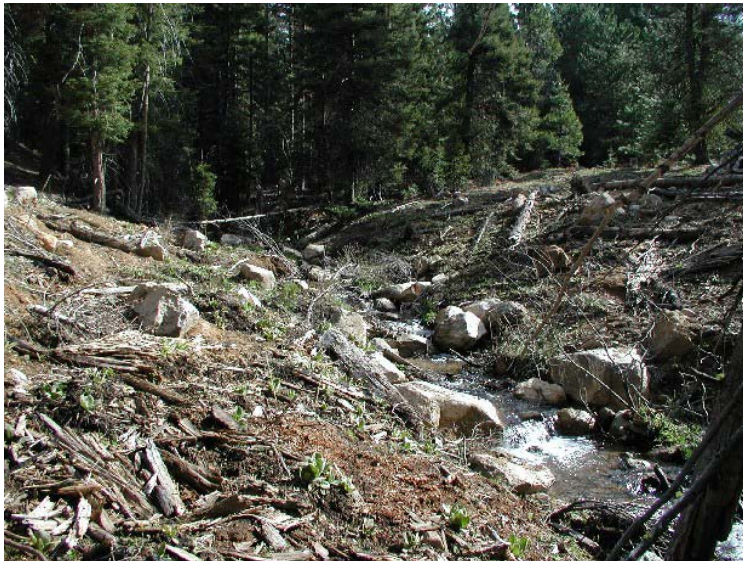
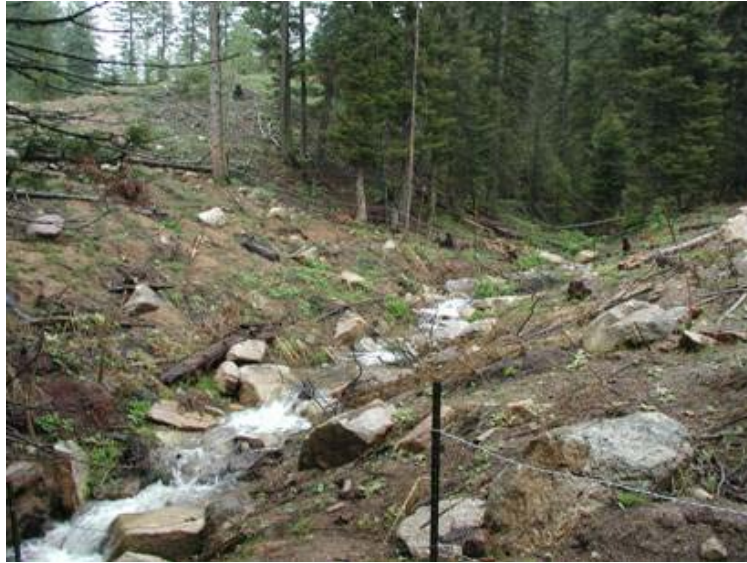
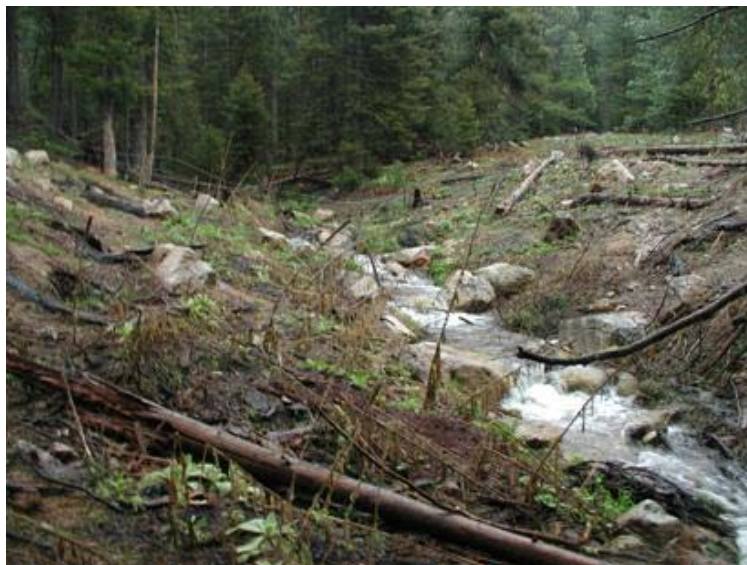
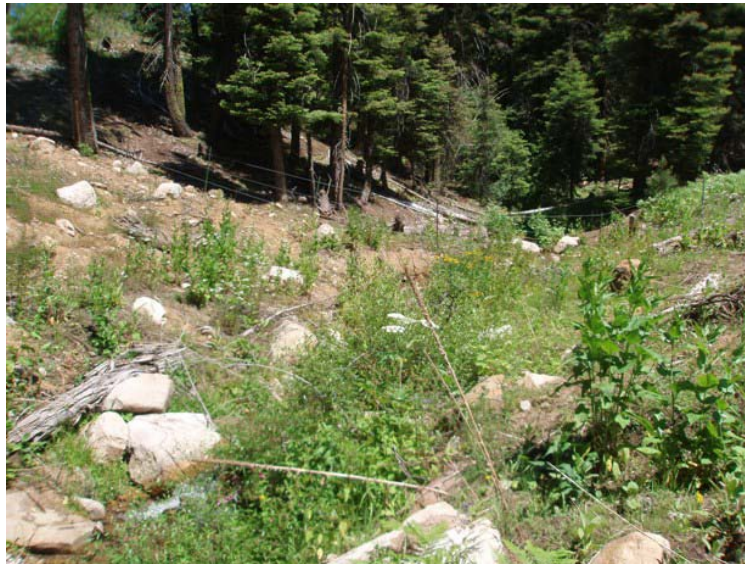
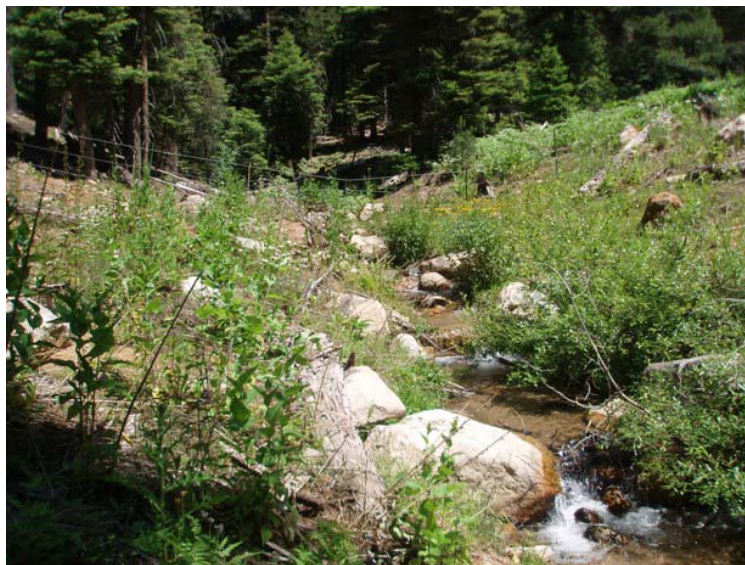
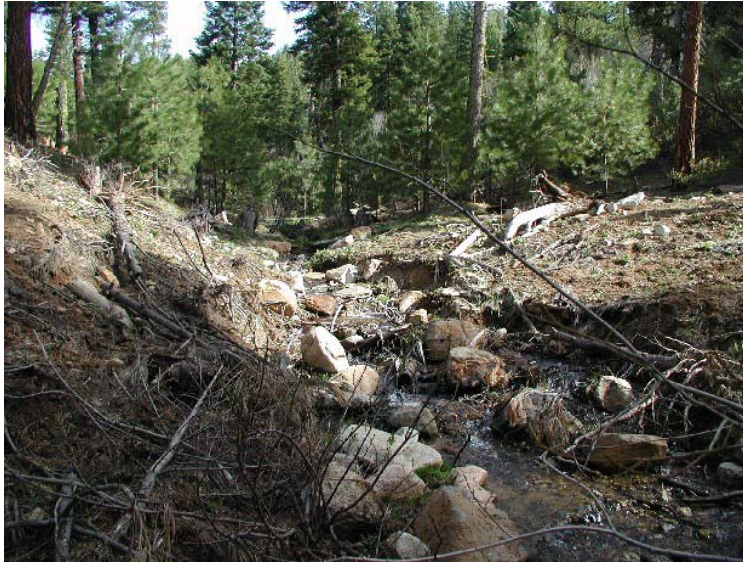
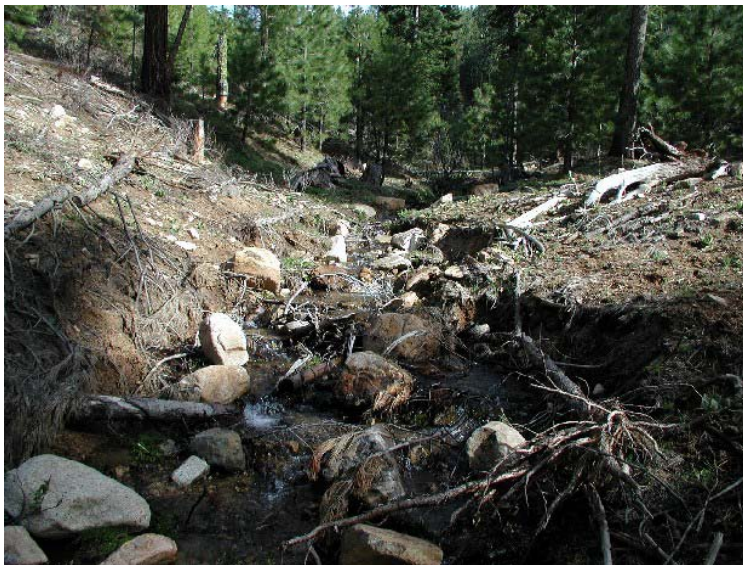
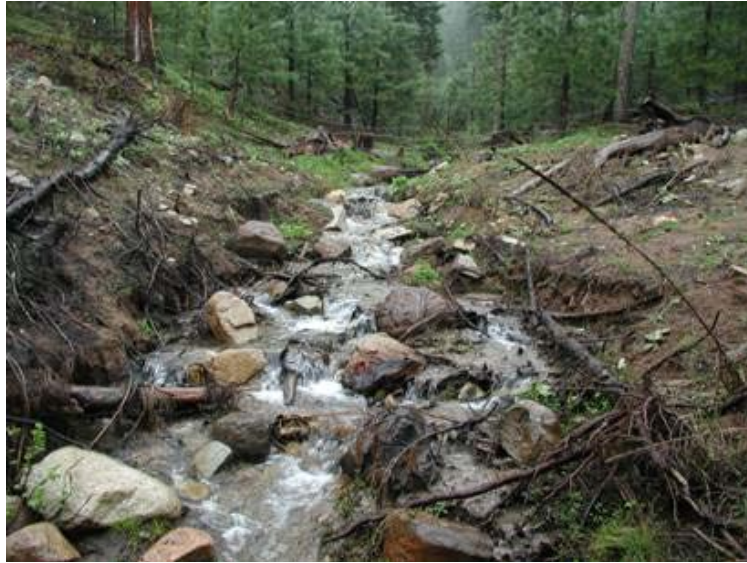
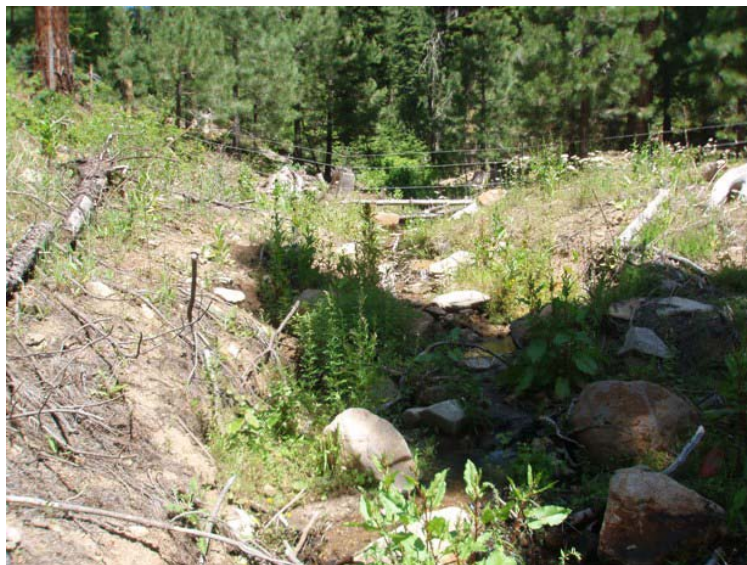
Figure 101. Culvert removal on Little Pine Creek. Photograph is looking upstream at the culvert location in May of 2007.

The culvert removal locations have been visited and photographed annually by fisheries personnel since 2007 ([Figures 101-110](#)). The culvert removal locations and the road decommissioning associated with culvert removal were fenced by the YCC crew in June of 2007 to exclude cattle use while vegetation re-establishes. Fish surveys were conducted in 2007 and again in 2008. It appears that fish are moving through both of the culvert removal locations based on fish captures in both of the streams. Additional fish sampling data can be referenced in Greenway (2008).

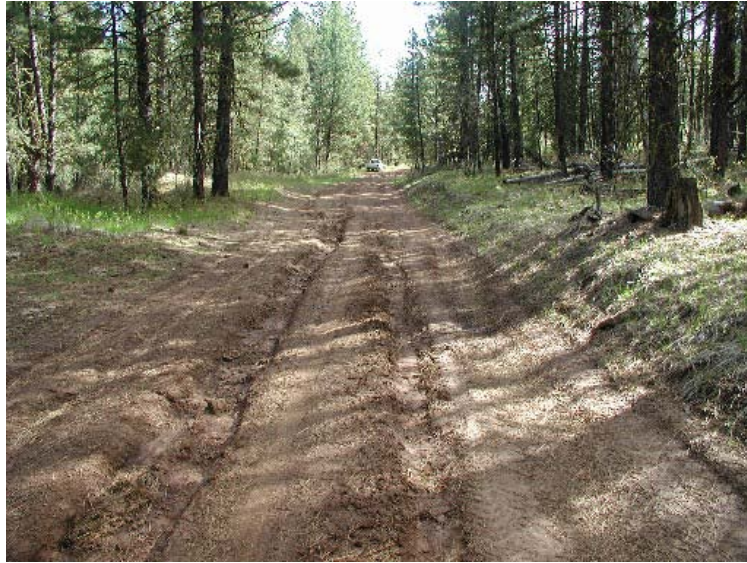
Figure 113. Representative photograph of the RCA buffer on Unit 12, looking at evidence of erosion on the Fawn Creek Road.

- During pre-harvest monitoring, surface erosion in buffers was not observed. Surface erosion was however, observed on roads within buffers encountered during monitoring. It may be useful to determine if erosion increases after harvest activities occur in the area.
- Additional site visits should be planned to investigate landings when harvest is initiated and investigate buffers after harvest activities occur in the area.
- If additional culverts are removed or replaced, site visits should be made by the fisheries biologist to ensure aquatic organism passage is provided.

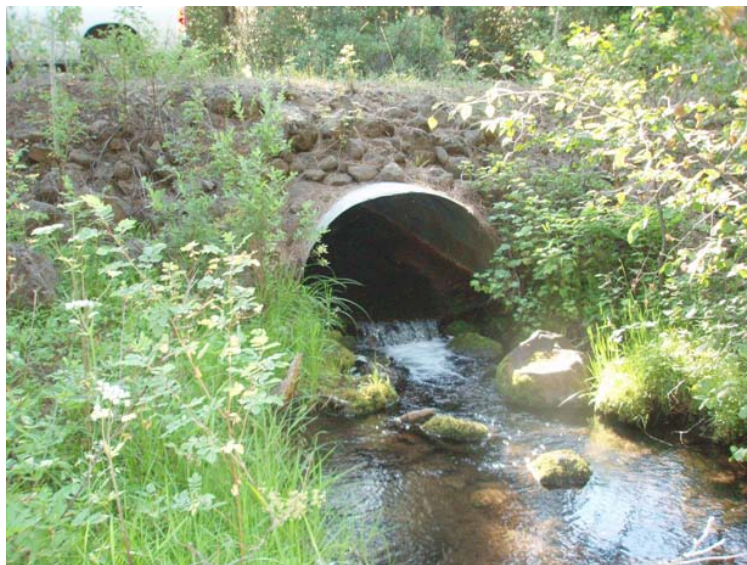
[Figures 118-121](#) depict the culvert replacement that occurred on Fawn Creek in 2009. This culvert was inspected by the fisheries biologist during installation to ensure aquatic organism passage concerns were met.

Figure 118. Culvert on FS Road at the Fawn Creek Crossing, looking at the outlet prior to replacement on July 20, 2009.

*****Ensure that the Fawn Creek culvert replaced in 2009 provides stream simulation and aquatic organism passage.***

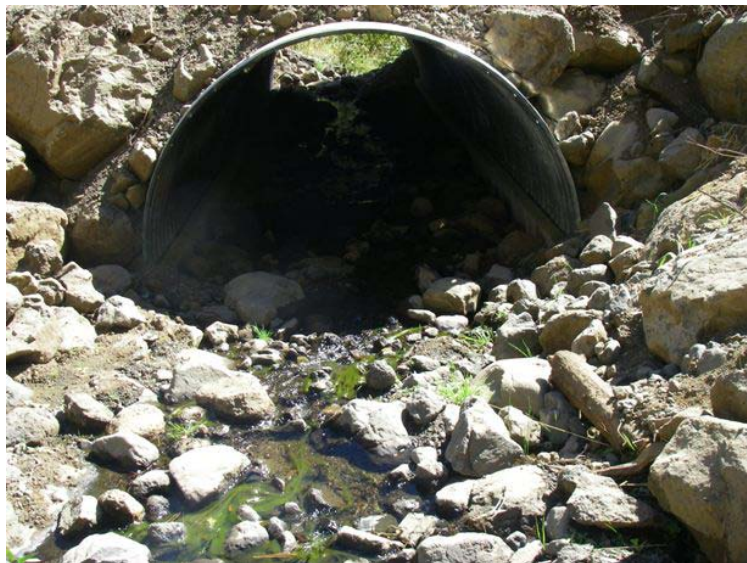
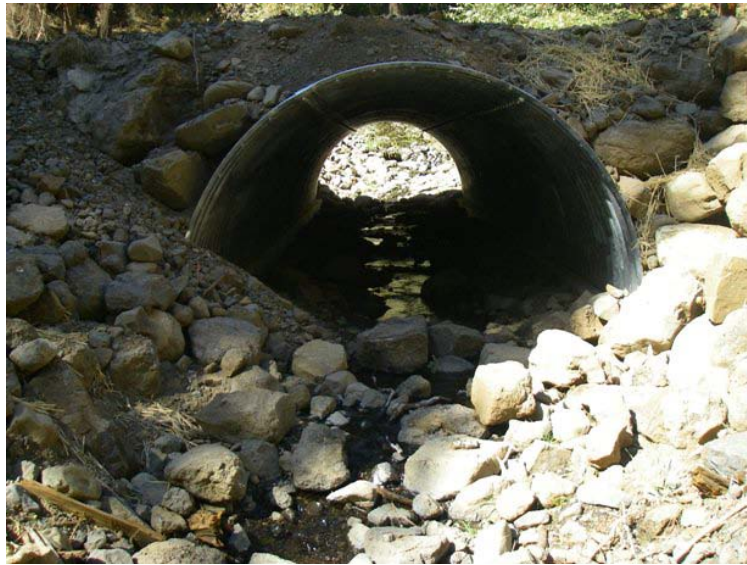
The culvert at Bar Creek contains a flat, wide channel, but still provides stream simulation [Figures 123-125](#). The outlet of this culvert is steeper than the channel within the culvert and water flows through loose rocks in the channel. Fish were observed immediately upstream of and downstream of the culvert.

Figure 123. Culvert on Bar Creek. Looking downstream at the inlet on September 23, 2009.

Figure 124. Culvert on Bar Creek. Looking upstream at the outlet on September 23, 2009.

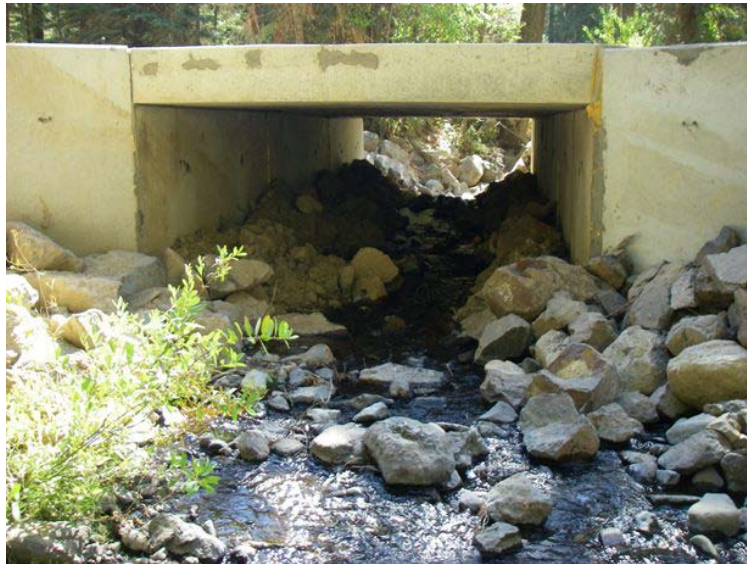
The channel within the bridge on Boulder Creek ([Figures 126-128](#)) was deeper than those constructed at the other two crossings. The “banks” within the bridge were approximately 18”-24” above the water level ([Figure 128](#)). Low and high gradient riffle habitat was present throughout the bridge. The outlet on the Boulder Creek crossing was

Figure 127. Bridge installed on Boulder Creek. Looking upstream at the outlet of the bridge on September 23, 2009.

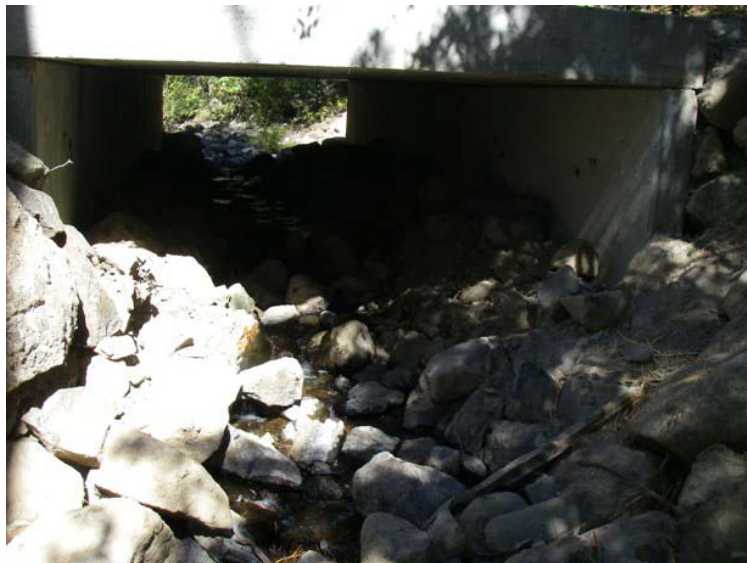
Figure 128. Bridge installed on Boulder Creek. Looking downstream at the channel inside the bridge on September 23, 2009.

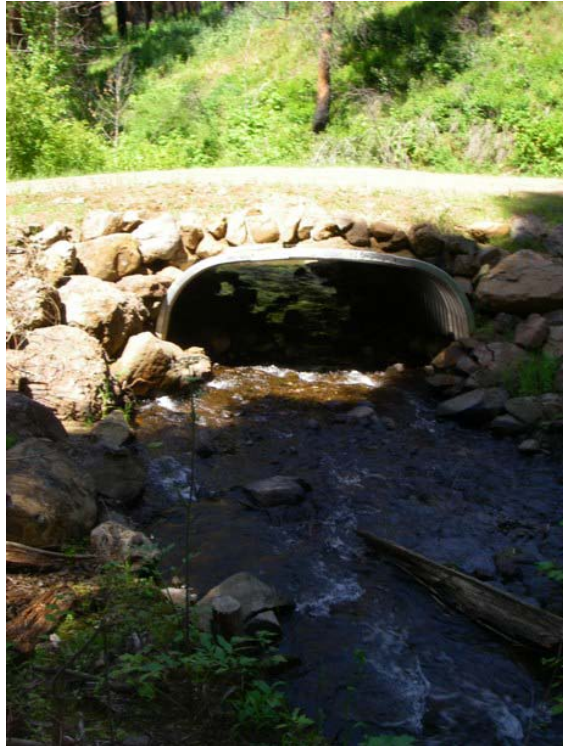
Figure 129. Open-bottom arch installed on North Grays Creek. Looking downstream at the inlet on July 15, 2009.

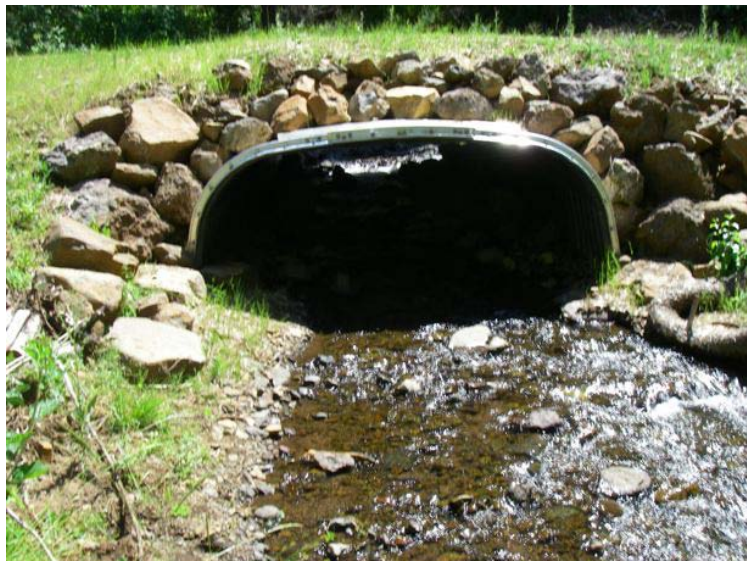
Figure 130. Open-bottom arch installed on North Grays Creek. Looking upstream at the outlet on July 15, 2009.

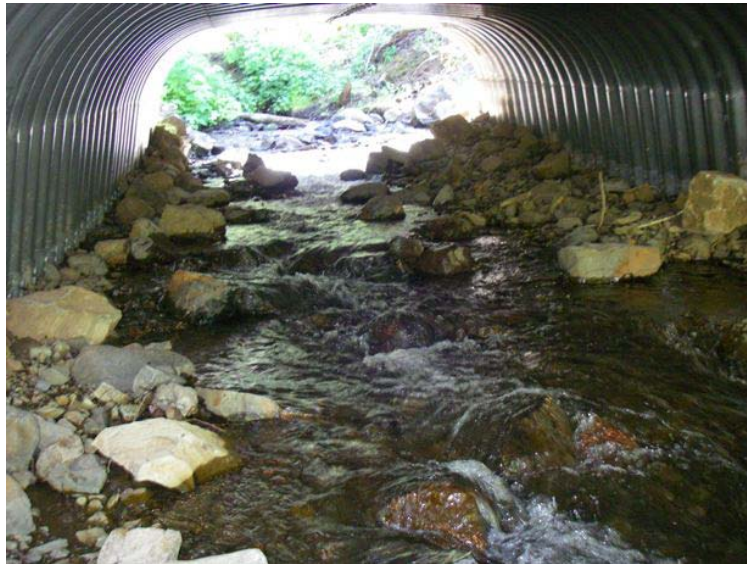
[Figures 129-137](#) depict the new culvert and road decommissioning on North Grays Creek. The new culvert, which is an open-bottom arch, provides good stream simulation ([Figure 131](#)). Photos were taken of the decommissioned road and culvert removal locations to document the reconstructed stream channel ([Figures 132-137](#)).

Figure 131. Open-bottom arch installed on North Grays Creek. Looking upstream at the stream channel inside the culvert.

The open-bottom arch provides fish passage and is of adequate size to accommodate high flow conditions in North Grays Creek. The reconstructed stream channels at the culvert removal locations provide stream simulation and are no longer barriers to fish passage. Cattle activity was observed at the upper culvert removal location on North Grays Creek and the culvert removal on the unnamed tributary (which are in close proximity to one another). Bank trampling was evident, especially in the unnamed tributary. Access to water and straw mulch at the crossing may have attracted cattle to that site. Signs of high cattle activity were not evident at other areas in North Grays Creek. If high levels of cattle activity continue at this site, it may be beneficial to place brush, large woody debris or other materials at this site to deter cattle access to the unnamed tributary at the culvert removal location. This should allow vegetation growth and allow the channel to become stable.
