Fisheries Monitoring Results 2006-2009

Prepared by: J. Greenway, Fisheries Technician

Reviewed by: Caleb Zurstadt, West Zone Fisheries Biologist

December 17, 2009.

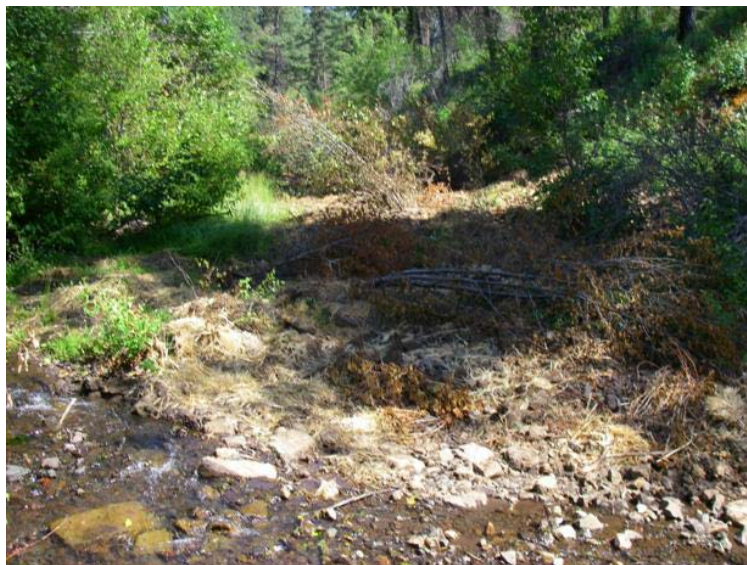
Figure 132. Upper culvert removal location and road decommissioning on North Grays Creek, July 15, 2009.

The open-bottom arch provides fish passage and is of adequate size to accommodate high flow conditions in North Grays Creek. The reconstructed stream channels at the culvert removal locations provide stream simulation and are no longer barriers to fish passage. Cattle activity was observed at the upper culvert removal location on North Grays Creek and the culvert removal on the unnamed tributary (which are in close proximity to one another). Bank trampling was evident, especially in the unnamed tributary. Access to water and straw mulch at the crossing may have attracted cattle to that site. Signs of high cattle activity were not evident at other areas in North Grays Creek. If high levels of cattle activity continue at this site, it may be beneficial to place brush, large woody debris or other materials at this site to deter cattle access to the unnamed tributary at the culvert removal location. This should allow vegetation growth and allow the channel to become stable.

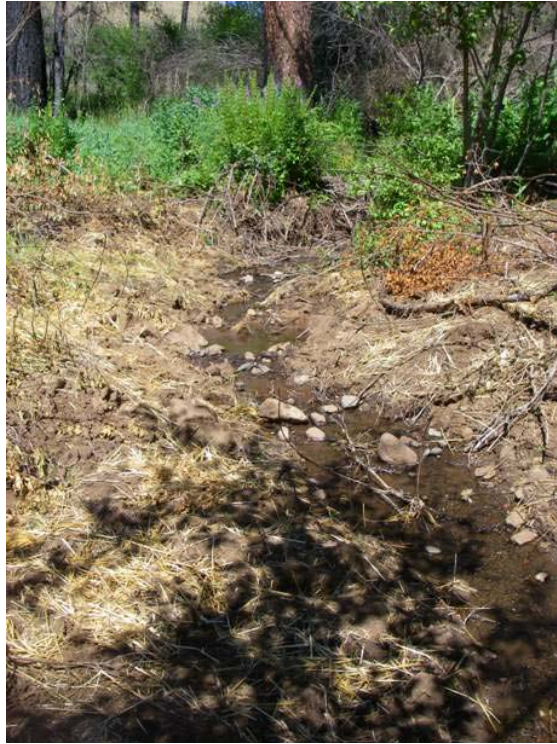
Figure 133. Culvert removal location on the unnamed tributary of North Grays Creek (looking upstream), July 15, 2009.

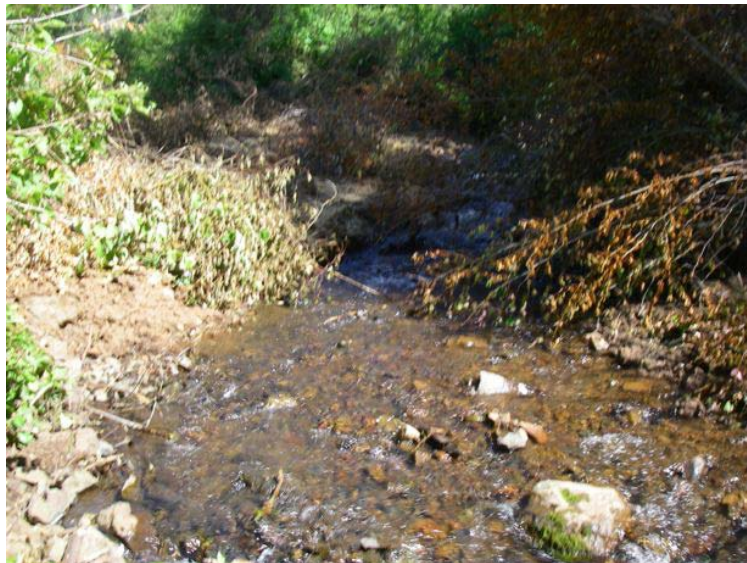
Figure 134. Lower culvert removal location and road decommissioning (looking upstream) on North Grays Creek, July 15, 2009.

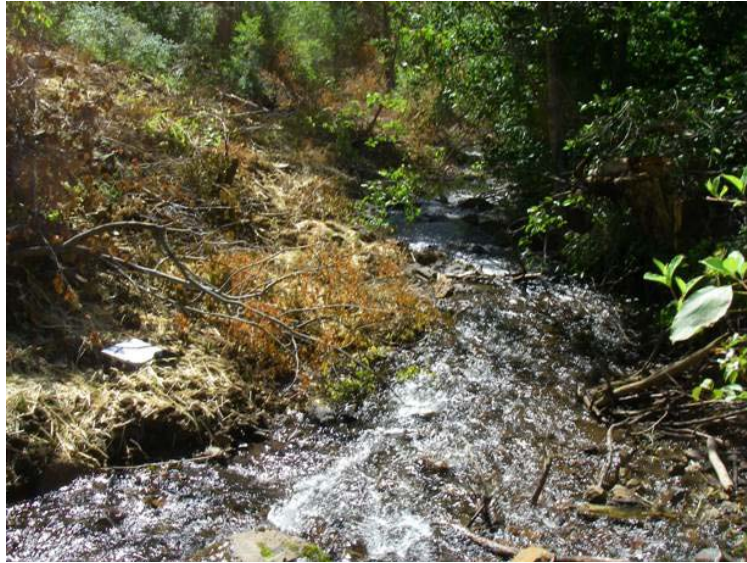
Figure 135. Lower culvert removal location and road decommissioning (looking downstream) on North Grays Creek, July 15, 2009.

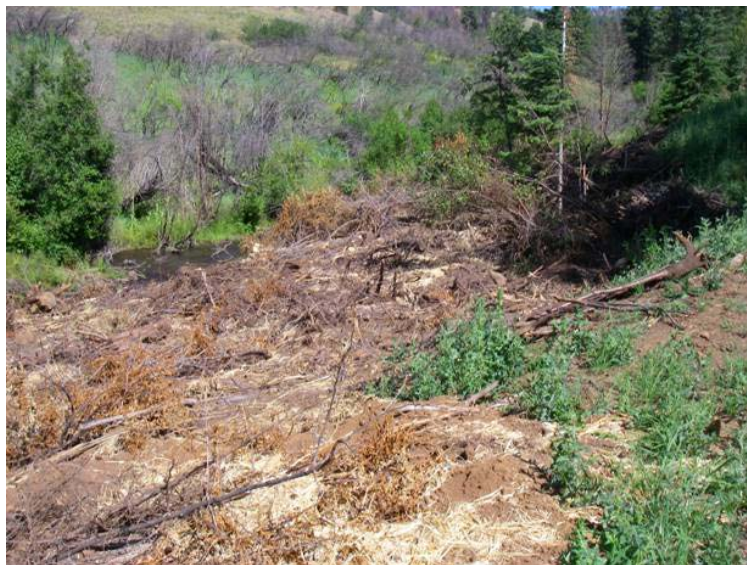
Figure 136. Road decommissioning where the re-route begins near the Forest Boundary on FS 217.

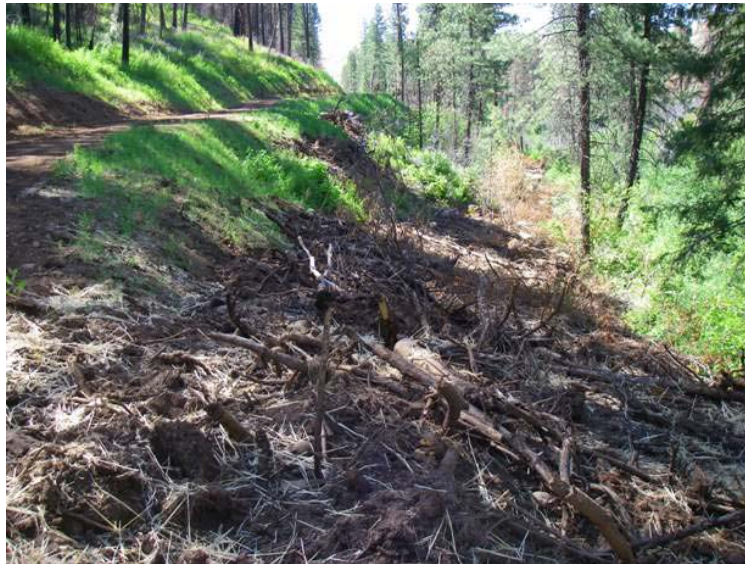
Figure 137. Road decommissioning where the re-route ends at the upstream end on FS 217.

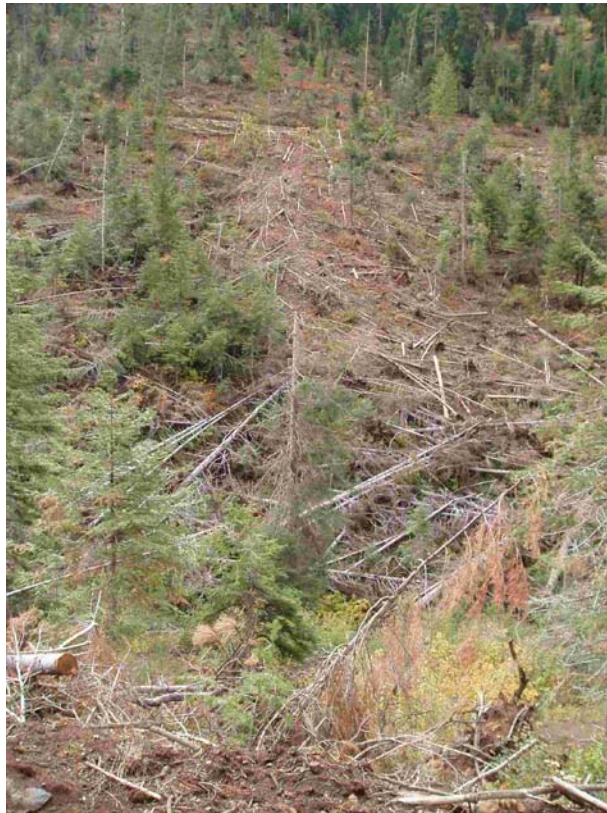
Figure 3. Post logging photograph of unmapped RCA in unit 10 where trees were removed. The pronounced draw in foreground was unmapped and logged. The less pronounced draw in the middle of the photograph was mapped and the 120 ft RCA buffered was not logged.

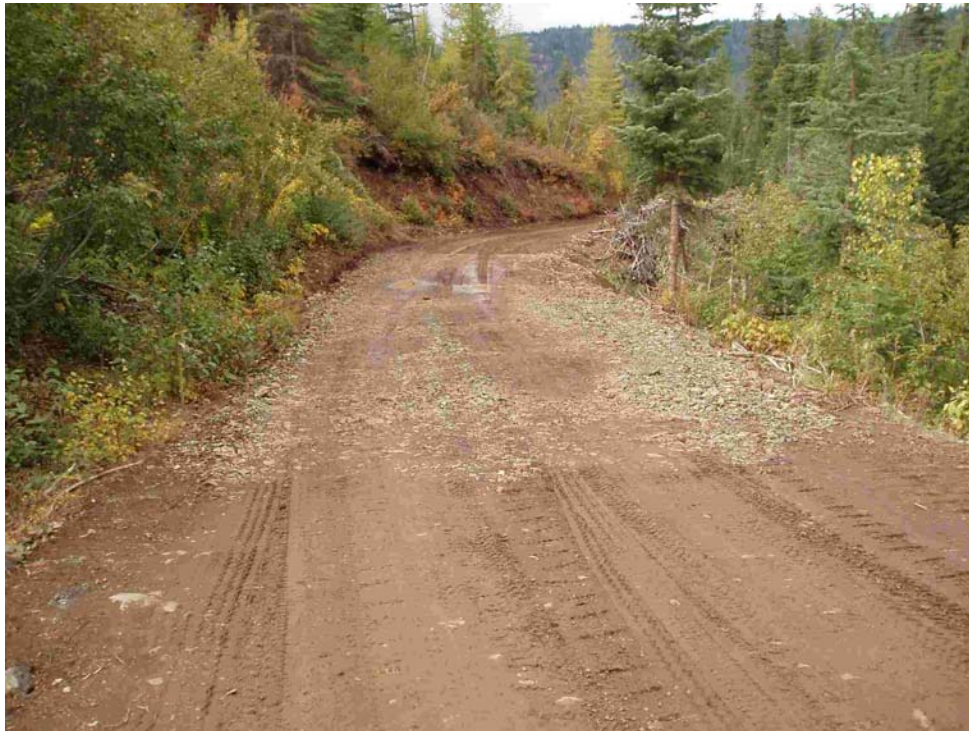
Figure 7. Approved loader trail within RCA of unmapped intermittent channel that was logged. The end of the loader trail is in the foreground.

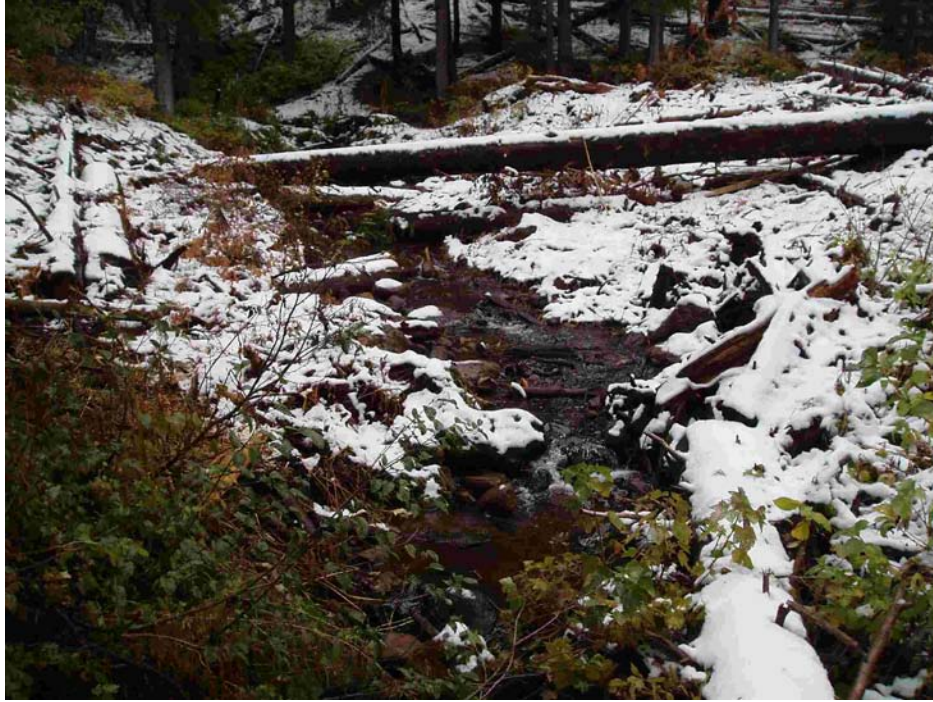
As described in the EA and BA, stream crossings within Bear North, Bessie Bear, and Bear South were graveled to reduce long-term sediment delivery ([Figure 8](#)).

Figure 8. Road gravel mitigation implementation on Bessie Bear sale.

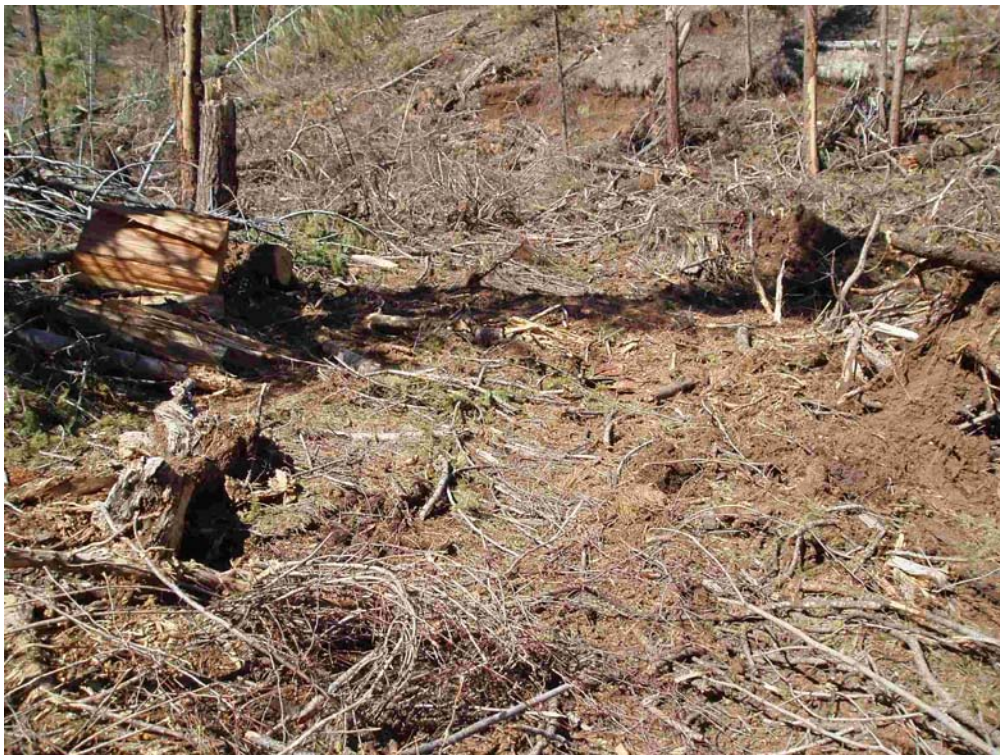
A hydrologist and fisheries biologist approved over snow skidding in Bear West RCAs and several snow bridges across intermittent stream channels. Minimal soil disturbance was observed during monitoring of RCAs after snowmelt and abundant ground cover to capture sediment was observed ([Figures 11, 12 and 13](#)). The snow bridges were located at old road fords or otherwise open locations. No streambank damage was observed during post snowmelt monitoring ([Figures 14, 15, 16, and 17](#)). Actions that occurred downstream of bull trout occurrence did not degrade WCIs along non-fish bearing streams; therefore, adverse affects to bull trout were avoided.

Figure 12. Pre logging view of RCA in Bear West where an over snow skid trail was approved due to lack of alternate access.

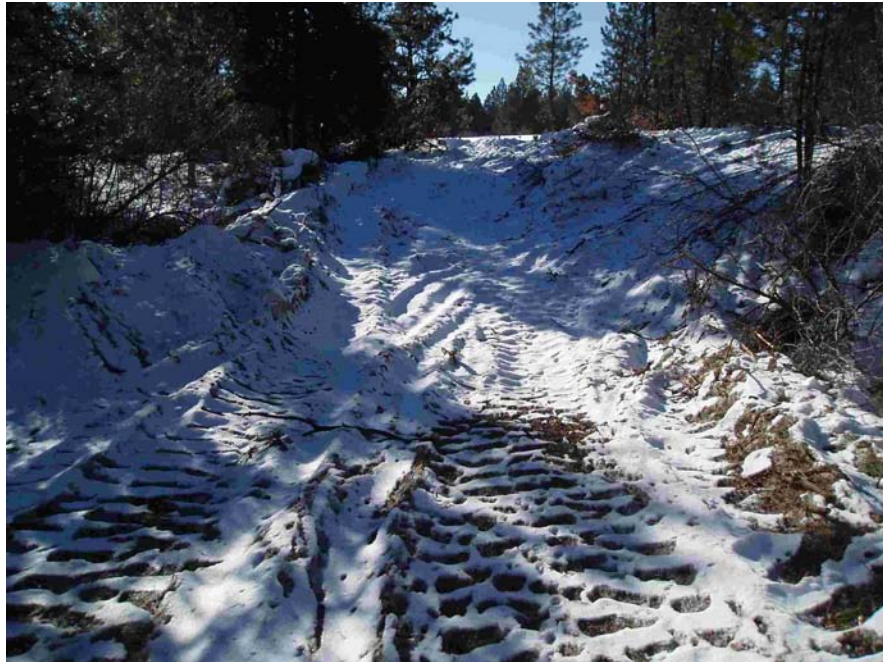
Figure 13. Post logging view of Bear West over snow skid trail that was approved in an RCA.

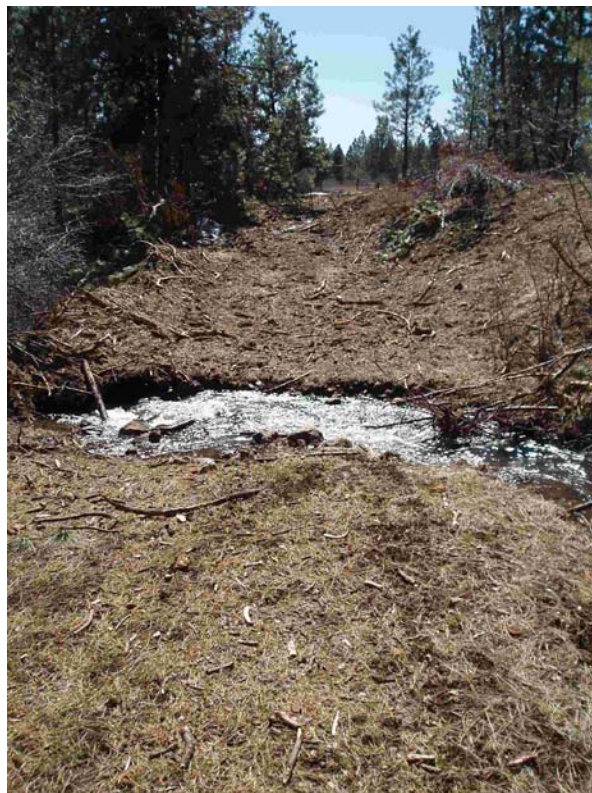
Figure 14. Snow bridge over intermittent channel at old ford in unit 12 of Bear West.
