2021 CALDOR FIRE

CA-ENF-023040

Burned Area Emergency Response (BAER)

Assessment Report Summary

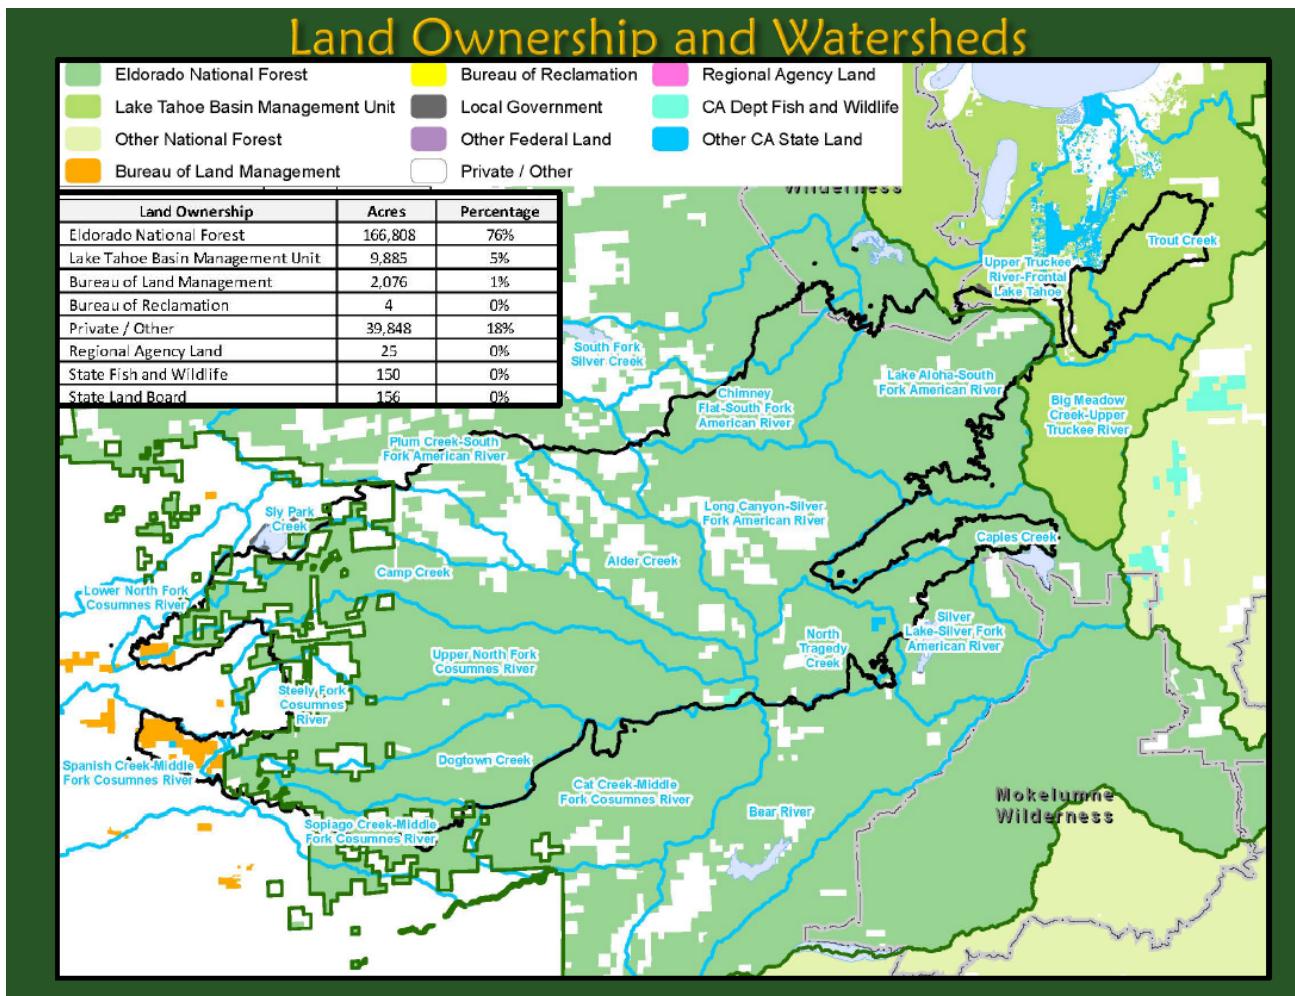
Figure 1. Map depicting ownership and Hydrologic Unit Code (HUC) watersheds.

The Caldor Fire started on August 14, 2021, about two miles east of Omo Ranch and four miles south of Grizzly Flat. The fire burned approximately 166,808 acres on the Eldorado National Forest (ENF), 9,885 acres on the Lake Tahoe Basin Management Unit (TMU), 2,076 acres on Bureau of Land Management (BLM) land, 40,183 acres of private or state lands, and in three counties (Eldorado, Alpine, and Amador)—for a total of approximately 218,952 acres--the number of acres analyzed by the BAER team as of September 18, 2021. As of October 19, 2021, the Caldor Fire burned 221,835 acres (See Figure 1).

The Caldor burned area lies within portions of twenty-two 12-digit Hydrologic Unit Code (HUC) watersheds: Alder Creek, Bear River, Big Meadow Creek-Upper Truckee River, Camp Creek, Caples Creek, Cat Creek-Middle Fork Cosumnes River, Chimney Flat-South Fork American River, Dogtown Creek, Lake Aloha-South Fork American River, Long Canyon-Silver Fork American River, Lower-North Fork Cosumnes River, North Tragedy Creek, Plum Creek-South Fork American River, Silver Lake-Silver Fork American River, Sly Park Creek, Sopiago Creek-Middle Fork Cosumnes River, South Fork Silver Creek, Spanish Creek-Middle Fork Cosumnes River, Steely Fork Cosumnes River, Trout Creek, Upper North Fork Cosumnes River, and Upper Truckee River-Frontal Lake Tahoe (See Figure 1).

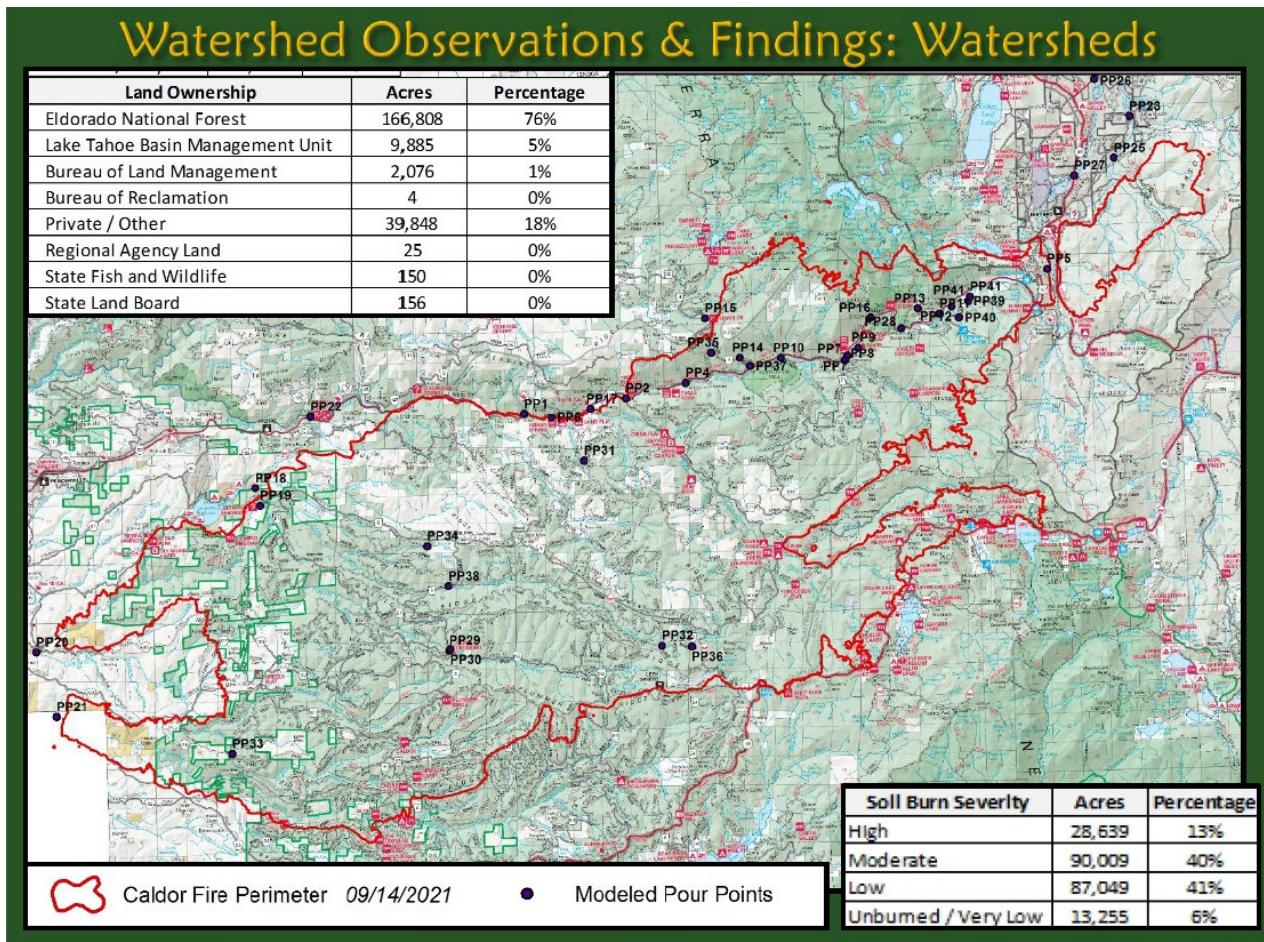
Figure 5. Pour Points Map.

Estimated Hydrologic Response: Hydrologic modeling showed highly-variable increases in post-fire runoff, with roughly half of pour points (certain specific areas identified within the burned area) having high-very high flow increases and half having low-moderate increases in flow. Twenty-nine pour points were modeled for watershed analysis. An additional 11 pour points were modeled for the engineering specialists to determine increased flows at road stream crossings for purposes of determining if treatments were needed. Of the 40 pour points modeled for a 2-year 6-hour storm event, 10 of them showed very high increases in bulked post-fire runoff and 14 showed high increases in bulked post-fire runoff (See Figure 5). These very large runoff responses have the potential to impact life, safety, and property on Forest Service managed lands (particularly roads), pose risk to life and safety in areas under special use permit (recreation residences and organization camps), and affect water quality downstream. Water quality is of particular concern at two locations: Jenkinson Reservoir and Lake Tahoe (See Figures 6,7).
