# Wildcat Fire Burned Area Summary

## Burned Area Report

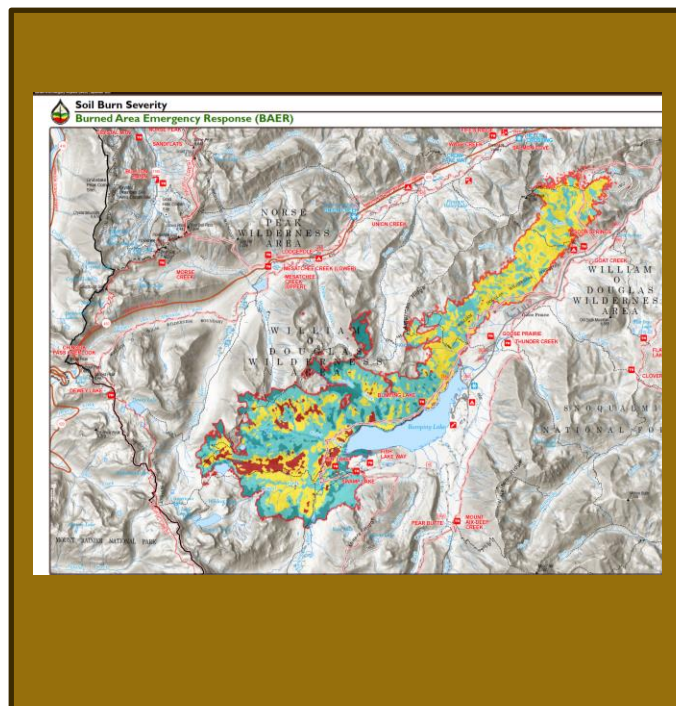
Mapped and validated SBS for the burned area resulted in very low (14%), low (38%) and moderate (41%) soil burn severity. (see map on page 1). The more severe a fire's effects are on the soil, the more likely those soils will erode in subsequent rainstorms – especially in locations with steep slopes. Erosion after fires can cause tremendous damage to homes and other structures in the years after a fire.

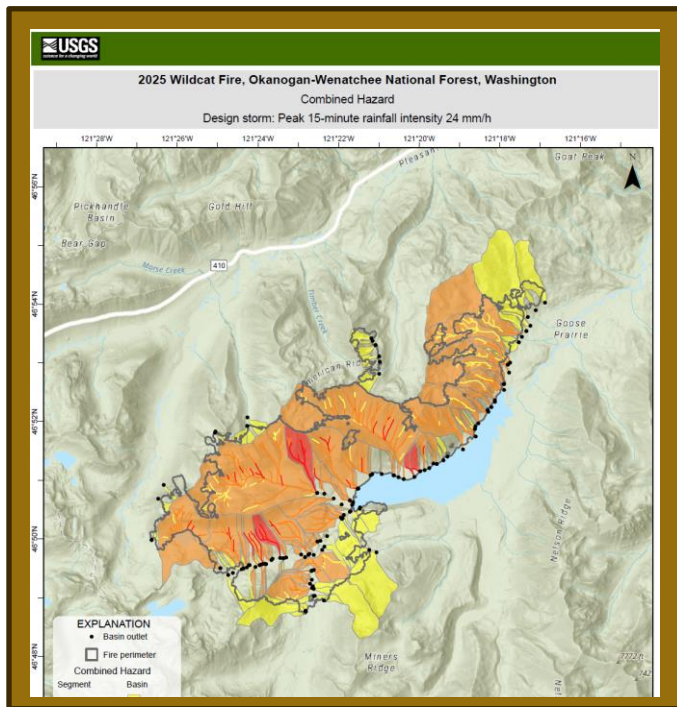
The team provided soil burn severity field data to the US Geological Survey Landslide Hazard Program to assist in forecasting the probability, potential volumes, and hazards of debris flows through their developed empirical models. The USGS Post-fire Debris Flow Hazard Model was performed using the fire perimeter dated 09/23/2025 and identify areas of increased mass movement under post-fire condition (see map on page 3).
