Construction Report

McLaren Adit Closure, Road Reclamation, and Revegetation Contract

Contract AG-0398-C-10-0023
2010-2011

New World Mining District
Response and Restoration Project

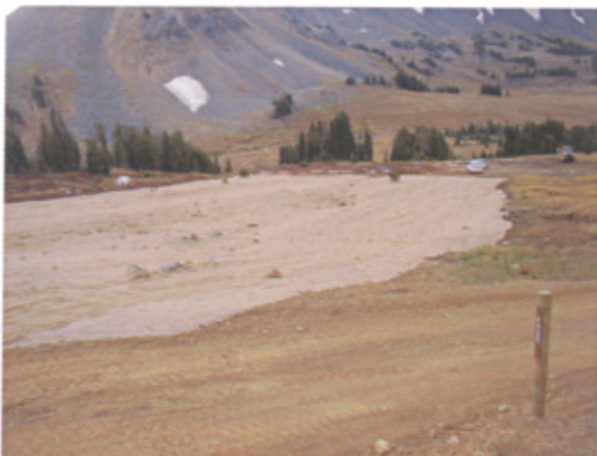
The CO and COR decided to have the Contractor install erosion mat on the area below the McLaren Adit (photo at left) given the proven success record for the mat and owing to the difficult environmental condition of this site, but agreed to use the EarthGuard Fiber Matrix product for reseeding areas along the road corridors where access was more favorable for hydro seeding.
