**CONSTRUCTION REPORT  
McLAREN PIT RESPONSE ACTION  
CONTRACT 50-0398-2-001  
2002-2004  
NEW WORLD MINING DISTRICT  
RESPONSE AND RESTORATION PROJECT**

**USDA Forest Service  
Gallatin National Forest  
Bozeman, Montana**

**July 2006**

**FINAL CONSTRUCTION REPORT**

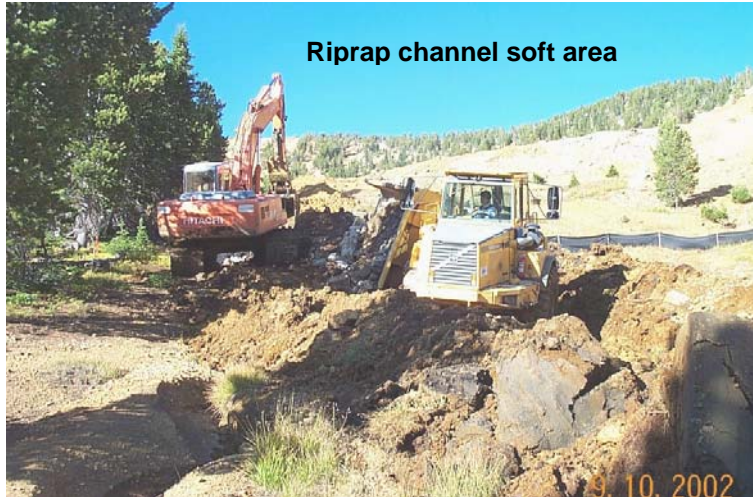
needed; whether to riprap the bed and/or sides of the channel depending on the amount of ferrocrete rock exposed. The COR initially had concerns construction of the middle three channels would cause extensive damage to the vegetation and scrub timber next to the channels due to the steep topography and incised draws. The superintendent and operators devised a plan

whereby the riprap haul trucks would drive down the channels from McLaren Pit, dump their load, and drive empty down the channel to the borrow access road. This worked well although occasionally a truck box would tip over when encountering soft ground.

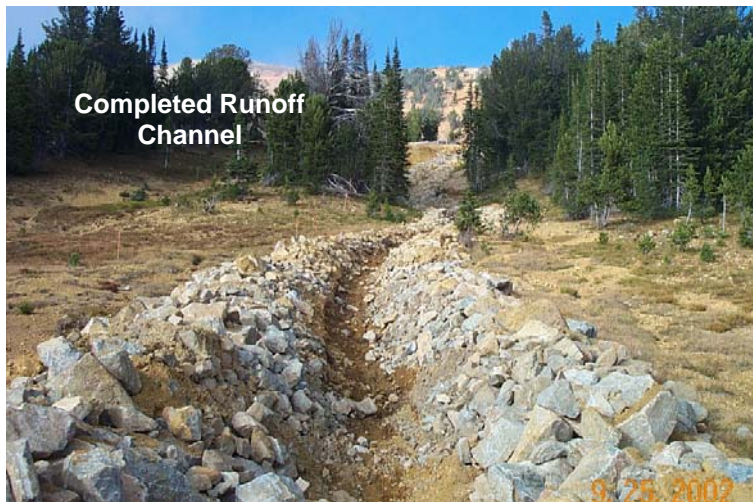
The contractor started haul to runoff channel #2 (second from north) on August 30, 2002, and proceeded with channels #3, #4, and #5 progressively. All four of these channels had riprap in place on September 17. Channels #2, #3, and #4 were then shaped to conform to the design sections. Channel #5, the southerly channel, was not shaped until August 2003.

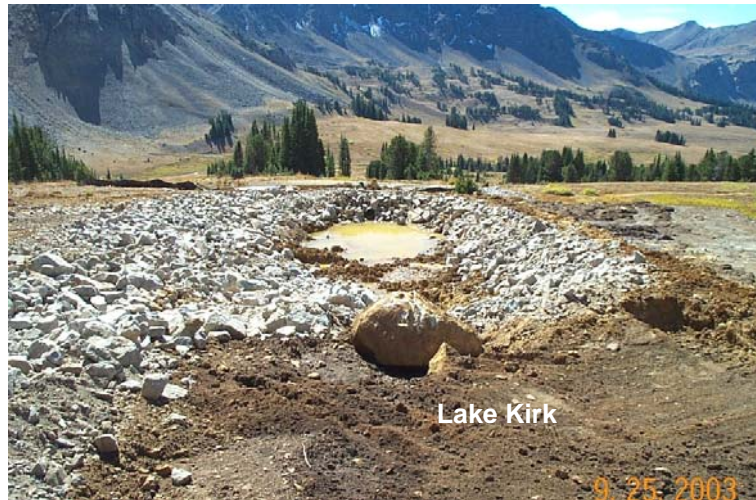
Lake Kirk

The northerly #1 channel was designed to run through the hot pile area once the pile was moved into the body of the pit. The hot pile foot print was immediately above an area of native sulfide, acidic soils. The purpose of runoff channel #1 was primarily to drain water from the McLaren Adit. Government contractors occasionally entered McLaren Adit for investigation and assessment, sometimes releasing thousands of gallons of

contaminated water. The COR got fed up with cleaning up after AK, thus decided to extend runoff channel #1 through the sulfide soils to a flat area, and install a 6,000 gallon sediment retention pond (WO J). Runoff channel #1 and the settling pond were completed on September 25, 2003, after removal of the hot pile.

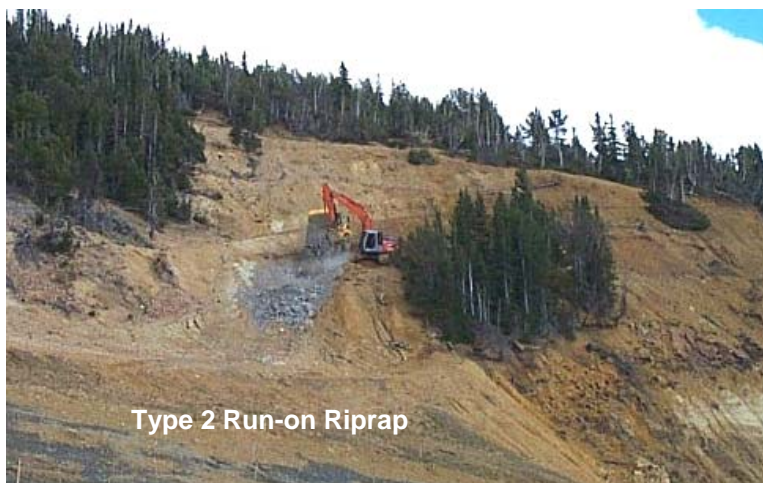
Type 2 Run-on Riprap

Field verification of the Type 1 channel location revealed that the design had located the channel on an 80% slope immediately above the high wall. This location was not feasible due to the steep slopes without incorporation of some sort of retaining structure. Construction on this location would have been hazardous to crews building the channel as well as any workers in the pit below the high wall. The COR and URS superintendent relocated the channel up hill, shortening the channel at the south end so as to avoid obliterating an existing access road needed in the future. The Type 1 channel essentially paralleled an old small run-on control ditch originally built by Crown Butte Mines (CBMI).

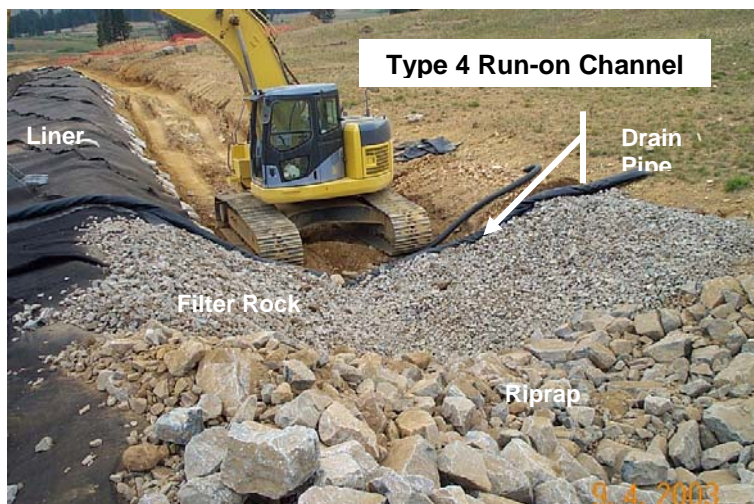
In mid-July 2003, when the new URS team assumed operations, a series of seeps were encountered for about 80 meters along the uphill toe of the Type 3 channel subgrade. The channel design required a PVC liner to minimize seepage under the channel. These seeps would have been under the liner and would have had an adverse effect on the stability of the channel, and could have introduced water into the covered waste rock in the McLaren Pit. The COR directed the contractor to install a 4 inch perforated flex pipe in geotextile sock at the uphill toe of the Type 3 and 4 channels to capture the seepage water and transport it to the lower stilling basin (Mod 6).

The initial liner design called for terminating the HDPE liner and geocomposite on the outside, downhill slope of the Type 3 and 4 channels. The liner subcontractor and COR had concerns this would not provide sufficient anchorage on the northeast perimeter where the pit slopes were 1:3. The COR directed the contractor to lap the HDPE liner and geocomposite over the crest of the Type 3 and 4 channels prior to placing the PVC liner into the channels (WO F). URS provided and installed the specified 40 mil PVC liner for these channels in 2003. Work on the Type 3 and Type 4 channels

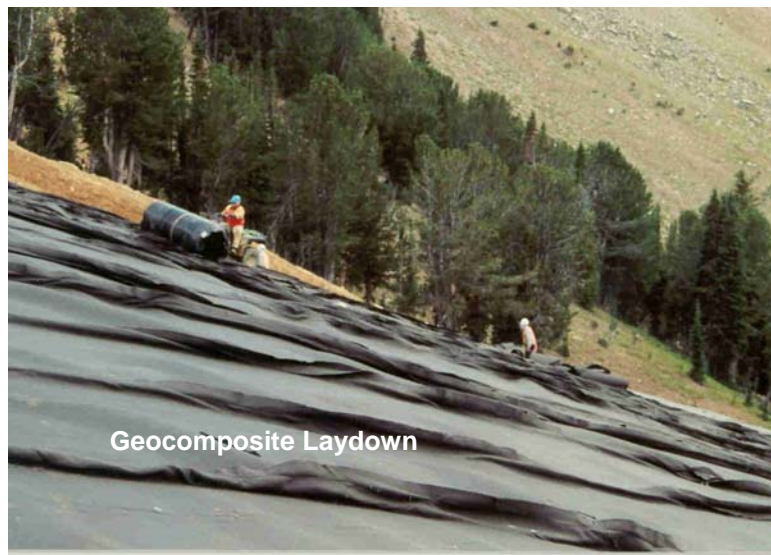
The design called for extending three monitoring wells and 9 moisture monitoring tubes through the liner system with polyethylene boots. After the first few boots were installed in the afternoon, the inspectors noticed that contraction of the geomembrane over night due to the cool air actually tore the liner around the boots. From then on the liner boots were installed during the cooler morning hours when temperatures were below 40° with some slack in the liner.

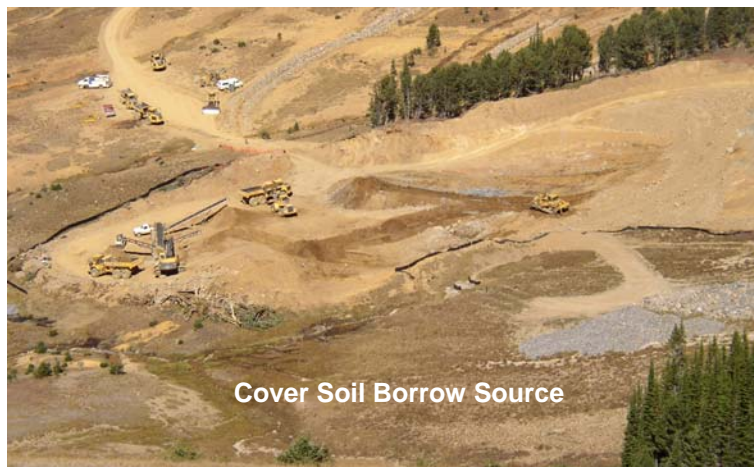
Woolsey Shale bedrock was encountered in the borrow excavation near the center of the borrow site at the toe of the east back slope September 18. The bedrock was within one meter of the design finish elevation thus causing no problems. Several seeps were encountered near the toe of the east back slope, but they were channeled into the

center of the borrow area presenting no problem. Groundwater was encountered close to the designed floor elevation of the borrow area. The contractor stopped excavation in

these areas. The wet areas remained mushy the rest of the season but did not cause significant problems and should develop into minor wetlands in the future.

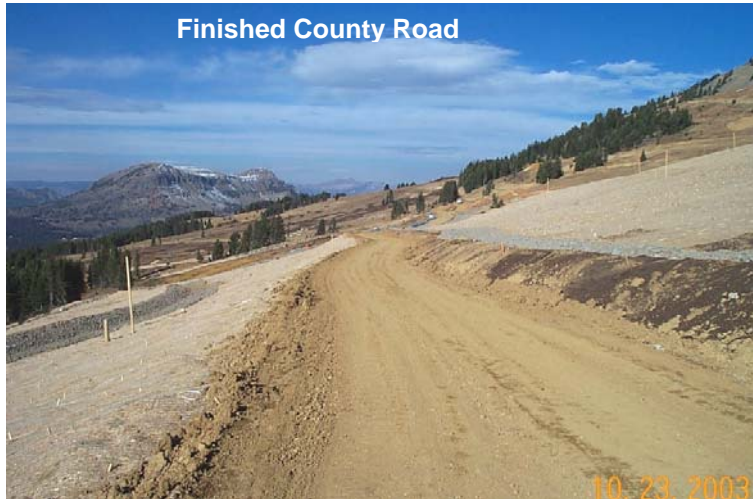
removal of three existing galvanized metal culverts which were installed in 1999. When removed in 2002, it was found that the inverts of the metal pipe had completely corroded through in three years due to the acidic water carried by the pipe.

The contract called for 150mm of crushed aggregate surface course to be placed on the road. The screened cover soil gradations were very close to the specified crushed aggregate gradation. The COR authorized the contractor to place screened cover soil as a road surface course in lieu of the specified crushed aggregate with an appropriate price reduction (Mod 9). The

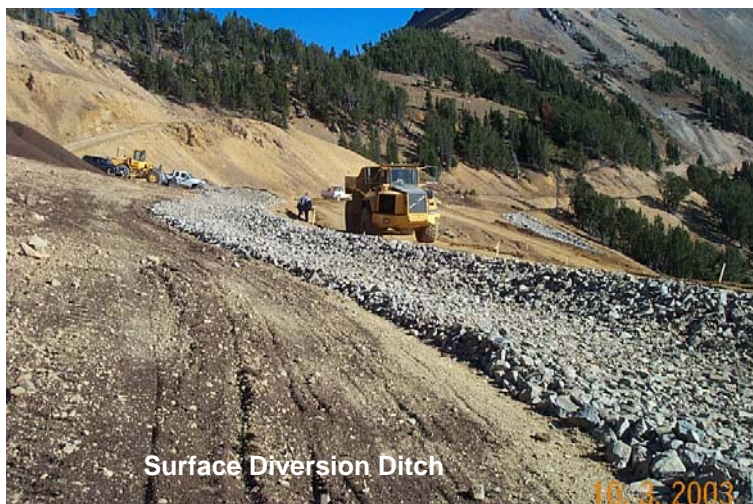
As the cover soil was shaped to support the flaps for the cover drainage system, the contractor welded the 300mm diameter HDPE perforated drainage pipe off site either to the north or south end. Once the drainage channel was formed with the geomembrane flap and cover soil, URS would snake 75m to 200m sections of the pipe into the formed drainage channel. The uphill run of geocomposite was

laid into the channel so water collected by the geocomposite would drain into the formed drain channel and be transported by the HDPE pipe and drain rock. The channels were then backfilled with clean drain rock, covered with geotextile, and capped with one meter of cover soil. The surface diversion ditch was then formed into the cover soil and lined with filter rock and riprap. The cover soil drainage system was installed essentially as designed with minor adjustments for small deviations in the benches. Several of the outfall points into the runoff channels and stilling basin needed to be field fitted and detailed, but there were no significant problems.

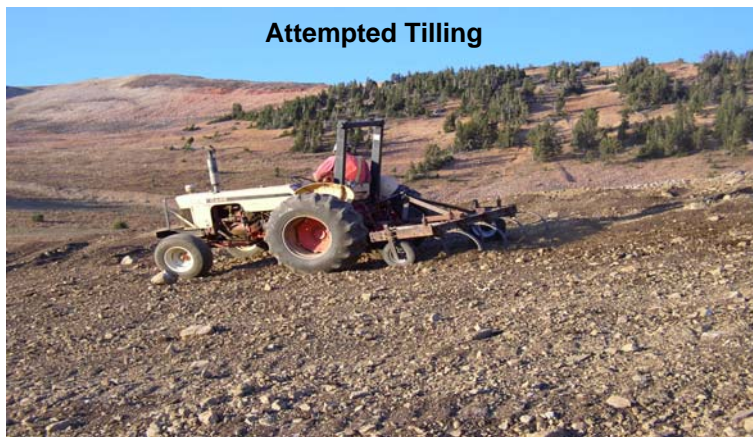
The contract required revegetation of all disturbed areas by mixing fertilizer, phosphorous and compost into the top 150mm of cover soil, seeding, and covering the treated area with high quality erosion mat held in place with organic staples. The specifications also called for lining the borrow site diversion channels with turf reinforcement mat (TRM), a mat formed with PVC mesh and coir fabric. The specification for compost was modified because the design compost material specification was difficult to interpret and out of date (WO G). The triangle area outside the original construction limits near the southeast corner of the pit was added to the area to be treated because revegetation monitoring indicated the area needed additional treatment. The treatment for this area included topical application of fertilizer, compost, agricultural lime and seed, and protecting the treated area with erosion mat (Mod 9). The COR also added revegetation to about 0.5 ha down grade from McLaren

Adit which was originally outside the construction limits. This was an area disturbed by historic mining activities which contained acid generating native soils. Although the area had not been disturbed in decades, there was no evidence of natural regeneration. The area was treated with the contract revegetation specifications. In hindsight, the area should have also received a heavy application of lime to neutralize the soil's acidity.

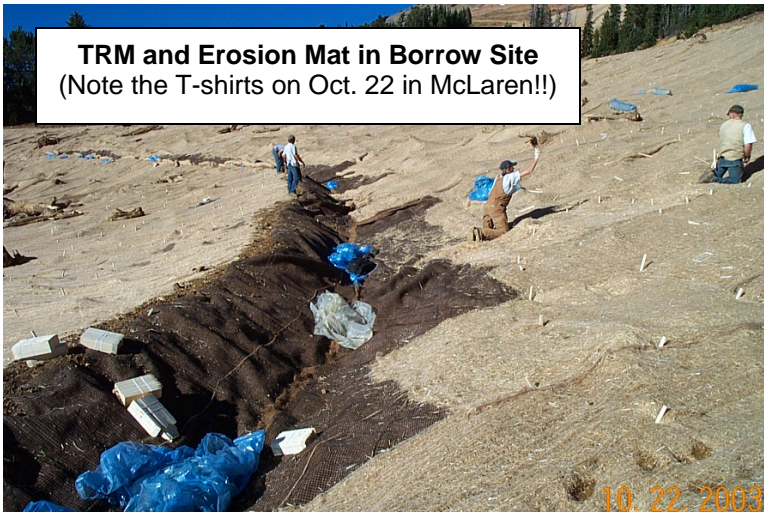
Revegetation started September 21, 2003, and was completed October 25, 2003. The seeding subcontractor was using fairly light equipment for tilling the fertilizer and compost into the cover soil. The equipment was not capable of tilling more than 50mm to 100mm deep. The seeding subcontractor complained that tilling the full depth in the compacted cover soil would roll large rocks to the surface. The COR told the contractor this is the Rocky Mountains, and rocks could therefore be expected. After two areas of fertilizer/compost application and tilling were rejected by the COR, the contractor assisted the subcontractor with heavier equipment for tilling the cover soil surface. The seeding subcontractor replaced the on site foreman, apparently because of the problems with complying with specifications.

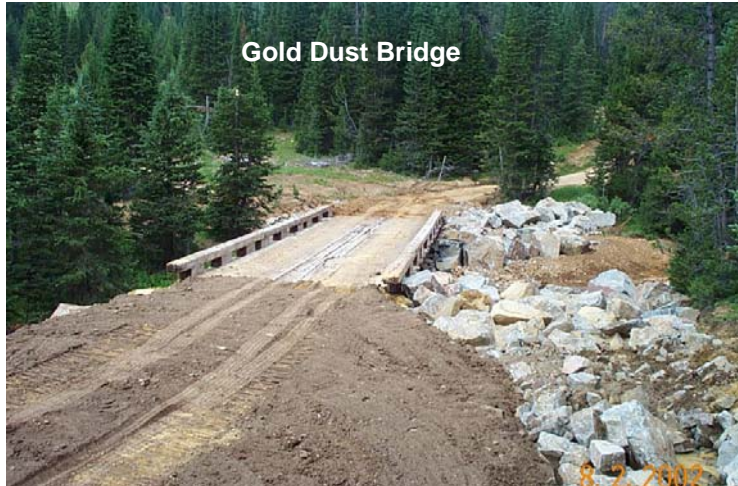
**Gold Dust Bridge 7/30-8/1/02:** In the spring of 2002, the ford across Fisher Creek on the Gold Dust Road washed out, making the crossing impassable to vehicles. This road was needed for access to the Gold Dust Mine for mine assessment and future access for removal and reclamation of the mine waste rock dump. The Forest Service had a 50 foot “portable” bridge rated for off highway loads from a previous project stockpiled about 1.5 miles from the Gold Dust Road. The COR negotiated a modification with URS to transport and install the bridge across Fisher Creek in a location suitable for use by off highway haul trucks in the future (Mod 2, \$13,500).

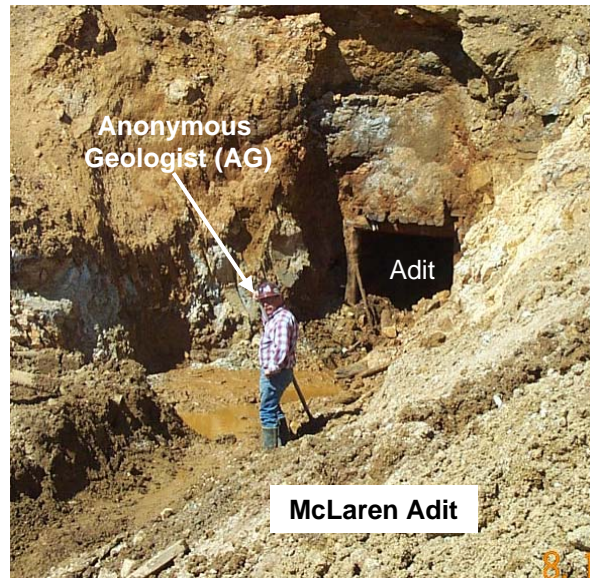
**Open McLaren Adit 8/15 – 8/16/02:** On July 26, 2002, a very large boulder rolled into and blocked the portal, which had been opened in 2001. 7 hours of Cat 345 excavator and 3 hours of 35T Volvo truck were used to remove the boulder under direction of a Maxim geologist who shall remain anonymous. When the boulder was pulled loose, several thousand gallons of water and spooge were released, filling the upper settling basin, washing out the lower settling basin, and flooding an area several hundred feet downhill of the hot pile. Although removal of the boulder did not take long, most of the equipment time was spent cleaning out and rebuilding the settling basins.

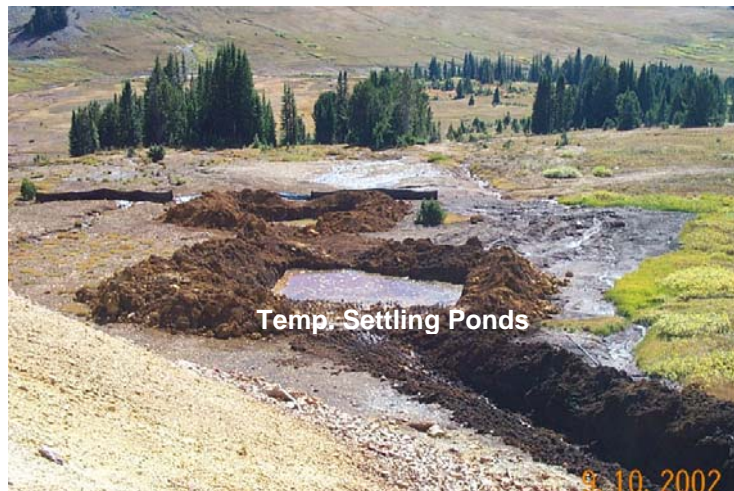
**McLaren Settling Ponds 9/9/02:** 6 hours Hitachi 200 excavator to build two temporary settling ponds down grade of the hot pile to handle expected sediment release from McLaren Adit scheduled to be stabilized September 12, 2002. Considering who would be doing the stabilization (AG), the COR felt it would be prudent to have the largest ponds feasible.

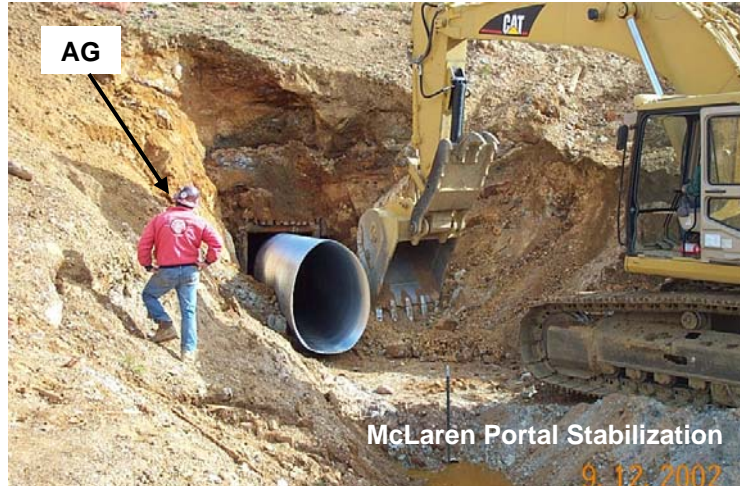
**McLaren Adit Portal Stabilization 9/10/02 and 9/12/02:**

1 hour Hitachi 200 excavator and 3 hours Cat 345 excavator to assist other FS contractors with stabilization of the portal by inserted an arch corrugated metal pipe into the portal, installation of a small drain pipe, and preparing a work pad outside the portal. Reference Maxim report “McLaren Adit Assessment” January 10, 2003.
