Machine Driving of
Wooden and Steel
HIGHWAY
GUARDRAIL POSTS
under Adverse Conditions

by Charles J. Gatchell
and Edwin L. Lucas

U.S.D.A. FOREST SERVICE RESEARCH PAPER NE-212
1971

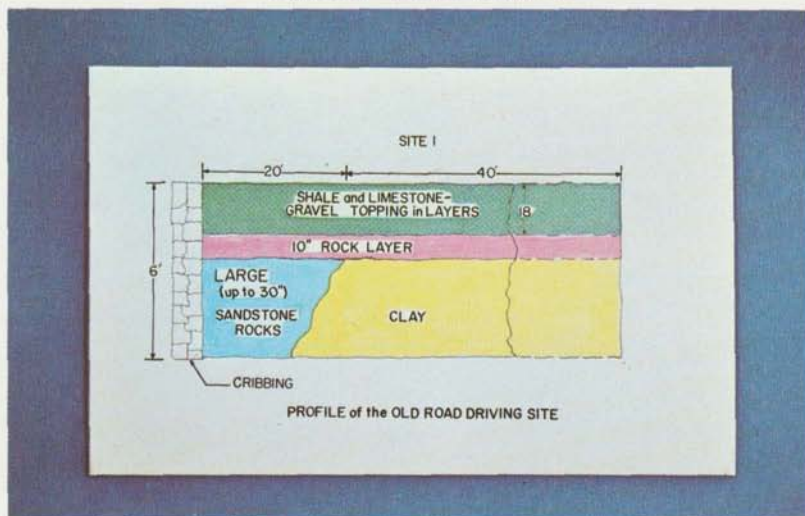
Figure 2.—Profile of site I.

After digging the trench, we found that all of site I was topped with 15 to 18 inches of dry and highly compacted limestone gravel and shale in layers. We assumed that these layers were laid down over a long period of time as a part of road maintenance. A 10-inch-thick layer of small rocks had been placed between the clay base and the limestone and shale

topping. This layer was not distinctly visible over the rock base. Extensive profile work in the clay base was not possible because the trench caved in shortly after being dug.

The three wooden posts and the first four steel posts had been driven into the sandstone rock base. Steel posts 5 and 6 were in a transition zone between the rock fill and the old stream bank. The other four steel posts and seven wooden posts were driven into the clay base.

The seven wooden posts and the four steel posts driven into the clay base were undamaged, though a slight bending of the steel flanges was observed (table 1). This slight bending probably occurred in the 10-inch layer of rock between the clay base and the limestone-shale topping.

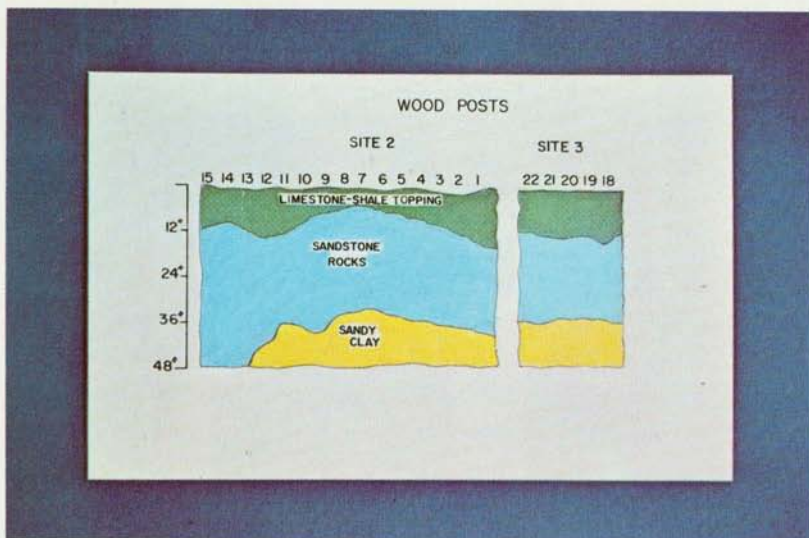
After backhoeing out the trench, we found site II to be much more variable than expected. The depths of the limestone-shale topping and the sandstone rock base along and between lines varied greatly. The severity of the conditions for the wooden posts was greater than those for steel. The rock base under the line of wooden posts was up to 9 inches deeper than that under the opposing position in the line of steel posts.

Figure 4.—Profile of sites II and III where wooden posts were driven. Numbers correspond to wooden posts as listed in tables 2 and 3.

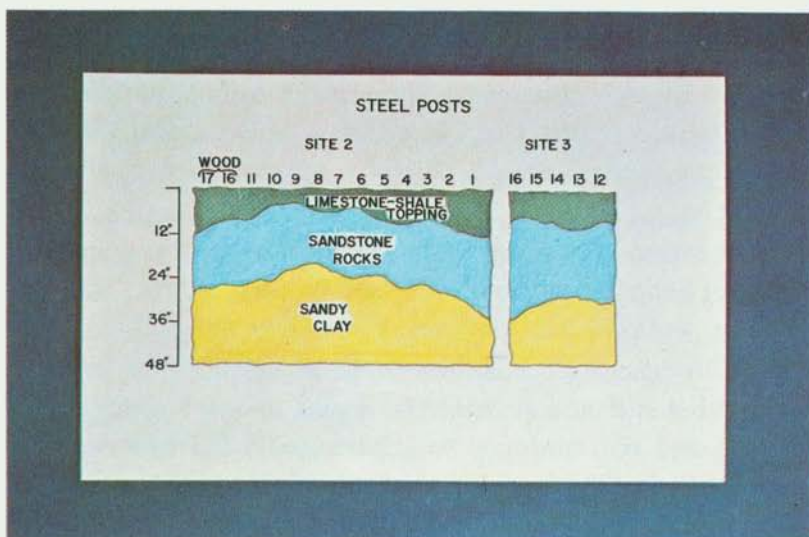
Figure 5.—Profile of sites II and III where steel posts were driven. Numbers refer to posts as listed in tables 2 and 3.

We observed little damage or difference in the severity of damage to steel posts driven with the 800- and 1,200-pound
