Interagency Aviation Lessons Learned

No. IALL 15-01

Date: February 17, 2015

Subject: Helicopter Load Management

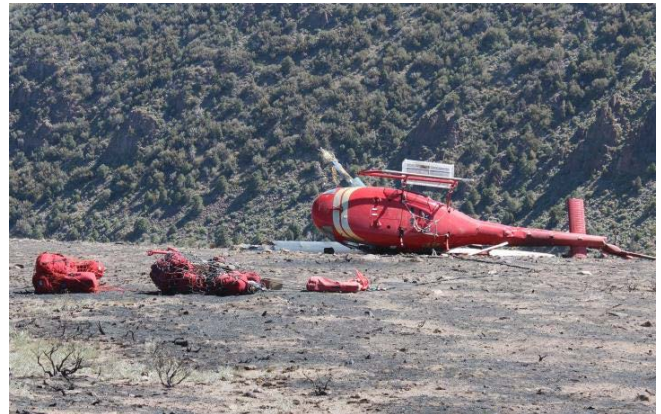
Discussion: Last summer, a contracted helicopter was destroyed when the pilot lost control of the aircraft while conducting external load operations in support of wildland fire operations. Fortunately, neither the pilot nor the firefighters who were in close proximity of the aircraft were injured. The investigation revealed the accident involved several links in that famous chain and lined up all the holes in the Swiss cheese model that contributed to the accident. In other words, it took a village.
