**Technology &
Development
Program**

2300 Recreation Mgmt
September 2000
0023 1202—SDTDC

Soil Stabilizers On Universally Accessible Trails

September 2000

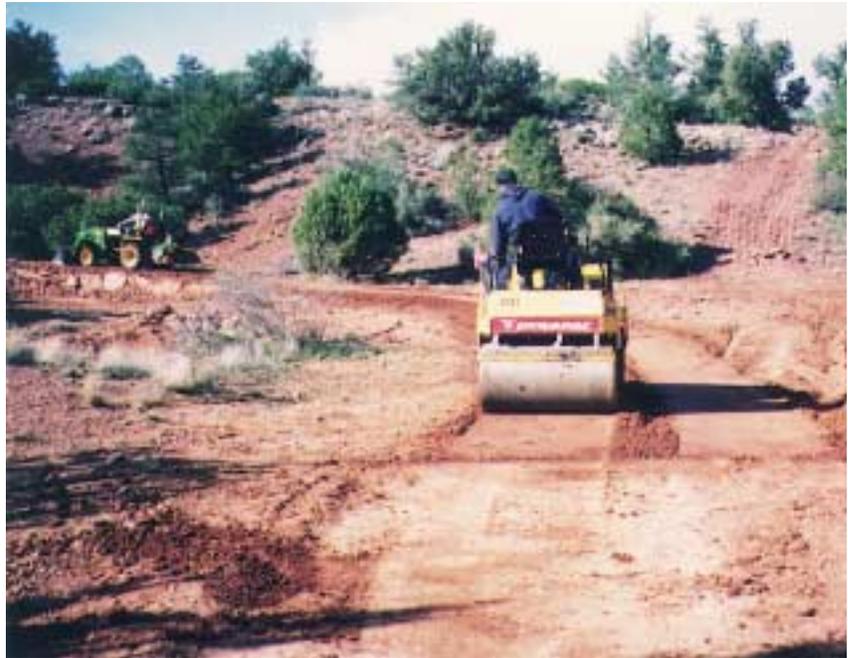
Figure 1. Equipment working on the Bell Rock Pathway on the Coconino NF.

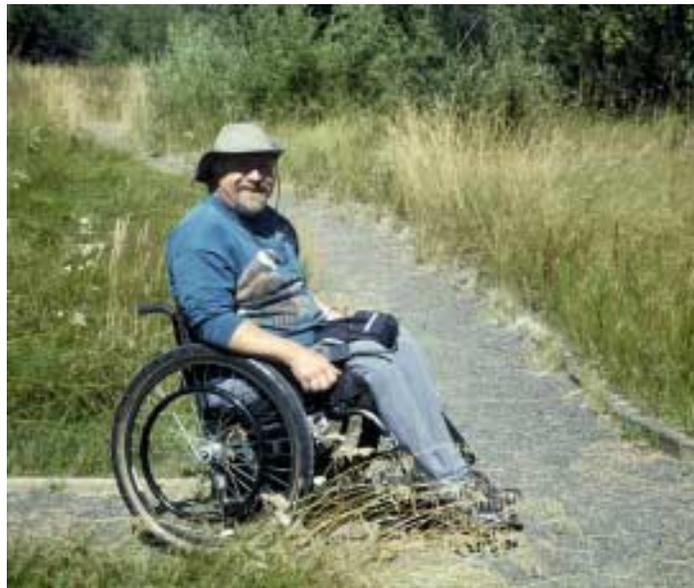
In August 1998, John Parker of Klamath Falls, OR (see figure 2) volunteered to assist the Forest Service by evaluating the various stabilized trail surfaces from the viewpoint of a wheelchair user. This evaluation was strictly a subjective determination of how one user perceived the trail. He used a medium weight chair with wider wheels than he would use in an urban area. The surfaces of the control sections located in the sun were soft, making it difficult to push the wheels of the chair. The chair did not continue to glide after each push on the wheels, and Mr. Parker found it difficult to turn the chair in these trail sections. The control sections located in the shade were firmer because of the mat of leaves covering the surface. Although the material did not appear to be stabilized (it was possible to use the edge of a boot to easily scrape away the aggregate), he found the shaded control sections to be very good surfaces for maneuvering the wheelchair.

Figure 2. John Parker evaluating stabilized trail surfaces.

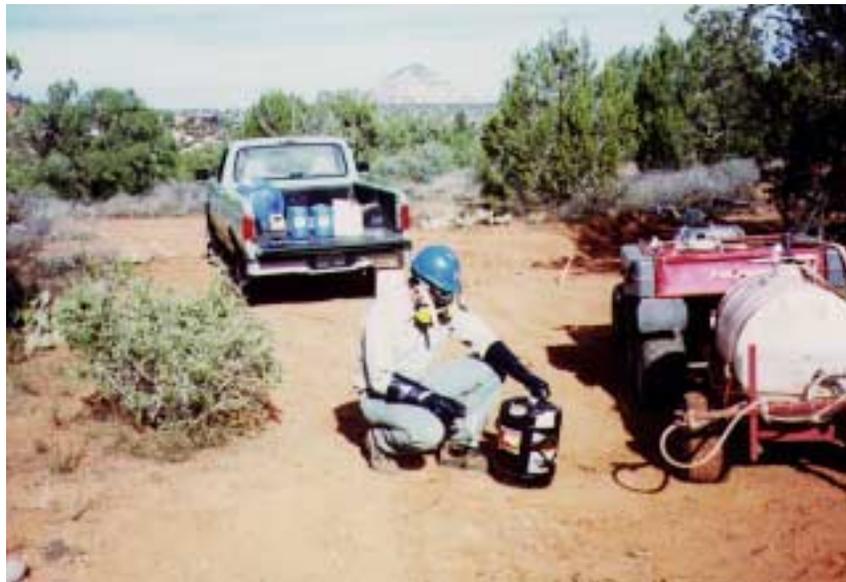
Figure 4. Bentonite with Roadbond EN-1 being applied to trail.
Note that the worker is wearing the required PPE.

This type of product has also been reported to work well with aggregate containing clay. Three percent bentonite clay was added to the aggregate at the Wood River project prior to application of the diluted Roadbond EN-1. The material was brought to optimum moisture levels and then compacted. As with all of the other products, the trail looked very good at completion of construction, but it did not hold up through the first winter. This trail section was adjacent to the bentonite with EMC², and had similar findings when reviewed in April 1996. The ruts caused by a wheelchair traveling across the EMC² surface continued through the length of the section constructed with Roadbond EN-1, and ended where the chair went onto a wooden platform built next to the river for fishing access. There was no visual evidence to show that the wheelchair user attempted to travel over any of the other trail sections. When John Parker reviewed
