Case Study 13. North Fork Consumnes River Tributaries Box Culvert Vented Fords

Central California. Eldorado National Forest, Placerville Ranger District. About 18 miles ESE of Placerville. North Fork Consumnes River basin. Meiss Cabin Road, Forest Road 52 upstream of Capps Crossing.

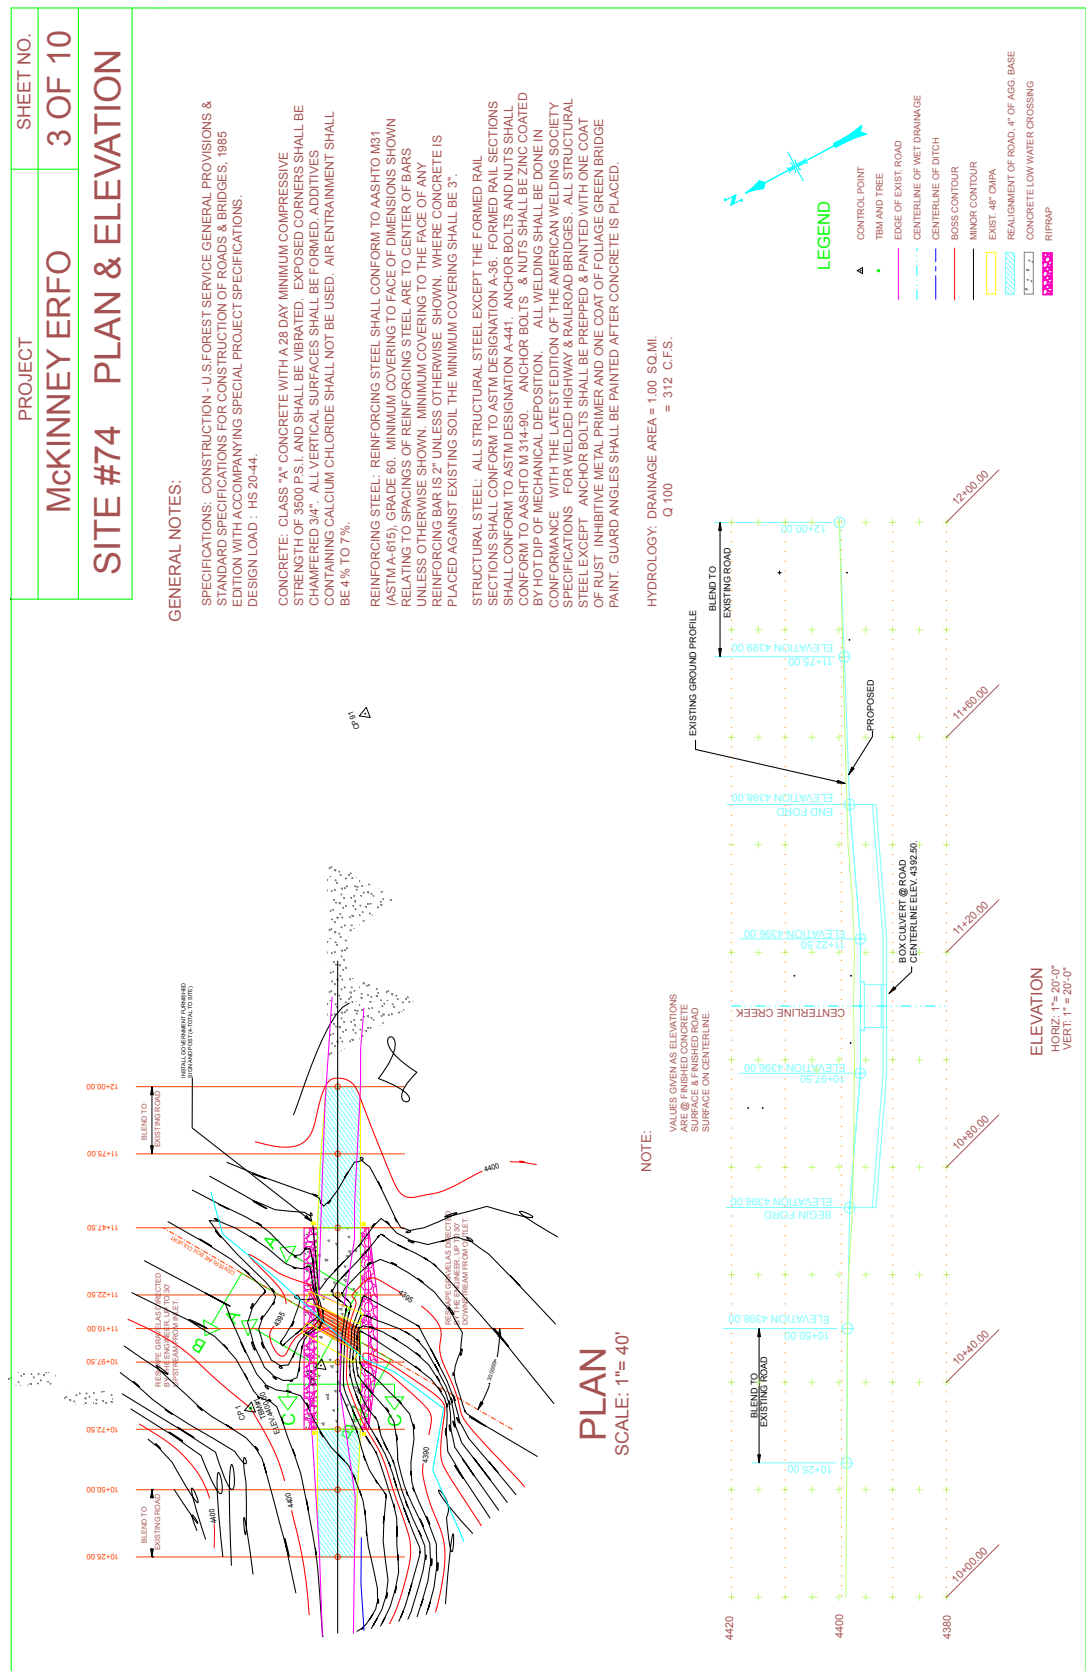
Figure A85—Site plan for McKinney Creek crossing, similar to Meiss Cabin Road box culverts but without the tilted floor. A full size drawing may be found on the CD included in the back of this publication.
