Technical Report GL-93-20  
August 1993

# **Effects of Variable Tire Pressure on Road Surfacing**

Volume I: Design, Construction, Behavior  
Under Traffic, and Test Results

Geotechnical Laboratory

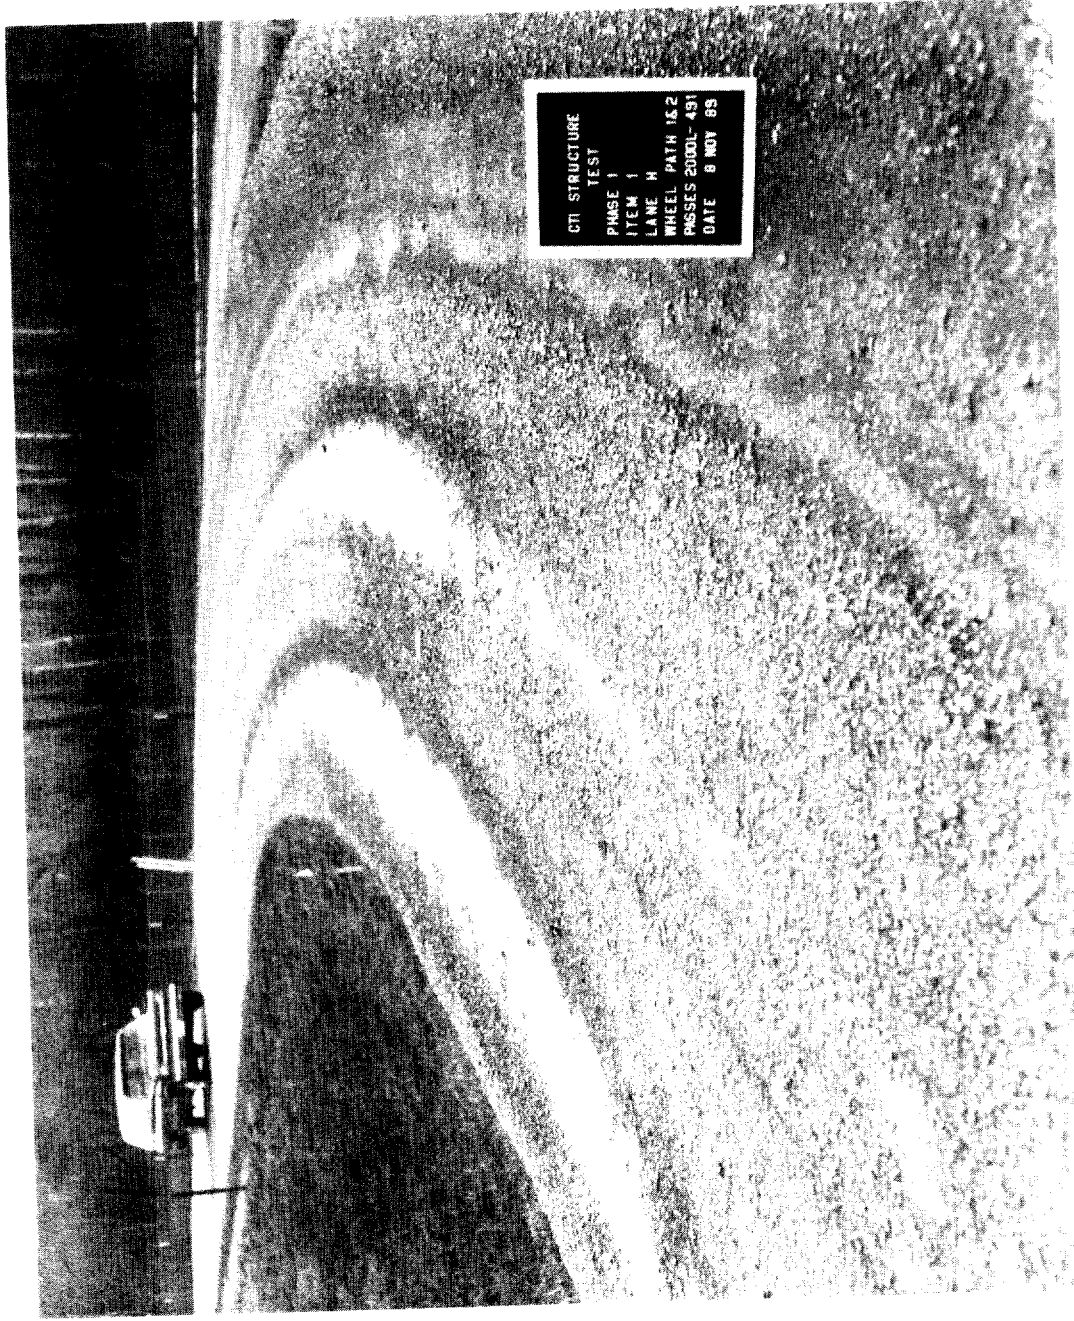
Photo 50. Item 1, high-pressure tire lane, low-severity rutting and washboarding at the end of traffic

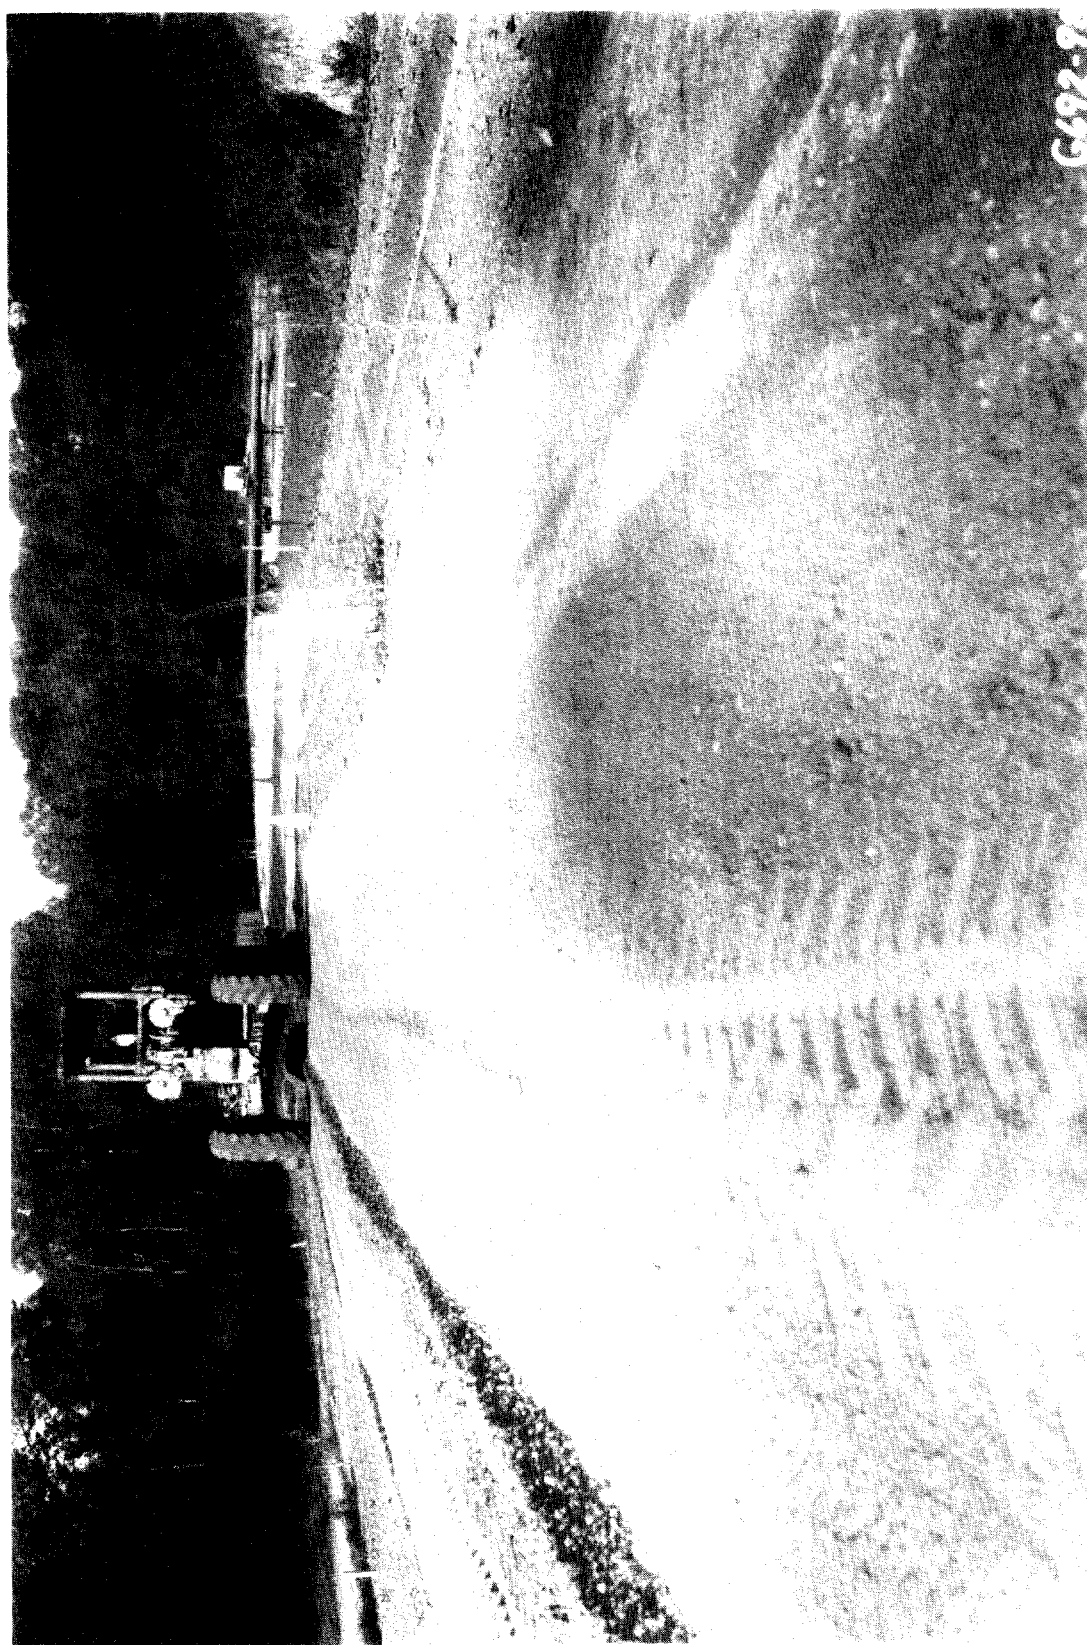
Due to the higher subgrade strengths and no vertical or horizontal curves, items 13 to 15 performed quite a bit better during traffic than did items 1 to 3. Very little distress was detected in items 13 to 15 until about 90 passes of loaded traffic was applied to both lanes during a light drizzle on 29 September 1989. Traffic had not been applied the previous day due to a heavy (1.22-in.) rain. A considerable increase in rutting of all wheel paths of each test item resulted from the 90 passes applied after this rain. The maximum rutting in item 13 increased from 1.5-in. to 4.75-in. In items 14 and 15 the rutting increased from 3.0-in. and 1.75-in. to 4.25- and 5.75-in., respectively. General views of the high- and low-tire-pressure lanes of item 14 at this time are shown in Photos 52 and 53. A total of 883 loaded and 672 unloaded passes had been applied in the high-tire-pressure lane and 1,077 loaded and 838 unloaded passes in the low-tire-pressure lane of these items. Each item was rated as failed due to severe rutting and required grading. It should be noted that these failures were attributed to a wet subgrade, and there was no notable differences between the performance of the various items or test lanes. The aggregate thicknesses of 3, 6, and 9 in. were not sufficient to protect the weak wet subgrade. Grading as shown in Photo 54 removed the ruts in all items. After grading, unloaded traffic was first applied to compact

Photo 54. Grading both lanes of Items 13, 14, and 15

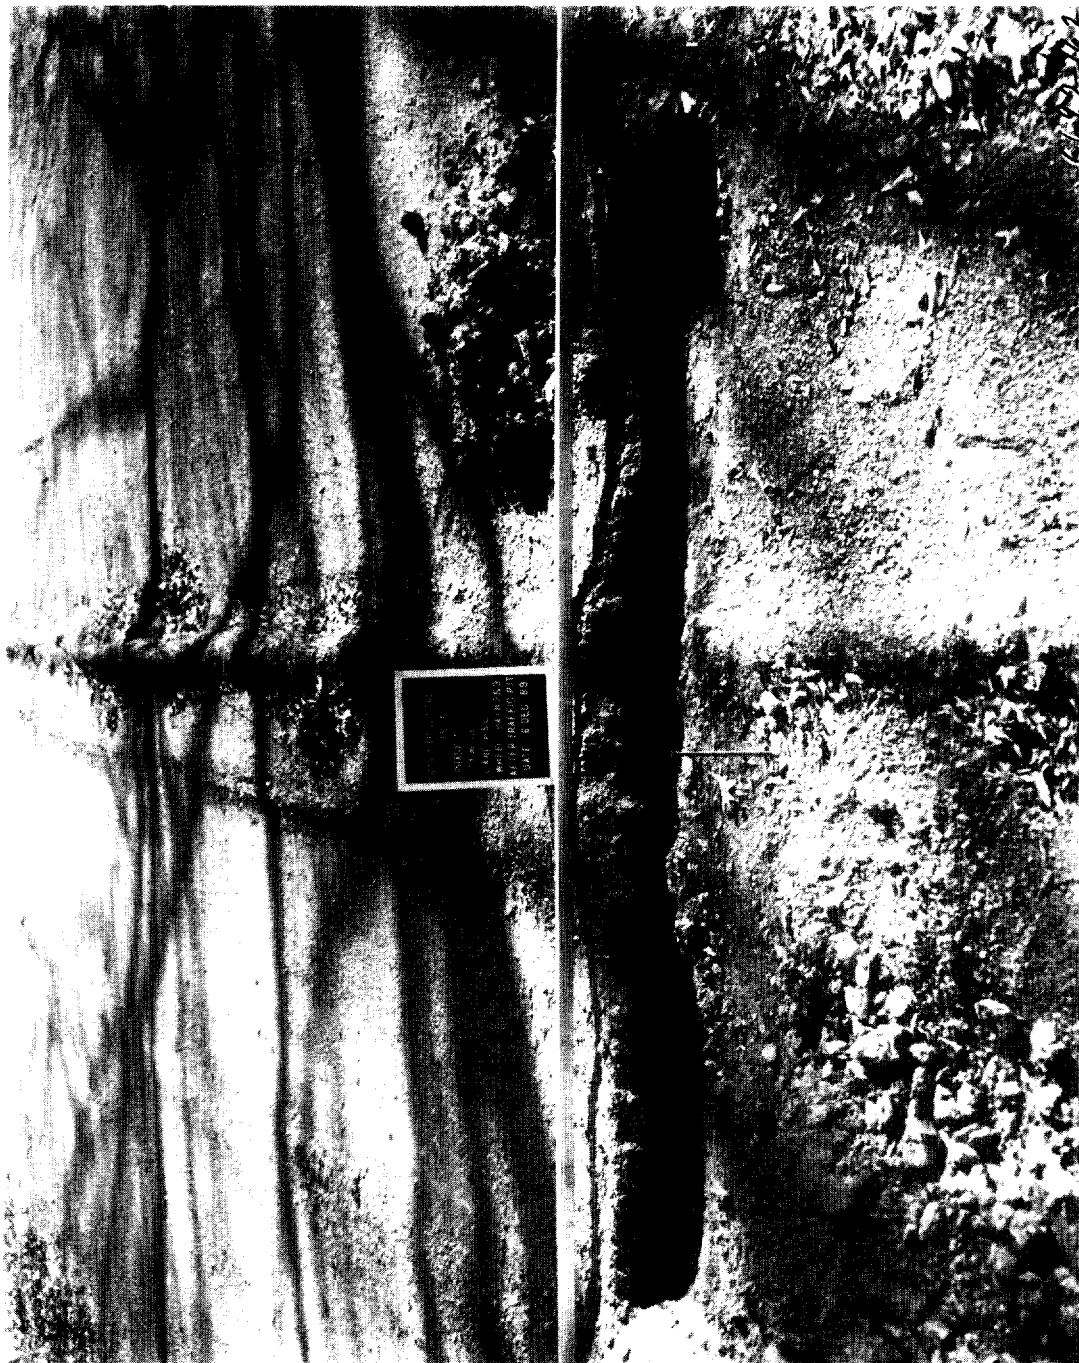
After most of the failures, the rut depth measurements were complimented with one or more of the following: photos, cross section and profile measurements, condition survey, DCP measurements, and/or NDT. A discussion or description of many of the failures is in the "visual observations" section of this report and include typical photos of areas judged failed. Cross section and profile measurements, condition survey results, and DCP and NDT measurements taken after failure of a particular item are stored in enclosed computer files. Test trenches were not excavated across the traffic lane after it was judged failed. Therefore, CBR, water content, and density measurements were not available for the failed areas. Once test traffic was applied on a regular bases, the top priority was to fail as many items as possible in a short time period because of limited funds and the possibility of damaging and uncontrollable rainfall. Therefore, test trenches were omitted and only limited data were taken after each failure. Traffic was discontinued on the 22 November 1989, and in early December test trenches were excavated in items 13, 14, and 15. At this time CBR, moisture content, density, and thickness determinations were made in the second and third wheel paths of the aggregate and subgrade materials. These data are summarized in Table 3. A general view of the post traffic test pit excavated in item 13 is shown in Photo 68.

Photo 68. Item 13, general view of the post-traffic test pit

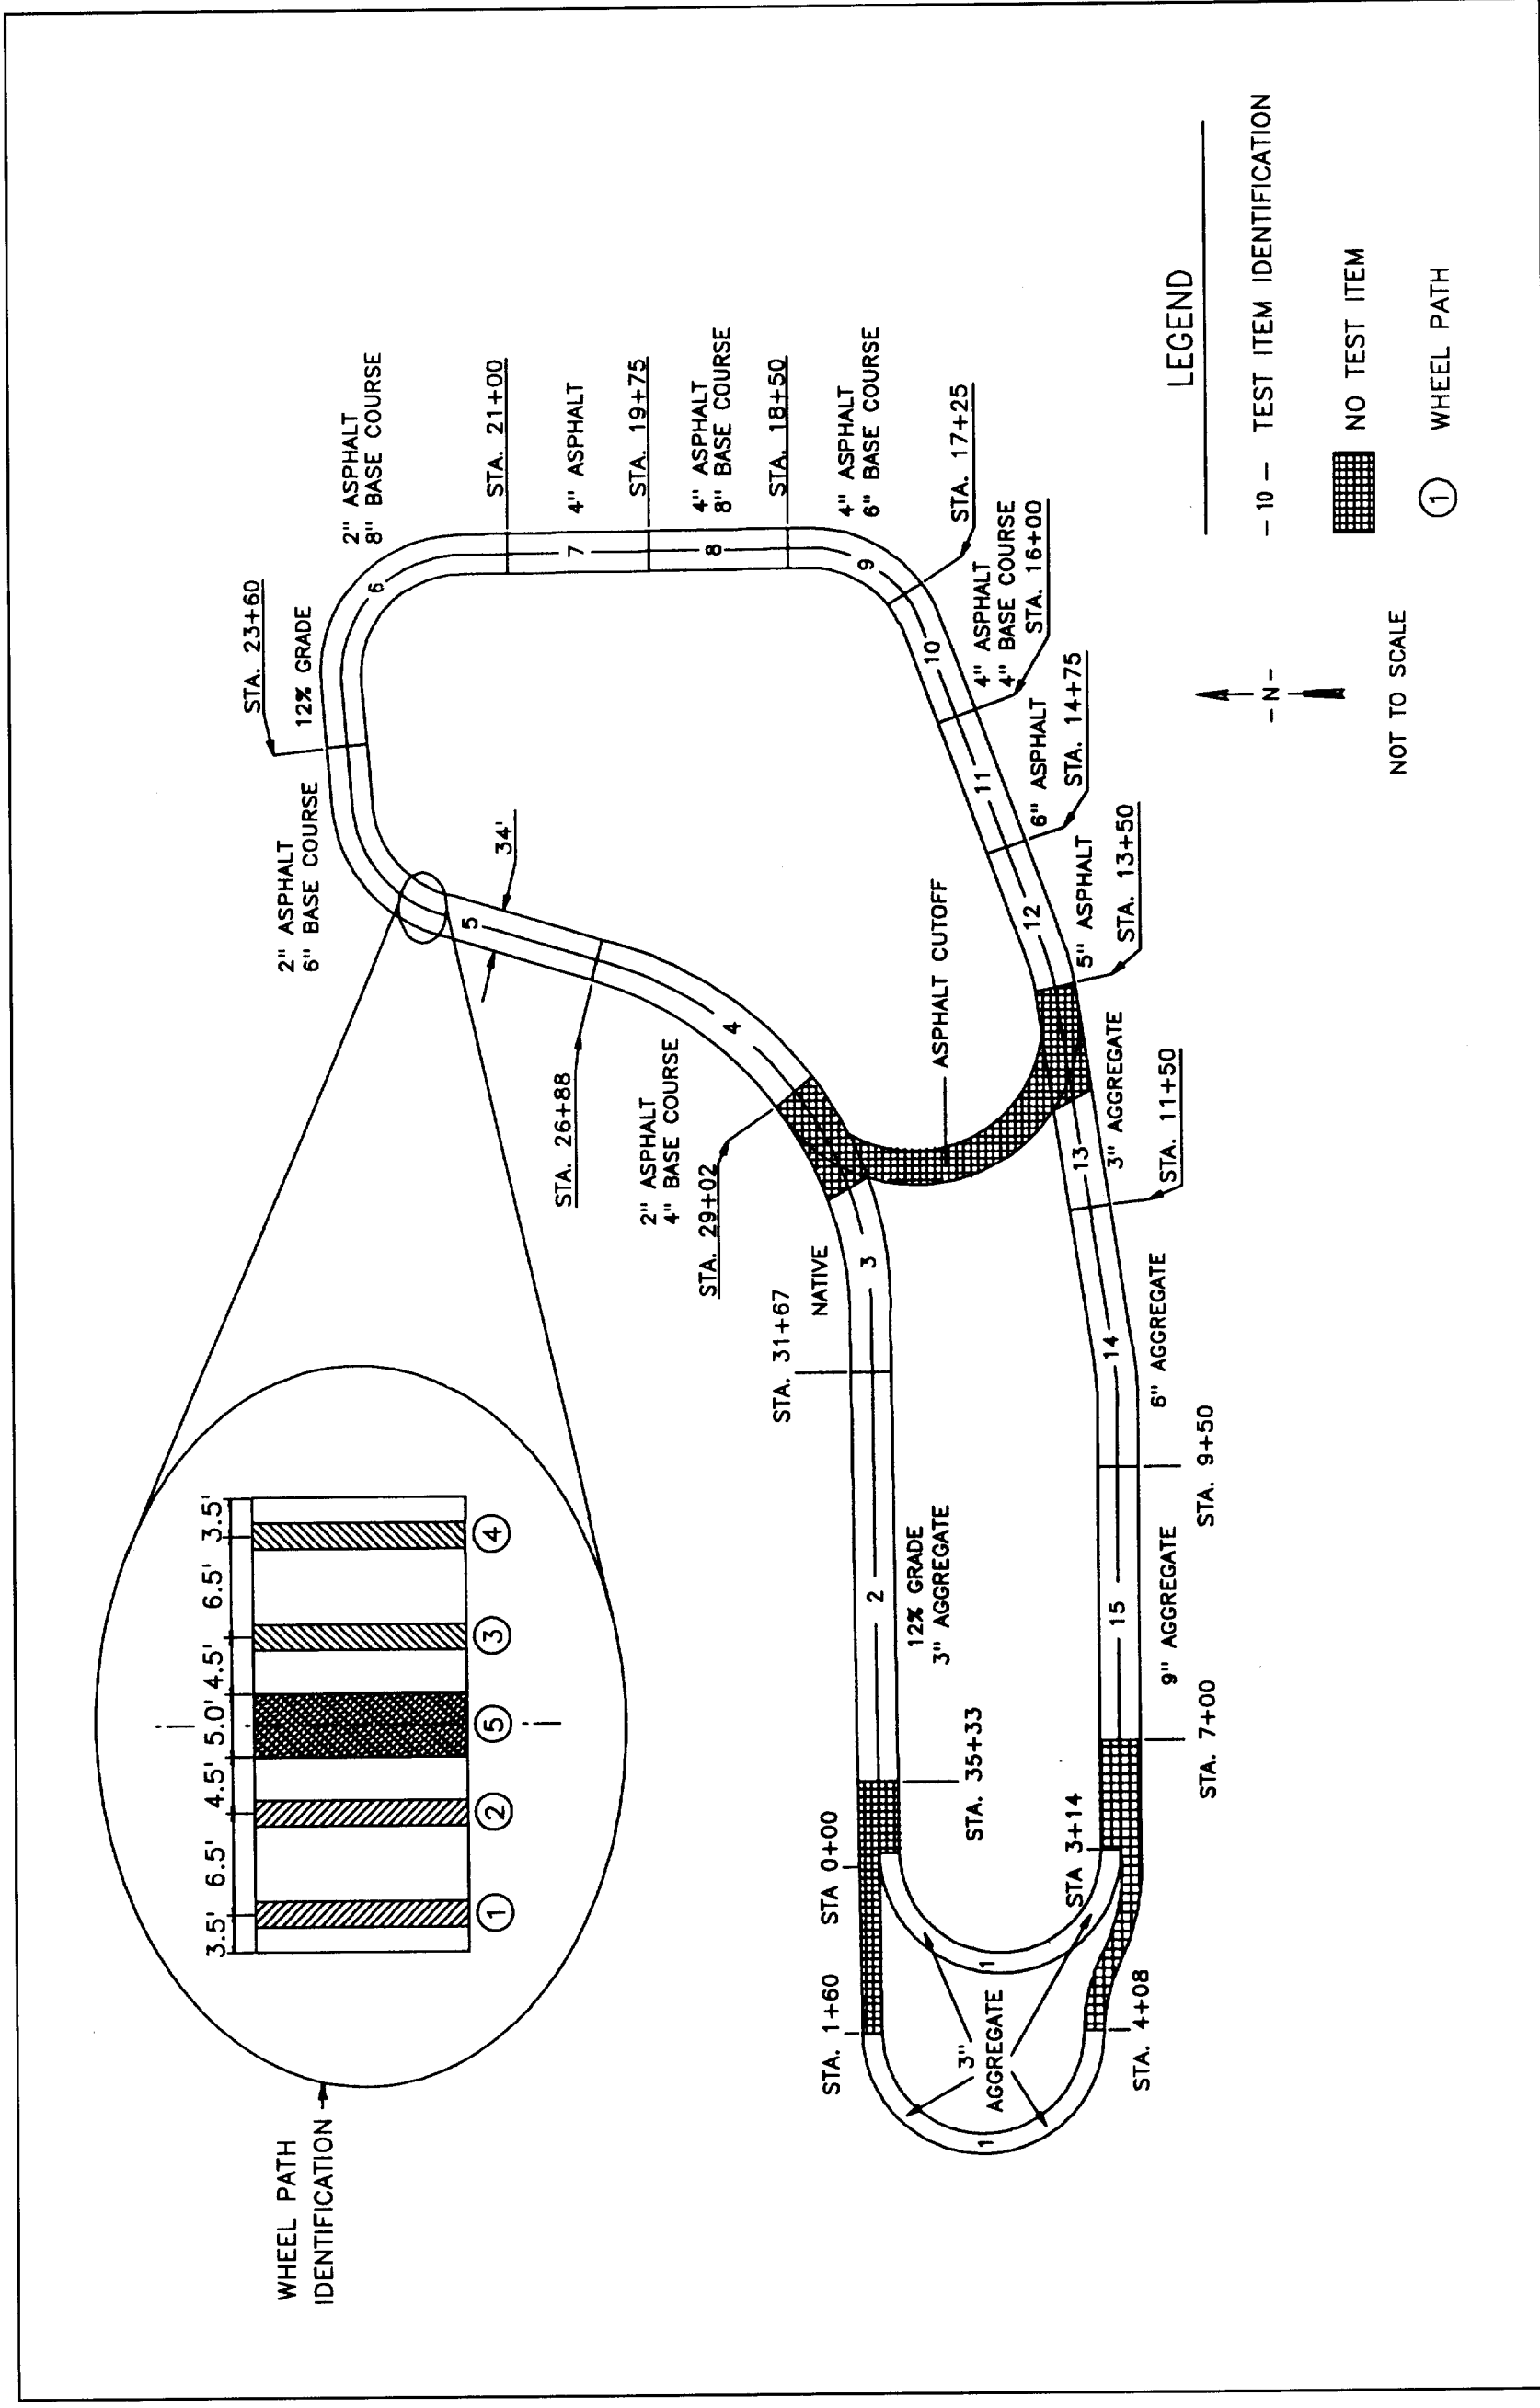
Figure 1. Plan view of test road

The test road was designed to determine the effect of tire pressure (deflection) on road surface deterioration and thickness design of low-volume roads. This road was approximately 0.7 mile in circumference with parallel 12-ft-wide traffic lanes. It was divided into 15 items and included curves and grades. The surfaces of these items were constructed of either native soil, crushed aggregate, or AC. The total pavement thickness or layer thicknesses were varied for each of the 15 items in order that failures or different amounts of distress would occur throughout the proposed traffic period. The primary variable in both the AC and aggregate test items was thickness. All of the items were designed for a constant-strength subgrade. A plan view of the test road is shown in Figure 1. The type and thickness of the various pavements or surfacing layers for each item are also shown in Figure 1.

The test road was divided into two lanes (high and low tire pressure) and two loops (the entire test road and the AC sections only). Figure 1 depicts these lanes and loops. A 5-ft-wide nontraffic area separated the two lanes in 14 of the 15 test items. Item 1 was constructed to determine the effect of tire pressure while the vehicles are traversing a horizontal curve. Therefore, this item was constructed with each lane having a 90-ft radius, which resulted in two separate road beds spaced about 140 ft apart. The high tire pressure truck operated in the outside lane at all times and the low tire pressure truck operated in the inside lane. Each truck traversed the loops in their respective lane with as little wander as possible, which resulted in four distinct wheel paths across the roadway. These wheel paths are numbered one through four with wheel path 1 located in the high pressure lane adjacent to the outside edge of the roadway (see Figure 1) and wheel path 4 in the low pressure lane and near the inside edge of the test track. Narrow (14.5-ft wide) traffic lanes with no outside shoulders helped keep the wander to a minimum. The loaded traffic was run in a counterclockwise direction while unloaded traffic ran in the clockwise direction. This traffic pattern resulted in simulating typical forest harvest conditions in that the loaded trucks are traveling down an aggregate grade and the unloaded trucks up the grade. During the trafficking of the aggregate sections, loaded and unloaded traffic were alternated on a daily basis until significant data were obtained to determine the difference in performance. Loaded traffic was then applied full-time. As can be determined from the traffic data in computer file (B:\TRAFFIC), the unloaded traffic was only run on 11 occasions or days in the high pressure lane and on 13 days in the low pressure lane. After the 12-in.-thick aggregate overlay had been placed on items 1 and 2, the traffic averaged 85 and 126 passes, respectively, on the high- and low-tire pressure lanes. The average speed during testing was approximately 20 mph. Applying traffic in this manner (alternating on a daily basis) was not representative of actual forest harvest conditions. Usually, only two to six trucks would be used in hauling which would result in only a few loaded and then several unloaded passes. Loaded and unloaded traffic was applied on a daily basis rather than 6 to 8 passes loaded and then the same number unloaded to obtain the maximum number of passes during a given time period. Approximately 8 hr was required to change the trucks from one loading mode to another. When measurements or repair was required on the aggregate portion of the test road, the asphalt cutoff was
