Modifying Water Hydrant Handles To Make Them Safer

Mary Ann Davies, Project Leader, and Tyler Kuhn, Mechanical Engineer

Davies, Mary Ann; Kuhn, Tyler. 2005. Modifying water hydrant handles to make them safer. Tech Tip 0523-2348-MTDC. Missoula, MT: U.S. Department of Agriculture Forest Service, Missoula Technology and Development Center. 6 p.

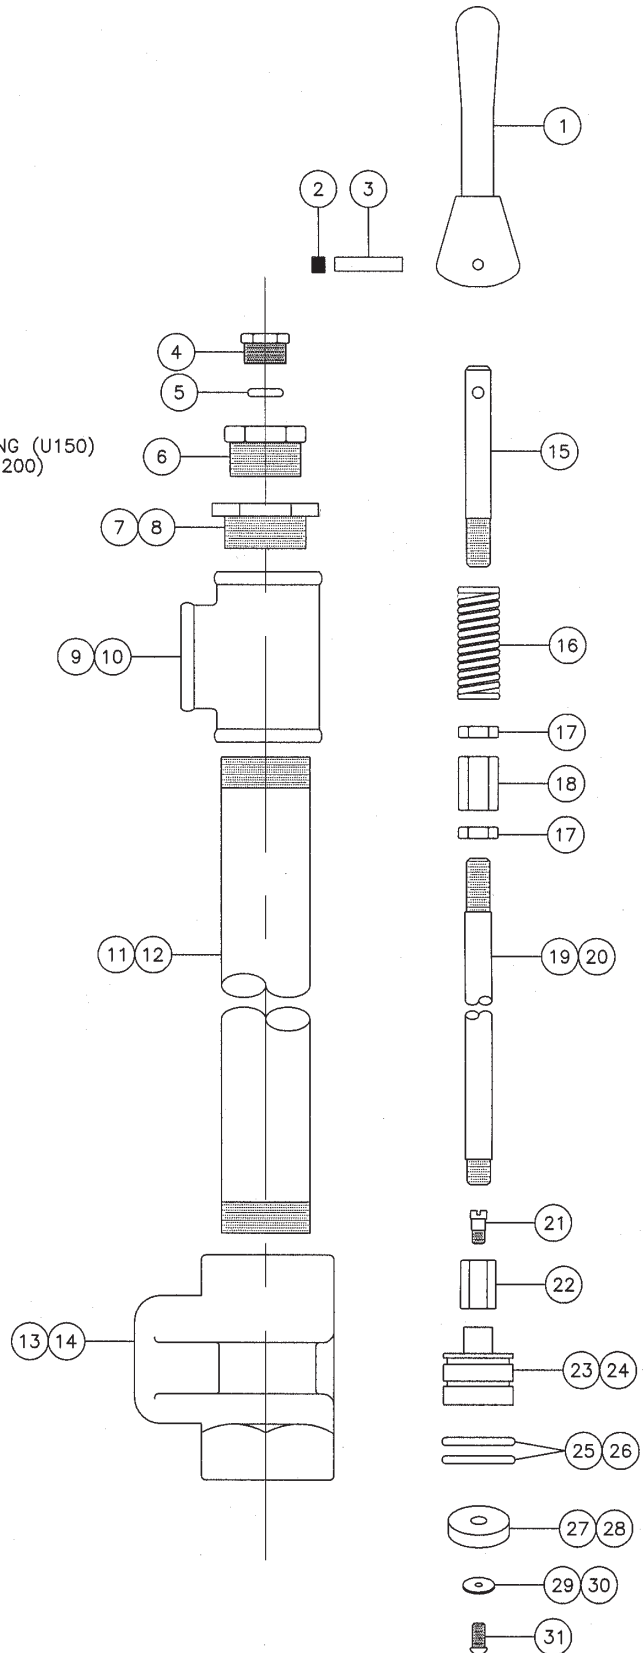
Figure 10—Refer to the parts list when maintaining the MK-6 hydrant.

Routine maintenance needs to be performed to ensure that hydrants operate properly and do not leak. Woodford Manufacturing Co. distributes the U150M and U200M hydrant models that replaced the MK-6 design. Replacement parts, such as O-rings and washers, are available for the MK-6 hydrants. See the Woodford Manufacturing Co. U150M and U200M model cut sheet (figure 10) for a parts list. Additional troubleshooting and maintenance information
