**Asbestos Inspection
Yellowstone Jumper Barracks
Gallatin National Forest
Hebgen Lake Ranger District**

Asbestos Inspection Report
Yellowstone Jumper Barracks
Gallatin National Forest
Hebgen Lake Ranger District

ASBESTOS SAMPLING
 JUMPER BARRACKS

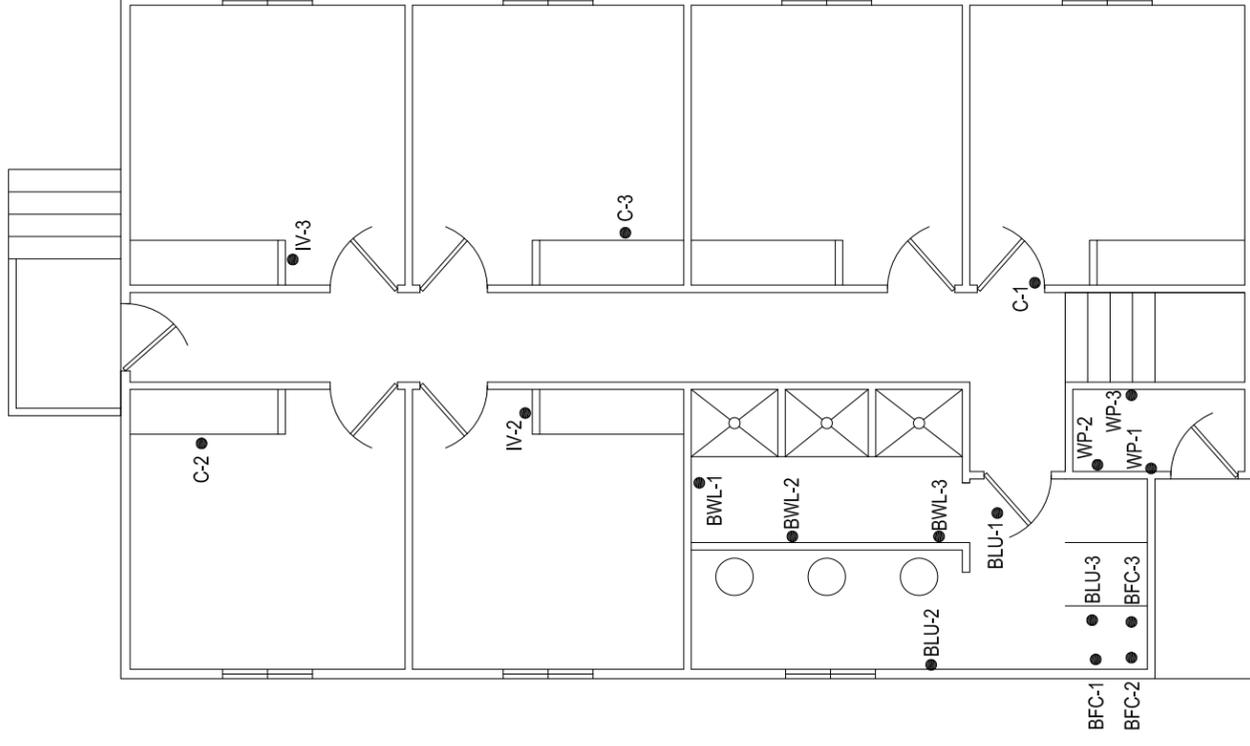
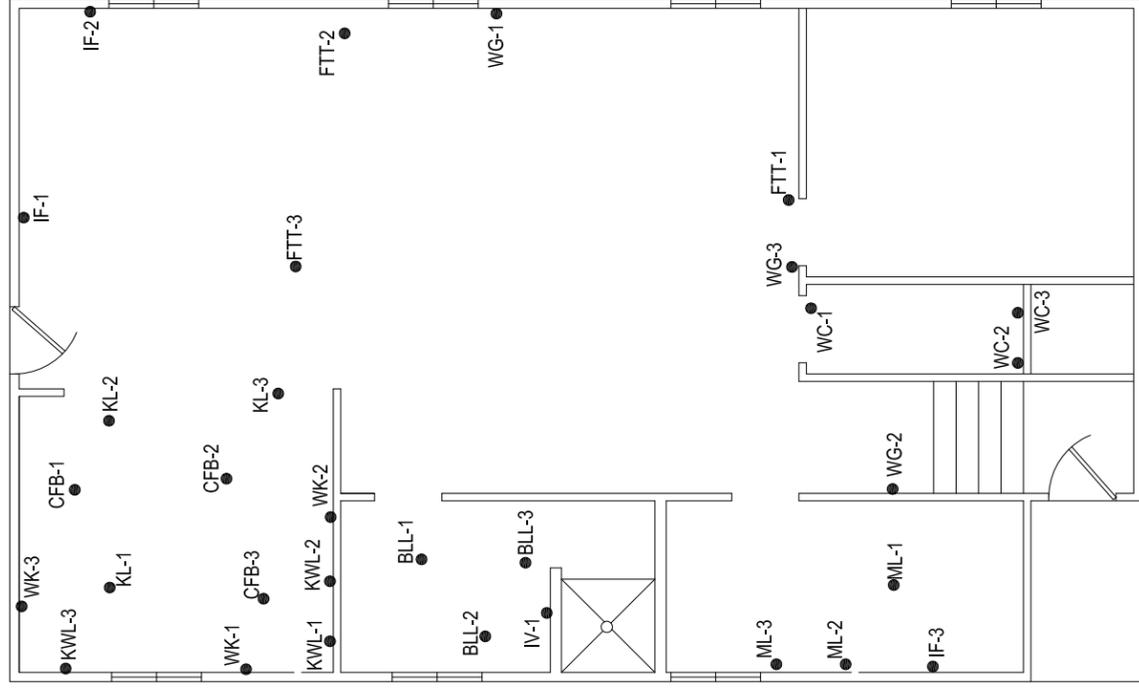
AUTOCAD FILENAME:
 ACAD.DWG
 SHEET 1

- LEGEND :
- CFB - CEILING FIBER BOARD
 - KL - KITCHEN LINOLEUM
 - FTT - FLOOR TILE TAN
 - BLL - BATH LINOLEUM LOWER
 - ML - MECHANICAL LINOLEUM
 - WK - WALLBOARD KITCHEN
 - WG - WALLBOARD GENERAL
 - WC - WALLBOARD CEMENT
 - KWL - KITCHEN WALL LINOLEUM
 - IF - INSULATION FIBERGLASS
 - IV - INSULATION VERMICULITE
 - C - CARPET
 - BLU - BATH LINOLEUM UPPER
 - BFC - BATH FLOOR COMPOSITE
 - WP - WAINSCOT PANEL
 - BWL - BATH WALL LAMINATE

Materials were grouped into Homogeneous Areas (HA): those considered consistent throughout an area of the building based on the material's appearance, including texture, size and color, manufacturer's labels, and/or construction era. Additionally, the condition of each material was assessed for damage and friability: the potential to release asbestos fibers through deteriorated condition or actions such as sawing, grinding or other mechanical actions. Photos are included in Appendix C.
