## **Appendix B**

### **Condition of Mill Lake Dam, Proposed Repairs and Minimum Requirement Analysis**

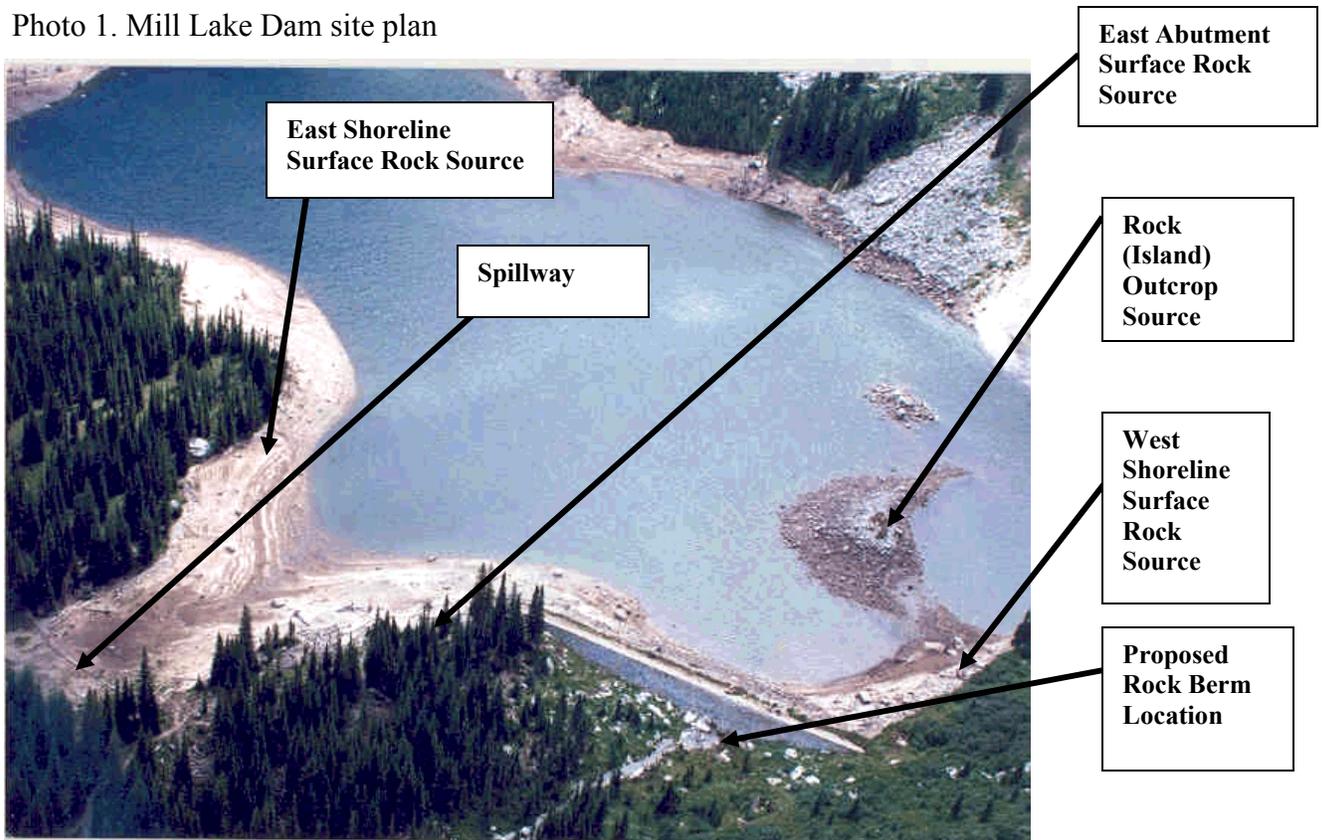
Photo 1. Mill Lake Dam site plan

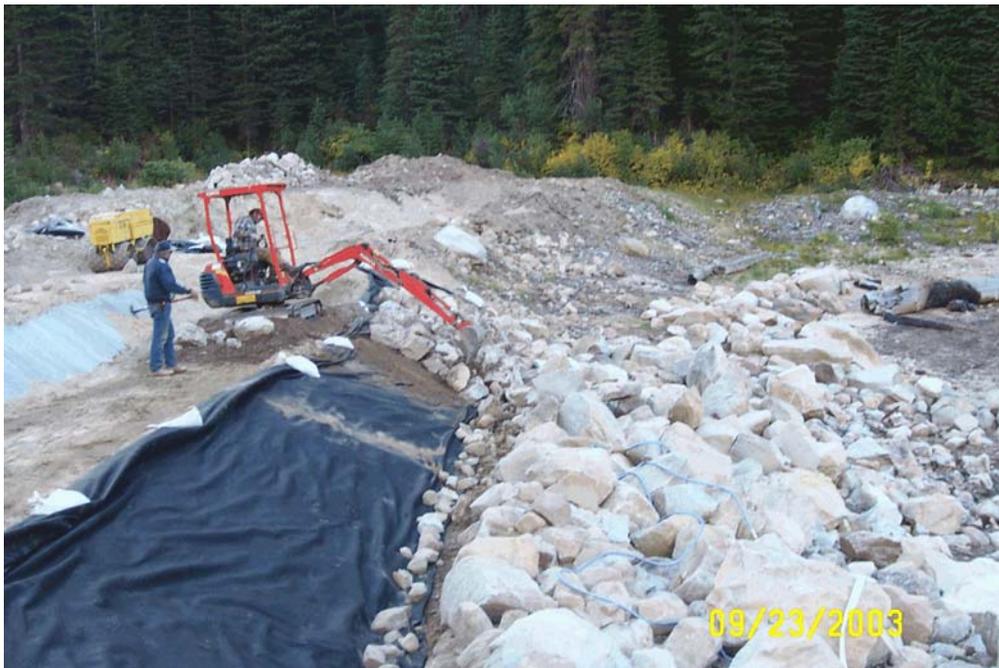
Photo 2. Mini-excavator placing rock protection on upstream slope at Tin Cup Dam 2003

This work could be accomplished using a mini-excavator, similar to that used on Tin Cup Dam during repairs in September 2003 (see photo 2 on app. page 15 below). If the work is attempted by hand labor using picks and shovels, there is a high probability of encountering water-logged woody debris or rock in the trench. It is important that a backup option be considered in the event that unforeseen problems are encountered, or the work falls significantly behind schedule. After the rock is removed from the upstream embankment, the erosive underlying materials will be exposed, and therefore, the installation of the liner (see step 6) could be accomplished in limited areas across the
