Mainstem Trail Creek & Sub-Watershed Summaries

The Trail Creek Watershed was delineated into 59 sub-watersheds along 2nd to 4th order drainages as identified by the number IDs in **Figures 75–78**. **Appendix D** summarizes the morphological, hydrologic and sedimentological relations to identify the hillslope, hydrology and channel processes contributing to sediment yields for the mainstem Trail Creek and sub-watersheds. The summaries for each sub-watershed and the mainstem Trail Creek include:

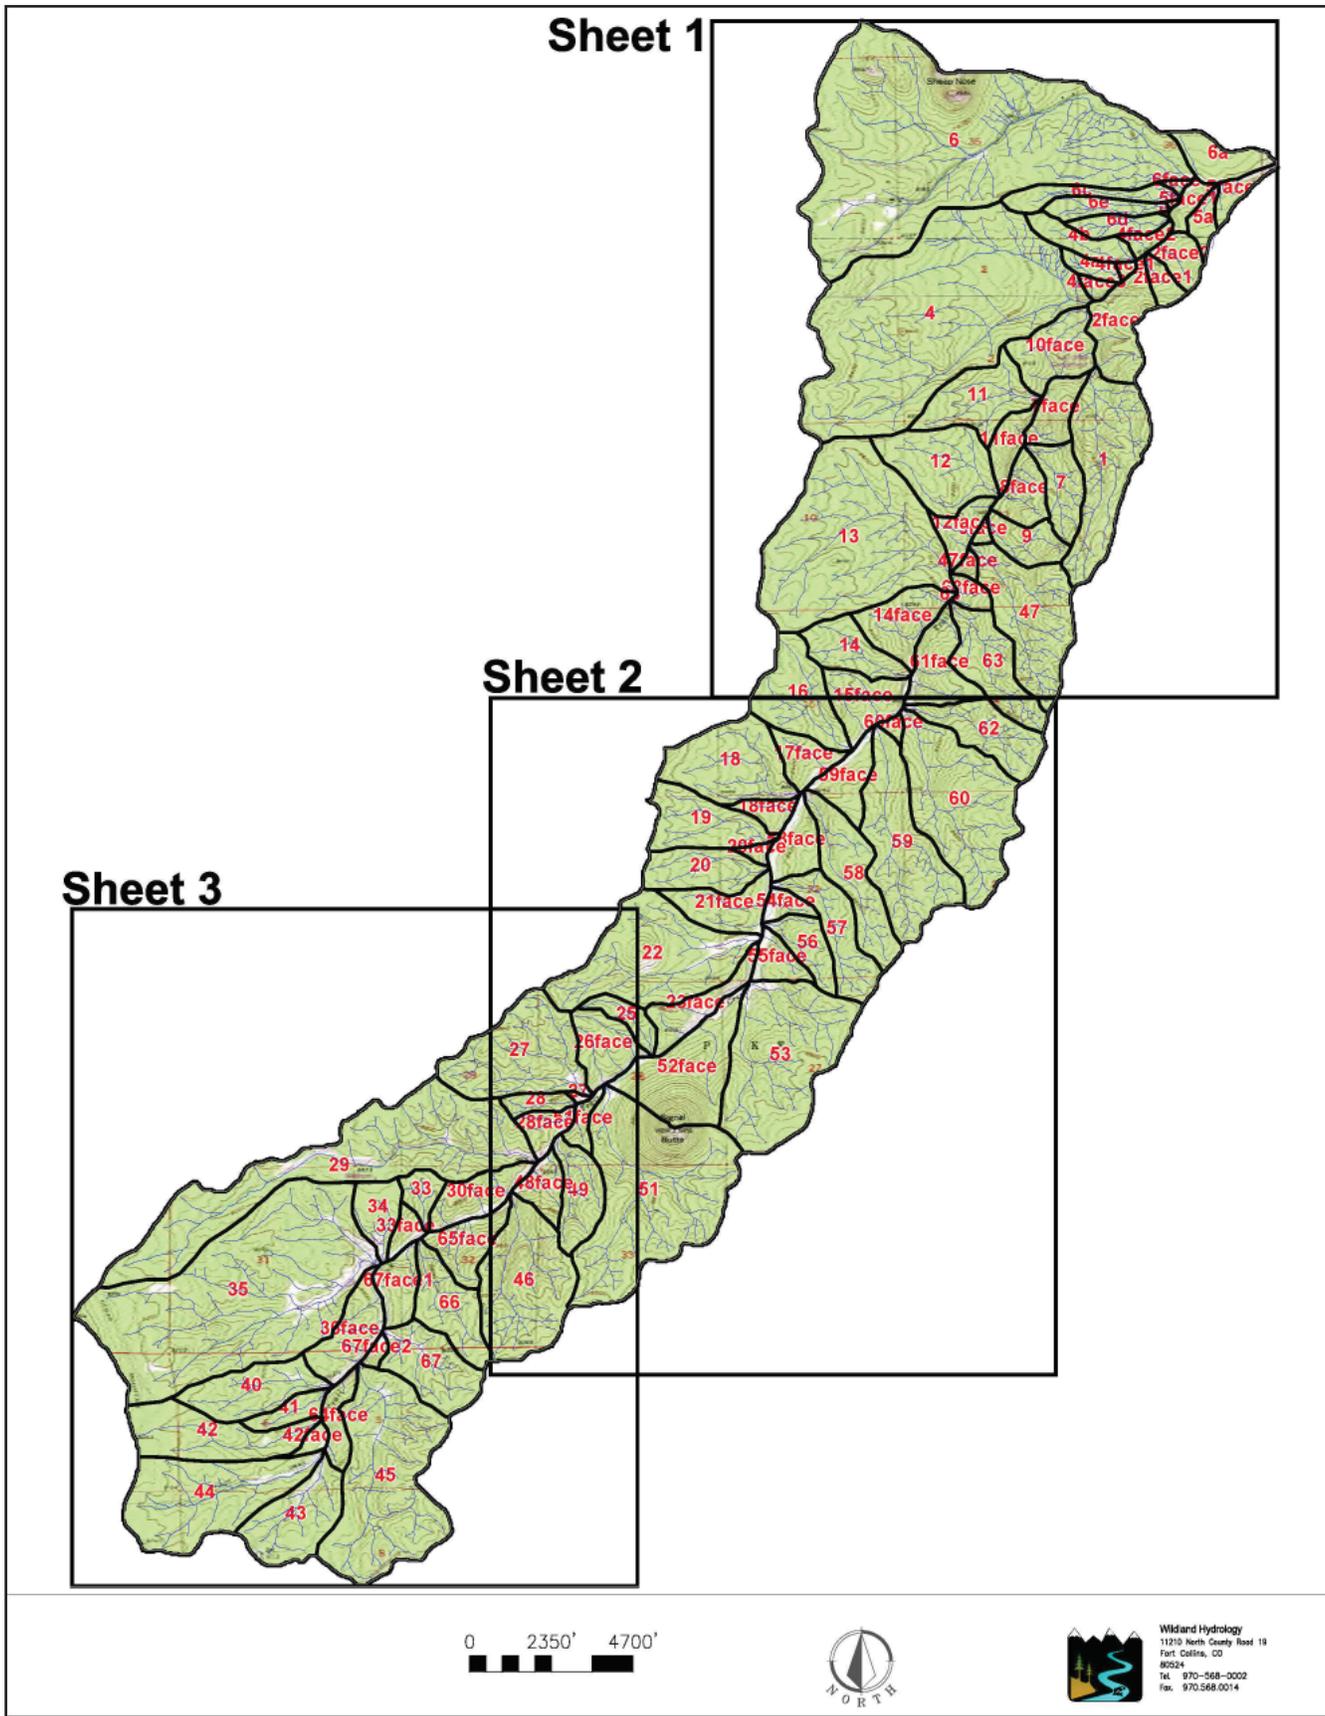
Figure 75. The sub-watershed delineation of the Trail Creek Watershed; the area in “Sheet 1” is depicted in **Figure 76**, the area in “Sheet 2” is depicted in **Figure 77**, and the area in “Sheet 3” is depicted in **Figure 78**.

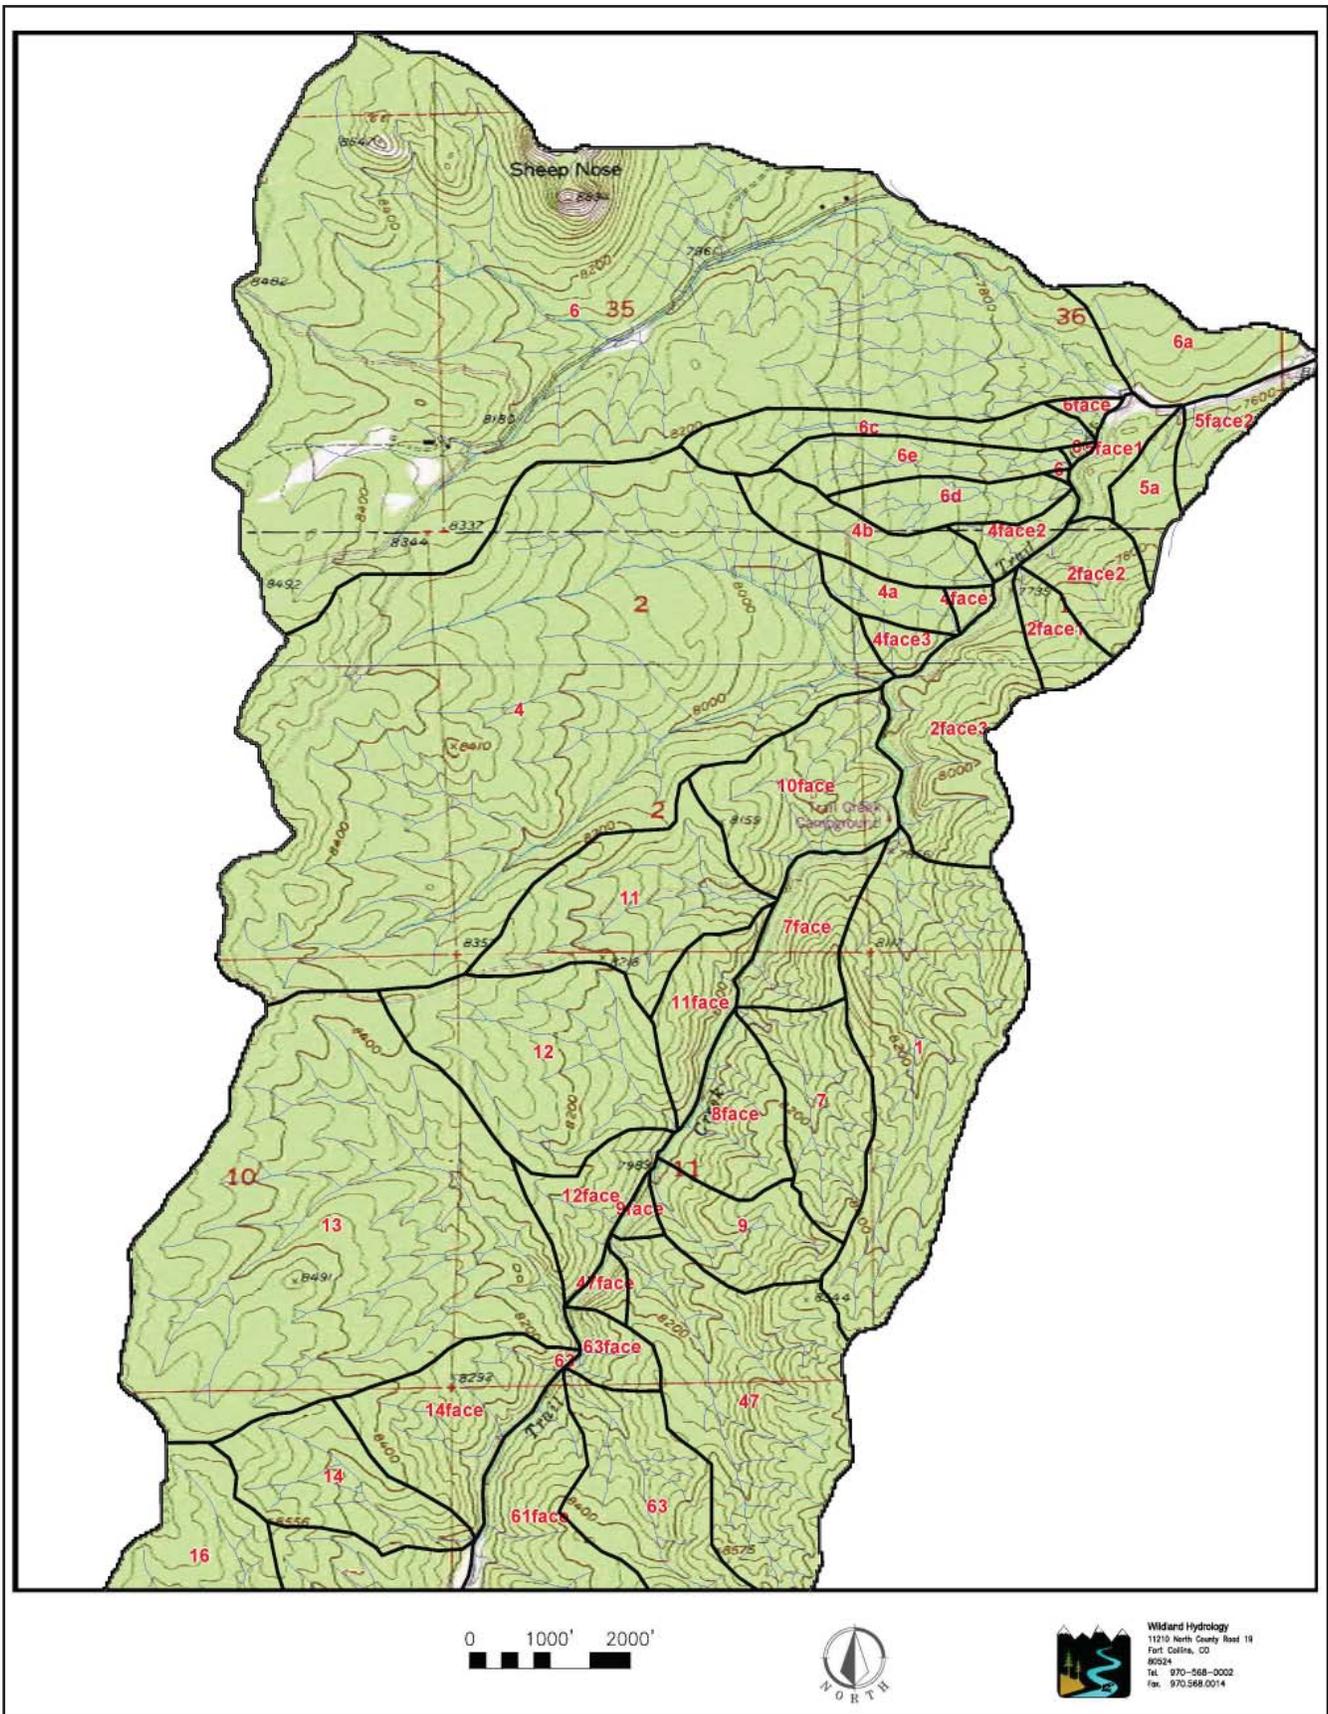
Figure 76. The sub-watershed delineation of the Trail Creek Watershed illustrating the area in “Sheet 1” in Figure 75.

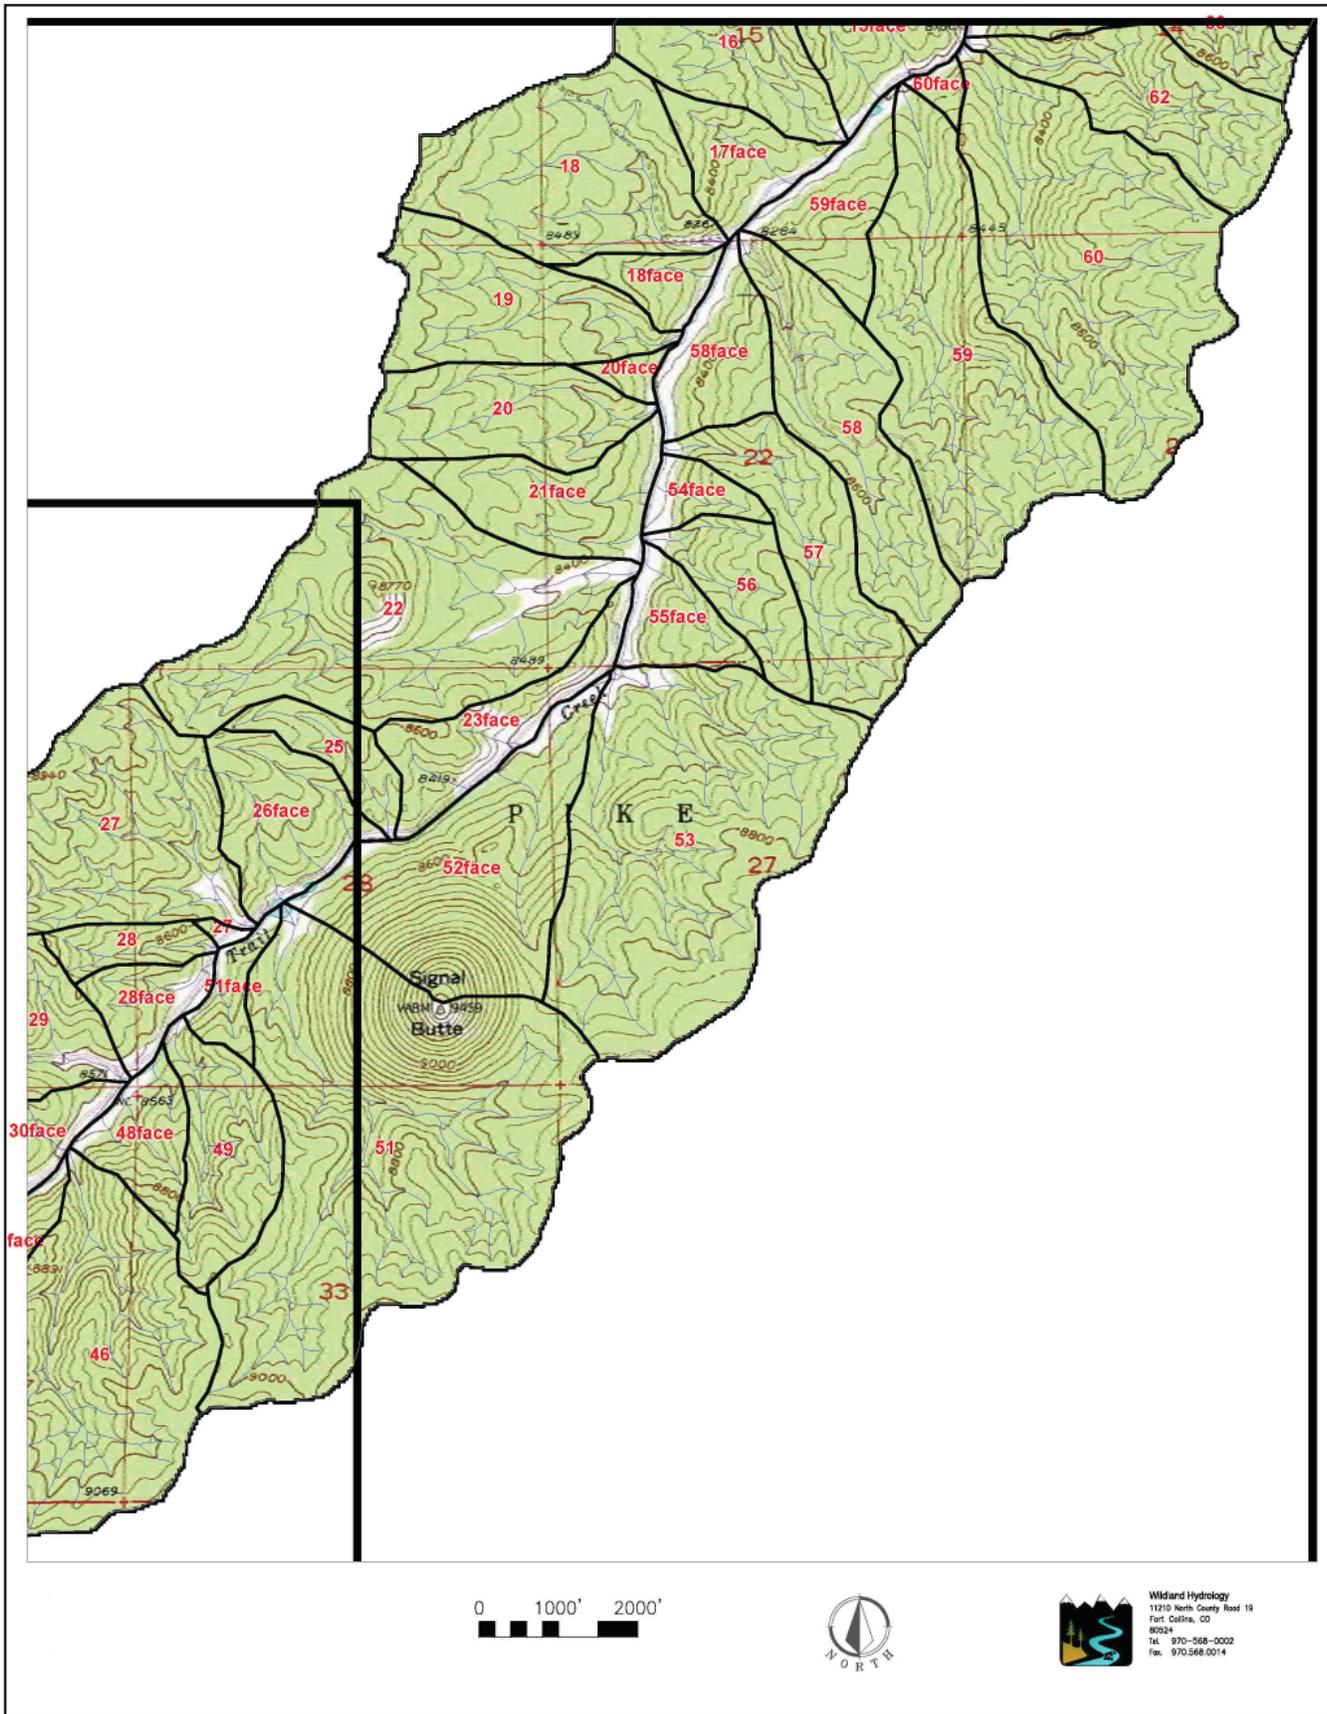
Figure 77. The sub-watershed delineation of the Trail Creek Watershed illustrating the area in “Sheet 2” in Figure 75.

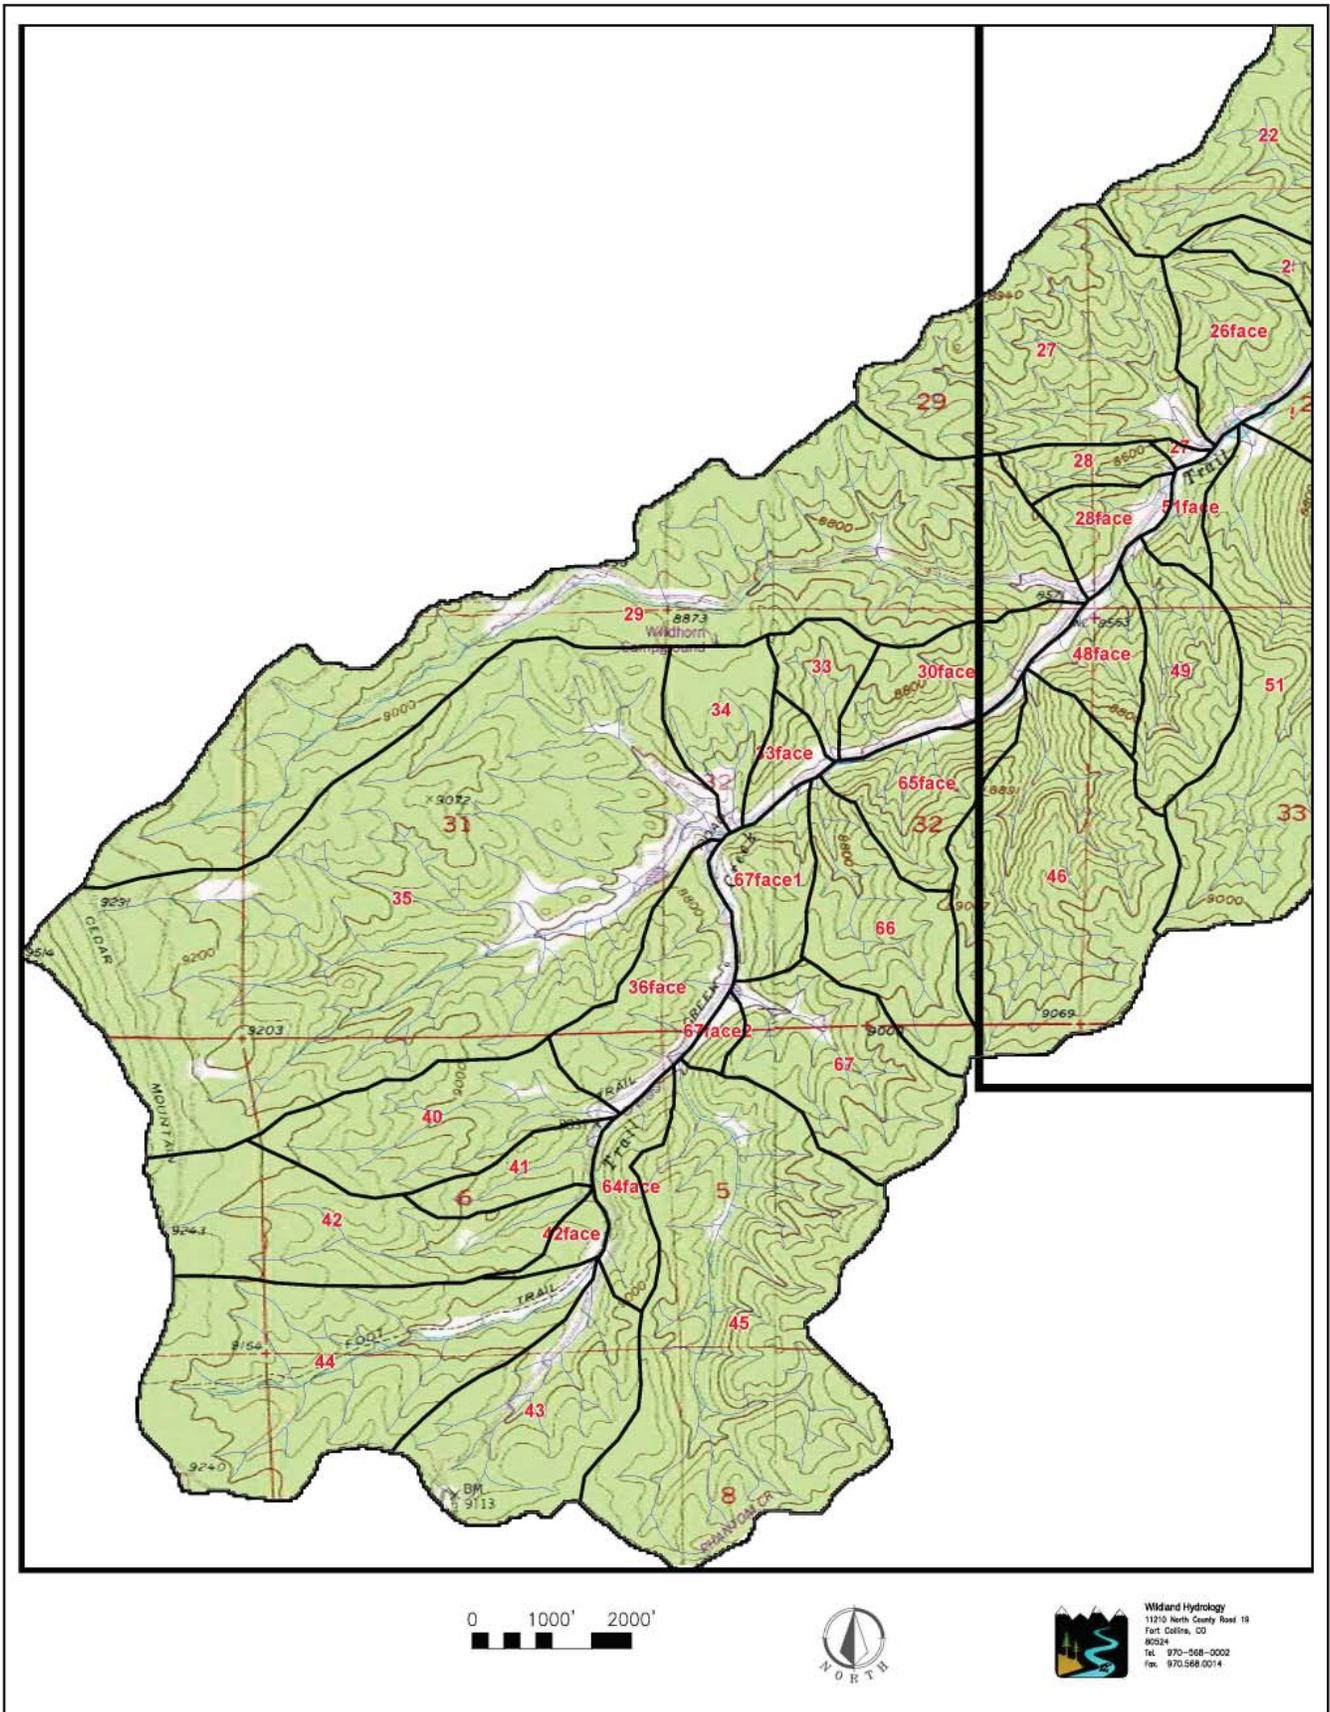
Figure 78. The sub-watershed delineation of the Trail Creek Watershed illustrating the area in "Sheet 3" in Figure 75.
