TECHNICAL MEMORANDUM

Re: Revised and Final Report on Potential Rock and Soil
Sources - McLaren Pit Capping System and Drainage
Channels - New World Mining District Response and
Restoration Project

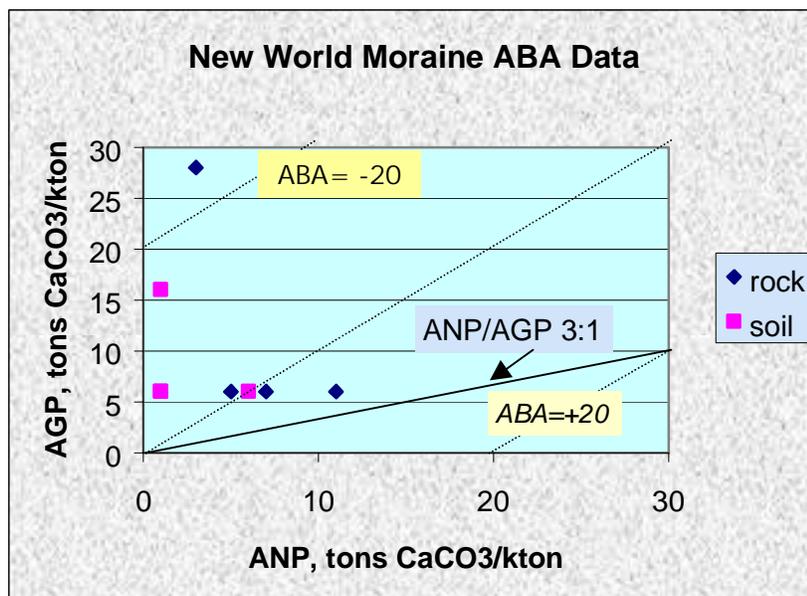
Figure 2. Graph of Acid Generation Potential vs. Acid Neutralization Potential for soil and rock samples from the Upper Daisy Creek Moraine.

Figure 2 depicts graphically the relationship between acid generation potential and acid neutralization potential for soil and rock samples from the upper Daisy Creek moraine. On graphs of this type, samples that fall to the right of the ABA= +20 line are considered non-acid generating and samples that fall to the left of the ABA= -20 line are considered acid generating. For samples that fall between these two lines it is uncertain if acid will be generated. All of the rock and soil samples from the moraine fall in this zone of uncertainty except for the rock sample from Test Pit #4 (at the base on the north side of the moraine), which appears to be acid generating. In order to address the question of whether these samples generate acid over time, it is likely that humidity cell testing would be required. Humidity cell testing places the samples in a simulated weathering environment and measures the actual acidity output over time.

Another means of evaluating acid generation or neutralization potential is also shown on Figure 2. Figure 2 shows the ratio between acid generation (AGP) and acid neutralization potentials (ANP) plotted as lines that have been derived mathematically and back-tested with empirical data. Samples with an ANP/AGP ratio of 1 have exactly enough neutralization potential to neutralize the acidity released by the acid generation potential. However, under empirical field conditions it has been shown that samples need an ANP/AGP ratio of 3:1 in order to insure that all of the acidity is neutralized. An ANP/AGP ratio of 3:1 has been adopted by the Bureau of Land Management (BLM) as the standard for evaluation of the potential for materials to generate acid. Sample from the Daisy Creek Moraine hover around the ANP/AGP 1/1 line and all of the samples have a ANP/AGP ratio of less than 3:1. This again suggests that the material may generate acid over time, in the weathering environment.

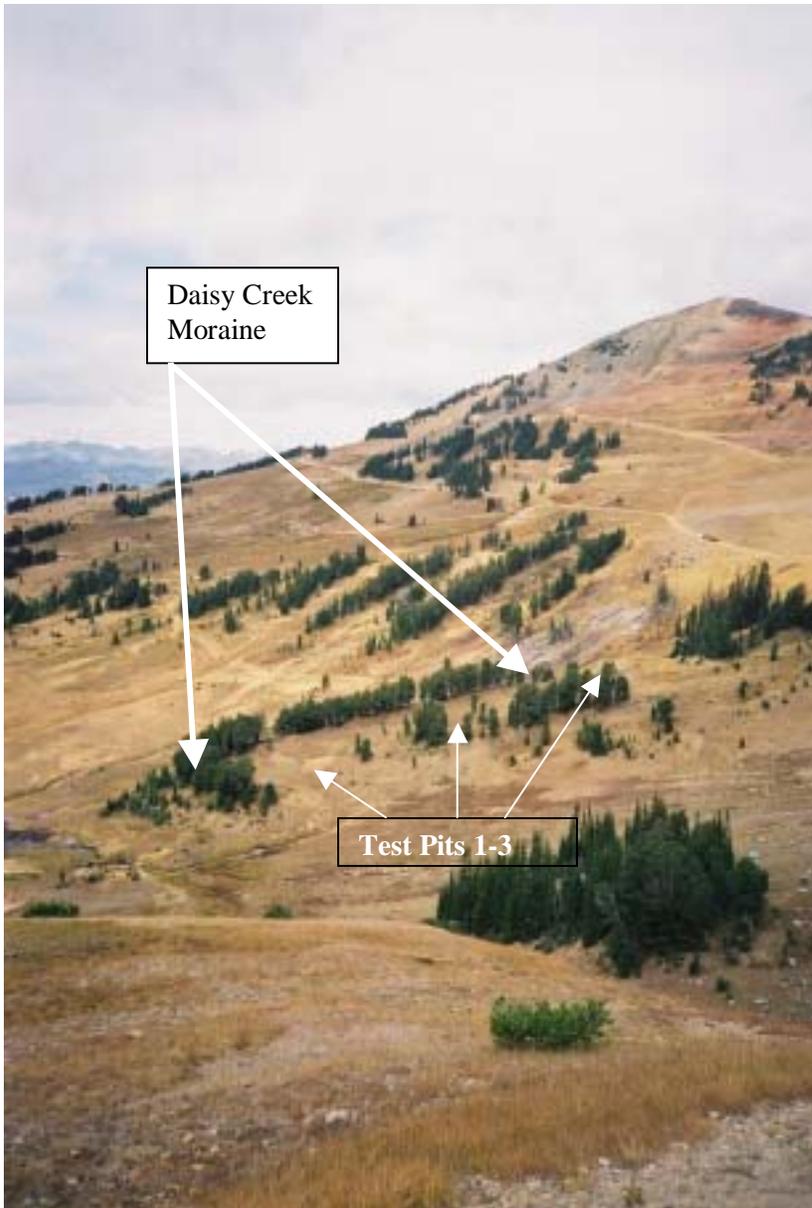
Figure 3. Daisy Pass Moraine Overview (between arrows, looking north from Daisy Pass)

This feature is a positive topographic feature that rises above the underlying valley bottom and abuts adjacent talus slopes. This site was studied in some detail. It was mapped with tape and compass and elevations hand-leveled at a number of locations around the perimeter of the moraine (Figure 3). The total volume of material contained in the landslide block as calculated from mapping is about 159,000 cubic yards.

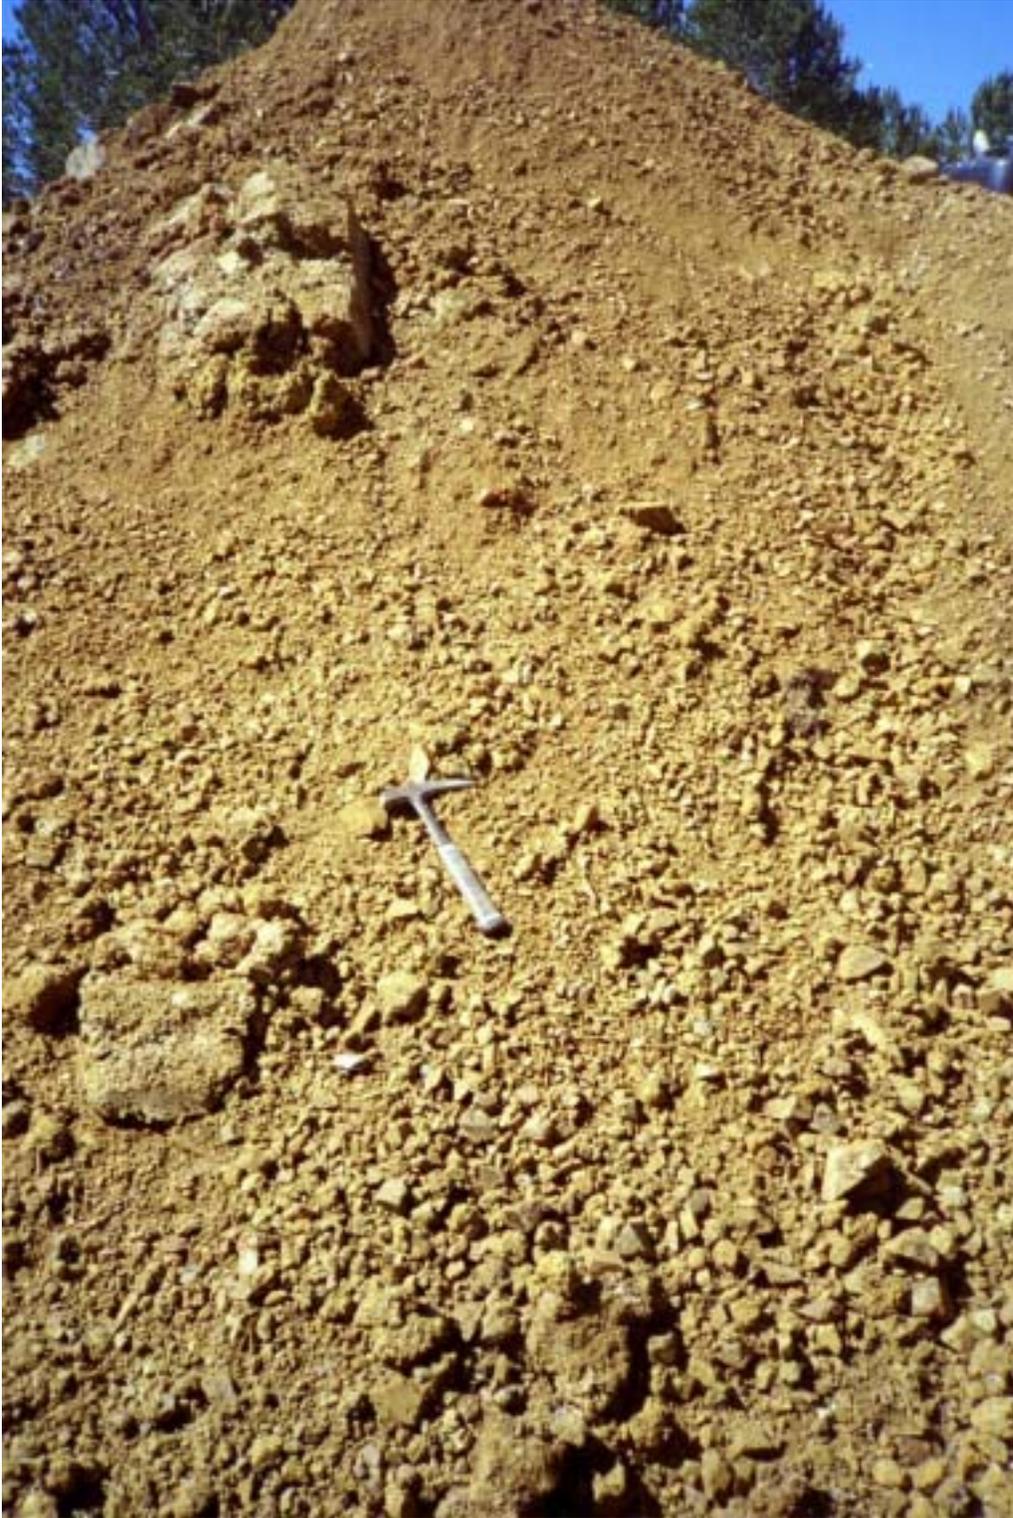
Figure 4. Upper Daisy Creek Moraine TP #1 (west end of moraine)

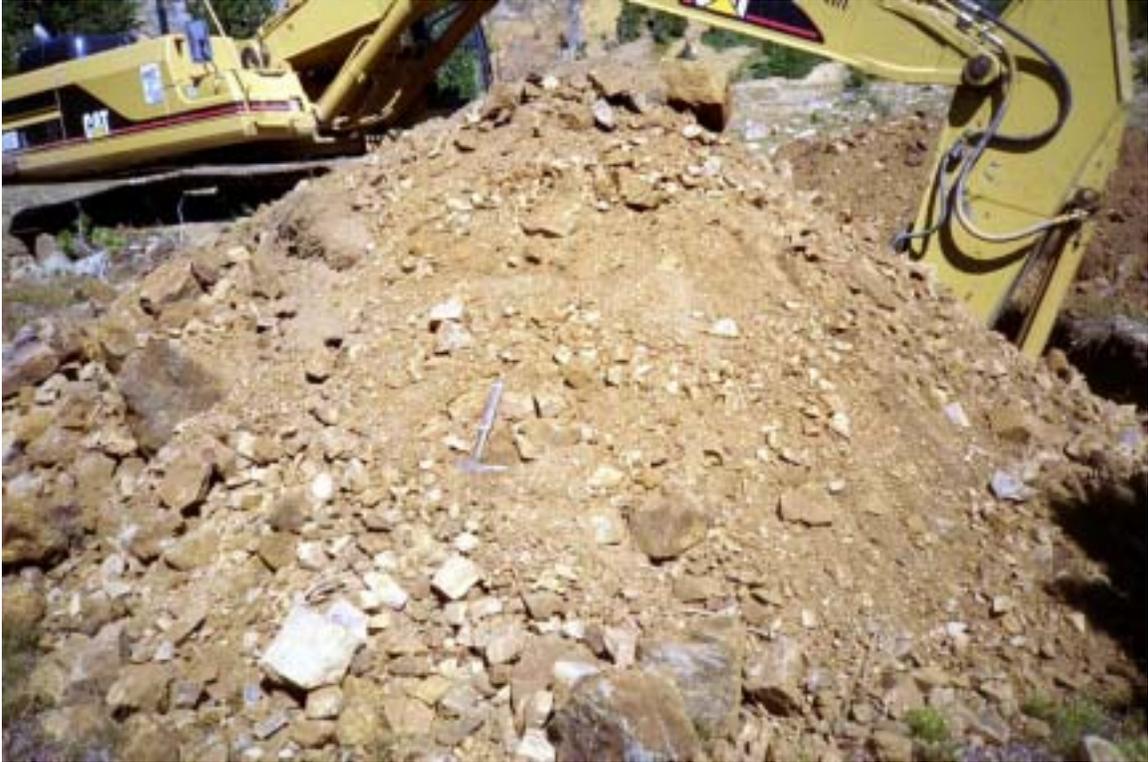
Figure 5. Upper Daisy Creek Moraine TP #2 (middle of moraine)

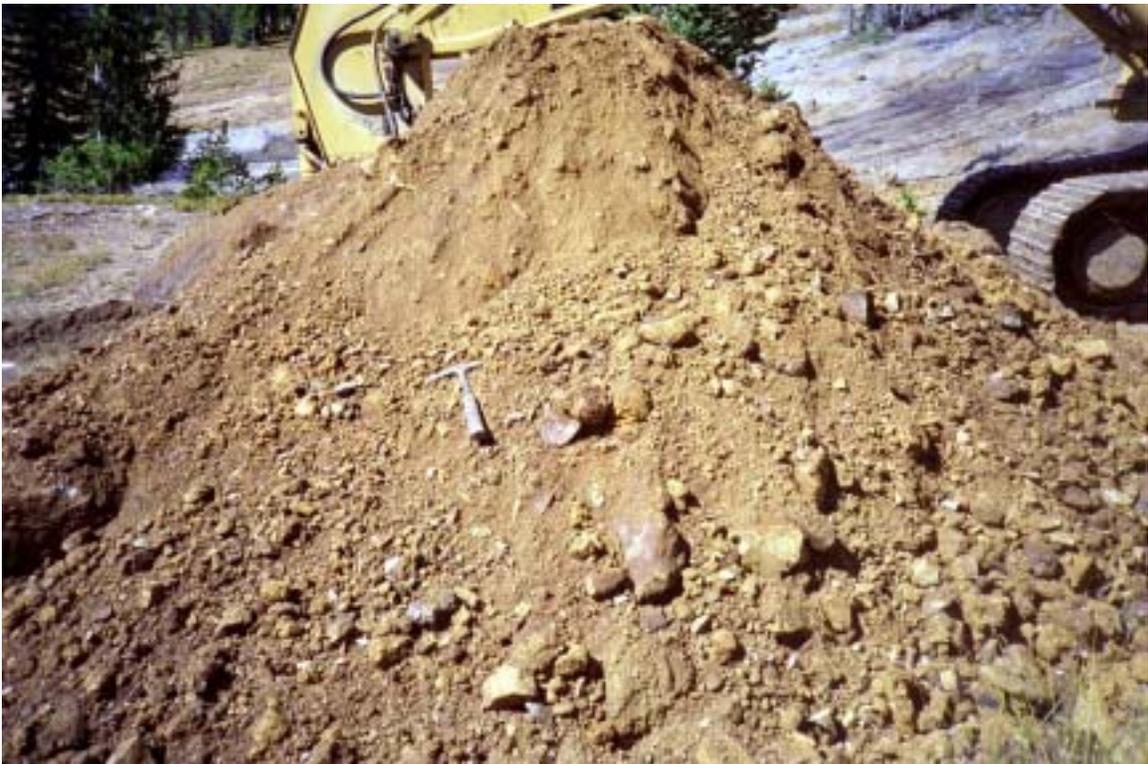
Figure 6. Upper Daisy Creek Moraine TP 3 (east end of moraine near cabin)

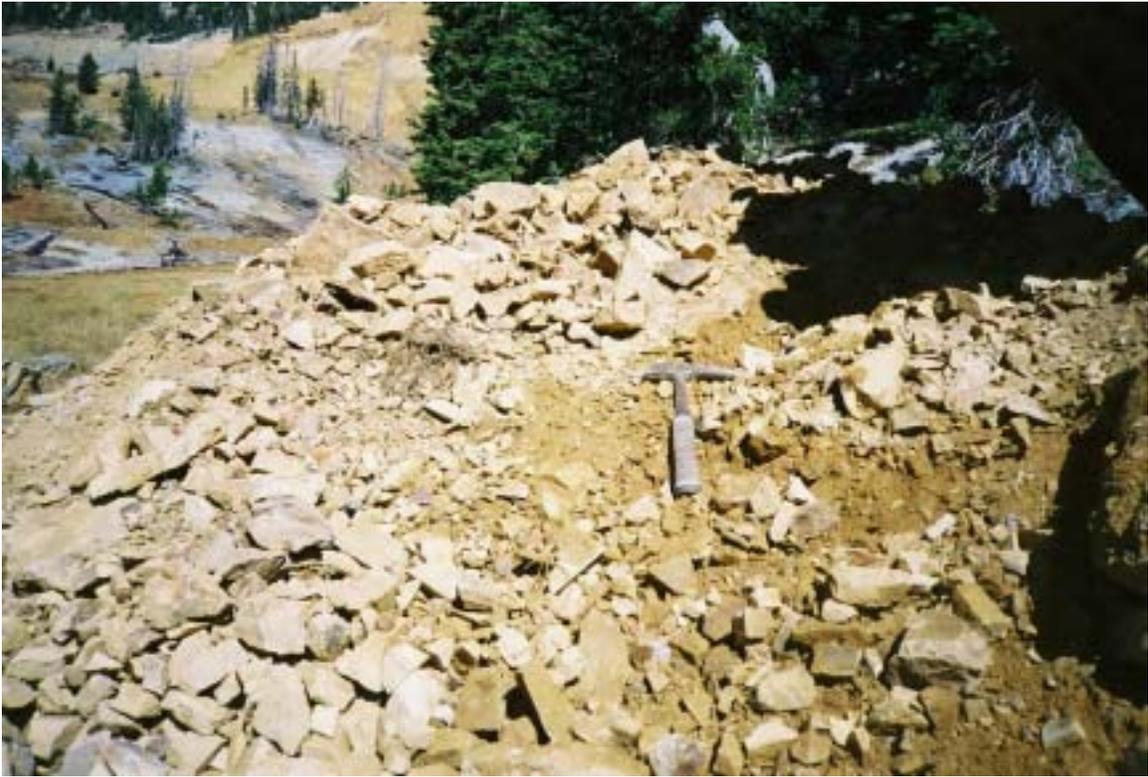
Figure 7. Upper Daisy Creek Moraine TP 4 (north side of moraine at base or valley bottom level)

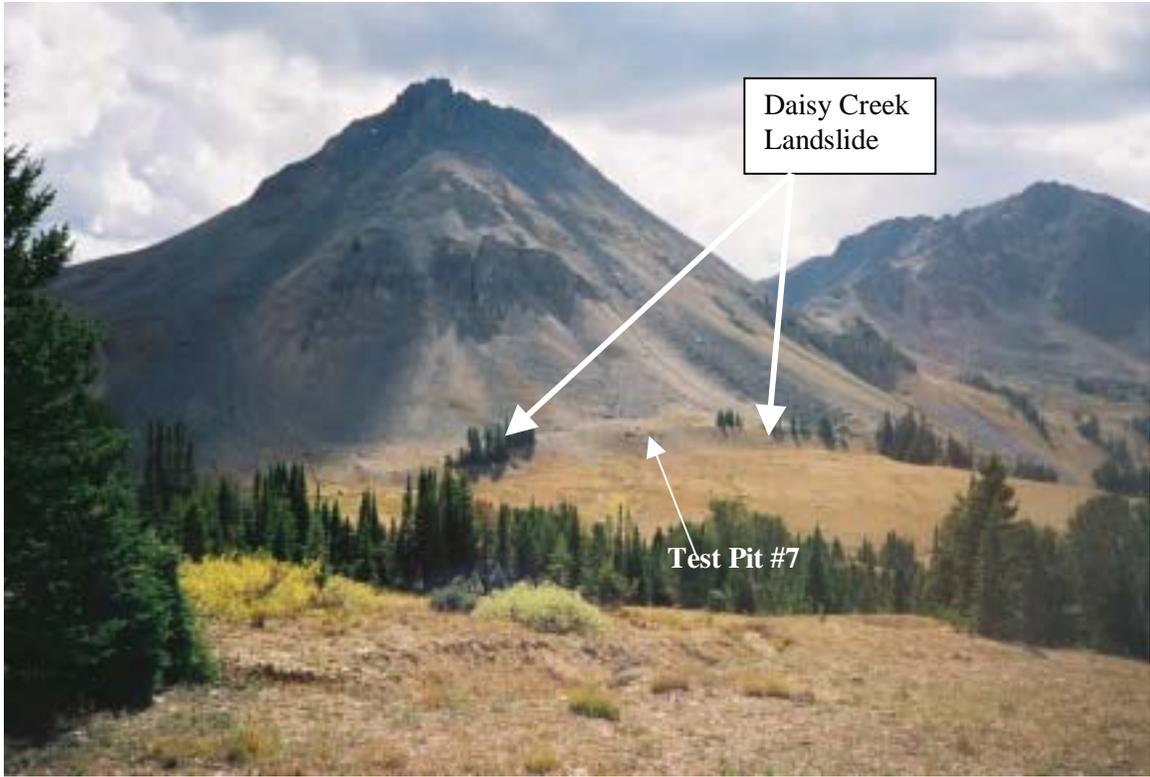
Figure 8. Overview of Upper Daisy Creek Landslide Block (looking SW toward Crown Butte from Daisy Creek Valley Bottom)

A) Landslide Block Upper Daisy Creek: A large landslide block lies at the base of the talus slope on the north side of Crown Butte in the upper Daisy Creek drainage (Figures 1 and 8). This block is approximately 850 feet long, about 50 feet high, and has a relatively flat surface, about 70 feet wide, that dips slightly back to the north into the talus slope of Crown Butte. The computed volume of material from mapping is 159,000 cubic yards. The surface of the landslide block appears to be comprised of about 70 percent rock material in a finer-grained, olive gray (5 Y 4/1) sandy soil matrix (30 percent of total material) (Figures 9 through 12). Rock fragments consist of limestone rock clasts and boulders (90 percent of total clasts material are limestone and dolomite) of the Cambrian Age Pilgrim Limestone and Snowy Range Formations and blocks and clasts of the Ordovician Bighorn Dolomite. In a localized area along the east end of the landslide, clasts, blocks, and boulders of the Lamar River and Cathedral Cliffs Formation (andesitic volcanoclastics and lava flows comprising 10 percent of total clast material) also occur admixed with the limestone and dolomite clasts. The average clast size is on the order of 4"-8," but the range of clasts is extremely variable, from 0.2 inch to 36 inches (one room-size clast (rock fall, Figure 13) was observed on the upper surface of the landslide block.

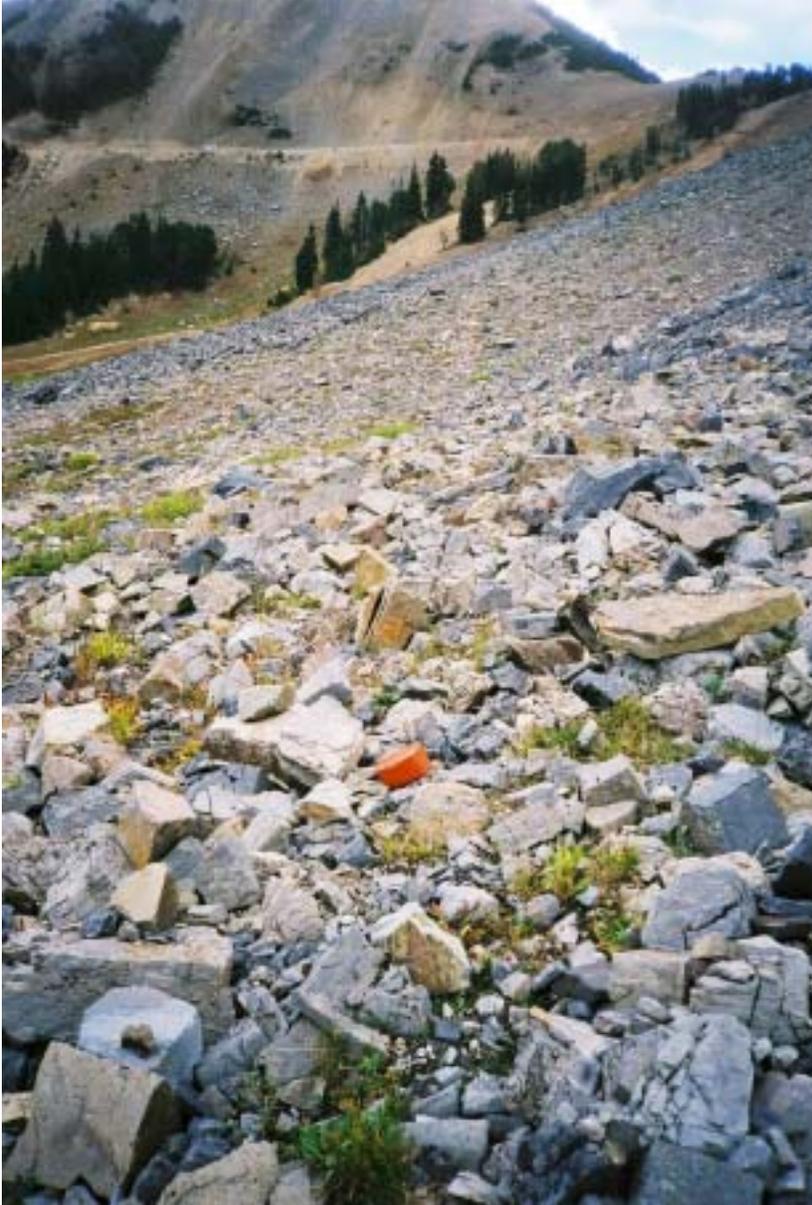
Figure 9. Daisy Creek Landslide (looking east on east end, north facing slope of landslide)

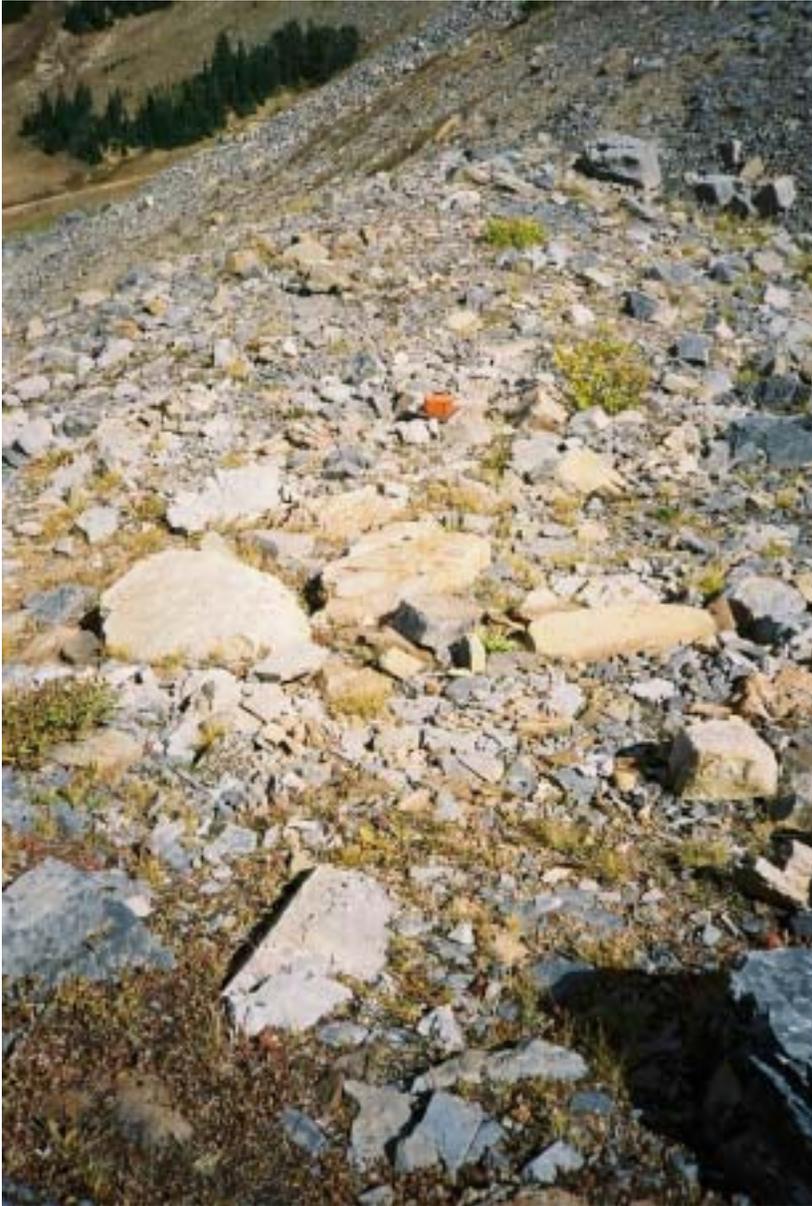
Figure 10. Daisy Creek Landslide Block (looking east at north facing slope of landslide from middle traves across block)

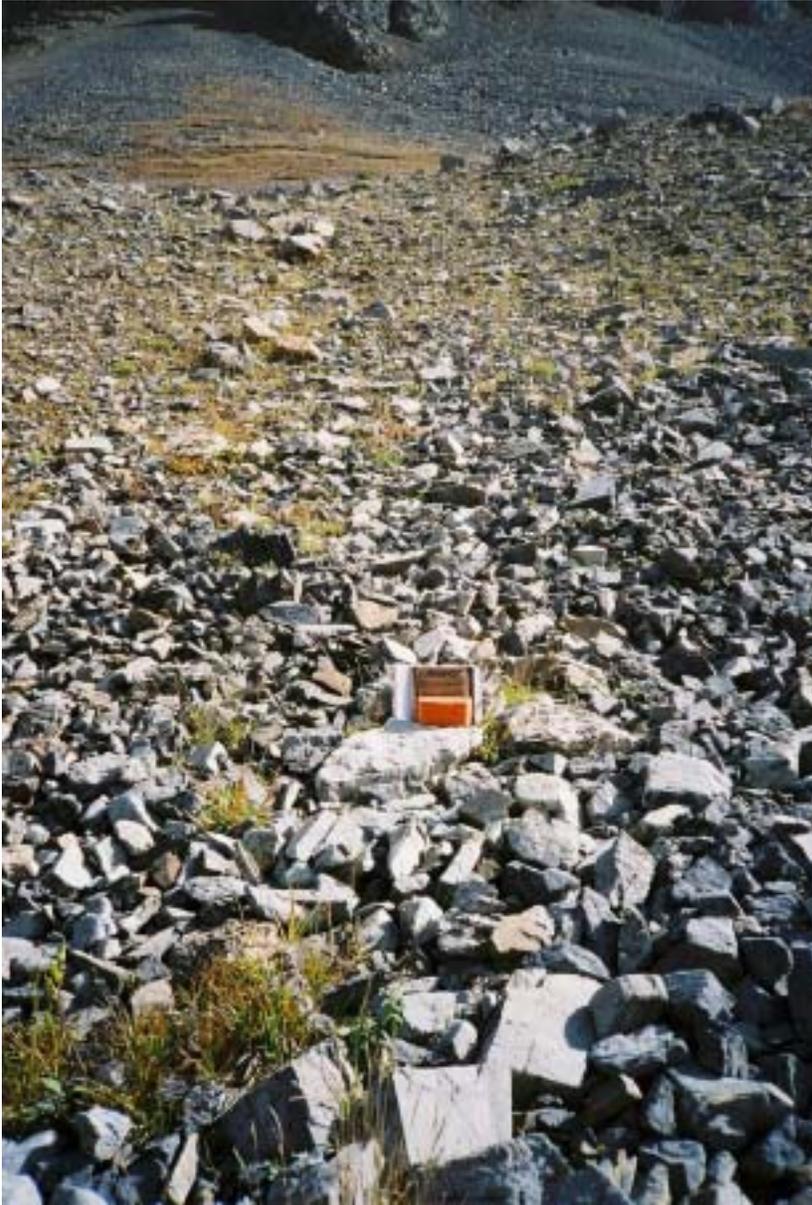
Figure 11. Daisy Creek Landslide Block (looking south across upper top surface of landslide on middle traverse)

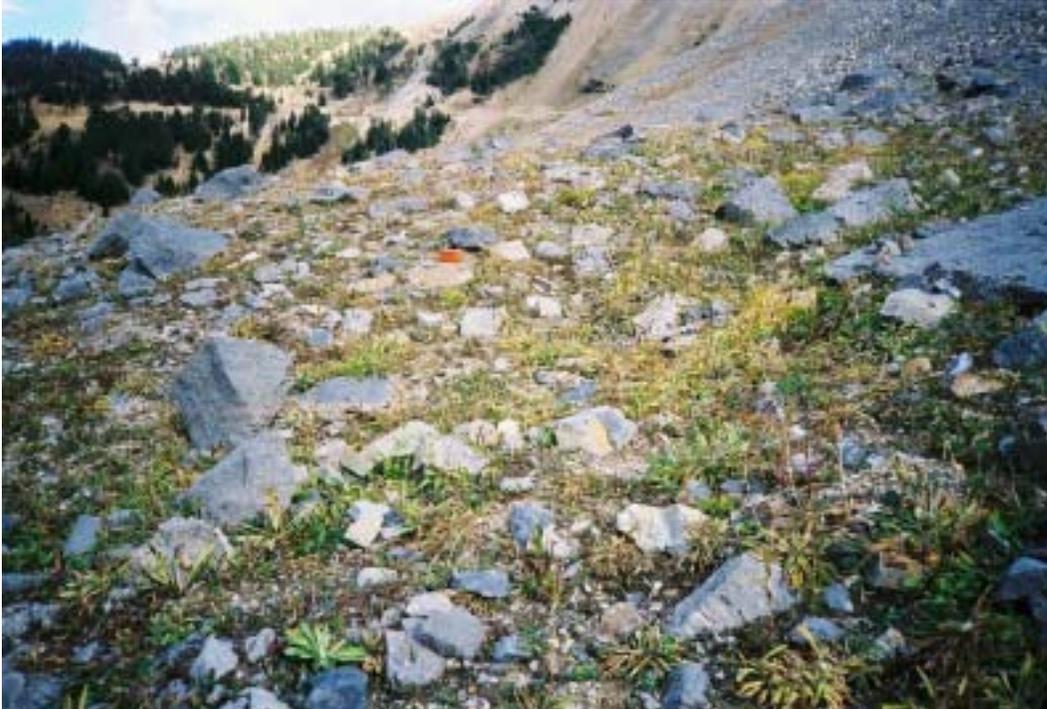
Figure 12. Daisy Landslide Block (looking east at upper top surface of landslide block on western end of landslide, western traverse)

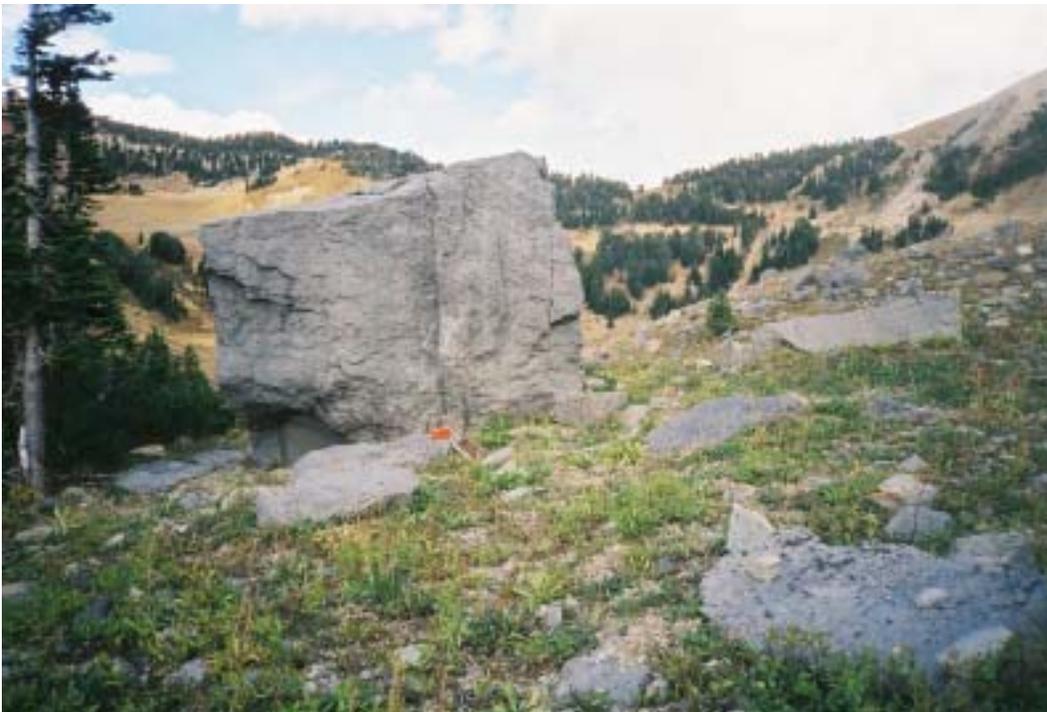
Figure 13. Daisy Creek Landslide upper surface western end showing unusually large boulder (orange box about 8")

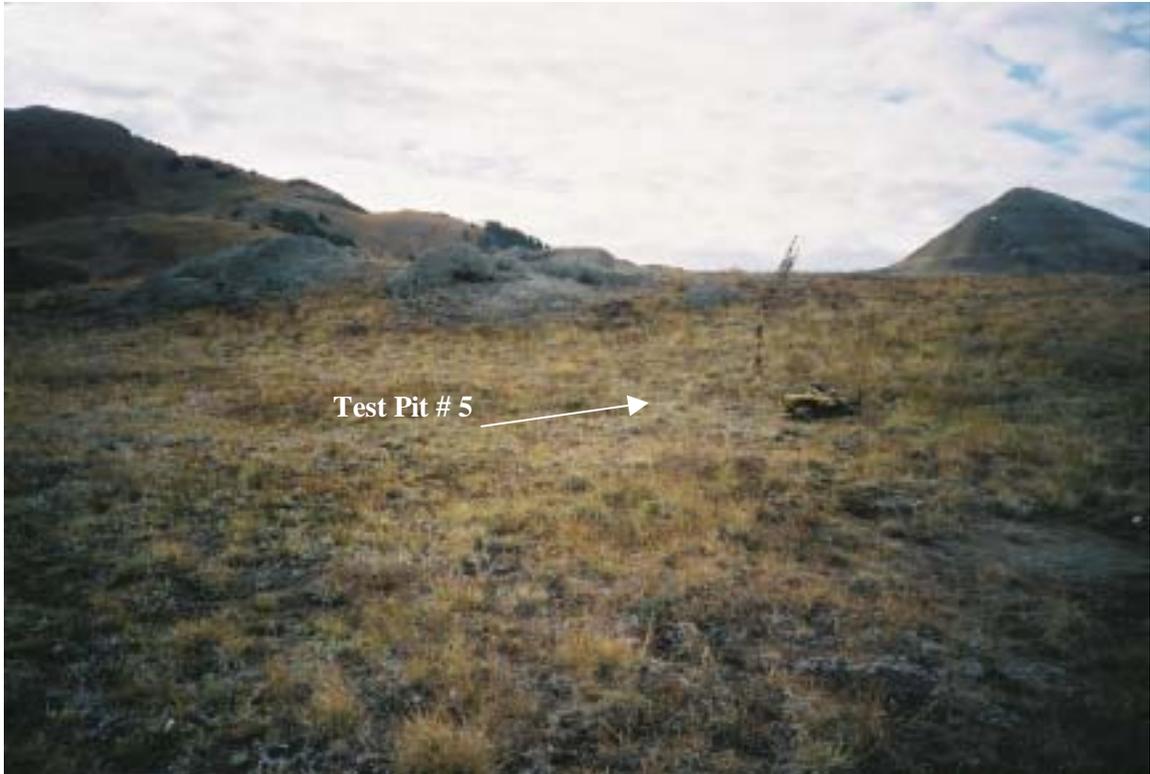
Figure 14. Tdlp Quarry Site (Moonscape, location shown on Figure 1)

F) Lulu Pass Rhyodacite Porphyry, Northwest of Scotch Bonnet Mountain: Northwest of Scotch Bonnet Mountain, the Lulu Pass Rhyodacite Porphyry outcrops over a rather extensive area. The weathering of this unit creates an unusual topography that is like subdued badlands with little vegetation (Figure 14). The rhyodacite porphyry is light gray and exhibits a weakly sericitized alteration. It contains phenocrysts of quartz and feldspar that exhibit a weakly developed spherulitic texture and biotite. The groundmass is largely comprised of fine-grained potassium feldspar with very few mafic minerals. The weathering of the potassium feldspar groundmass causes the rock to disintegrate into quartz-feldspar spherulites and weathered surfaces often contain abundant pea-gravel sized and shaped material. Two shallow test pits were excavated in this material (Appendix A, and Figures 15 and 16). The material was found to be very hard and resistant to excavation even with a tracked excavator. However, once excavated from the pit and struck with a hammer, this material was very friable and disintegrated into smaller clasts and eventually pea-gravel sized material. This suggests that the rock quality is likely not suitable for the proposed construction uses (above liner drainage layer and channel armor). However, this material may be highly desirable for road base or a bedding layer for the geosynthetic membrane. Rock was collected from both test pits but has not been analyzed or tested for material strength or ABA.

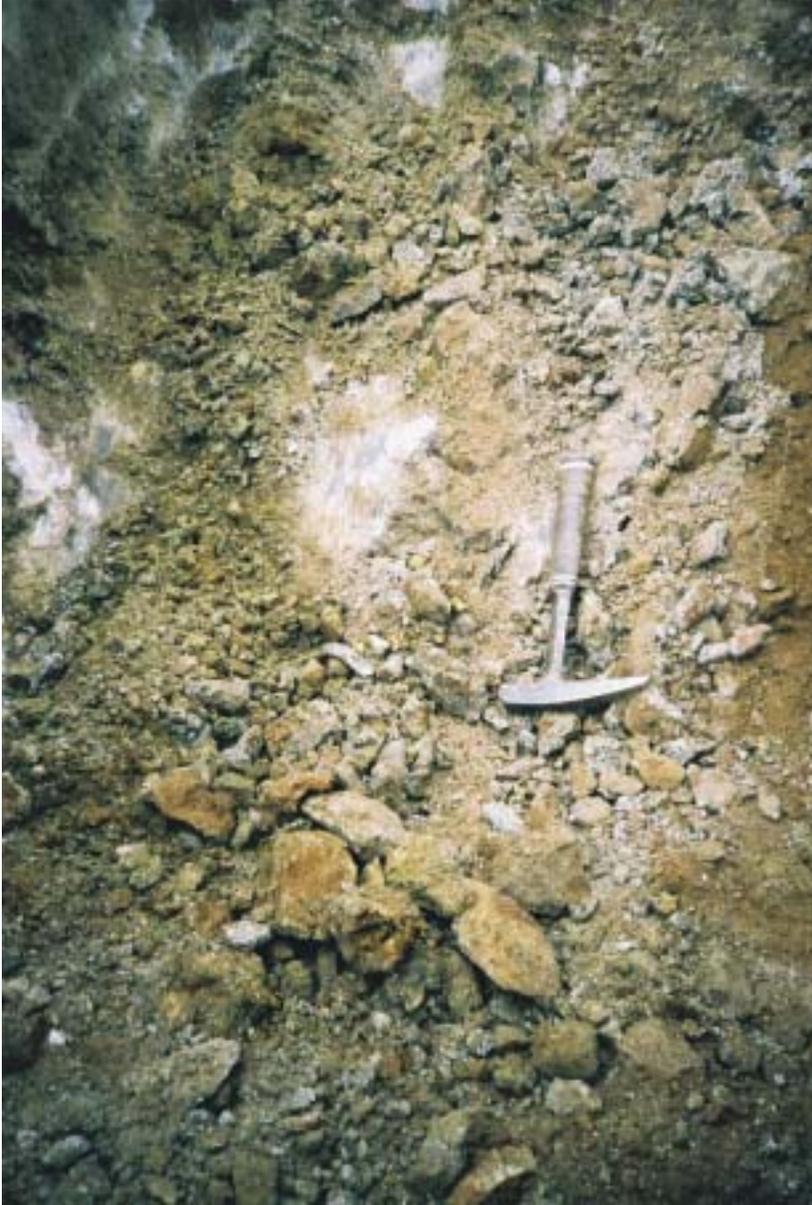
Figure 15. Tdhp Quarry site TP #5, note scrape makes from excavator teeth, very hard digging, but friable material once excavated. Has to do with the formation of spherulites of relatively hard quartz and feldspar minerals in an altered clay and fine-grained mafic matrix. Material is probably unsuitable for use as a drain rock at McLaren but excellent for road base.

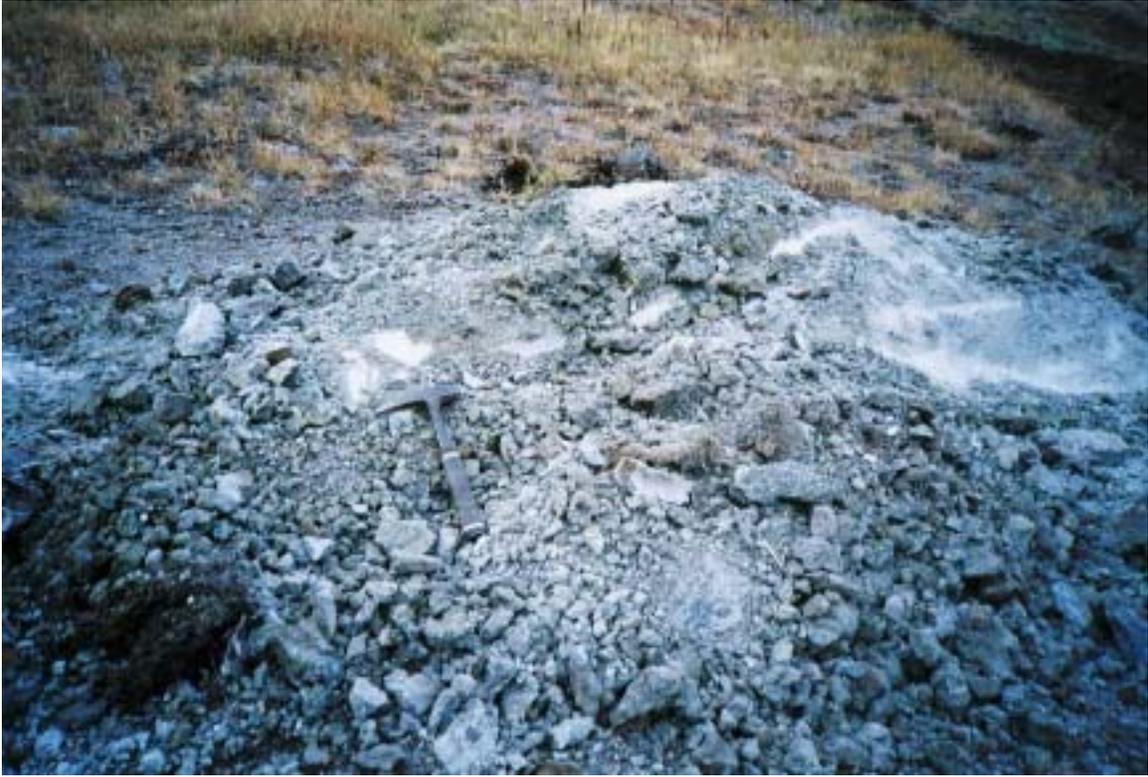
Figure 16. Tdip Quarry Site, excavator worked very hard trying to rip this outcrop (front of machine off ground while digging this very hard material, but again friable once excavated).
