2300—Recreation Management 1123 1804—SDTDC April 2011

Plastic Wood and Alternative Materials for Trail Structures

By Martha Willbee, Outdoor Recreation Planner Forest Service

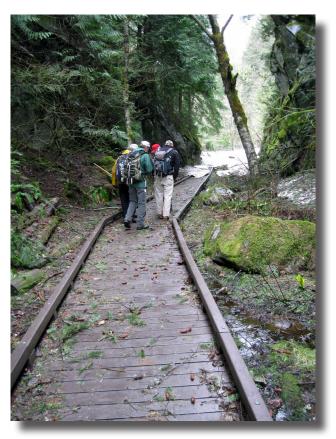
Figure 2—Forest Service Region 6 Iron Goat Trail, made of 100 percent HDPE RPL, installed in 2004.

HDPE is used for decks and boardwalks. Companies are striving to make the materials more color-fast and ultraviolet (UV) stable. It is nonabsorbent, well suited for decking, decay resistant, and can have a 50-year warranty.

Although plastic tends to be slippery, the surface can be textured to help with the slipperiness. However, HDPE plastic lumber does not have the same load-bearing capacity as wood and should not be substituted in applications calling for wooden load-bearing components.

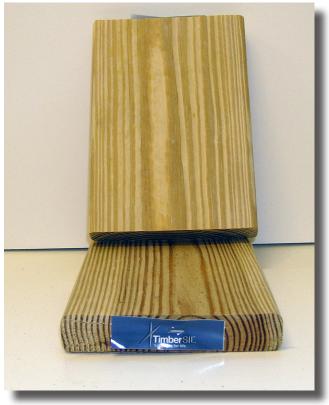
Figure 13—TimberSIL™ lumber.

TimberSIL™ engineered wood is made of southern yellow pine and is treated using sodium silicate and redried. It is nontoxic and lighter in weight than traditional treated wood, it weathers to a silver gray, and it is paintable or stainable. It is noncorrosive, fire retardant, noncarcinogenic, insoluble, and will not leach. It has a 40-year guarantee against rot, decay, and most wood-protection problems. It is recyclable. Visit the Web site at: http://www.timbersilwood.com/. Contact the company directly for further information and availability.

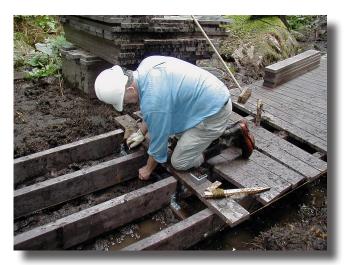
Figure A.2—Volunteer building the trail.

Volunteers built the puncheon over the summer of 2004. It took about 30 work days with 4 or so volunteers per day. The project was very labor intensive. And, since there were more pieces of lumber than a treated wood puncheon, the amount of time involved installing the sill and attaching all the pieces was increased. An onsite generator powered the drills and the holes were predrilled.

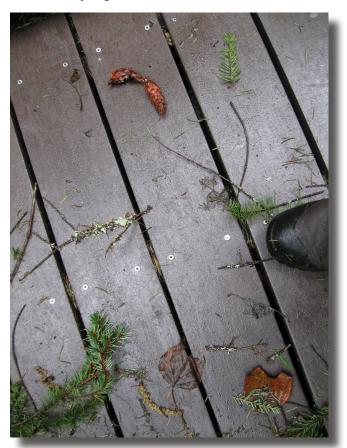
Figure A.3—Trail is 5 years old.

The plastic lumber cost \$12,000, which was about twice as much as treated lumber; installation time was probably about twice as much too. However, the manufacturer said the plastic material should last 50 years or more, whereas treated wood puncheons on the same trail are having slippery deck issues after 10 years, and we may have to replace them after 20-25 years. After 5 years of use, the puncheon with plastic lumber is in good condition, and we are pleased with the results. The deck isn't slippery and we have not done any maintenance on it. At some point we will need to remove any algae.

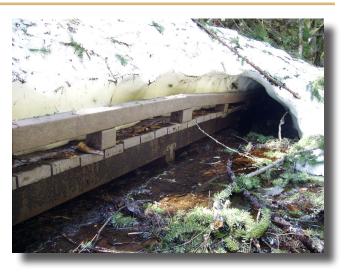
Figure A.4—The puncheon in May 2008 after a winter of very heavy snow loads. After the snow melted and some summer heat, it bounced back to normal (or so close to normal it's not noticeable).

Heavy snow loads a couple of winters ago caused the curbs to bend but they bounced back to normal. The puncheon is located in a shady spot, so issues with direct sunlight and warping are not a factor.

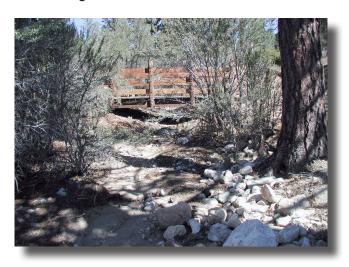
Figure A.9—San Bernardino National Forest trail bridge.

Trail bridges were installed in 1998 or 1999 and have lasted well with little or no maintenance. They are made of lpe wood and are expensive, but due to high vandalism, they are well worth the investment because people cannot carve on them. The forest staff would definitely use this material again.

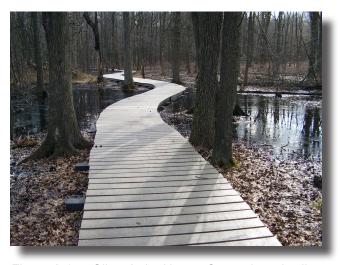
Figure A.14—Silver Lake Nature Center boardwalk.

"A minor annoyance is the static electric charges. Since plastic is a poor conductor, people are not grounded and as they walk they build a static charge. Some kids get a big kick out of shocking everybody. Would I choose the material again? Yes. I do think it is important that we demonstrate what we preach, and using recycled material is important.

"The structures are still very nice looking and in 10 years have not required the slightest maintenance beyond sweeping. I have noticed a few of the boards are showing some minor spalling on the inner surface, which is the thinnest portion of the board. We have not had anyone slip on or complain about the structures (other than the shocks)."

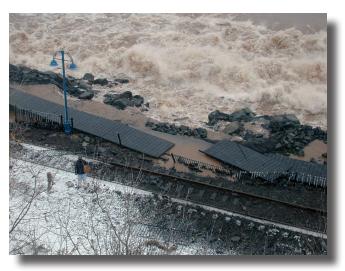
Figure A.17—Lake Superior. Lake surge takes out boardwalk during storm.
