## **Chapter 2—Alternatives**

### **2.3 Alternatives**

## 2.3.2 Alternative 2 —Proposed Action

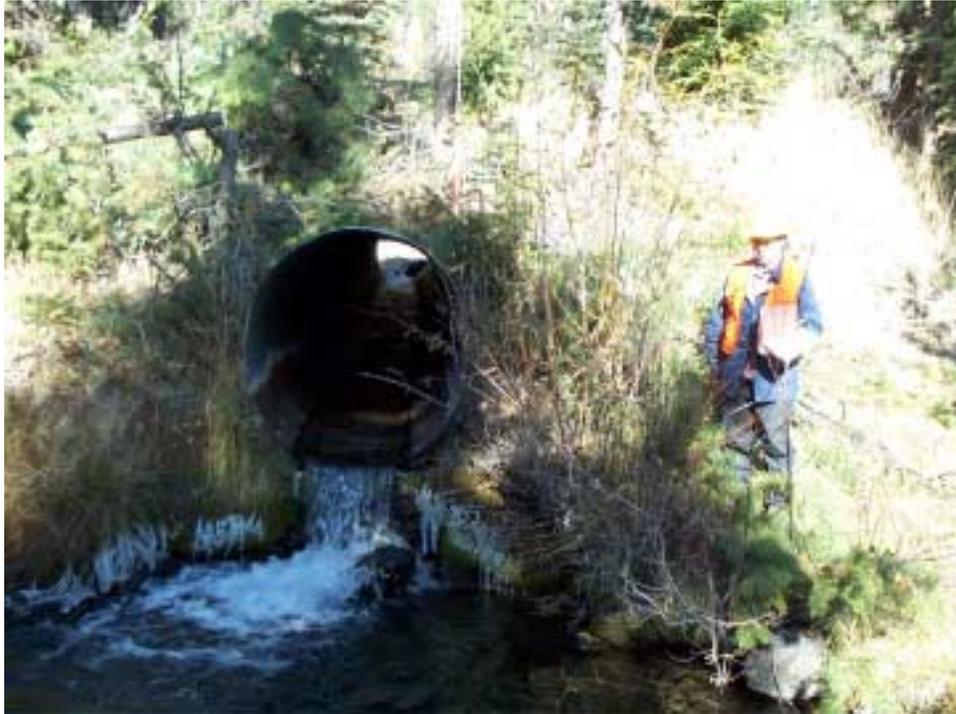
**Photo 1**—Alternative 1—FS Road 2010618 at upper crossing with Vinegar Creek pictured below has typical barrier problems for fish passage (juvenile fish cannot pass upstream). For comparison with the proposed action see a description of Alternative 2, Project Point 2 page 13.

#### **Alternative 1—FS Road 2010618 at upper crossing with Vinegar Creek (Alternative 2 Project Point 2)**

Currently, the jump height at the culvert outlet and the slope of the culvert limits fish passage upstream. The individual bull trout found during ODF&W surveys was captured less than ½ mile downstream of this location. This culvert is reducing summer rearing habitat available for bull trout and steelhead as there is over 0.5 miles of cold water, providing summer rearing habitat upstream of this culvert.

### **Alternative 2 Project Point 2—FS Road 2010618 at upper crossing with Vinegar Creek**

This alternative would improve fish passage at this project point by replacing the current structure with a bottomless arch that has a natural streambed for juvenile fish to rest during an upstream movement. . The individual bull trout found during electro-shocking surveys was captured less than ½ mile downstream of this location. Because stream gradient would be the same or similar to the natural grade, and there would be a natural substrate stream bed under this crossing, fish passage for all species and life stages would be possible during normal low flow and spring flow conditions. These stream crossings would be designed to accommodate an estimated 100-year return interval peak flow, with a provision made for overtopping at the culvert or at a nearby low spot in the road if debris loads cause the culvert capacity to be exceeded. This new arch culvert would have a span of approximately 15-20 feet and a height of 6-8 feet. This culvert if replaced with this alternative would be about 50 feet long and provide another 0.5 miles of cold water for summer rearing habitat upstream of this culvert—important for the viability of declining populations of bull trout and steelhead. Disturbed ground around this stream crossing will be planted with native and/or non-invasive grass seed, native trees or shrubs if available, and mulch will be placed on bare soils to reduce erosion and moisture loss.

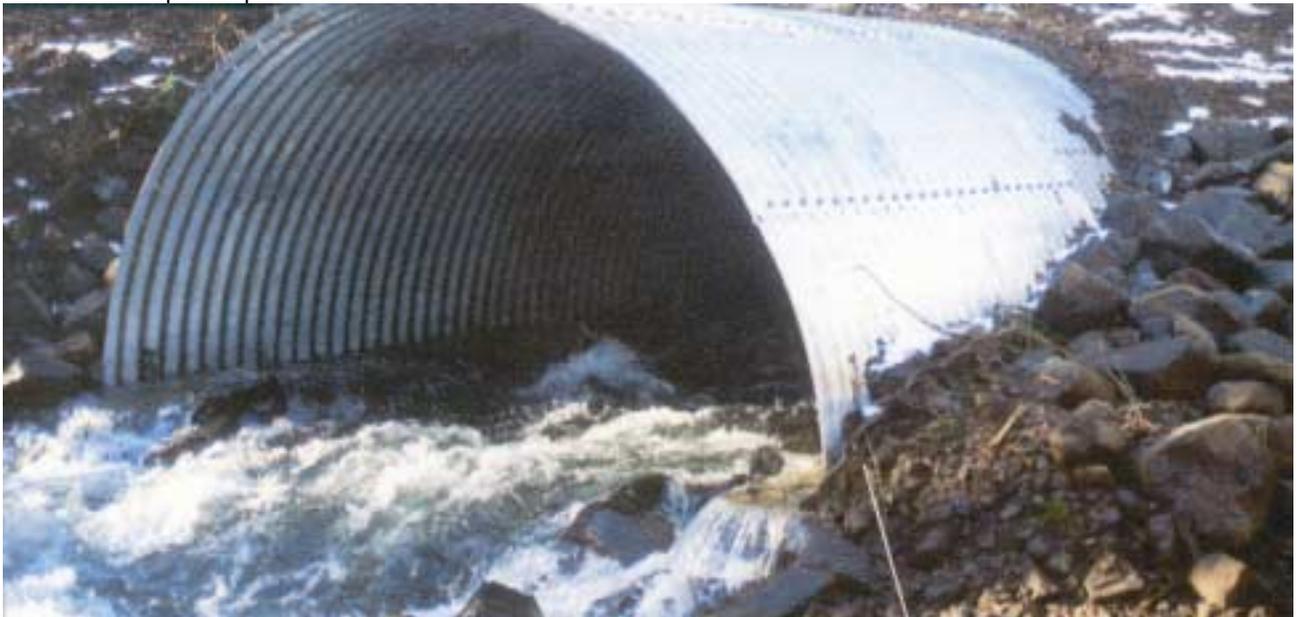
Photo 2 Example of open bottom arch used on the Wenatchee National Forest.

Existing culverts would be removed using an excavator. New structures, called bottomless arches and box culverts will be aligned with stream channel profile (vertical and horizontal) and be designed to handle 100-year flow events. Each site will be prepared for installation including widening location for new structure and excavation for footings. Installation will include rocking the inlet and outlet ends and catch basin, and stabilizing the fill slope with straw mulch and short-term grass seeding as needed. Structures would include use of native materials for natural stream bottom simulation to mimic natural conditions upstream and downstream of the project site. Sites would be backfilled with materials removed from existing road fill.

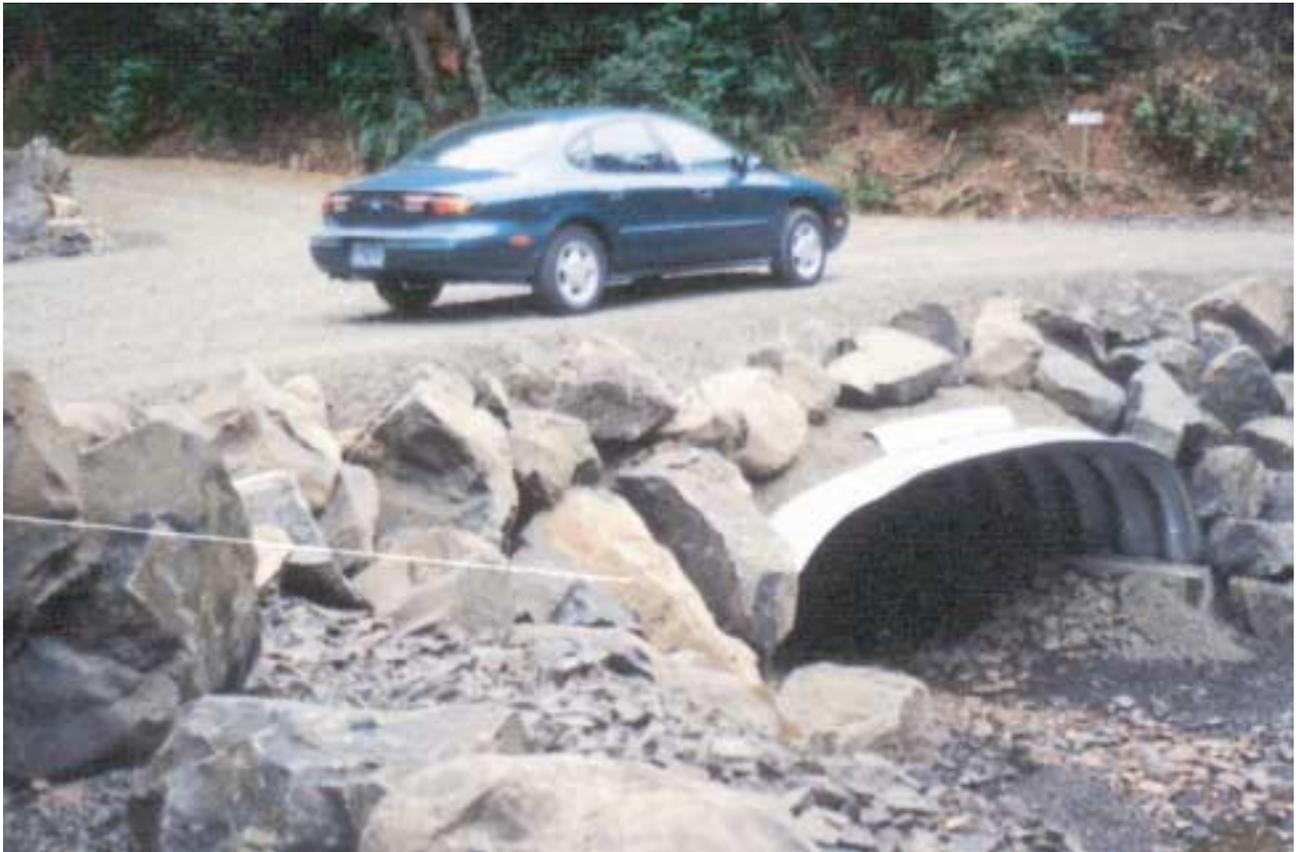
Photo 3 Example of box culvert used on the Wenatchee National Forest.
