Project Title – “Assessing the Proper Functioning Condition of Waters Creek, Siskiyou NF.

Submitted as the completion step for Senior Project, Grants Pass High School, by Mike Rubin. Instructor is Mr. Gulden, project Advisor is Mike Lunn.

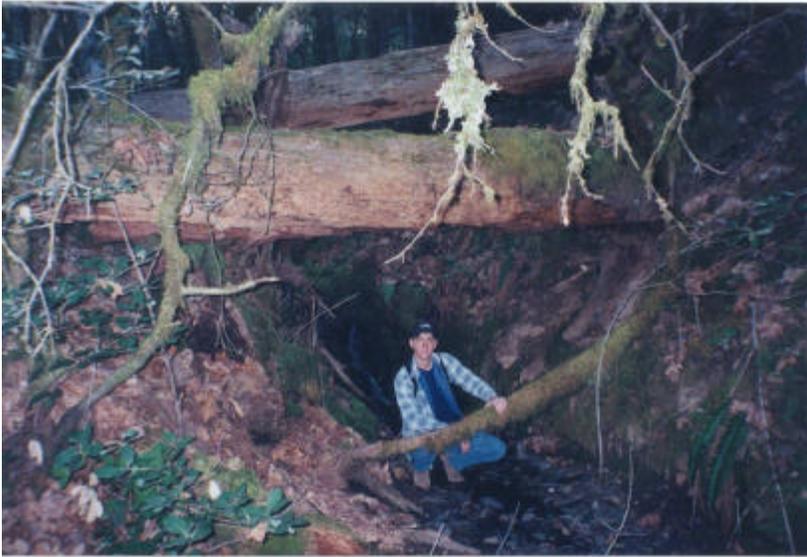
Photo 1. Rosgen B1 stream type, large wood typical of incised canyon area.

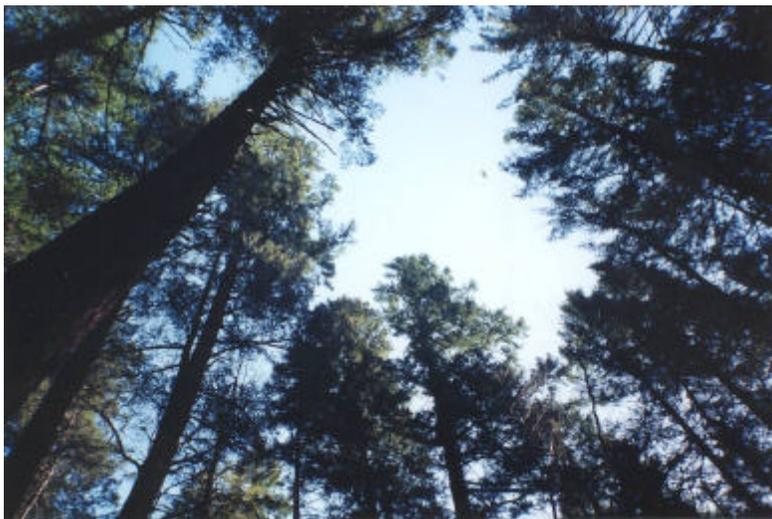
Photo 2. Old-growth canopy over riparian. Future large wood recruitment source.

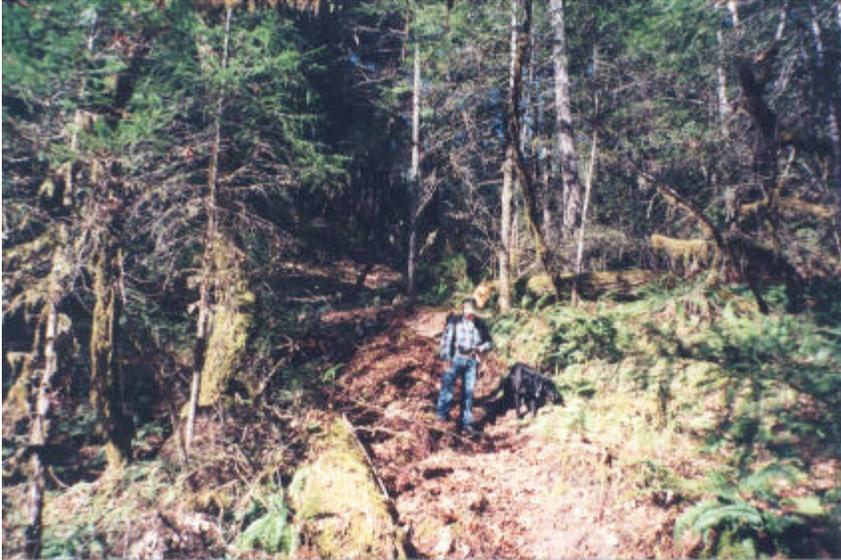
photo 3. Cutting unit fireline, direct source of sediment to creek.

Question #5 reading and trail construction may be contributing excess sediments not readily apparent.

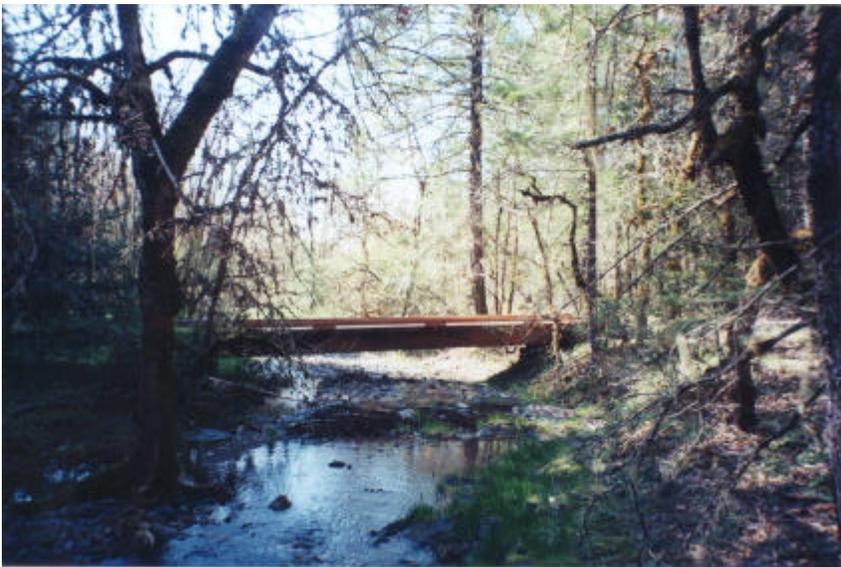
Photo 4. Newly installed trail bridge. Questionable whether adequate height above flood channel to permit flows and natural debris from causing blockage and blowing out around footings.

Recommendation: review elevation of existing foot bridge to insure clearance of stream.

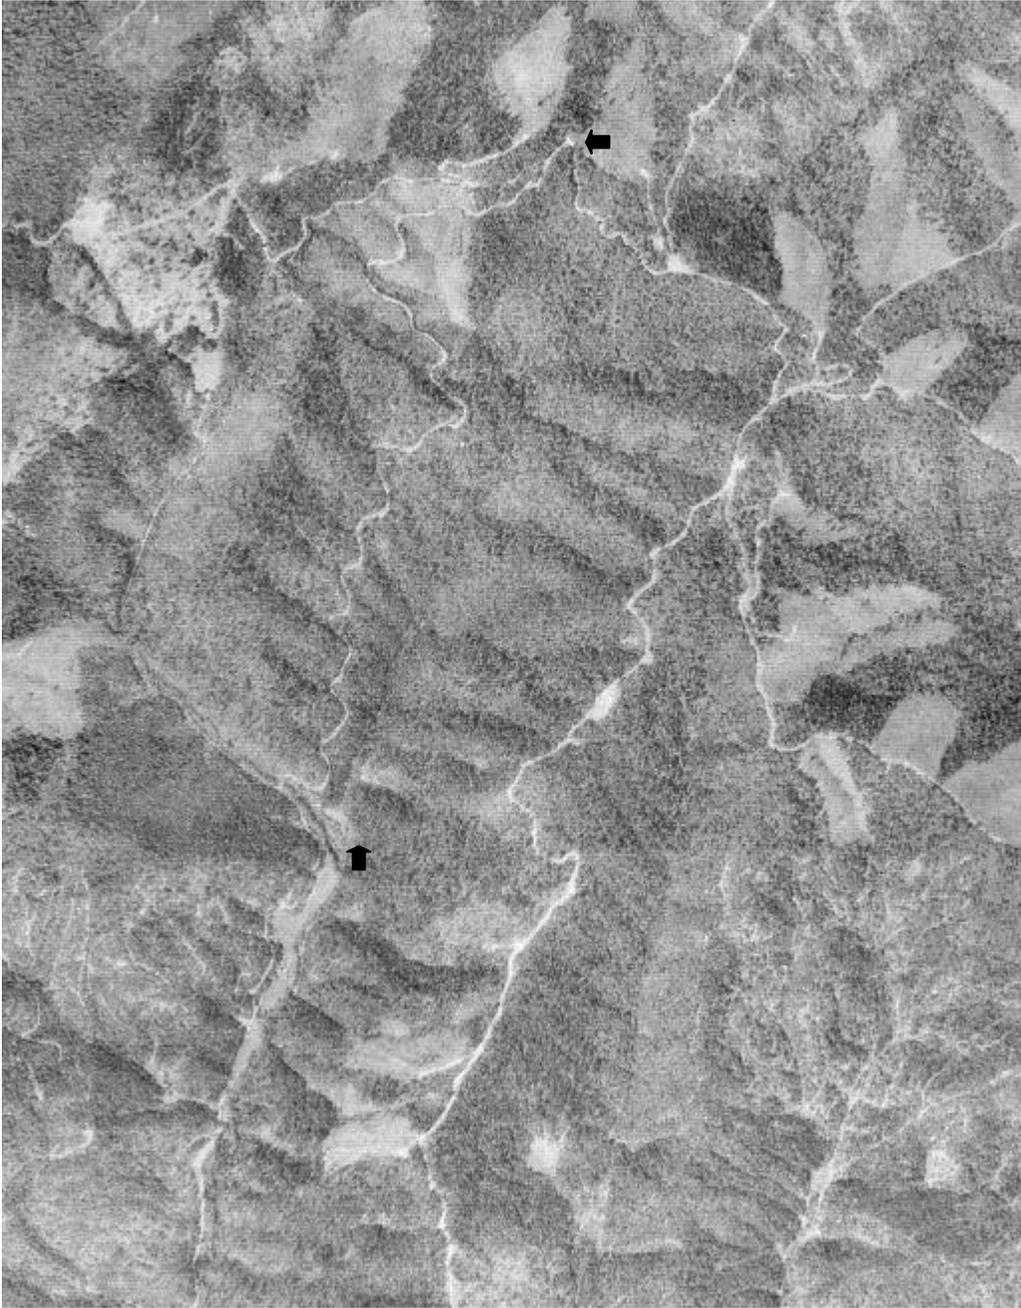
Project Area - Upper Arrow denotes point of beginning, at watershed divide, of PFC field examination. Lower arrow marks end of survey at Forest Boundary on Waters Creek.
