RE: Chattooga Wood Inventory

American Whitewater's Comments on the "Inventory of Large Wood in the Upper Chattooga River Watershed", Including the "Executive Summary"

March 25th, 2008

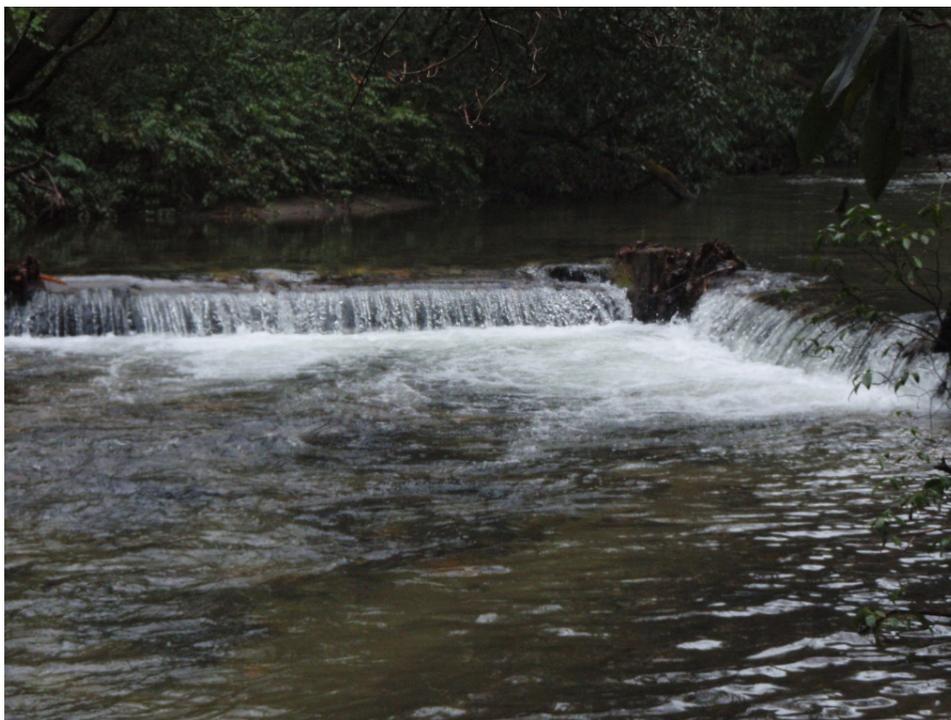
1. Human placed log v-weir on Holcomb Creek.

In several places, the Inventory indicates that Holcomb Creek may be an acceptable reference stream for Overflow Creek. This is not appropriate. Holcomb Creek 1) contains many saw-length pieces left behind by loggers¹, 2) was and is the site of at least one splash dam², 3) has human placed wood structures not mentioned in the report (see photo in Appendix 1), and 4) is smaller and likely has a lower transport capacity than larger streams like Overflow³. Overflow does not share any of these characteristics. In essence, Holcomb Creek's high number of logs can be directly traced

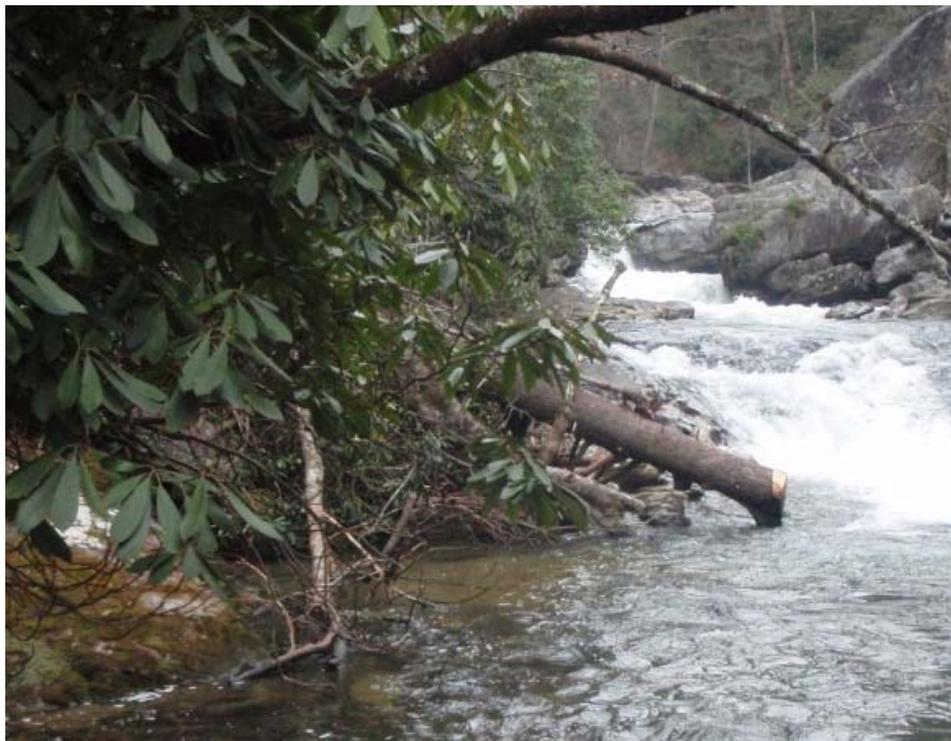
2. Logs featured in Inventory photos. Small pieces are submerged or absent, sub-bole is in the water column, and main bole is nearly in the water column at a flow that is significantly below bankfull.

The Inventory states that several wood pieces in Overflow and the West Fork “had been cut into small, easily moved pieces. Some pieces had been placed outside of the bankfull channel. Pieces that are removed from the channel can not function as LW and will not soon be replaced, an unintended consequence that will span generations (Inventory 8-9).” It is clear that the wood pieces and the main bole featured in Figures 6-9 were not in fact removed from the bankfull channel. Photos taken at a modest (lower than bankfull) flow reveal that the main bole and pieces in Figures 6 and 7 are in fact submerged or nearly so even at that flow (see photo in Appendix 1). We feel that the inventory misrepresents the fate of these few pieces of wood.
