Section 319 Nonpoint Source Success Stories

New Mexico: Rio Cebolla

Watershed Program Reduces Sedimentation

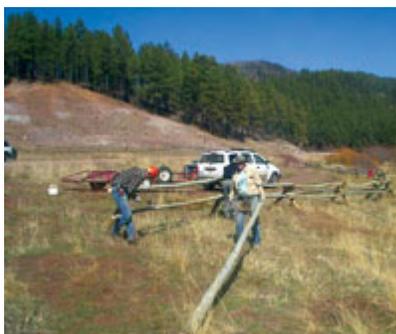
Figure 1. This August 2003 photo shows erosion damage from off-road vehicle use near Rio Cebolla.

Figure 2. New Mexico Trout volunteers build fences to

**prevent cars from travelling
off-road.**

In 2003 NMED completed a total maximum daily load (TMDL) for sediment for the Rio Cebolla. The TMDL identifies runoff from rangeland and roads (Figure 1) as potential sediment sources. The TMDL established target levels that are based on relationships between embeddedness (the degree to which fine sediments fill the spaces between rocks on a stream bed), fines (sediment particles that are 2 millimeters or smaller), and biological score. Those relationships show that at the desired biological score, the target embeddedness (for fully supporting a designated use) would be 45 percent, and the target fines would be 20 percent.

Dispersed recreation contributes significantly to degraded water quality, so the program includes a major education and outreach component aimed at the recreational users of the national forest area. An aggressive outreach campaign effectively increased awareness and educated people on ways to protect the stream. Program partners further reduced recreational impacts by installing fences to prevent vehicles from crossing the stream (Figure 2). The partners then worked to restore the closed areas (Figure 3).

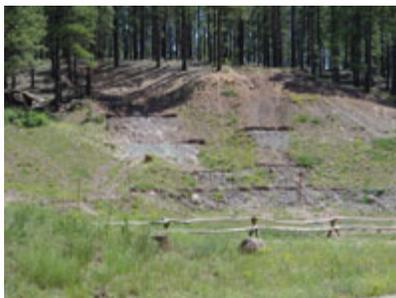
**Figure 3. The same location
as shown in Figures 1 and 2
after fencing and restoration
were complete.**
