# ***ASHLEY NATIONAL FOREST***

## **Lower Stillwater Pond Fishery Enhancement**

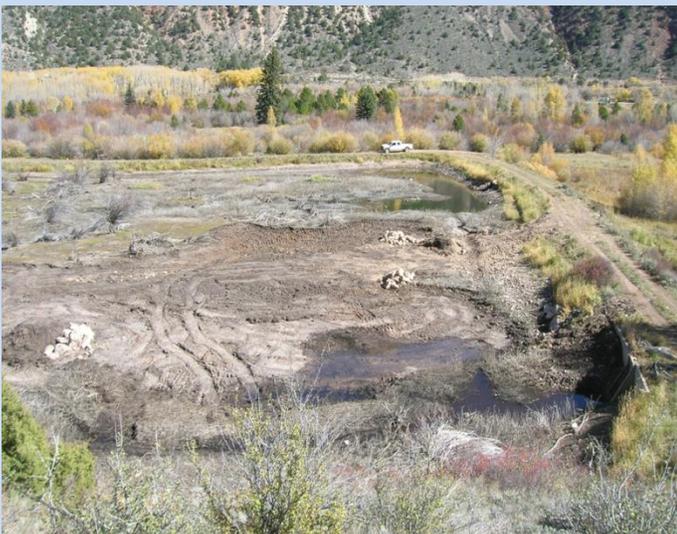
*Pond 2 was drained and dredged during October 2014 on the west side. Rock rubble fish habitat structure was also created*

Pond 2 – This pond is approximately 2 surface acres, and ¼ of the pond was dredged in October 2014 on the west side to remove brush and increase water depth. This pond has a head gate structure that delivers water to the Kids' Pond (Pond 8) through a pipeline. Five rock rubble piles were created to provide habitat complexity and islands within the pond. Rainbow trout were stocked during summer 2015.

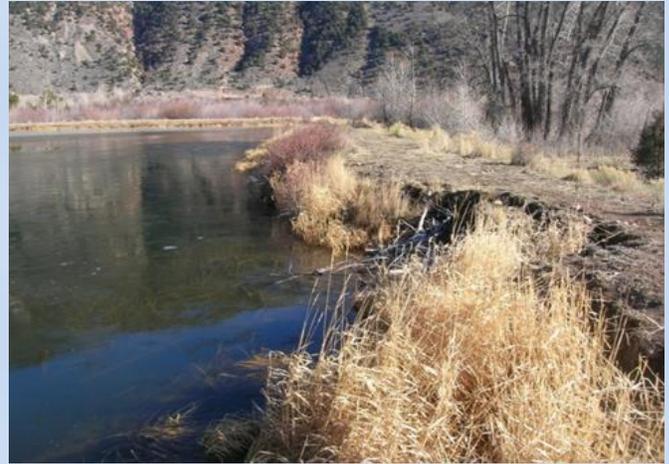
*Pond 3 before restoration work*

Pond 3 – This pond is approximately 3 surface acres. The dike which was damaged from burrowing rodents and beaver activity was repaired in June 2015. The work was completed with the use of a back hoe. Material was hauled to the site using a dump truck loaded with suitable fill material obtained from one of the ponds.

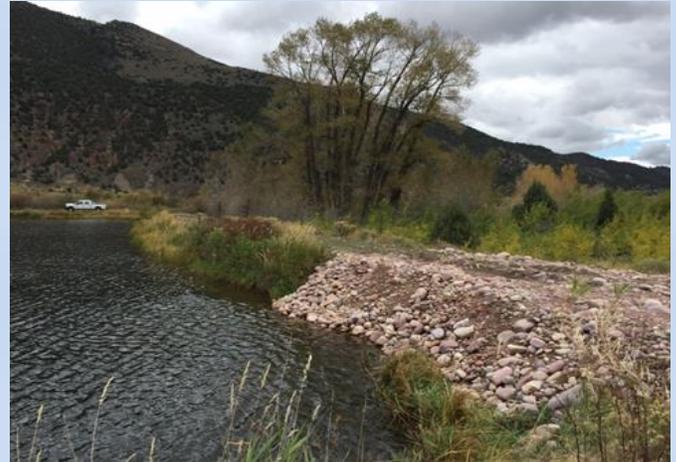
*Pond 3 following restoration work*

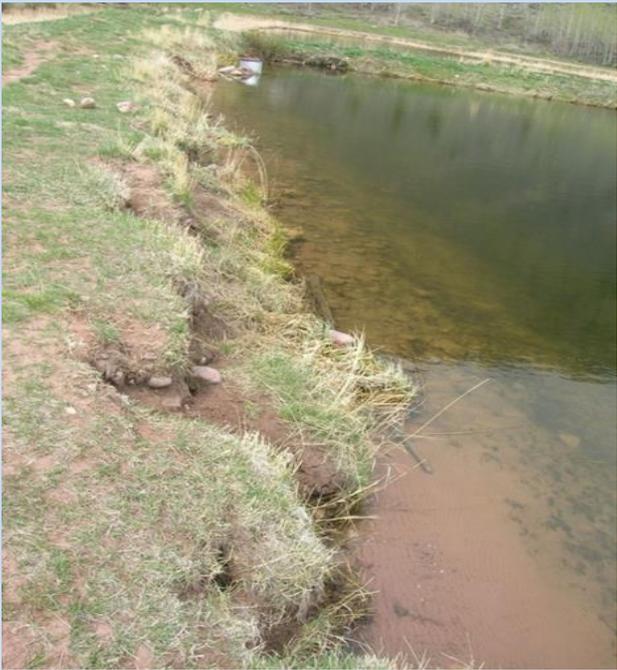
*Pond 8 before restoration work*

Pond 8 (Kids' Pond) – The dike on the south end of the pond was reshaped and stabilized by placing large angular rip rap along the slope down to the waterline. The disturbed soil on the top of the dike was reseeded with a native grass and forb mixture. Additional work planned for next spring will include anchoring logs to the bank in several locations to improve bank stability and provide fish hiding cover.

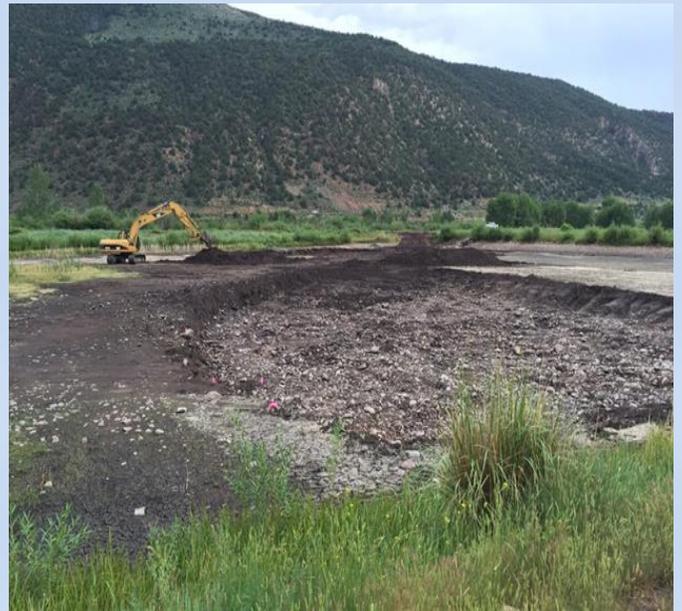
*Pond 6 being dredged and islands constructed*

Ponds 5 and 6 were drained and dredged. Accumulated sediments were dredged out and placed in the fill location adjacent to pond 5 and north of the big pond. Pond 5 was restocked with catchable size tiger trout during summer 2015.

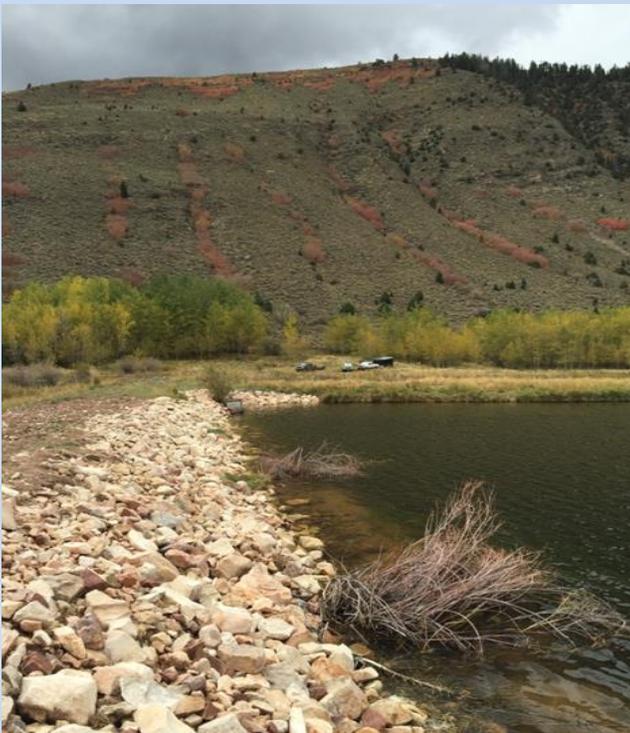
*Pond 8 after riprap placement*

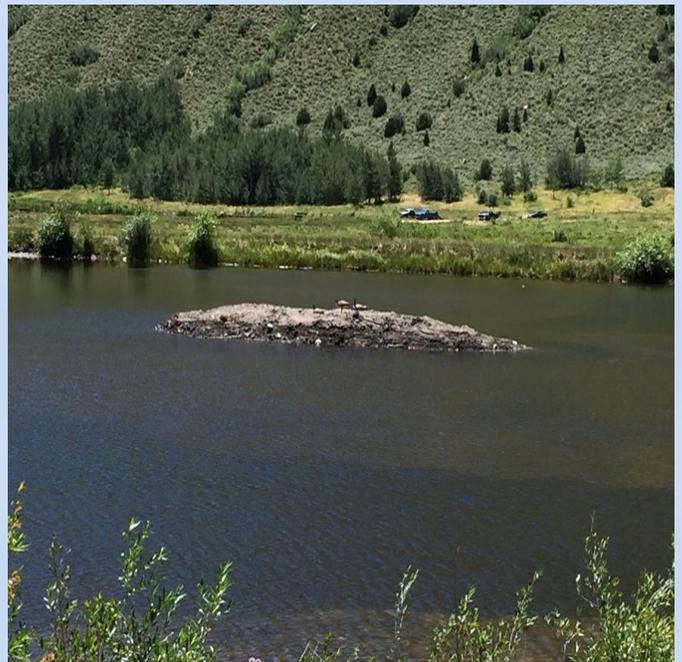
*Pond 6 following dredging with geese utilizing island*
