Cold Creek / High Meadows Ecosystem Restoration

Background:

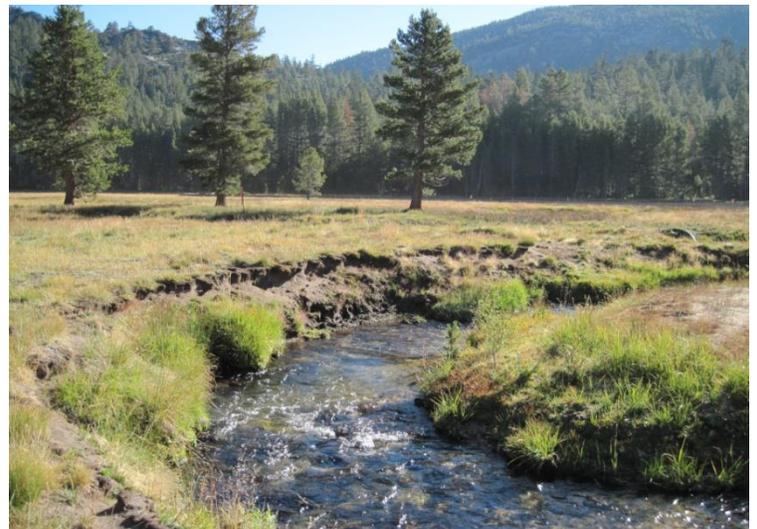
Mainstem Cold Creek, circa 2004

This landscape has been highly altered and degraded since the mid-nineteenth century by logging, cessation of natural and indigenous fire and over 100 years of cattle grazing and associated diversion ditches. This led to down cutting and widening of the stream channel, lowered groundwater table, drying of the meadow and lodgepole pine encroachment into the meadow.

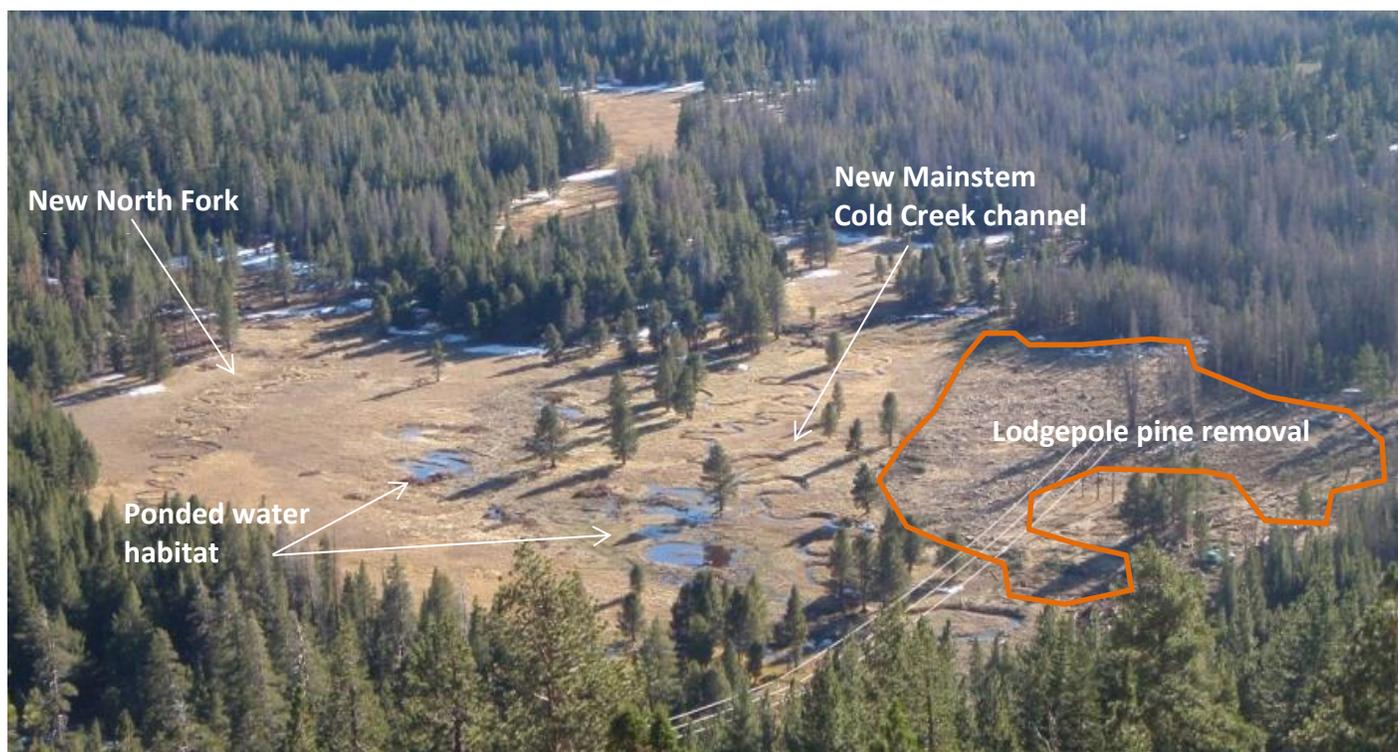
Photo of lower and middle meadow taken November 2012

Large scale restoration activities to reverse the trend of degradation began in 2010 and were completed in 2012. Restoration actions were primarily focused on the lower and middle meadows of the complex because these were the areas that showed the most extreme degradation.
