**Sisters Ranger District
Deschutes National Forest**

October 2009

Executive Summary

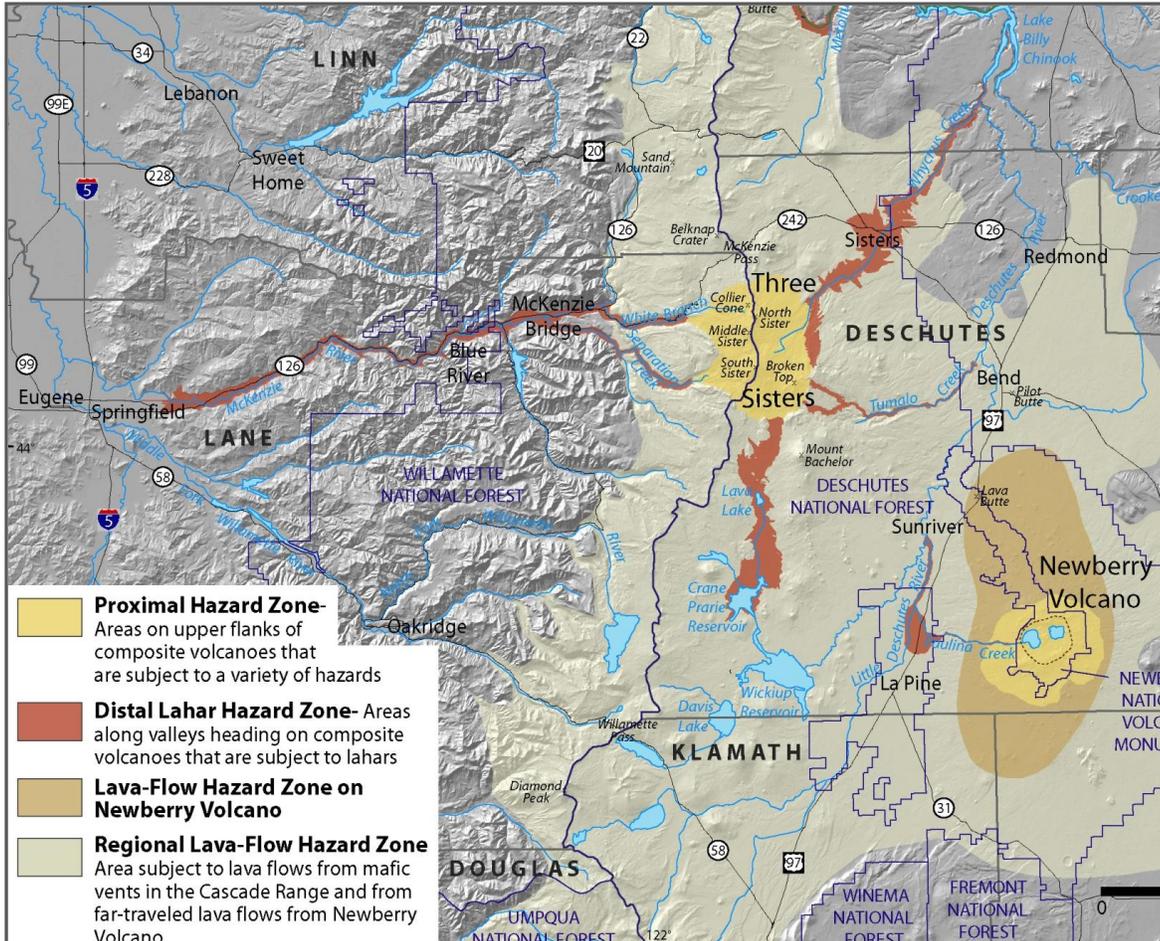
Map from USGS presentation by Willie Scott and Jim O'Connor 2009

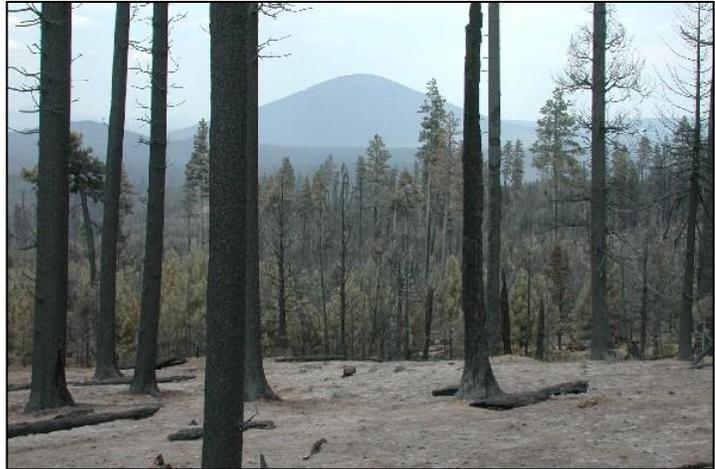
Stand replacement burn on east slope of Trout Creek

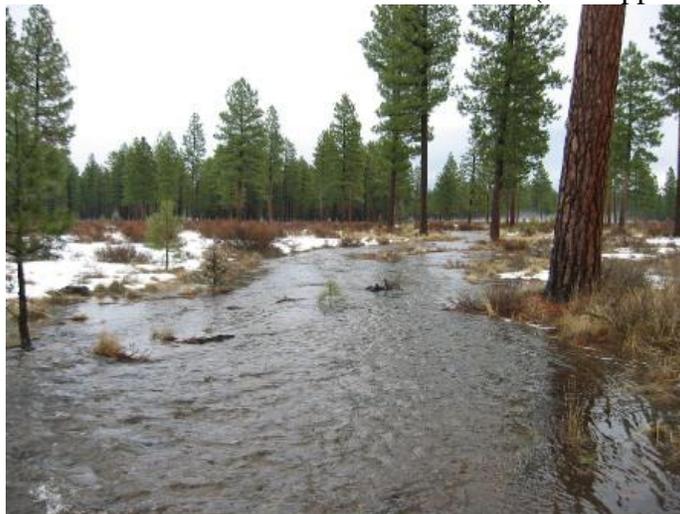
**Winter flood on Trout Creek near land to be developed
McKenzie Meadows -2006**

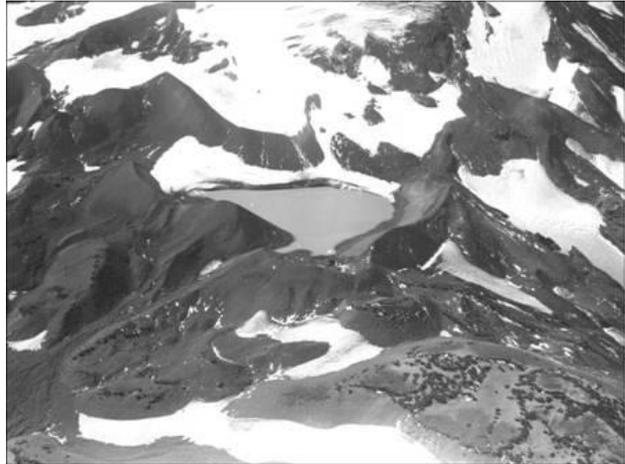
Carver Lake on South Sister – USGS photo

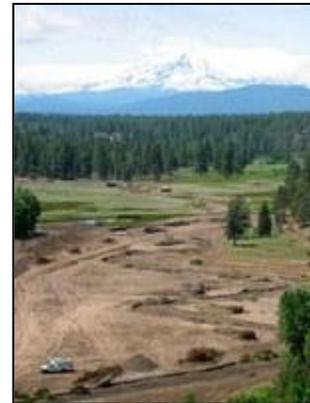
Camp Polk Restoration- a restored meandering new stream channel for Whychus Creek
Photo by Deschutes Land Trust

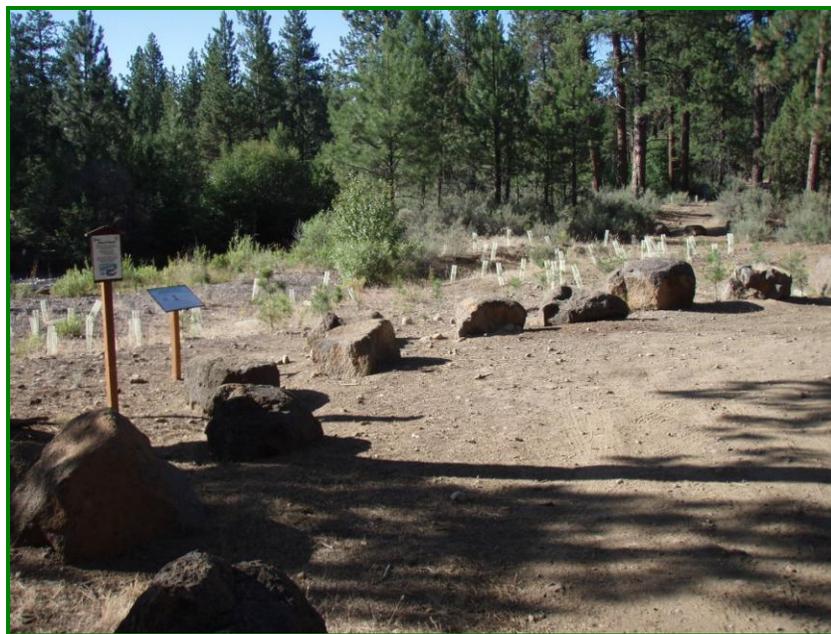
Plantings, signing, and site protections at Turtle Beach on Whychus Creek. This site was formerly a ford where vehicles drove through (and up) the creek.

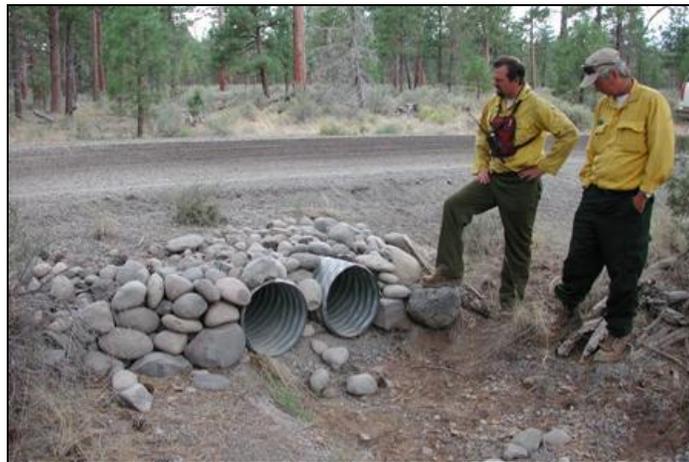
Many undersized culverts near Trout Creek were replaced after the Black Crater Fire

- Upsized the 1510-400, 1018, and 1024 road culverts.
- Removed the 1510 and 1008 road culverts.
- Improved drainage and fords on all road-stream crossings on USFS lands downstream of Black Crater Fire.

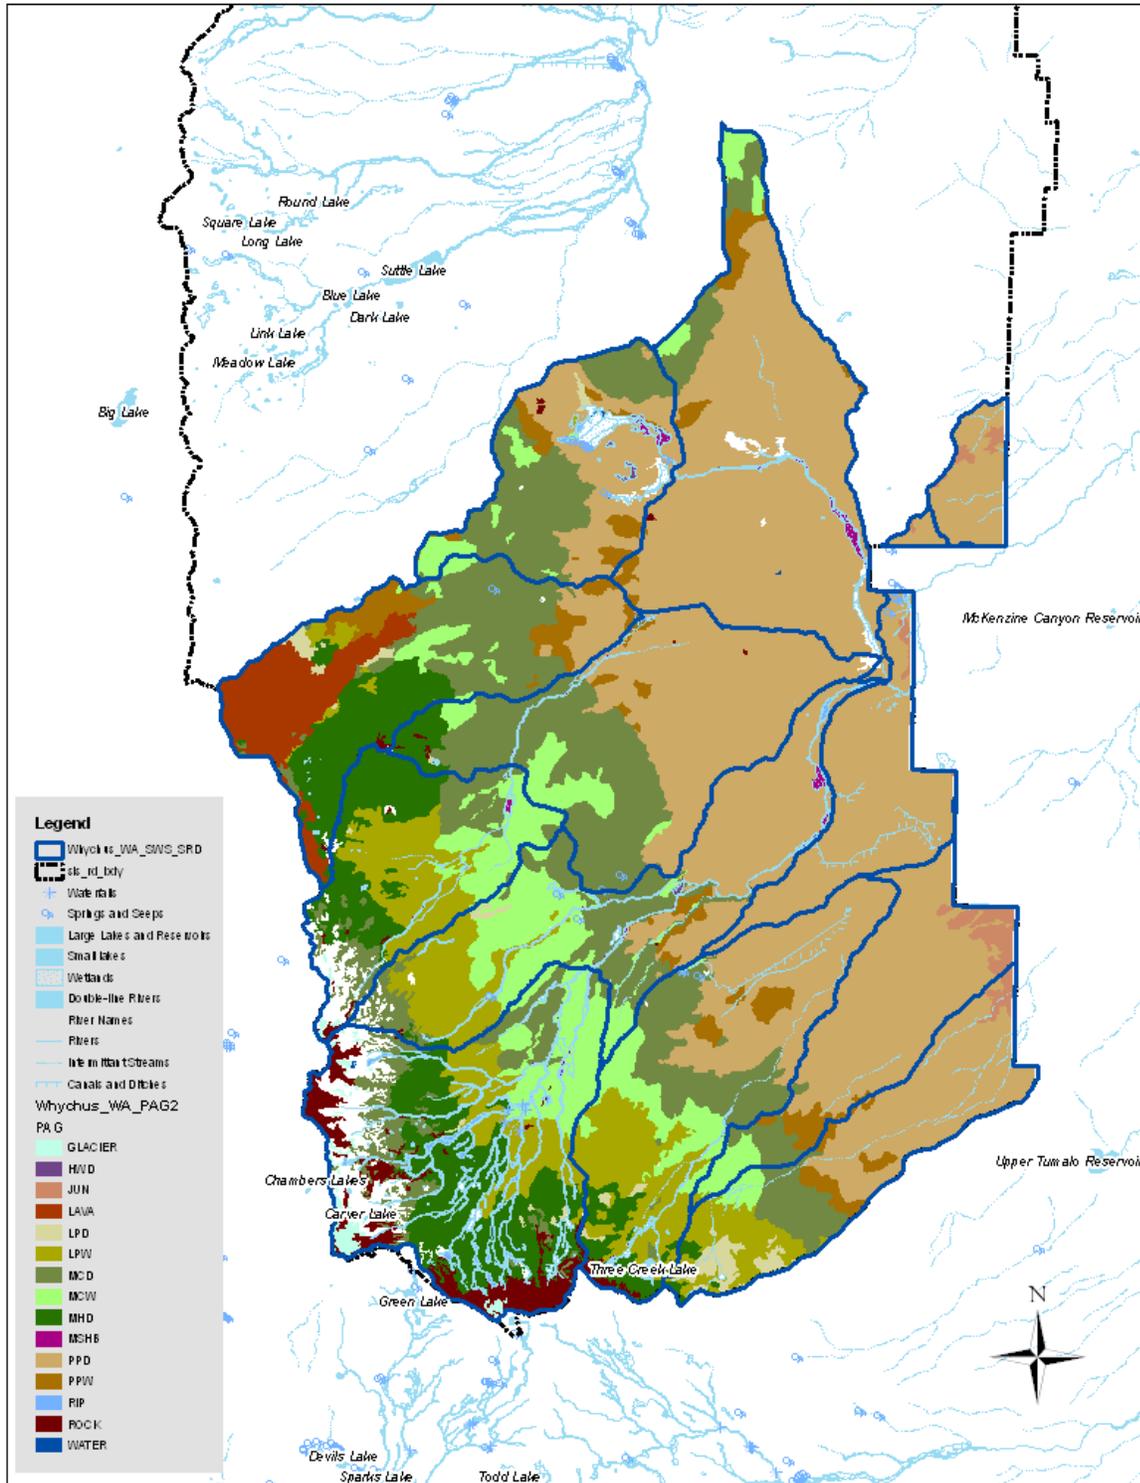
Updated Plant Association Groups (PAGs) for the Whychus Watershed

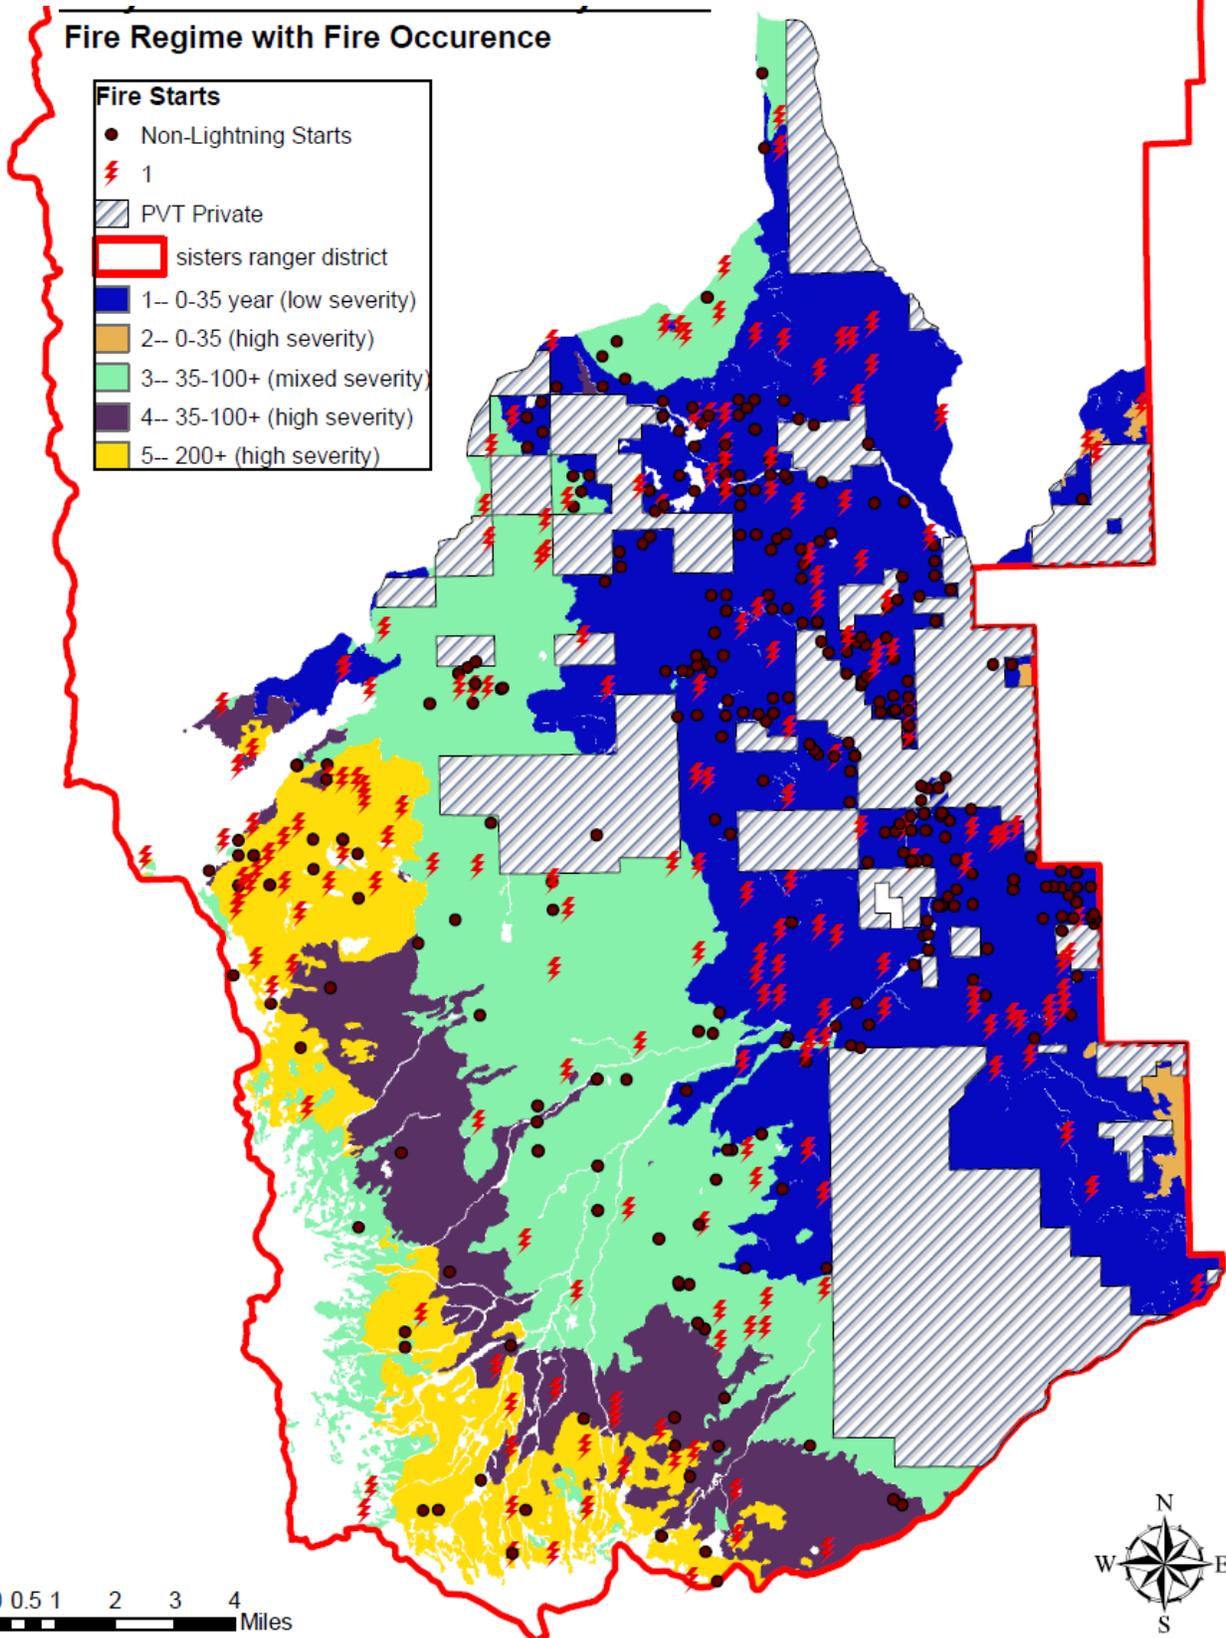
Fire Regime Condition Class with Fire History

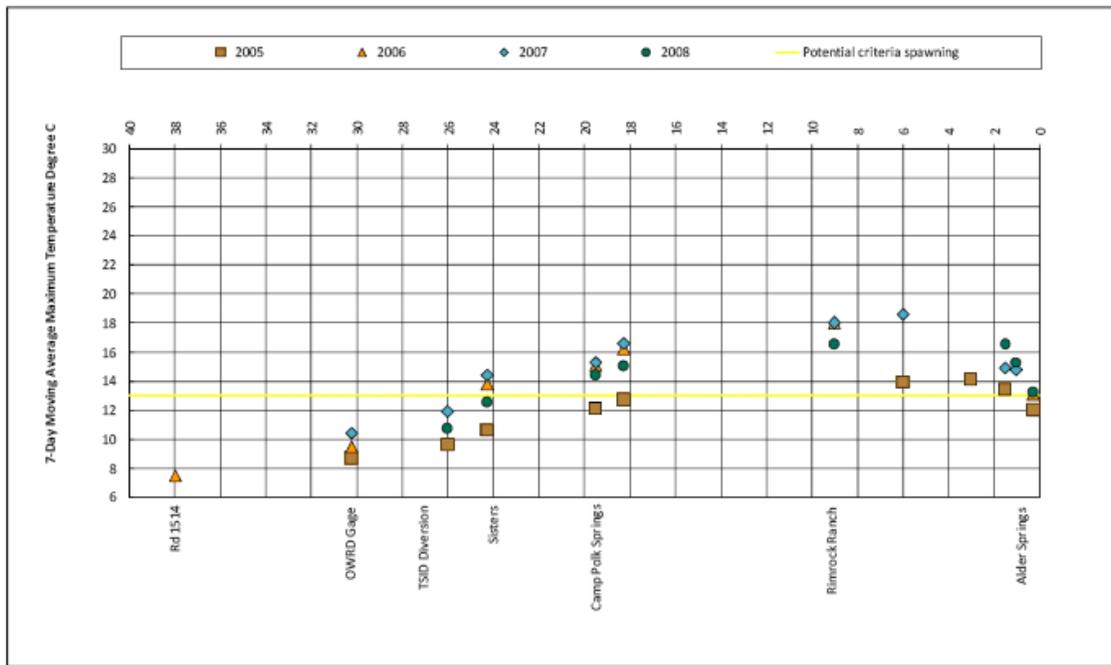
Figure 1. Longitudinal temperatures on the hottest spawning day of the year in Whychus Creek: 2005-2008 (Hill et al. 2008).

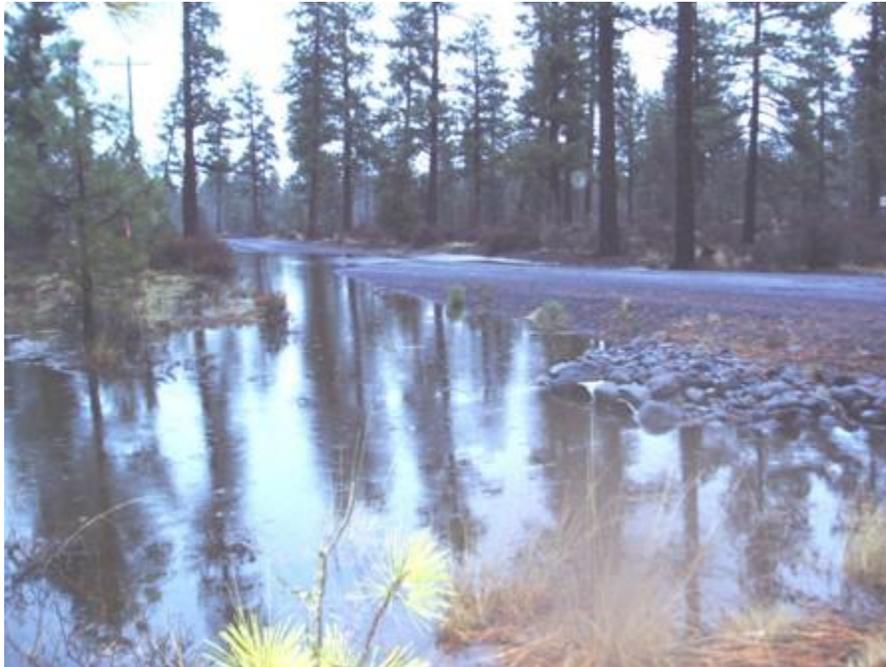
Winter flooding on Trout Creek 2007
