Eagle Creek Fire Trail Assessment

Wahclella Falls Trail – Complete Assessment

Trail: Wahclella Falls

Date Assessed: 4/9/18

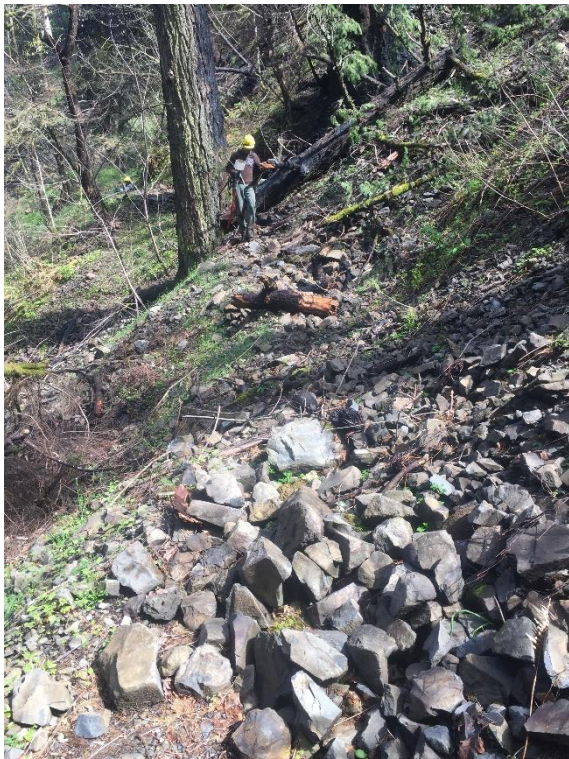
Photo 1 - Section of large rock fall and debris on trail

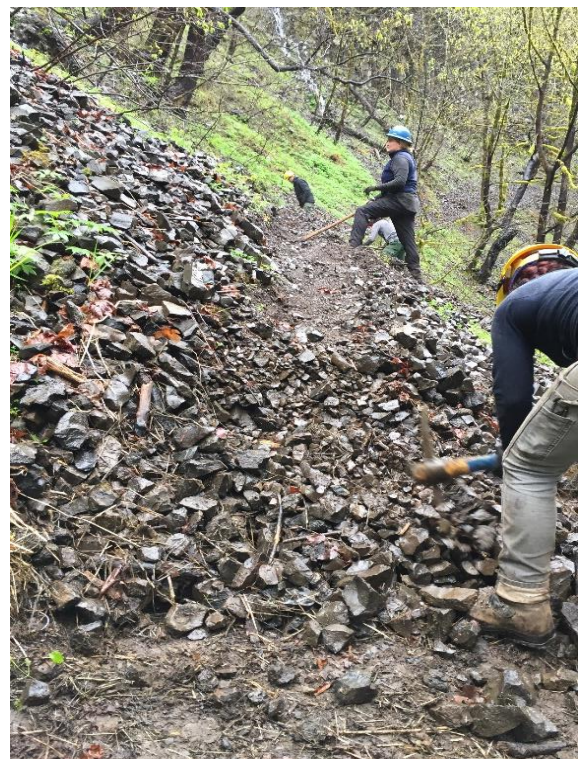
Photo 2 - Approximately 100' section of unstable rock slide crew is working to clear. Work is ongoing in this section.

Other: Forest Service crew has cut trail through all slides and has begun clearing sections of slides off the trail.

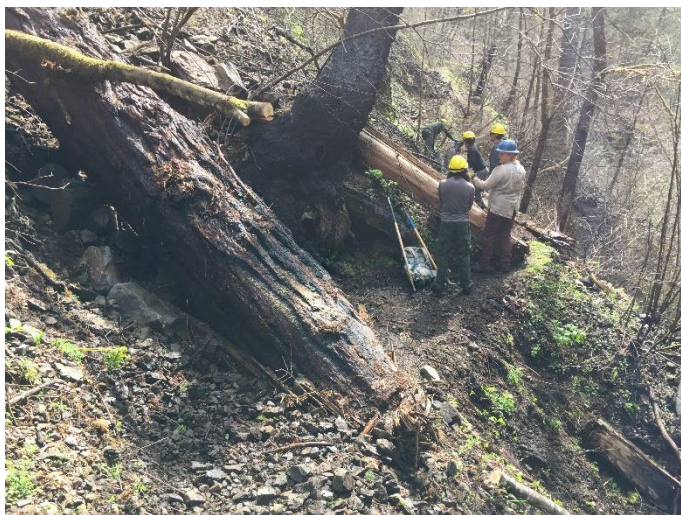
Hazard Trees/Brushing/Log Out: While very little brushing is needed, log out is required. Large diameter logs on trail; may need rigging to help remove. Large log jam near “tunnel” on east side.

Photo 3 - Large logs imbedded in trail

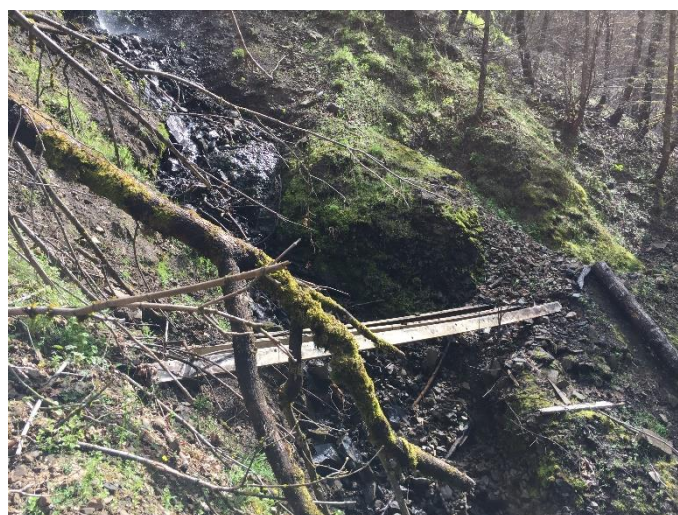
Infrastructure: No signs affected. Two boards damaged on first bridge. Upper bridge #4 destroyed by fire (metal sills remain) and gabion at junction is destroyed.

Photo 4 - Wooden bridge burned by fire, metal sills remain

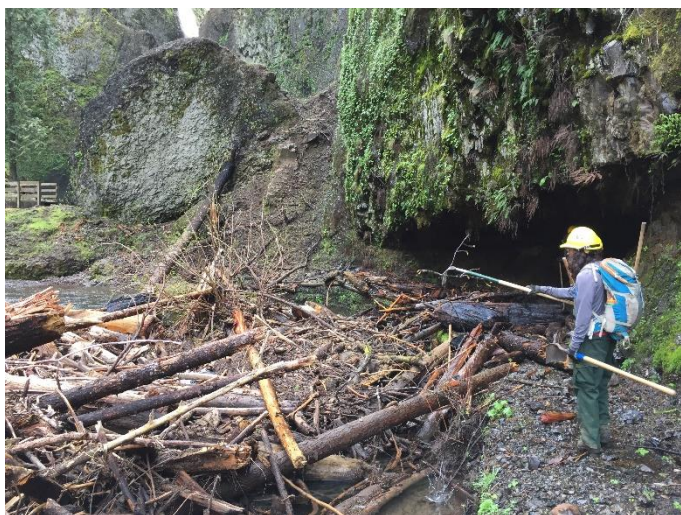
Photo 5 - Crew cleared debris from log jam on east side of trail
