## Willamette and Mt Hood National Forests Burned Area Emergency Response Summary – Beachie Creek Fire October 21, 2020

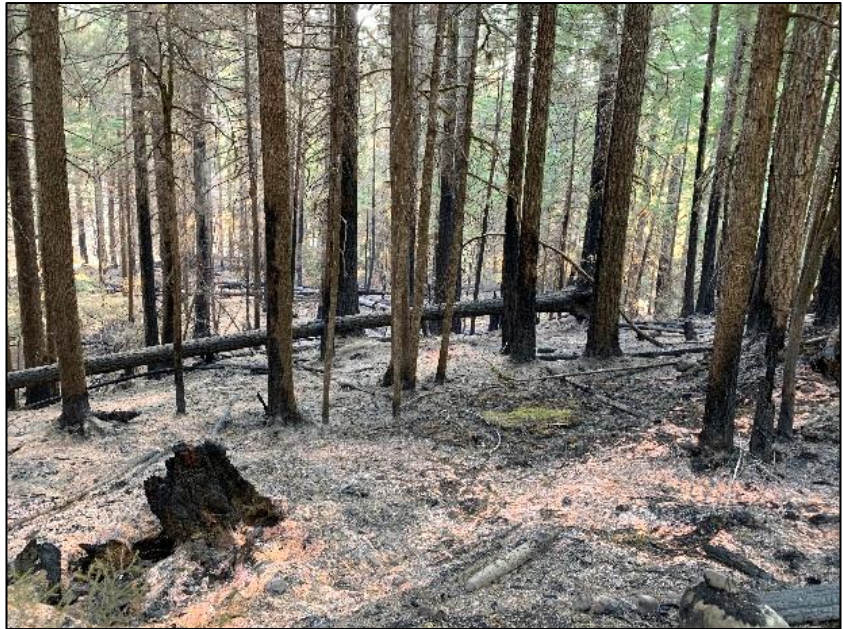
*Figure 1 - Low to moderate soil burn severity with extensive fungal bloom on soil surface, providing natural recovery and stabilization*

Long-term soil productivity was identified as a critical value with a high risk of damage or loss. However, no treatments are prescribed to mitigate impacts. The team completed additional modeling to examine effectiveness of mulch treatments within identified potentially feasible treatment blocks. These treatments were shown to have a nominal effect on total soil loss and sediment delivery (decreases of 0.7 to 1.6 tons per acre for the five-year storm event). Furthermore, two major precipitation events in the past few weeks have already resulted in significant topsoil loss in high-risk areas. Allowing for natural recovery is the recommended course of action.

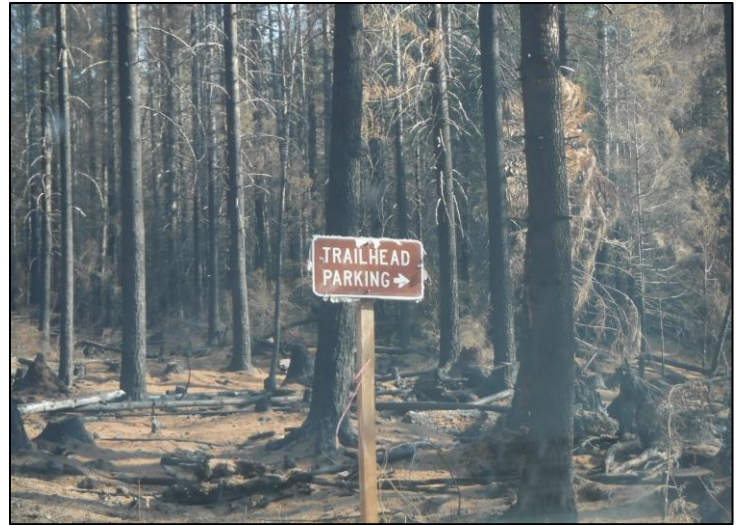
BAER team members observed 31.1 miles of trails of concern (trails within moderate to high soil burn severity areas), 14 trailheads, 3 campgrounds, 3 day-use areas, and a historic guard station. Closures of the areas to prevent the public from entering areas with hazard tree danger and debris flow damage are necessary until hazards can be fully removed or signage can be placed to indicate the hazards present.

*Figure 2 - Burned trailhead within the Beachie Creek Fire*

For the area within the fire perimeter we are suggesting restricting public access until the proper hazard tree mitigation has been completed. Areas that the public will be able to access outside of road closures will be posted with warning signs and hazard trees removed. Every location with restrictions in road access will be closed for the winter and will be reassessed in the spring.

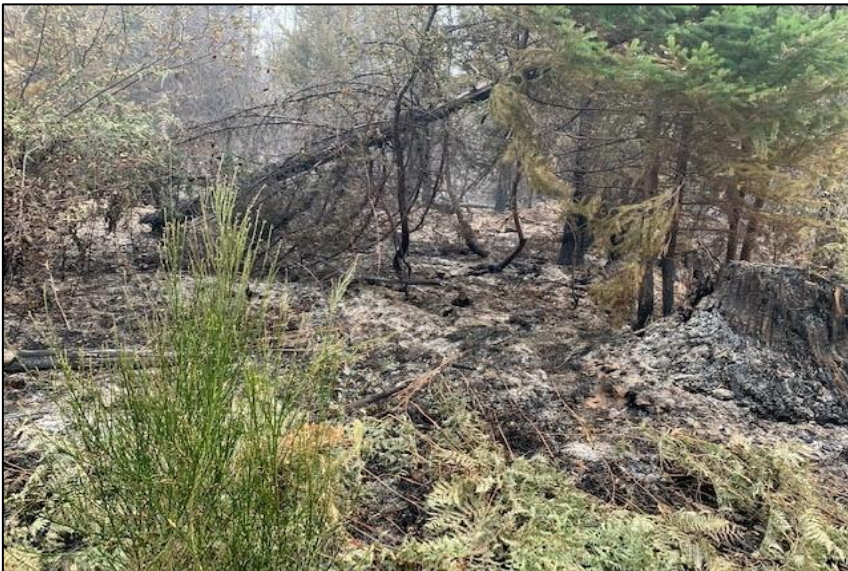
*Figure 3 - Disturbed areas are prime locations for the establishment of invasive weeds*

Native plant communities that were burned at moderate to high severity are threatened by the introduction and spread of noxious weeds. This threat is due to the likelihood that some noxious weed seeds were brought into the area by fire equipment and suppression activity as well as from known noxious weed locations within the area. Several threatened and endangered plant species occur within the burn area including Gorman's aster and several listed species of lichens and fungi. The slow natural regeneration of these native plant communities following

severe burns also leaves some areas at risk, including the Opal Creek Wilderness. Most documented weed populations occur along roadsides and are expected to aggressively compete with native species for space and nutrients in adjacent burned areas. Early detection and rapid response inspections are recommended for approximately 84 miles of roads and 20 miles of trails.
