Resurrection Creek Stream Restoration Project

Completion Report

September 2007

Bill MacFarlane, Chugach National Forest

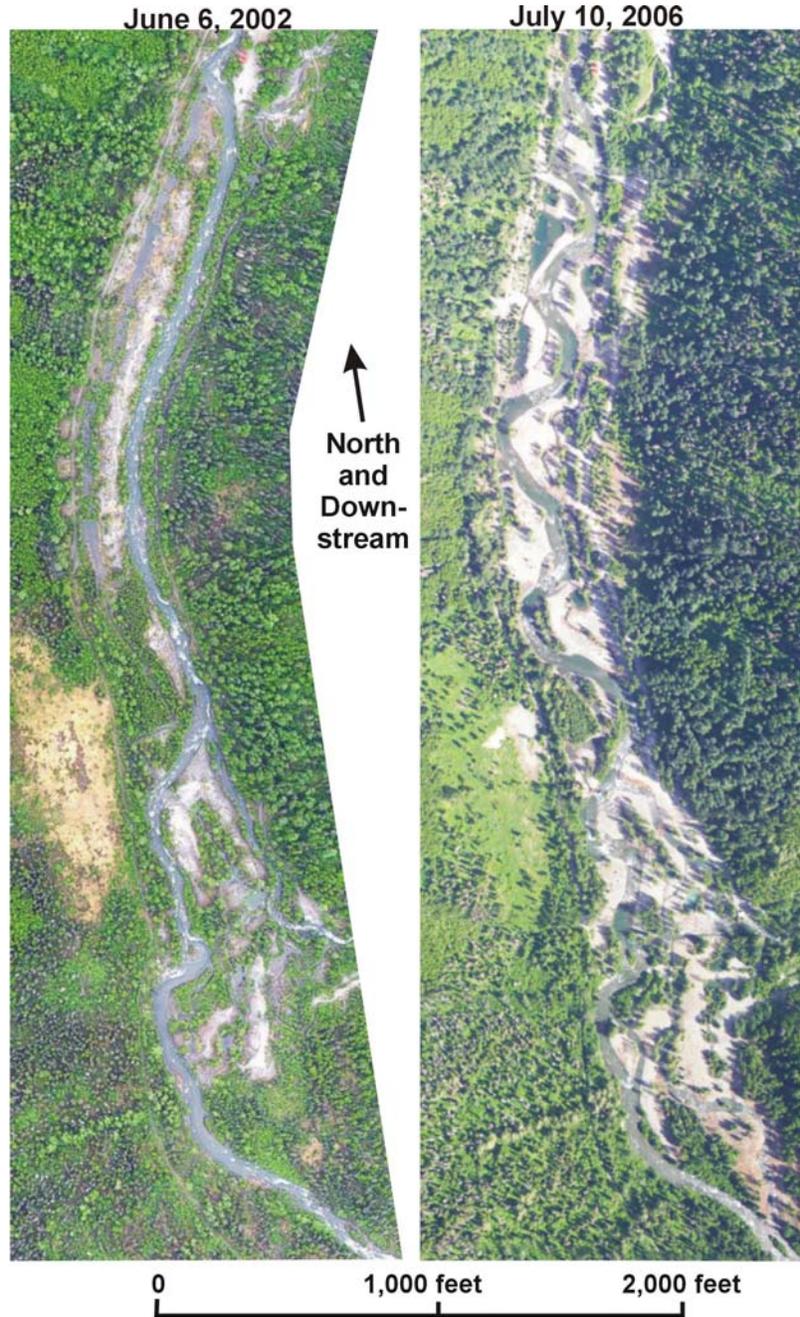
Aerial view before restoration (left) and after restoration (right)

The results of this restoration are very positive. Because of the natural design of this channel and its wide floodplains, the newly constructed channel easily handled flows from an abnormally high snowmelt runoff in June 2006, with minimal bank erosion. The response of the restoration by wildlife is extremely encouraging. Numerous harlequin ducks have moved into the areas around the deep pools that hold fish. All five species of Pacific salmon have been observed in the restored channel and side channels, with nearly 70 chinook, over 4000 pinks, 175 coho, and nearly 100 chums spawning in this reach following restoration in 2006. Vegetation now flourishes throughout the project area while salmon transport tons of marine-derived nutrients to the floodplain and side channels. This one-mile valley reach of Resurrection Creek now displays characteristics of a naturally functioning, self-maintaining ecosystem.

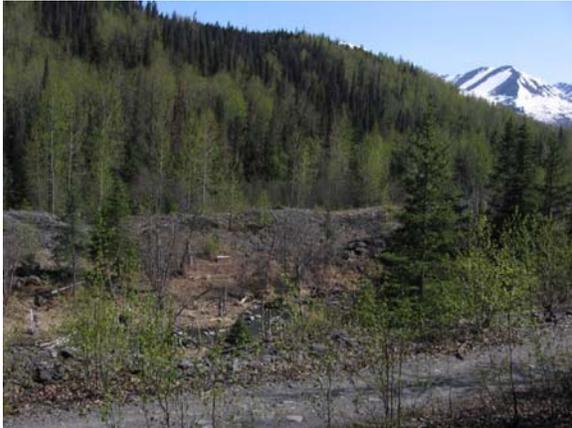
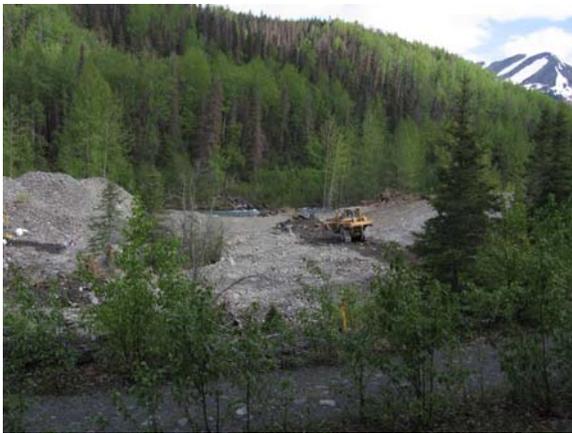
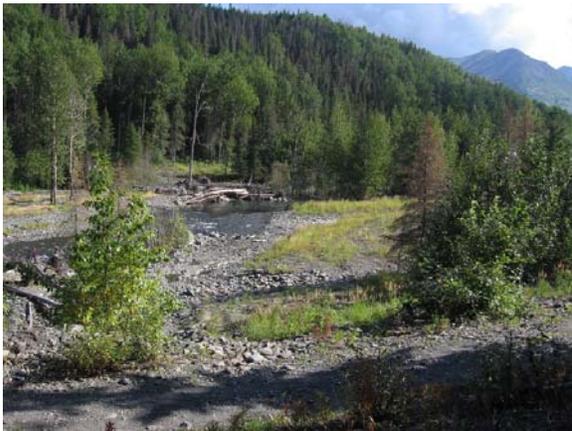
***Photo point sequence at Meander 2:
Top: Before restoration (May 10, 2005)
Middle: During restoration (May 25, 2005)
Bottom: After restoration (August 31, 2007)***

- Redistributed 120,000 cubic yards of tailings piles to develop a new stream channel and floodplain,
- Constructed 5 meander bends with natural pool-riffle sequences, increasing the channel length by 20%, increasing sinuosity, and decreasing average slope,
- Shaped 40 acres of new floodplains,
- Constructed 1 mile of new side channels and side channel ponds for off-channel habitat,
- Spread 5,000 cubic yards of soil and woody debris on the floodplains,
- Placed hundreds of trees into 10 engineered logjams along the channel, and
- Monitored channel morphology, photo points, vegetation, and aquatic species.

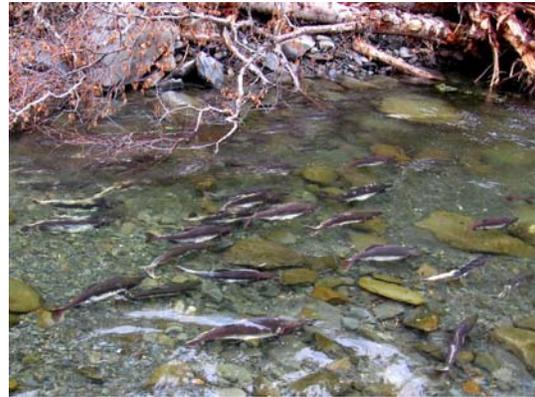
Pink salmon in newly constructed Resurrection Creek side channel (fall 2006)

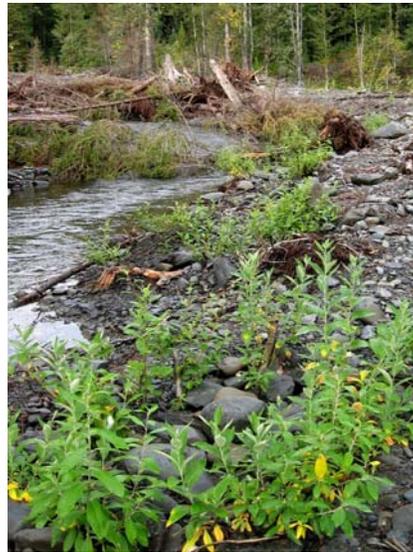
Willow plantings along newly constructed Resurrection Creek side channel (fall 2006).

- Planted about 1000 spruce seedlings, 1800 birch, and 500-1000 sod transplants on the newly created floodplains,
- Planted about 4000 willow stems and 150 feet of sod and willow wraps along the banks of newly created side channels, and
- Monitored channel morphology, photo points, vegetation, and aquatic species.
