## Trail Creek Cedron Bridge Fish Barrier Removal

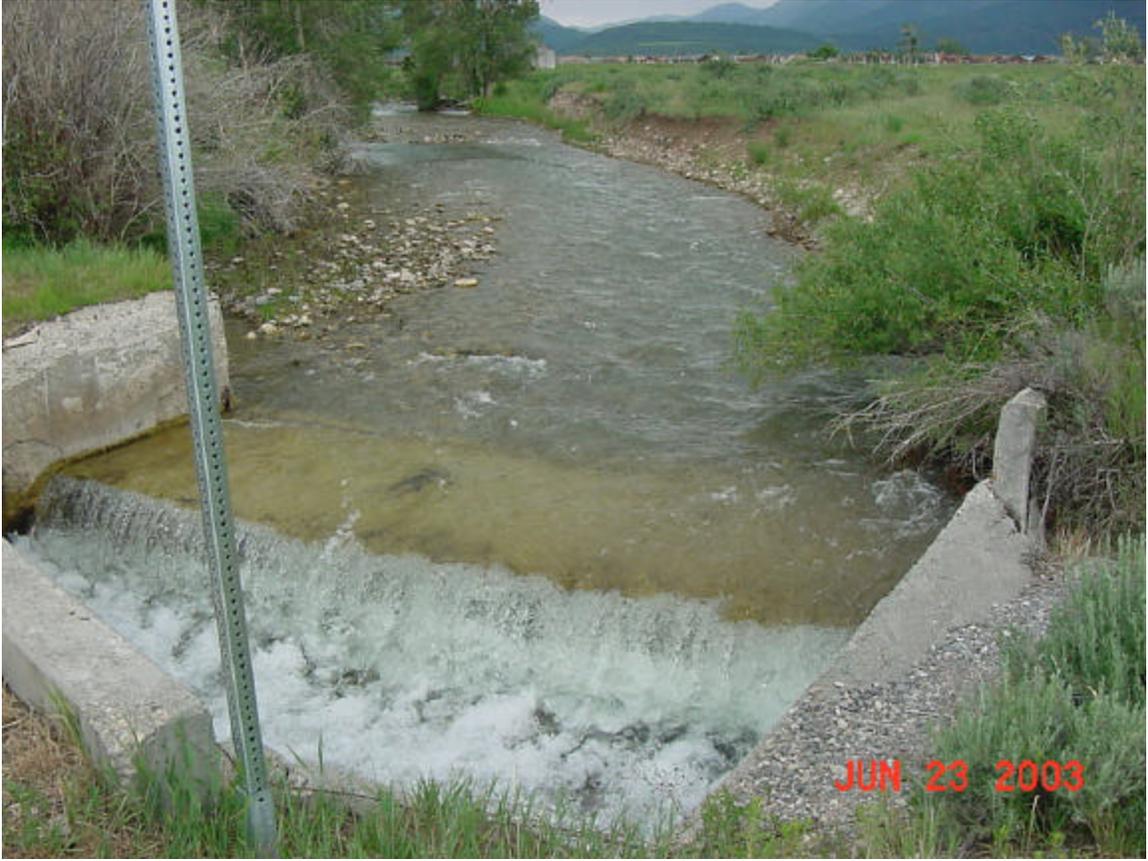
Upstream Barrier before removal

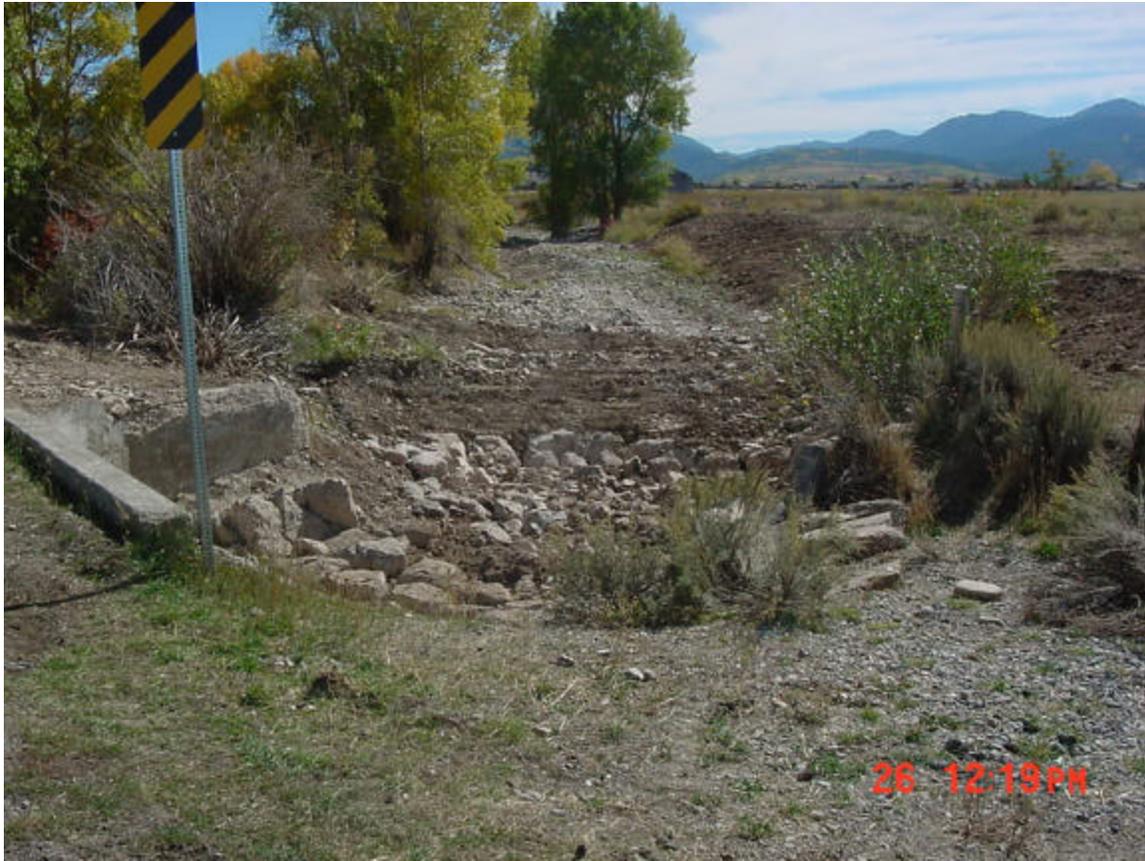
Vertical barrier has been removed. Edges of removed sill and stream bottom were armored with rock. Two rock weirs were constructed one is visible in middle of photo and the other is buried level with present stream bottom. Complete sloping of bank done.

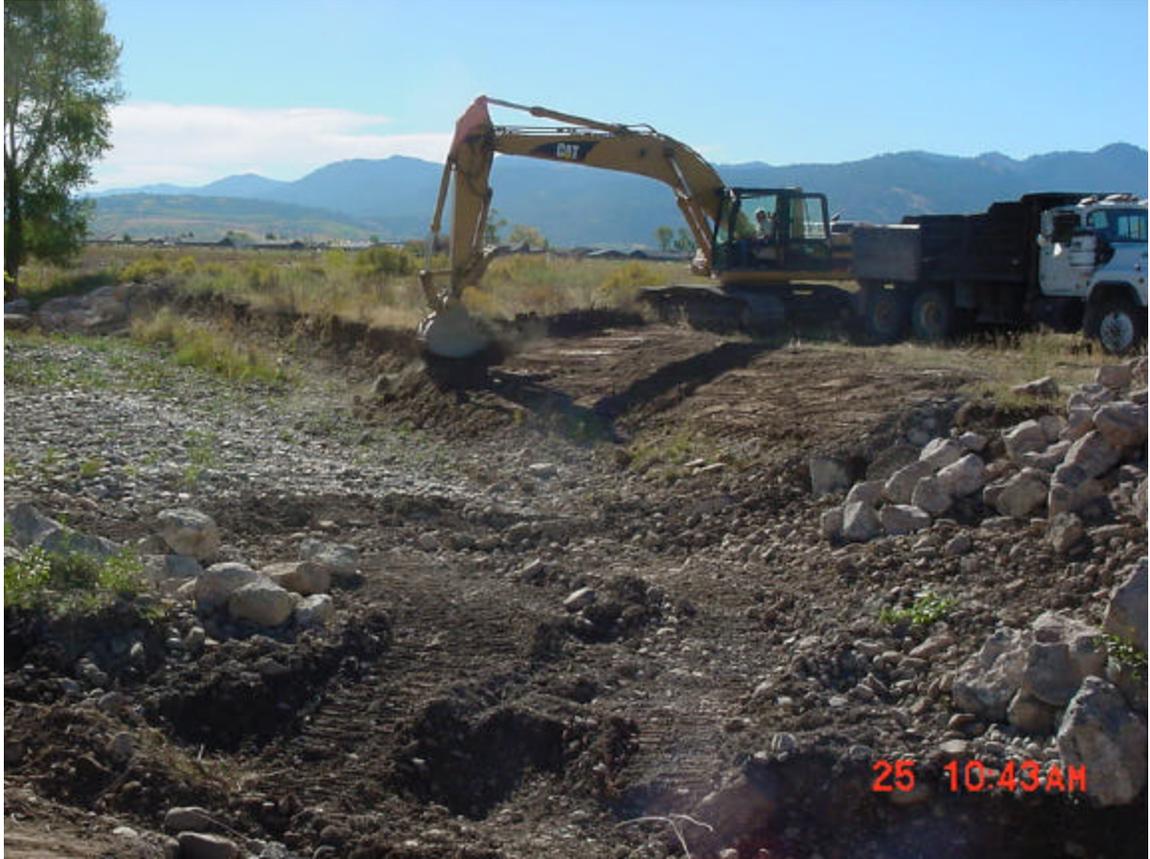
Vertical bank was sloped back at bankfull level and seeded to encourage cottonwood establishment.

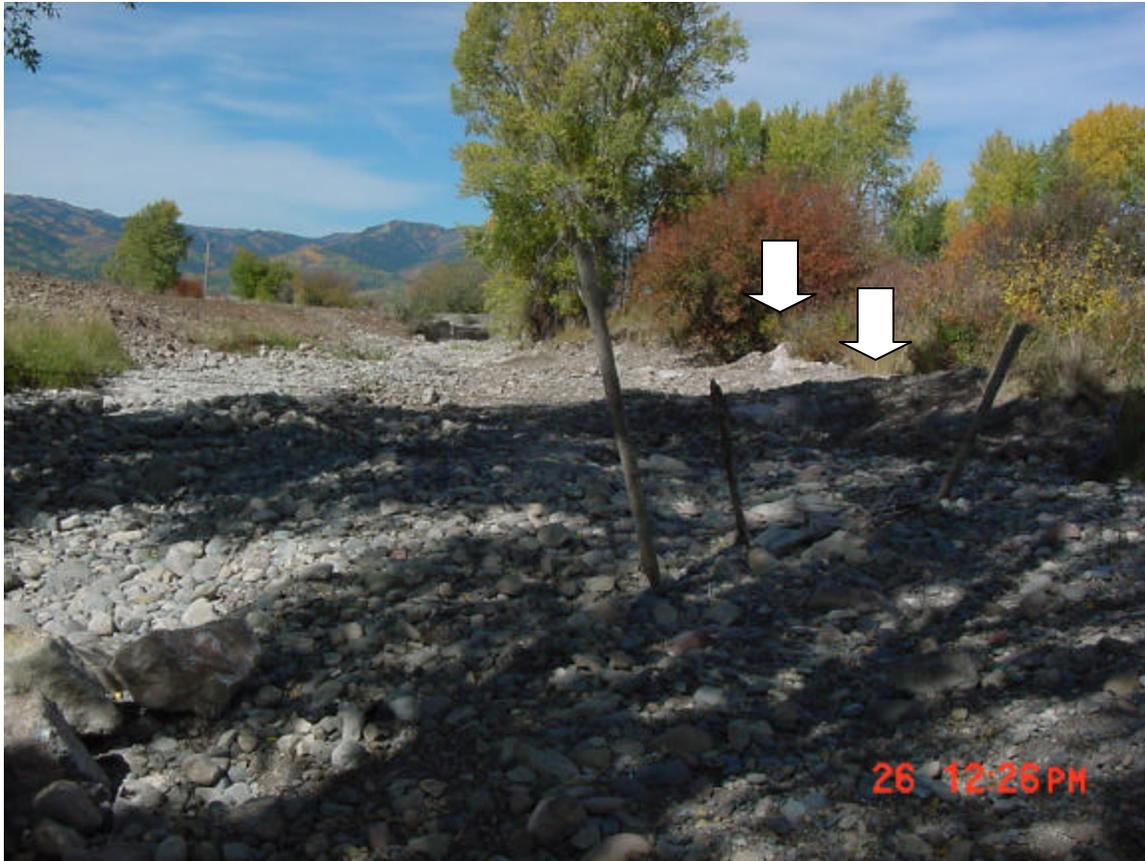
Two upstream barbs were placed per desires of the county. These were placed as an addition to the stream alteration permit based on a phone conversation I had with the army corp. of engineers. The intent of these barbs is to remove forces from the outer banks and decrease erosion and long-term threat to the road.

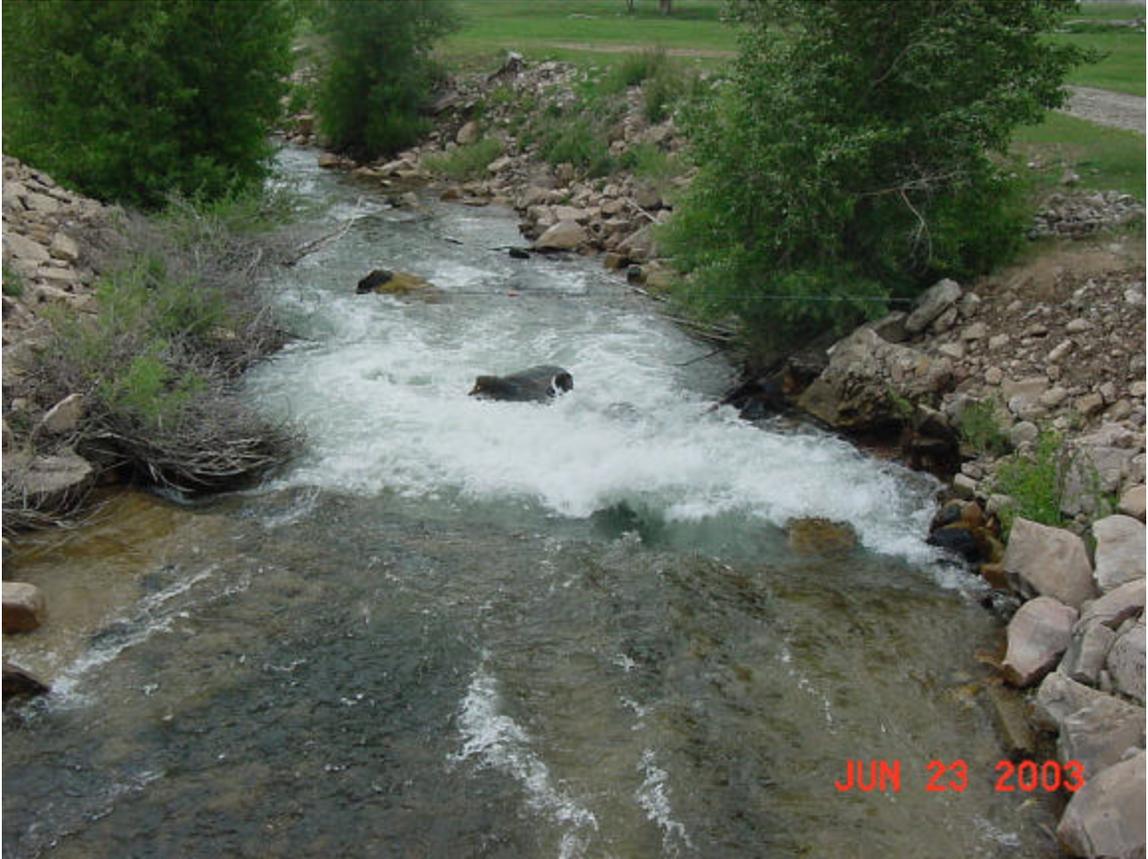
Lower channel pre-project.

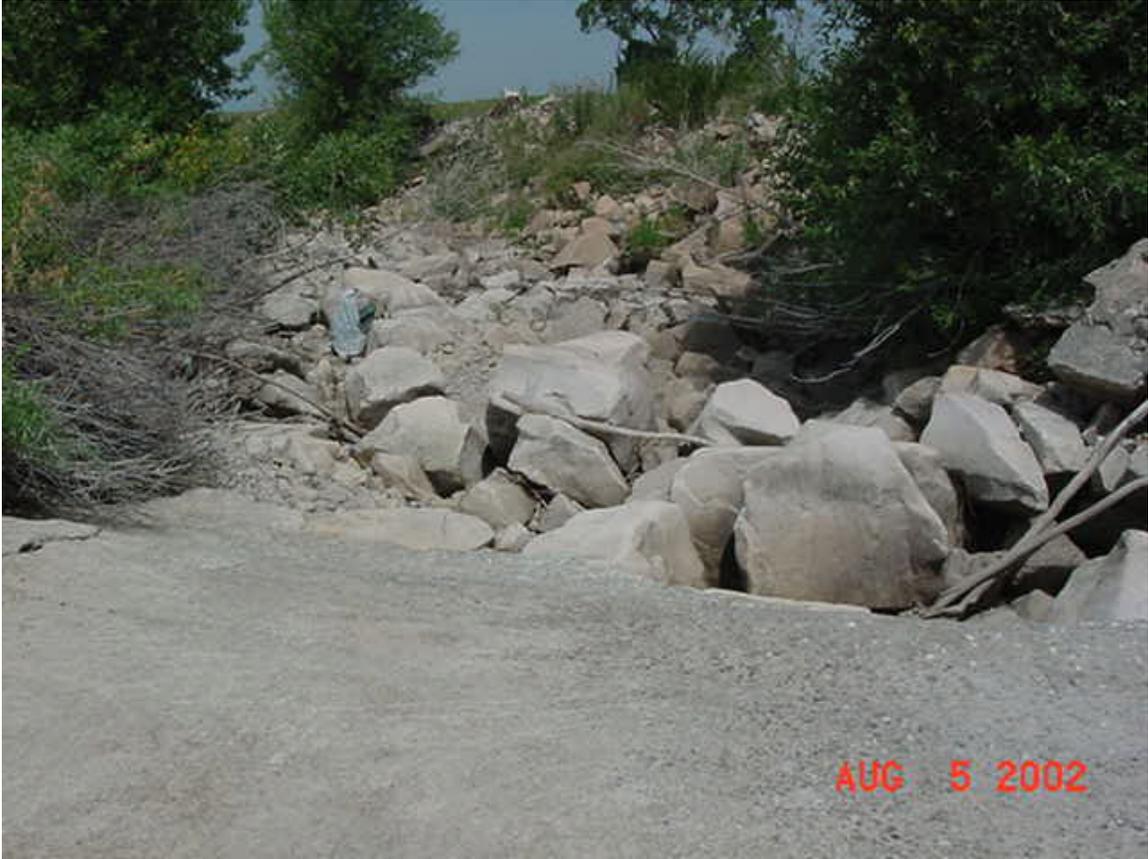
Lower channel pre-project

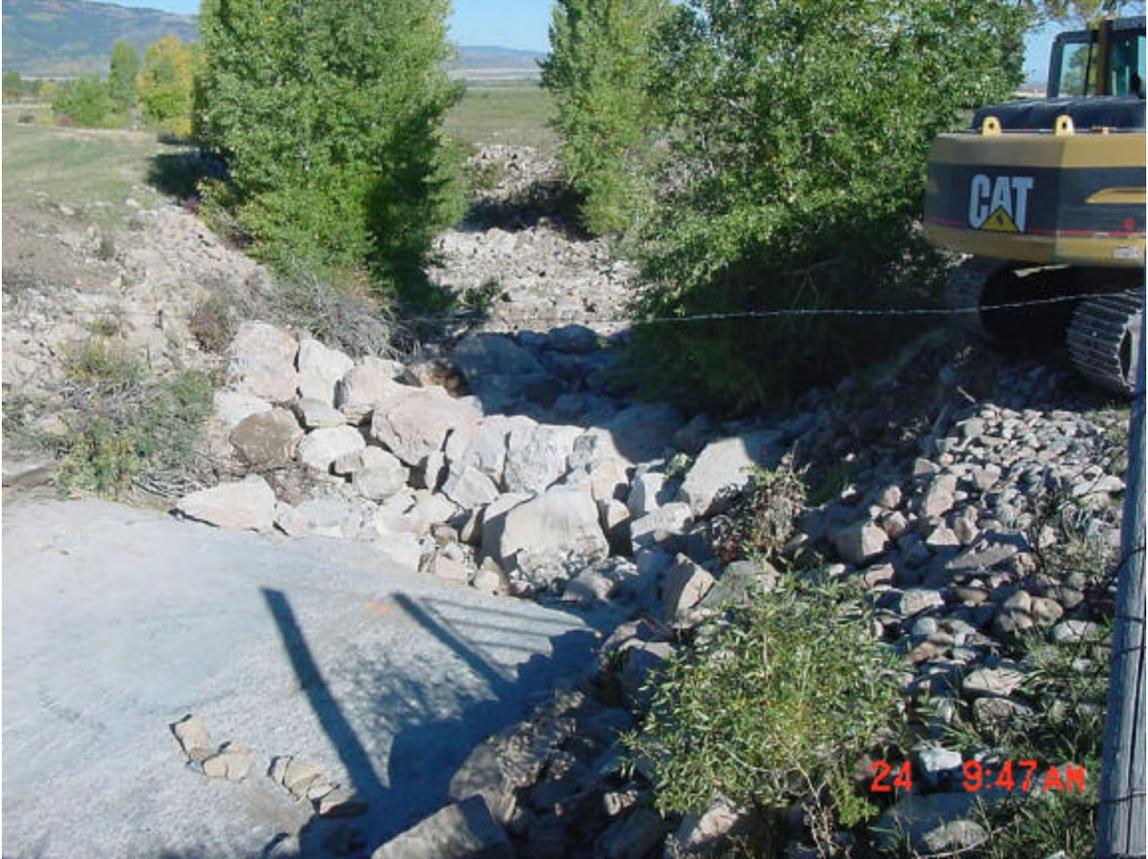
Lower Channel – mid construction.

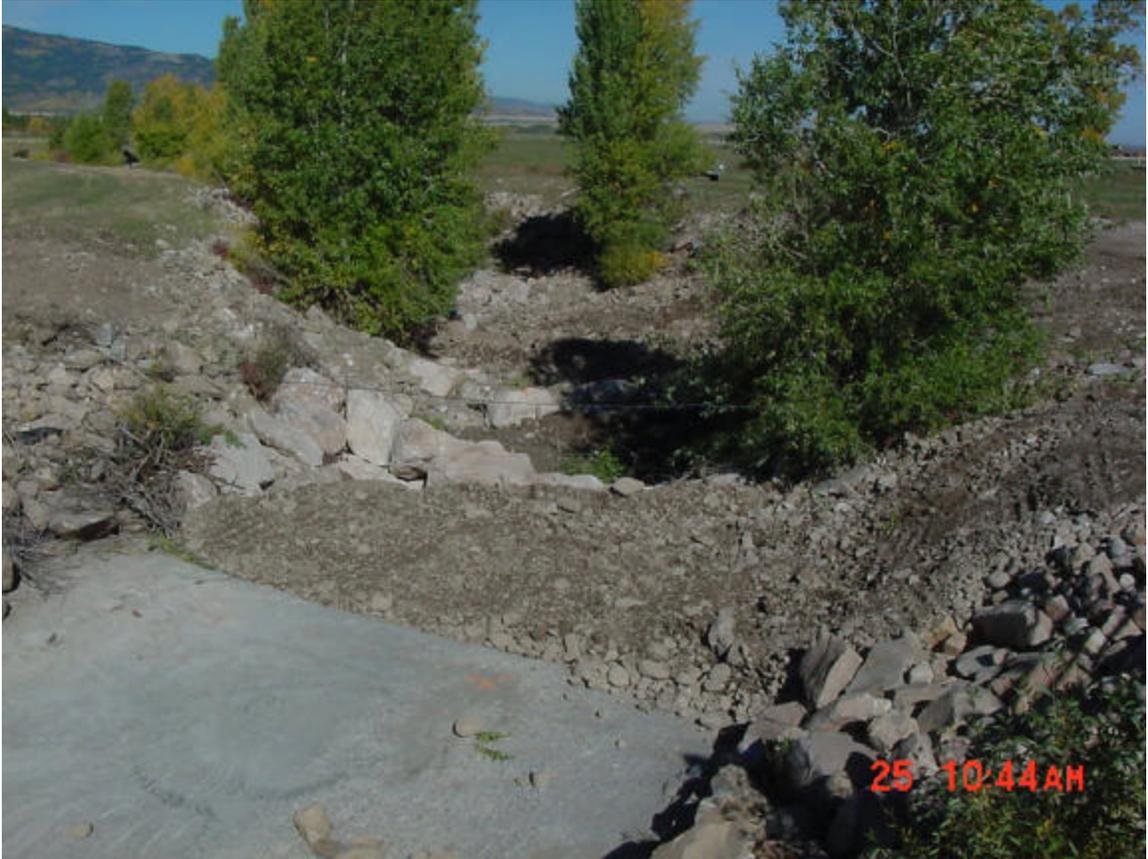
Lower channel post construction of 4 weirs
