Trails and Public Access Options

Theoretical Inundation due to Lake Level with Swale 1 Excavated

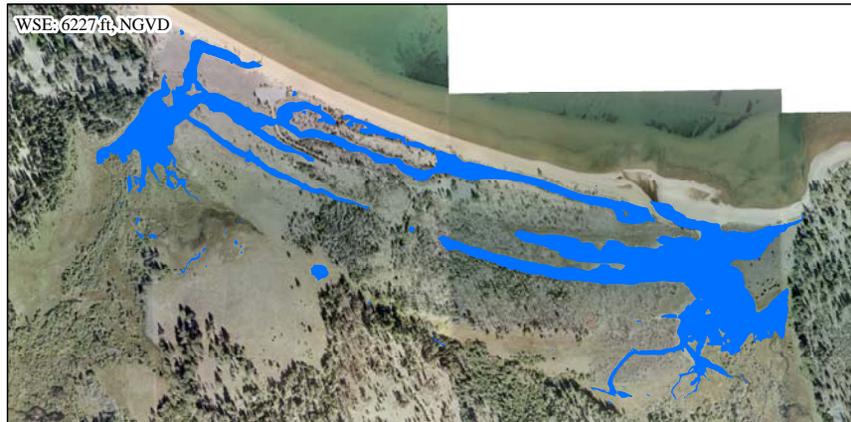
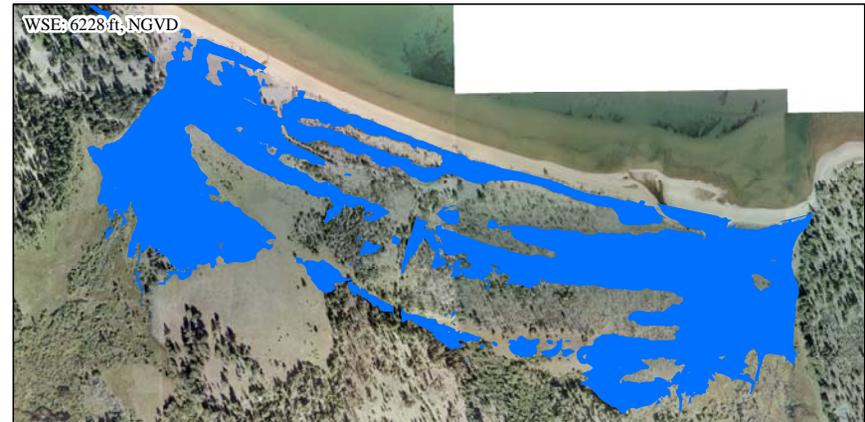
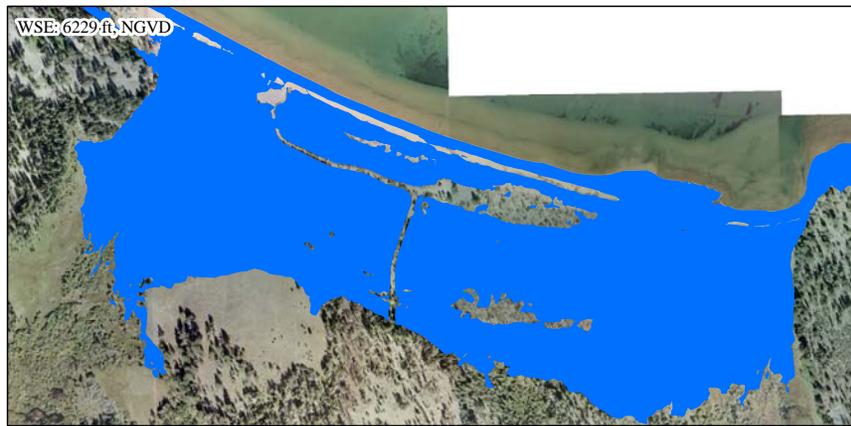
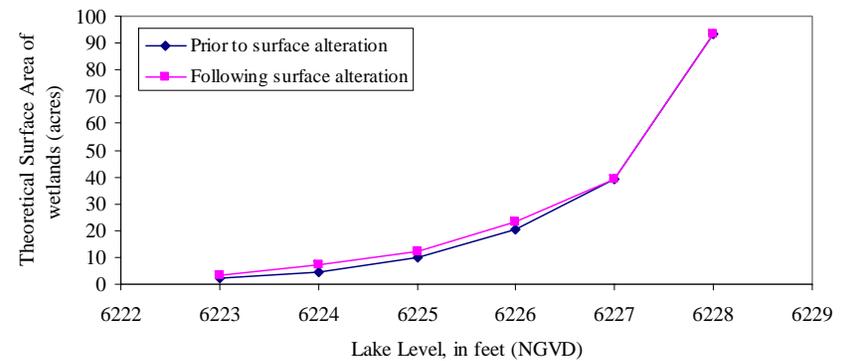
EXHIBIT 7.5-2

Theoretical Inundation due to Lake Level with Swale 1 Excavated

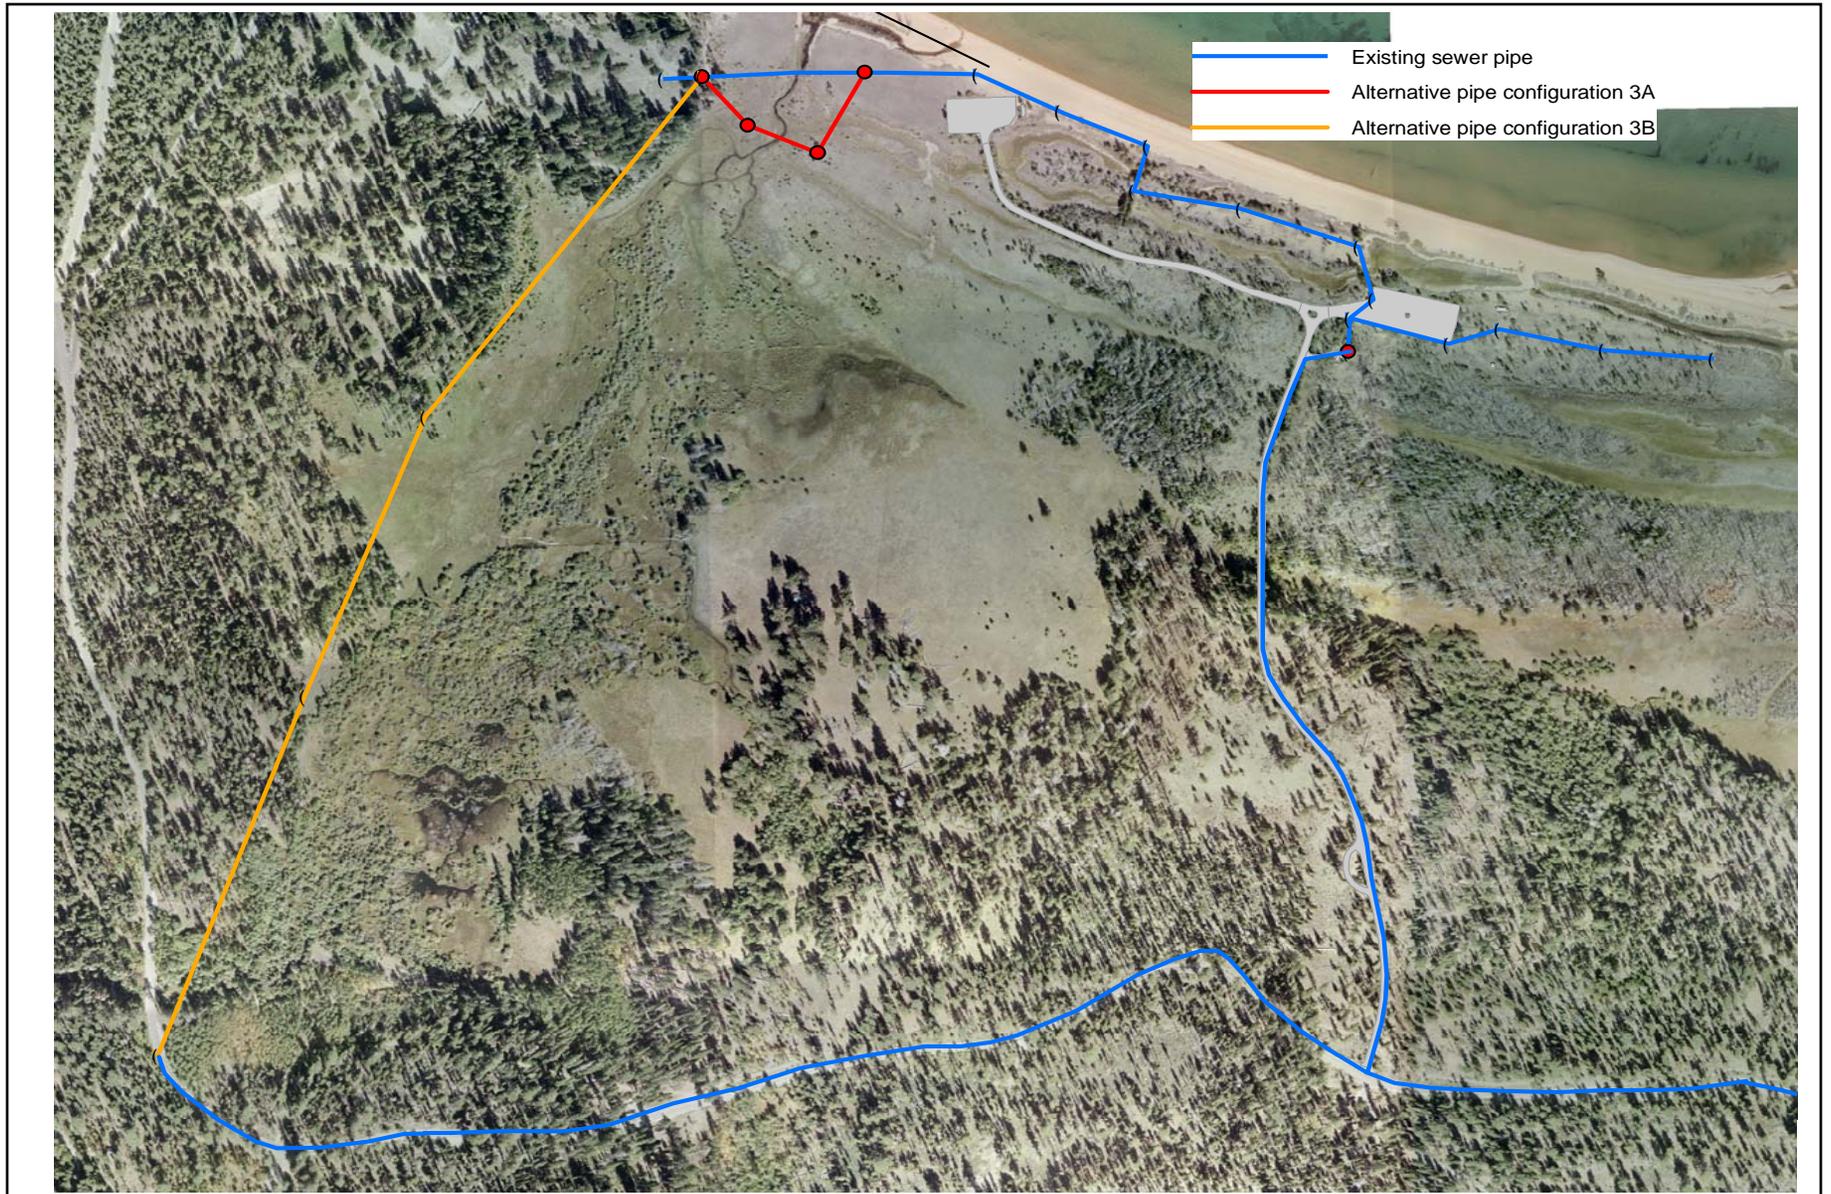
EXHIBIT 7.6-1

Sewer Pipe Realignment Alternatives

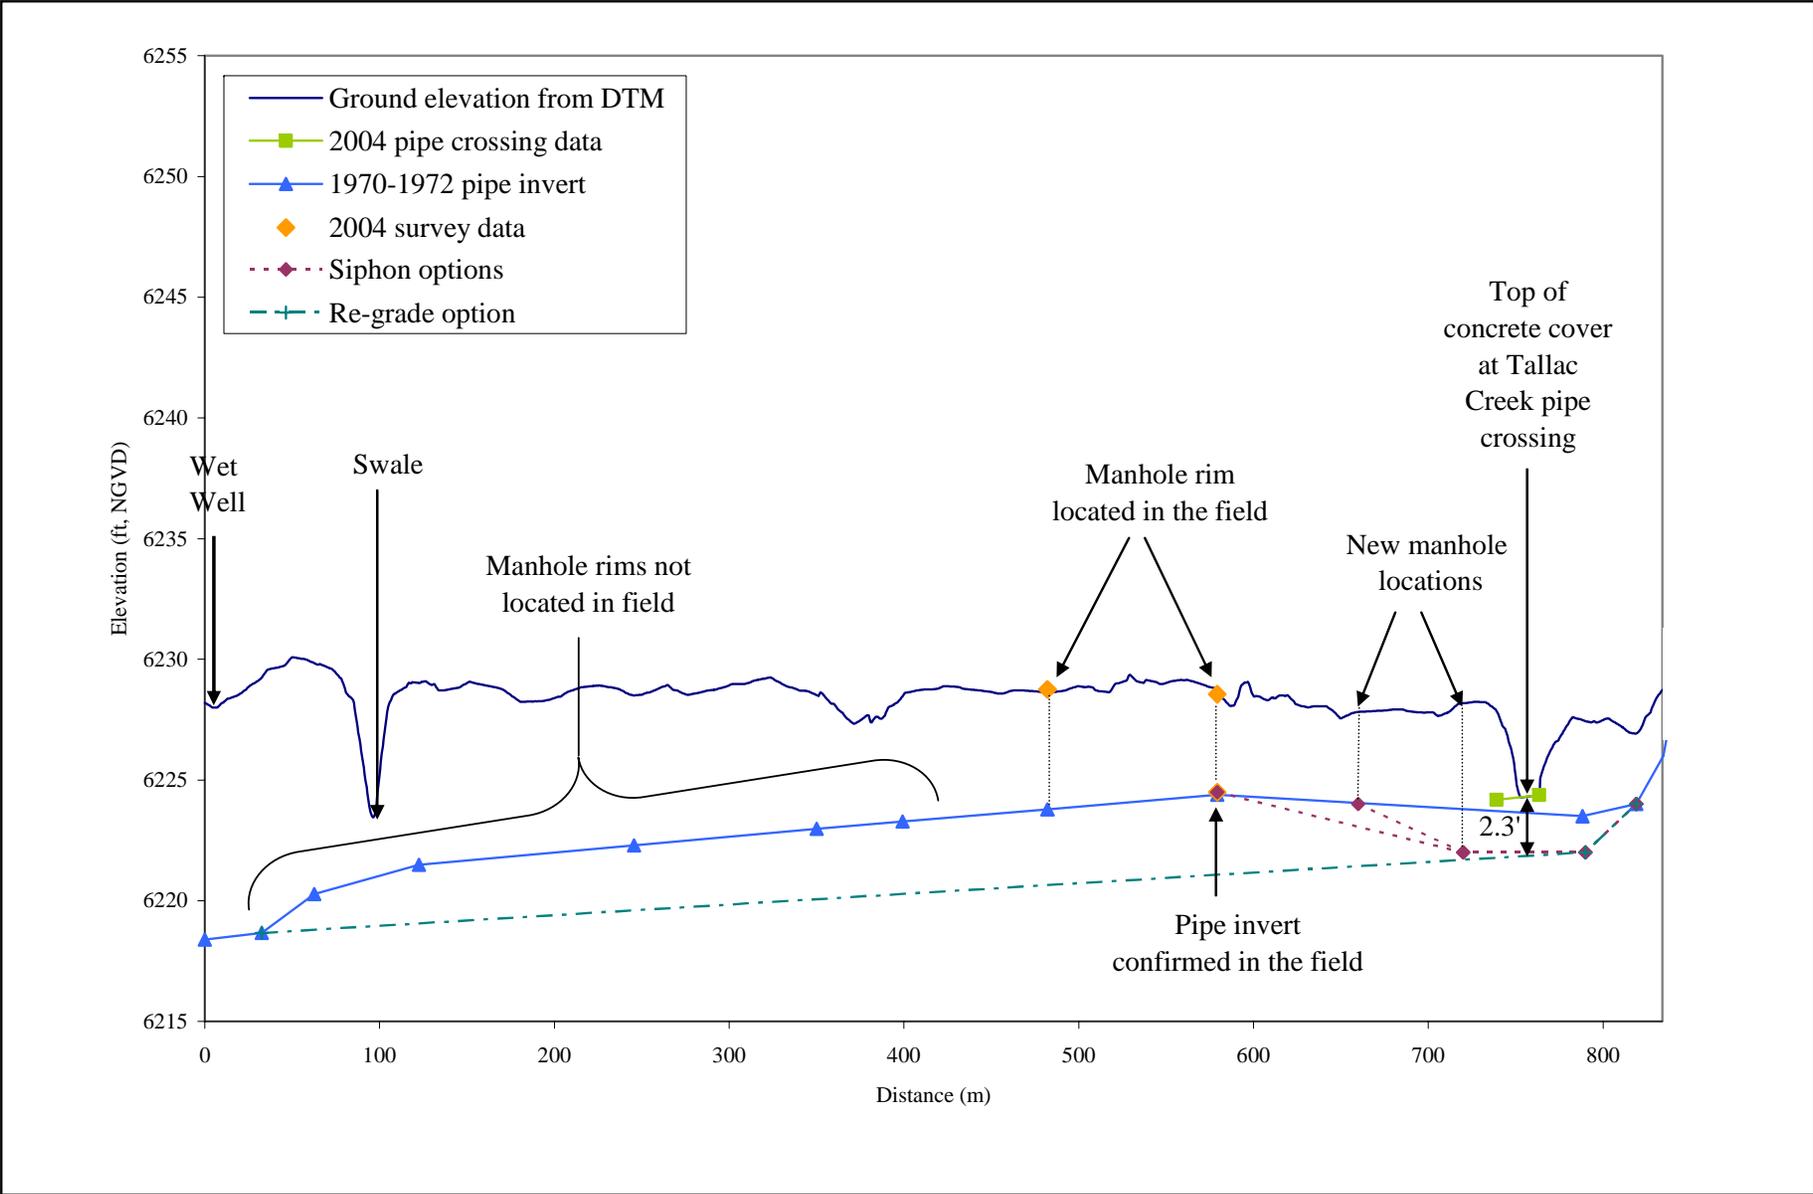
Sewer Pipe Longitudinal Section
