Mr. Lider, following are the U.S. Forest Service responses to your 18 May 2015 comments on the Explanation of Significant Differences/Removal Action Memorandum and the Workplan/Design Drawings for the Comprehensive Environmental Response, Compensation and Liability Act (CERCLA) Removal Action to be implemented at the Monte Cristo Mining Area (MCMA).

#### **Hazardous Waste Repository Area**

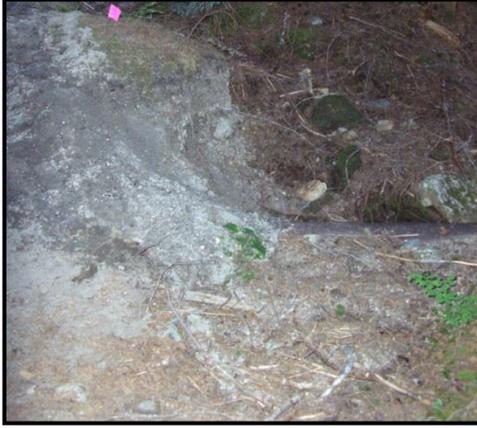
**Contaminated surface material at the Lower Concentrator, which contained total arsenic at about 127 times the natural background**

R55. The Concentrator has obvious areas devoid of vegetation as shown in the photos below:

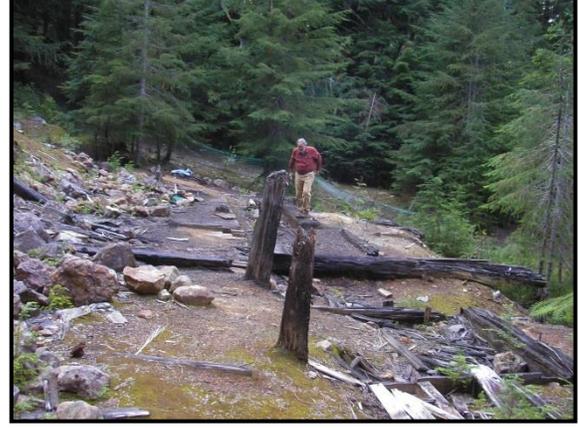
**Upper Concentrator also devoid of significant vegetation, duff, or soil deposition. This area contained total arsenic at a concentration about 145 times the natural background**
