USDA-FOREST SERVICE

OREGON FIRE BURNED-AREA REPORT
(Reference FSH 2509.13)

- A. Fire Name: Oregon Fire
- B. Fire Number: Oregon = CA-SHU-007763
- C. State: CA
- D. County: Trinity
- E. Region: 5
- F. Forest: Shasta-Trinity
- G. Districts: Trinity River Management Unit

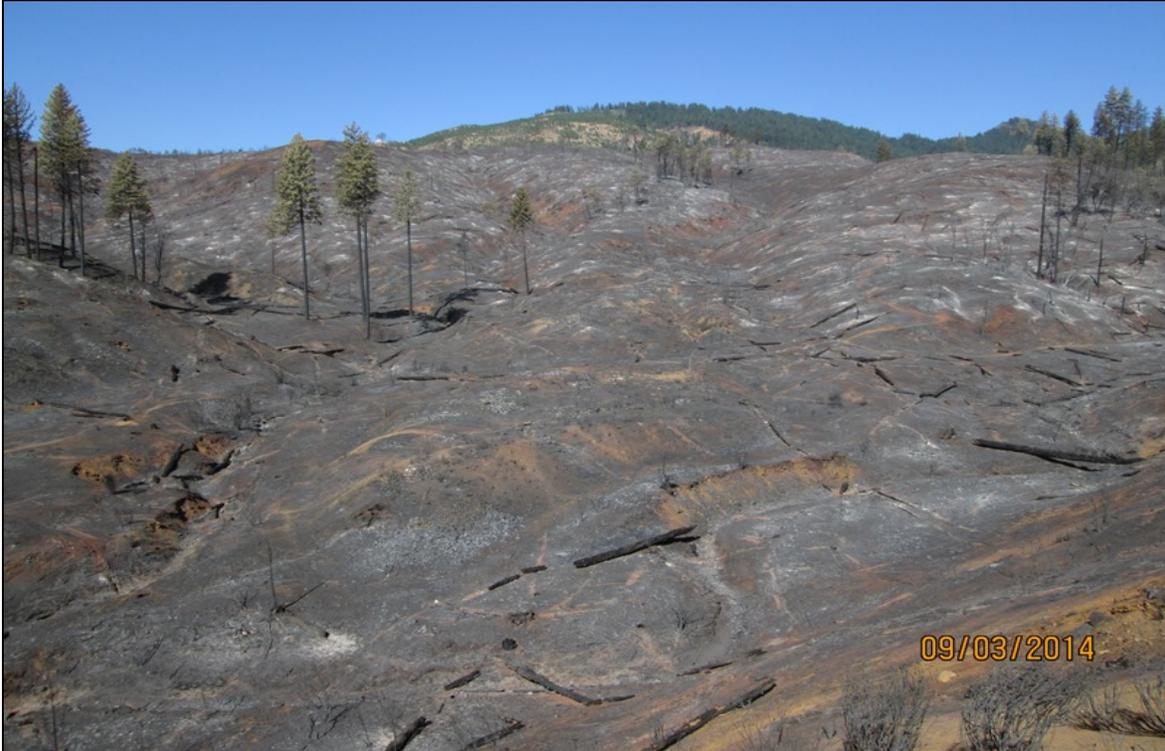
The Oregon Fire of 2014 looking into McKenzie Gulch area reburned since Oregon Fire of 2001.

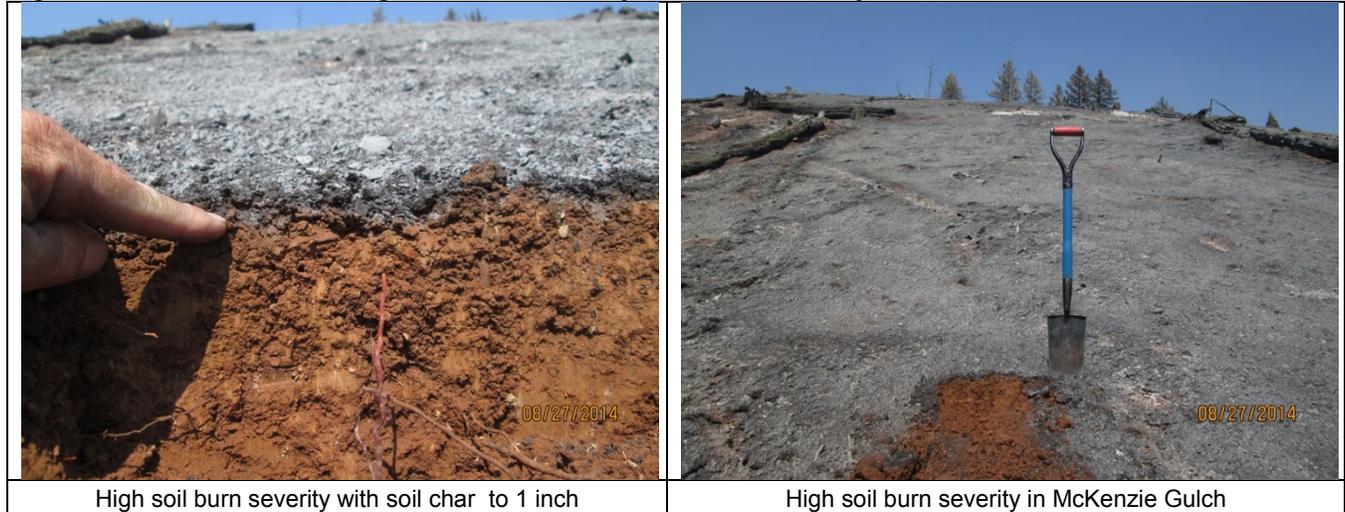
Figure 1 – McKenzie Gulch high soil burn severity in red Forbes clay loam soil

Approximately 40% burned at high and moderate soil burn severity (see soil burn pictures above). The rest of the fire was either low or very low soil burn severity (see below soil burn severity map). It is very important to understand the difference between *fire intensity* or *burn severity* as discussed by fire behavior, fuels, or vegetation specialists, and *soil burn severity* as defined for watershed condition evaluation in BAER analyses. Fire intensity or burn severity as defined by fire, fuels, or vegetation specialists may consider such parameters as flame height, rate of spread, fuel loading, thermal potential, canopy consumption, tree mortality, etc. For BAER analysis, we are not mapping simply vegetation mortality or above-ground effects of the fire. Soil burn severity considers additional surface and below-ground factors that relate to soil hydrologic function, runoff and erosion potential, and vegetative recovery.

Particular area of concern is located northeast ¼ of section 2 into section 1. This area is a Forbes soils in the headwaters of McKenzie Gulch a tributary of Sidney Gulch (see cover picture). The area in the past was hydraulically mined. Several small area slides existed in the drainage system prior to the fire. All vegetation including an existing conifer stand was 100 percent killed and in-channel structures projects are proposed for this area to curb anticipated erosion.

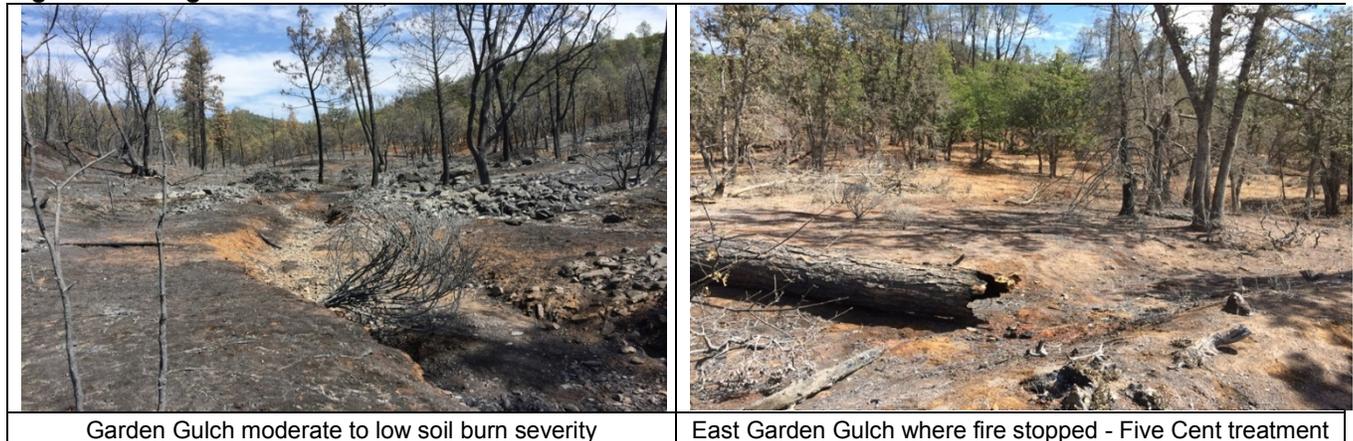
Figure 2 – Oregon Fire eastside soil burn severities

Pictures below show Garden Gulch mixed mortality due to the fire stopping at the 5-cent fuels treatment on the east side of the Oregon fire.

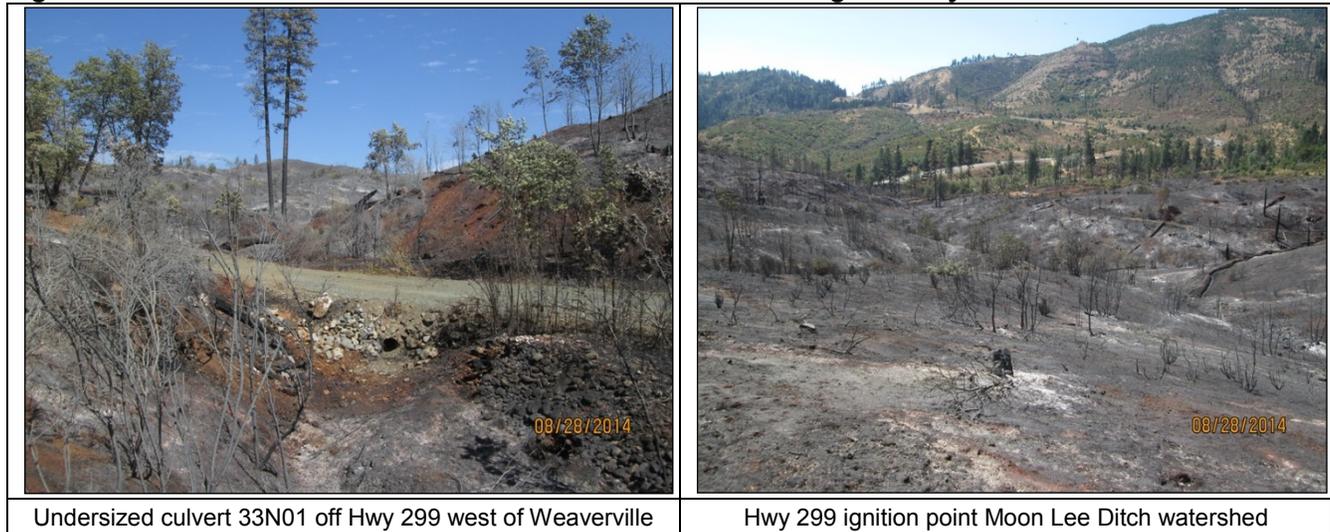
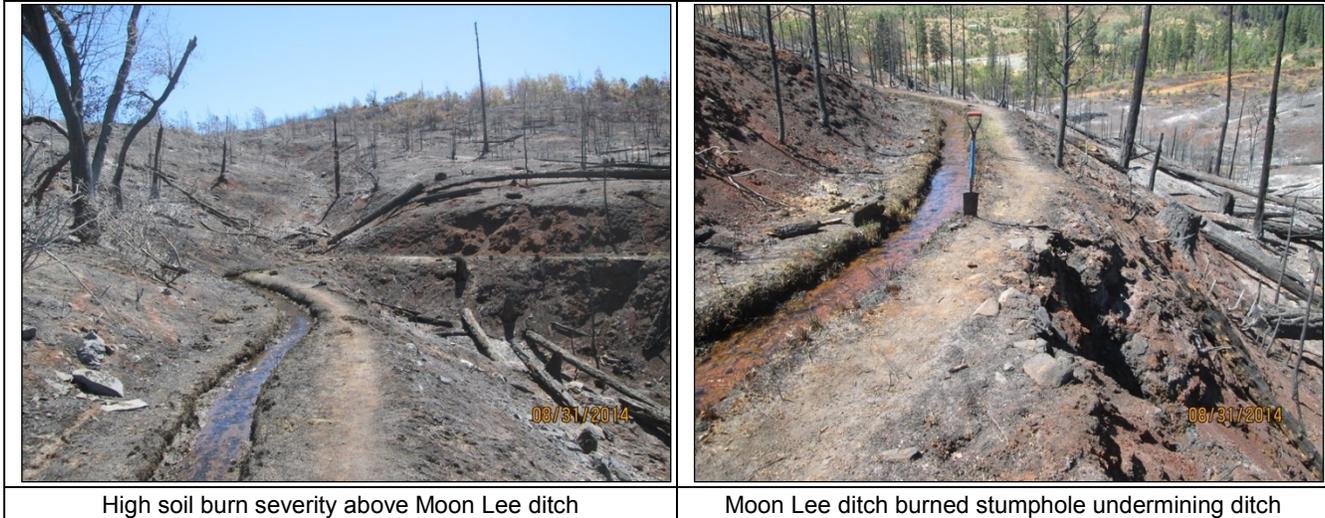
Figure 3 – West Weaver Creek area of Moon Lee Ditch and fire origin at Hwy. 299

High soil burn severity above Moon Lee ditch

Moon Lee ditch burned stump hole undermining ditch

The fire burned with high intensity the area in and adjacent to the Moon Lee Ditch (see pics above). This ditch is a diversion off of West Weaver Creek initiating on USFS land in the NW $\frac{1}{4}$ of section 2 and moves onto private ownership land in the NE $\frac{1}{4}$ of section 11. Just north of the section line common to sections 2 and 11 an underground piped diversion off the ditch belongs to the Weaverville Community Services District which feeds a holding tank and water treatment system. During the six month warm season period, demands for water increase and this system provides ten to fifteen percent of the towns domestic water supply, where the remaining water (in the open ditch) services 17 private ownerships with water rights. Water rights for all users exist prior to 1866. The primary water user off the open ditch is the Weaverville Cemetery. The ditch is a registered historical site. After consultation with FS Special Uses, only portions of the ditch system are under permit and most either predates the need or is currently not under permit. The portions in section 11 have been historically maintained by the private ownerships. It is unclear exactly who has responsibility for maintenance on USFS ownership although the Weaverville Community Services District has performed emergency repairs as needed in the past. The Proposed BAER treatments are listed below in the Treatment Narrative for 2,215 feet of USFS lands only.

The Moon Lee Ditch is a historic feature dating prior to 1860 and a primary domestic and irrigation source for the town of Weaverville. Moon Lee Ditch is a diversion off West Weaver Creek servicing Weaverville water demands. The ditch was directly damaged by intense fire as was the adjacent area and associated watershed draining into it. Moon Lee Ditch hillsides and ditch structures were severely burned and areas of the ditch are undermined by burned out trees making the ditch susceptible to extensive damage from hillslope erosion.

Straw bale check dams with rock dissipators are proposed in treatment area 4. The purpose of a small straw bale check dam with rock dissipators is to temporarily capture sediment in the upper reaches of stream channels. Wood or rock is used to dissipate the overflow of water on the downstream side of each dam and to provide a longer term storage capacity once the straw has decomposed. Straw dams have been proven effective in similar burned areas. The dams are effective at catching sediment in the first two years after the fire and allow the sediment to be metered out at a lower rate in subsequent years. This treatment will be used above the Moon Lee Irrigation Ditch and selected locations in McKenzie Gulch.

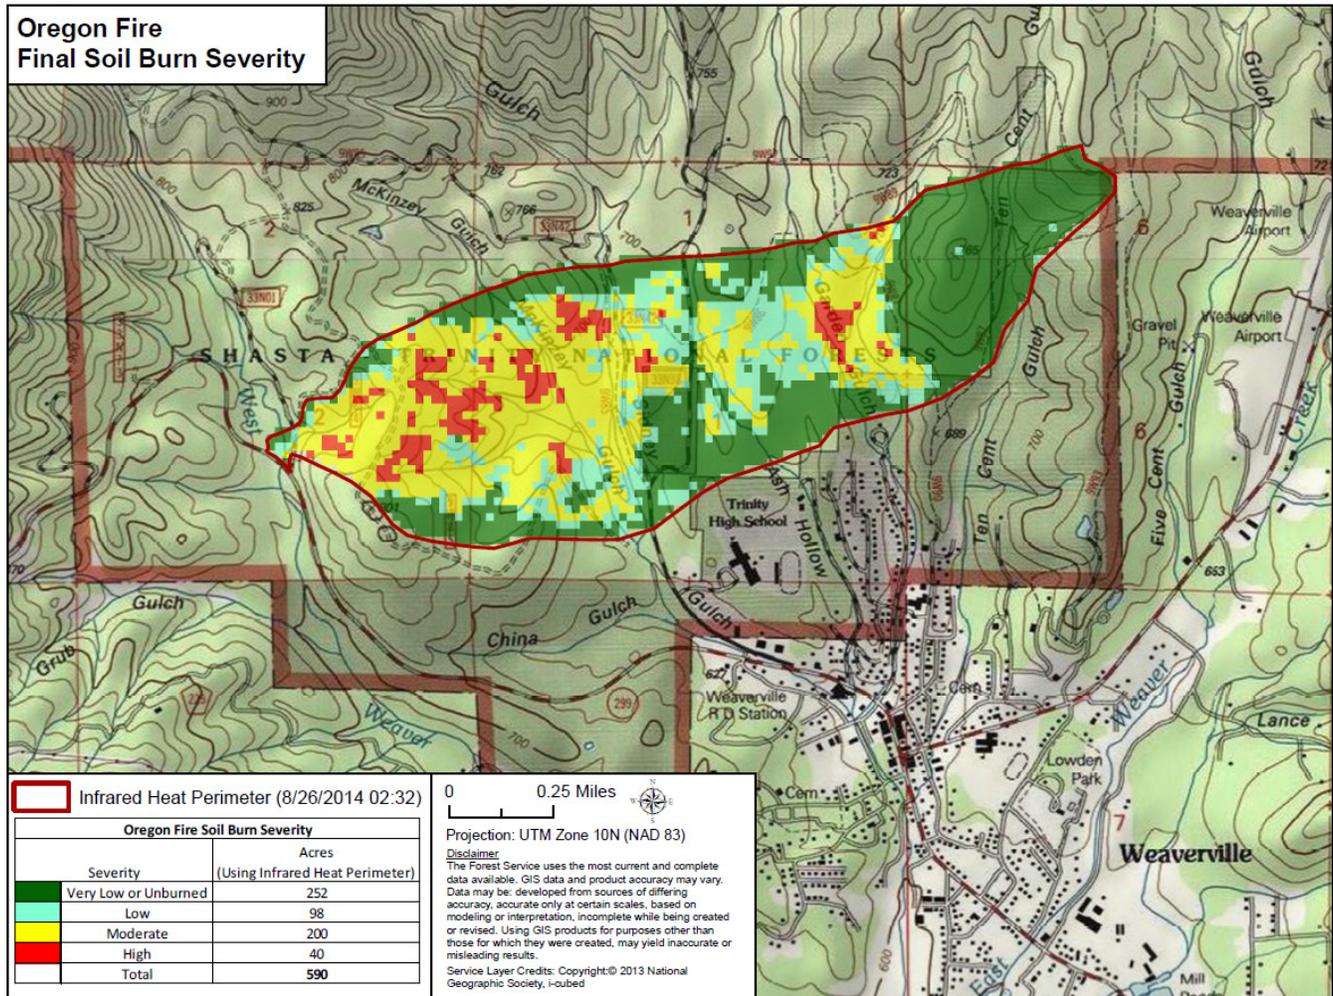
Oregon Fire Soil Burn Severity Map:

Twenty soil burn samples were taken in the field to confirm the soil burn severity mapping (see Appendix E). Looking at the soil burn severity maps below shows the majority of soil burn severity was moderate to low east of Sidney Gulch. Areas that burned the hottest were the west portion of the fire above West Weaver Creek, McKenzie and Sidney Gulches. This was due to heavy accumulations of dead and down timber left from the Oregon fire of 2001.
