Bear Run Riparian Project

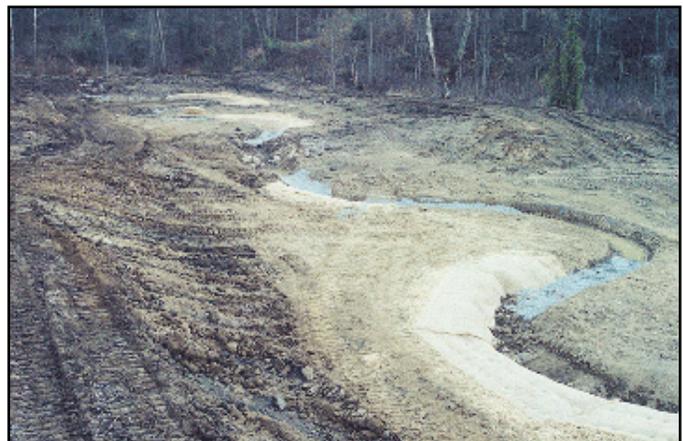
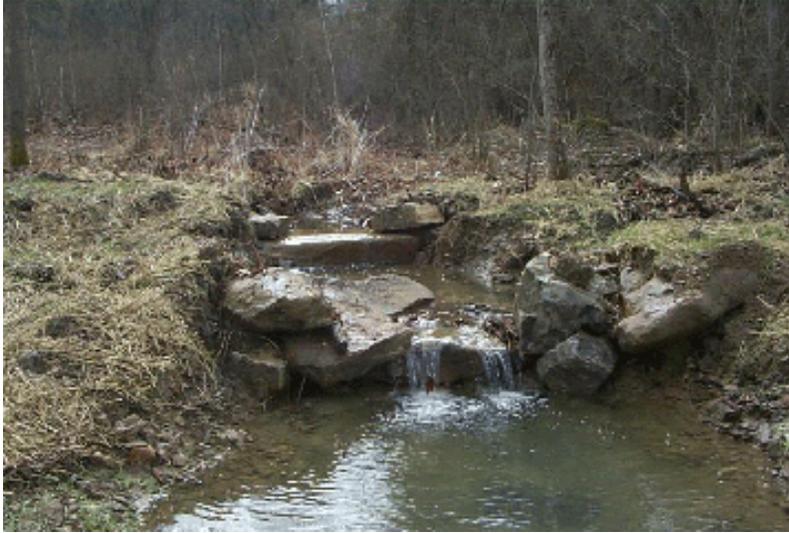
The construction phase shown here demonstrates the restoration of natural meanders in the stream bed. Some of the channel was lined with jute matting (below)

to provide bank stability during storm events until natural vegetation was established.

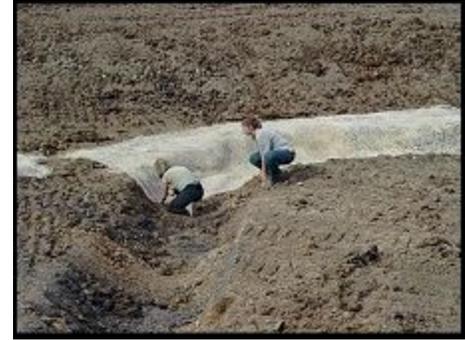
The restored channel has numerous pools as seen in the picture above which host aquatic life and provide water sources for wildlife.

Restoration using natural channel design incorporates the natural meanders, depth, width, and floodplain a stream should have. This design leaves a stream stable and maintenance-free as well as immediately able to provide quality habitat for fishes and other organisms.

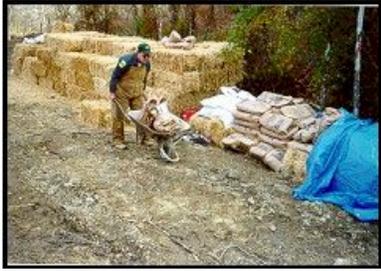
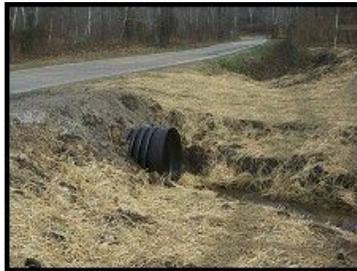
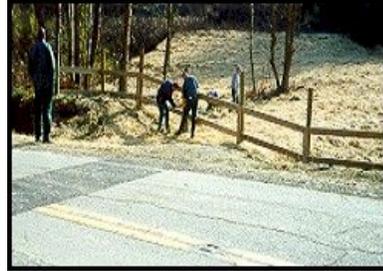
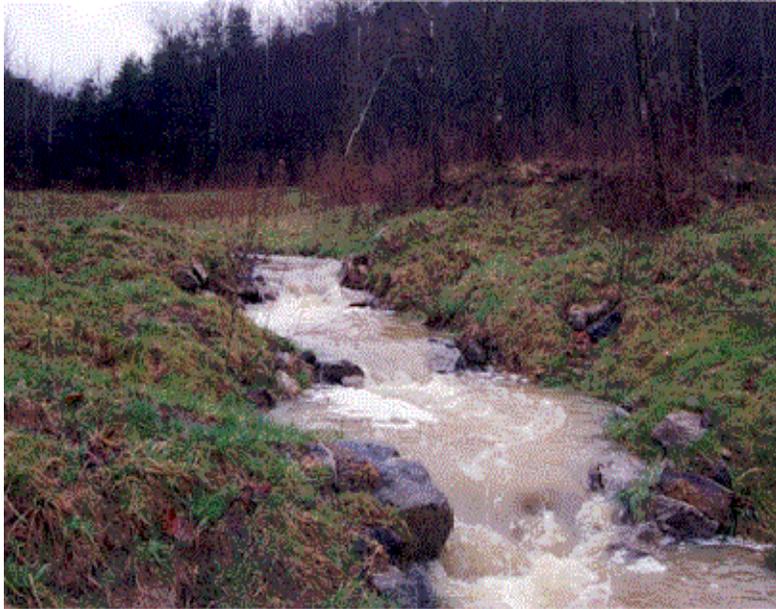
Shown below are various stages of the project as the area was seeded and mulched. Today a lush growth of vegetation covers the site. A fence was built to eliminate illegal ORV traffic from accessing the site and a larger culvert was installed by ODOT to provide for fish migration from the main stream.

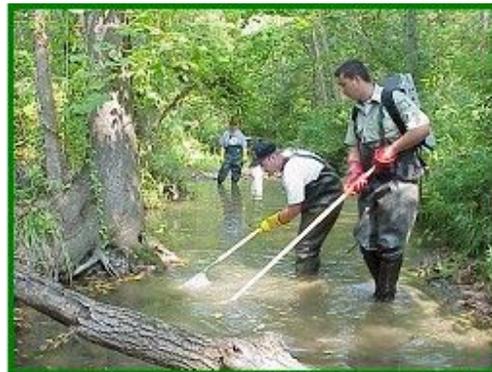
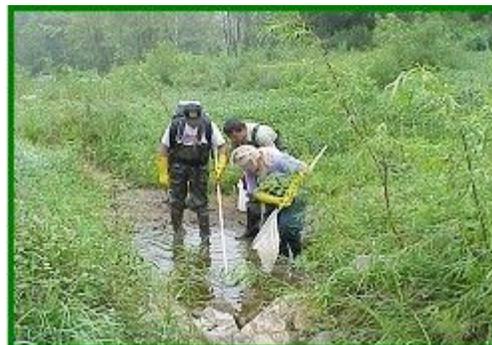
Technicians from the Ironton District recently surveyed the stream channel for fish species. They used electro-fishing, a practice that gently stuns the fish and causes them to come to the surface. Proper use of electro-fishing does not injure the fish and allows us to easily record the different species. In the short stretch of Bear Run tributary they surveyed, 123 fish were found. The fish represented 5 different species, including Creek Chub, Pumpkin Seed, and Greenside Darters.

The fish had migrated into the channel during storm events. Monitoring reveals that creek chubs and southern redbelly dace are reproducing in the new channel in 2001.
