GULCH FIRE BURNED-AREA REPORT
(Reference FSH 2509.13)

- A. Fire Name: Gulch Fire
- B. Fire Number: CA-SHF-1144
- C. State: CA
- D. County: Trinity
- E. Region: 5
- F. Forest: Shasta-Trinity

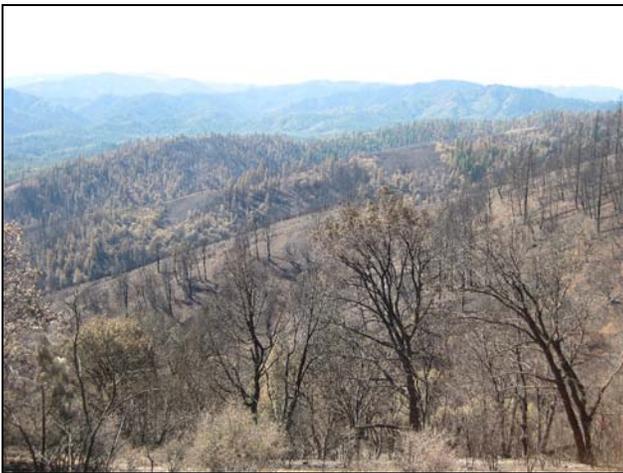
Gulch Fire East-facing slopes with mixed timber mortality

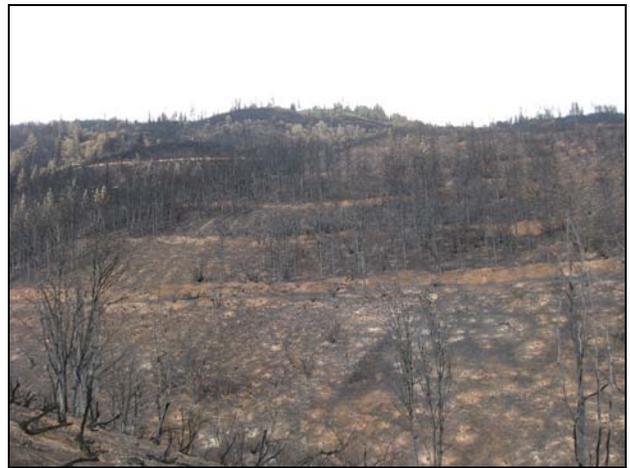
Gulch Fire South-facing slopes with total plantation mortality

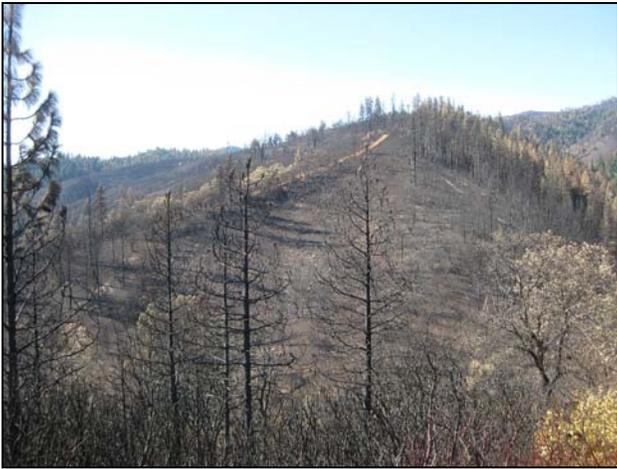
Chaparral areas had moderately high to high soil burn severities and most vegetation removed.

Gulch Fire South-facing burned brush fields

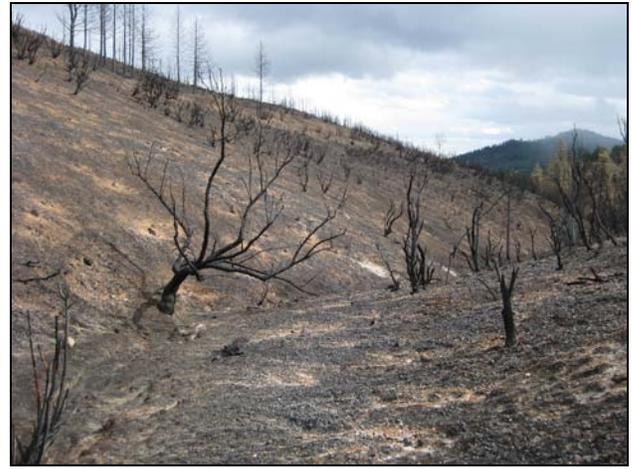
Gulch Fire South-facing high soil burn severity

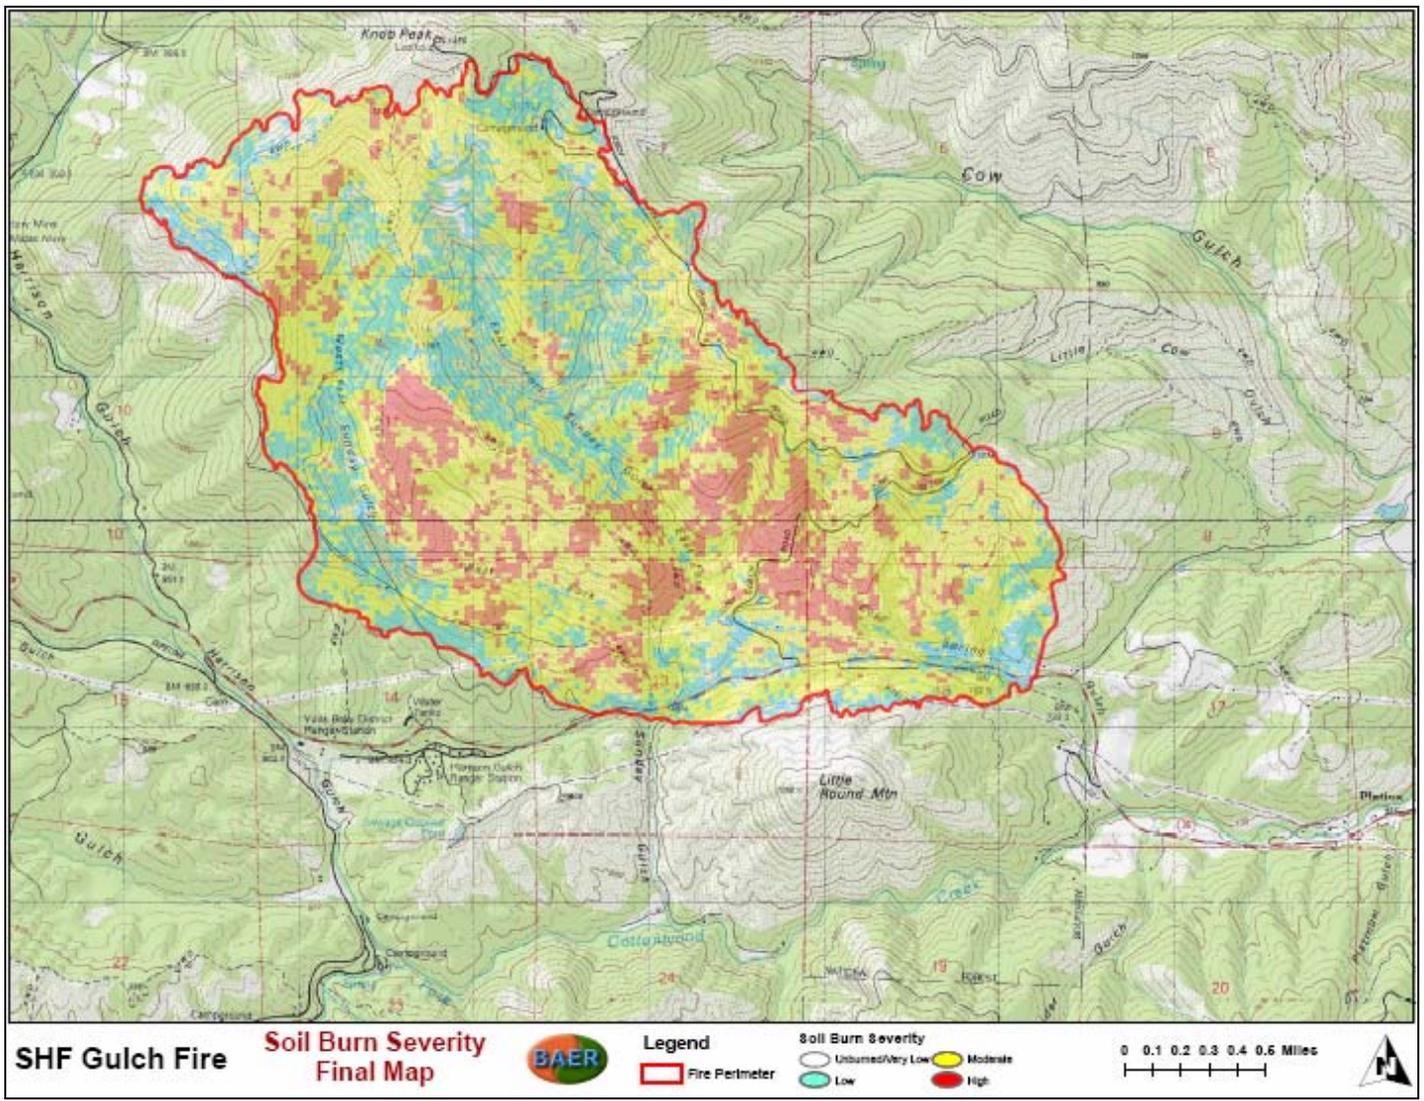
Gulch Fire Soil Burn Severity Map:

A. Burn Severity by total and FS (acres): 882 (31%) (low) 1,479 (52%) (moderate) 512 (18%) (high)

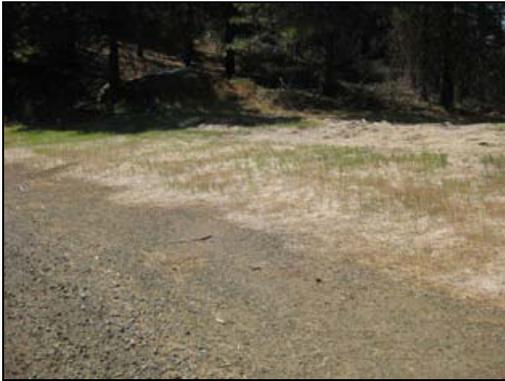
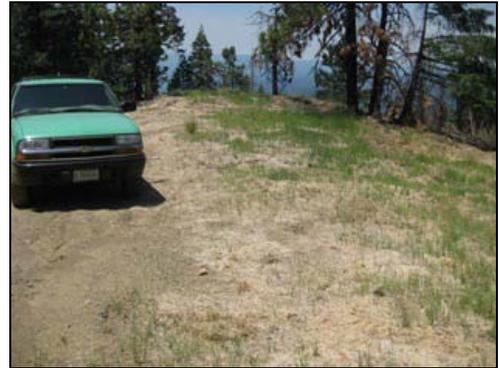
- Completed all noxious weed treatments of seeding and mulching firelines intersecting main roads throughout the Gulch Fire area.

Noxious weed treatments of seeding and mulching the last 50 feet of fireline intersecting main roads will be employed to stop weed infestations. Noxious weed detection survey on firelines for introduced weeds due to suppression will consist of detection, handpulling and bagging. Areas found to be too large for bagging will be treated by hired handpulling crews.

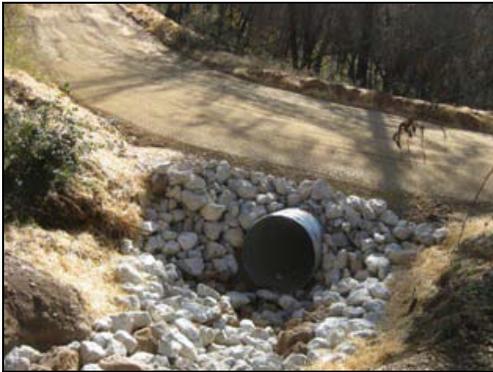
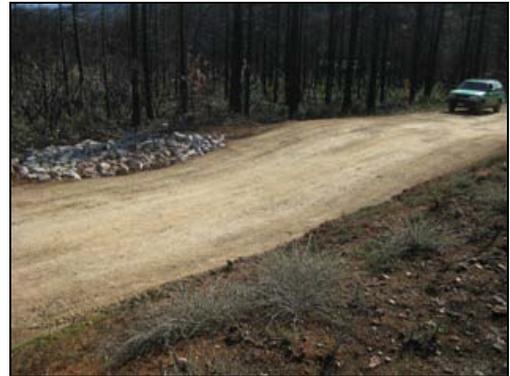
- Gulch Fire stormproofing consisting of constructing rolling dips, replacing and cleaning of culverts, and rock dissipaters completed on May, 2009 (5 miles).

Road stormproofing will consist of outsloping when appropriate, replacing undersized culverts, culvert clean out, installing critical dips and rolling dips to allow safe passage of anticipated increased water flows due to burned landscapes. Road work will focus on 29N01 and 29N05 roads that are located in high soil burned areas of East and West Sunday Gulch and Cold Spring Gulch.

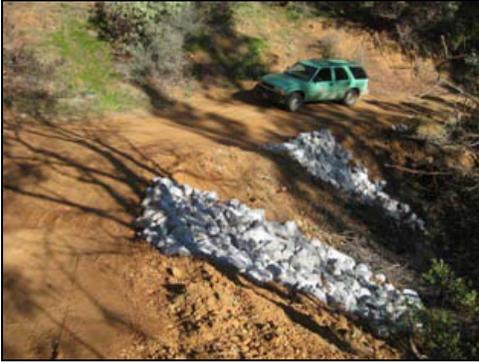
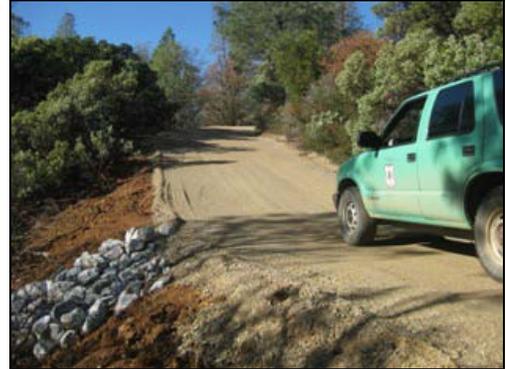
- Rolling-dips with rock dissipaters and regrading of road base.

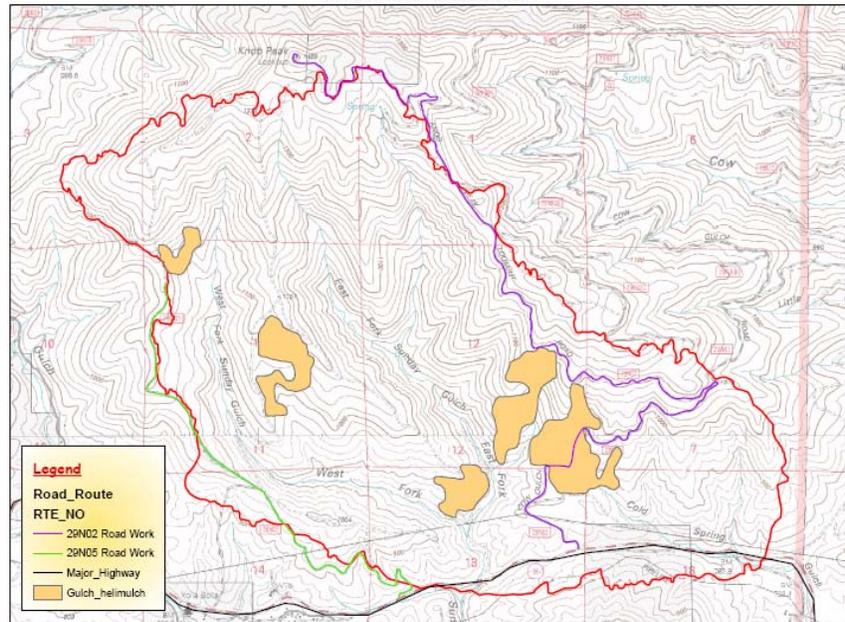
Gulch Fire Treatments

Helimulching of 185 acres in East Sunday Gulch and Cold Spring Gulch at 1.5 tons/ac was considered but calculated reduction in sediments was not enough to justify the cost vs. the benefits (see Appendix C, D, and E). The goal was to reduce erosion on sensitive erodible soils, to protect water quality for domestic water users, to reduce sediments into anadromous fish spawning habitat for Spring Chinook and steelhead, and to protect productive topsoil for adaptive management timber plantations destroyed by the fire. But erosion modeling showed only a 7% reduction in sediments for selected treatable acres (see Treatment Map Appendix C) and economic modeling showed marginal benefit/cost ratios (see Appendix D).
