Taylor Fork Watershed Rehabilitation Section 1 Implementation Review

August 7, 2006

Prepared by: Mark T. Story, Hydrologist

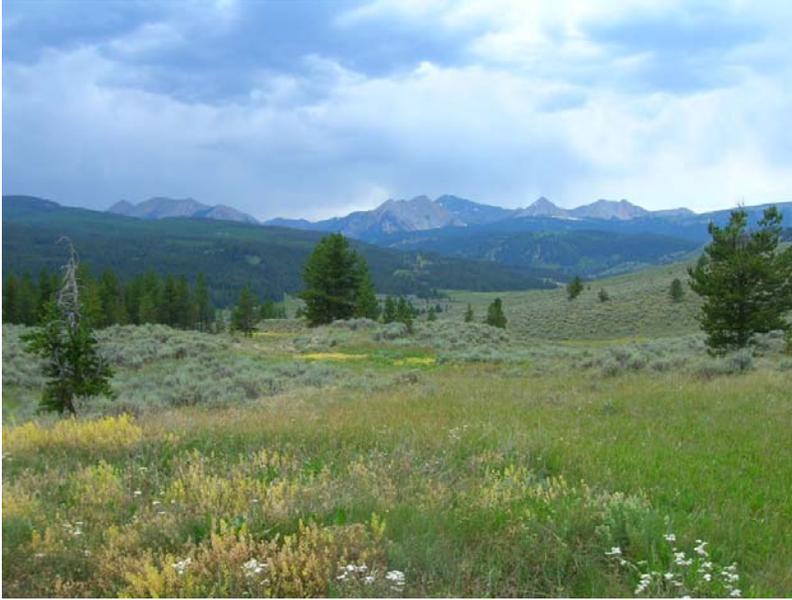
Former cabin site in the north east part of Section 1. Twenty nine of the 32 cabins were removed in the fall of 2004 and the cabin sites reclaimed.

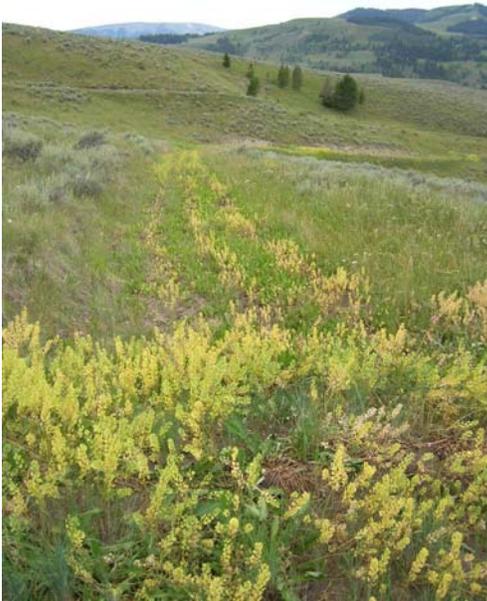
4. Forest Service designates the seed mixture to be used in road rehabilitation activities.	Taylor Fork TS and Road Restoration EIS pg. 23	3	2	Forest Service designated seed mixture which was certified as “weed free”. However considerable field penny cress was evidently in the seed mix with considerable growth on treated areas.

Ripped and drained road on the north side of section 1. These north facing roads had more organic soils than the harsher south facing slopes and had excellent germination of the grass seed mix. No erosion on these ripped roads was occurring. The field penny cress in the seed mixture, however, provided a robust response.

1. Evaluate the appropriateness of the heavy guided horse use from the Nine Quarter Circle Ranch on the rehabilitated road areas. Consider closing Section 1 to horse use off Trail 223 until the road re-vegetation is complete (approximately 3 years) then confine horse use to a single trail (not multiple trailing widths).
2. Weed treatments in Taylor Fork Section 1 are a high priority since the area is relatively weed free. The field penny cress - evidently introduced in the seed mix, and thistle - likely released by the ground disturbance, should be aggressively treated.
3. No grass/forb reseeding is needed.

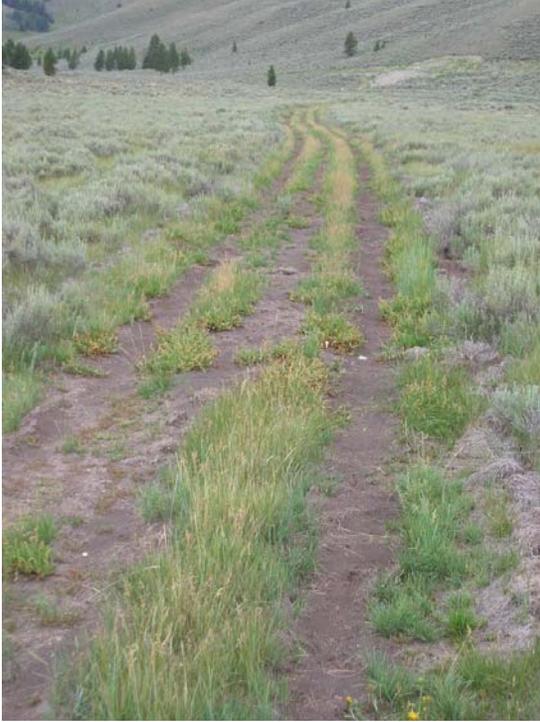
Ripped road on the south part of section 1. Revegetation and grass establishment was excellent. However, heavy use by recreational horses from the Nine Quarter Circle guest ranch has compromised the road recovery. The horse use is re-compacting the ripped roads and creating parallel trails.

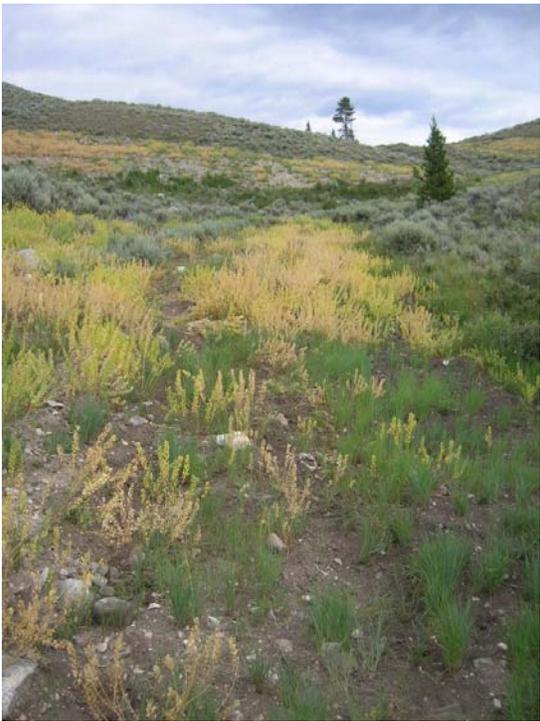
Recontoured road segment in the south part of section 1. The recontouring was very successful in obliterating the road prism by eliminating the road surface as well as cut and fill slopes. No erosion along this re-contoured section was observed although the field penny cress in the seed mix is competing with the new and native grass establishment.

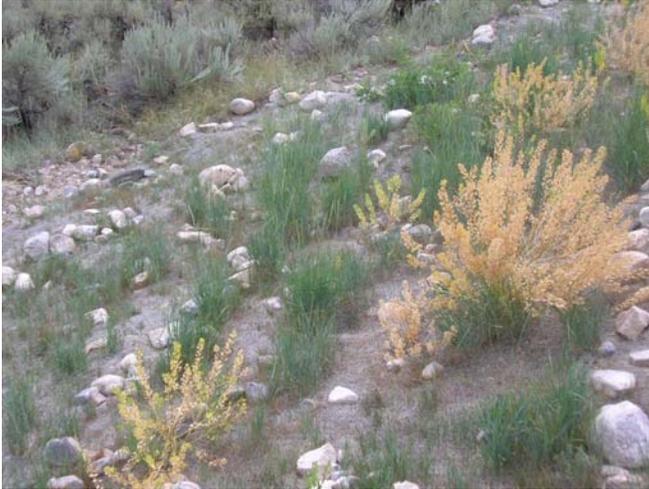
Erosion blankets were very effective in checking erosion on some of the most harsh and visually sensitive areas of the re-contoured roads.

4. Erosion blankets greatly enhance vegetative establishment, visual recovery, and retard weed establishment. Erosion blanket use is appropriate for highly visible areas.
