## Partnership Project Success Story

<b>State:</b>	<b>Colorado</b>	<b>FS Funds Used:</b>	<b>\$80,733</b>
<b>National Forest/Grassland:</b>	<b>Arapaho and Roosevelt National Forests and Pawnee National Grassland</b>	<b>Other Funds Used:</b>	<b>\$</b>
		<b>Partners:</b>	<b>\$64,000</b>
<b>Project Name:</b>	<b>Doctor Mine Reclamation and Wetland Restoration</b>	<b>Total Project Cost:</b>	<b>\$144,733</b>

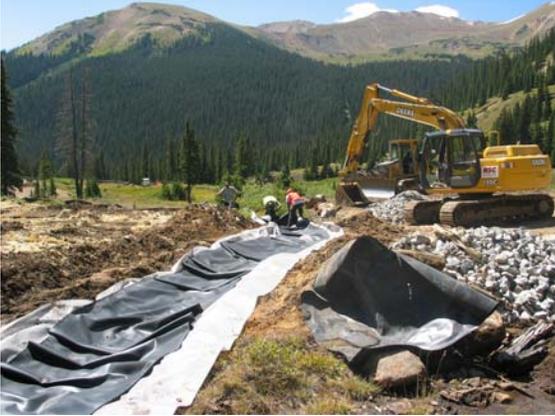
1. Doctor Mine Site prior to reclamation.
2. Consolidation of mine waste.
3. Cap material is placed on consolidated waste.
4. Cap material graded and soil amendments applied.

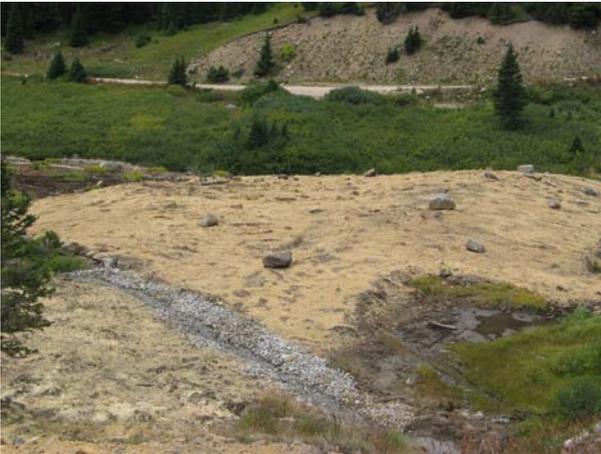
5. Construction of lined water diversion ditch.
