Canyon Lake Survey
(Draft 08/26/03)
Bitterroot National Forest
J. Kightlinger, J. Watkins, R. Brassfield

Fish Spawning/Migration Observations

Mid-project Dam Observations (8/25/03)

Cross-Section (7/2/03 Data)

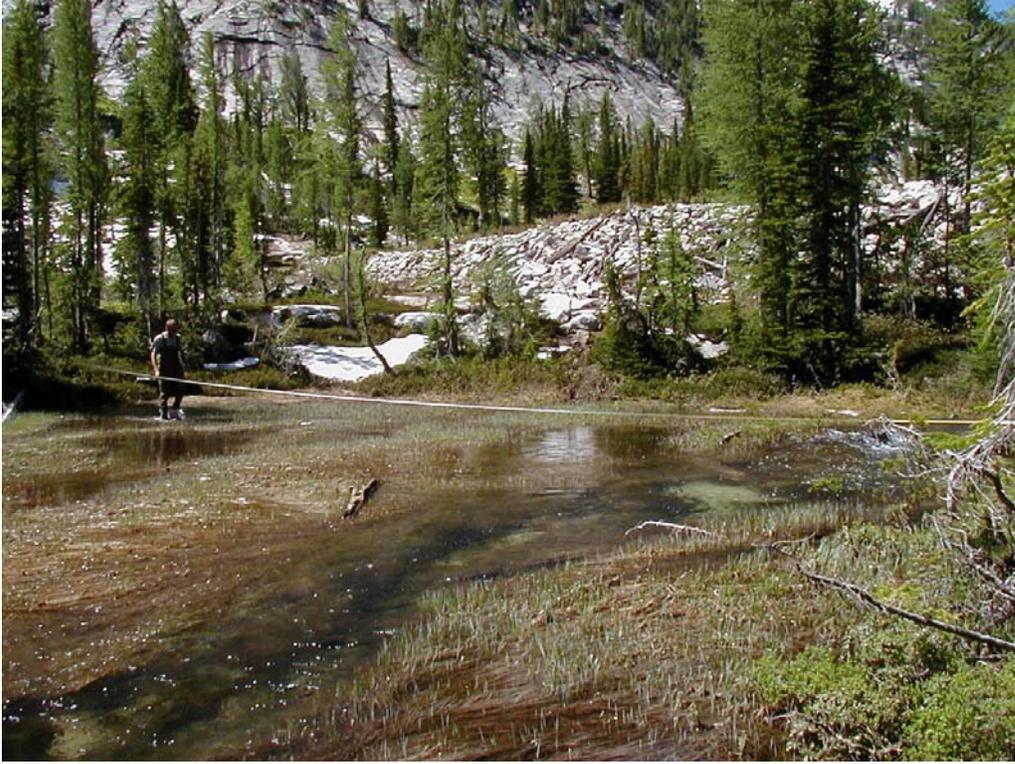
Cross-Section location

Three cross-sections were carried out in the meadow below the outflow of the lake to study the effects of the removal of the dam and possible increased flow during the high water period. The cross-sections done on 7/2/03 were flagged with pink flagging.

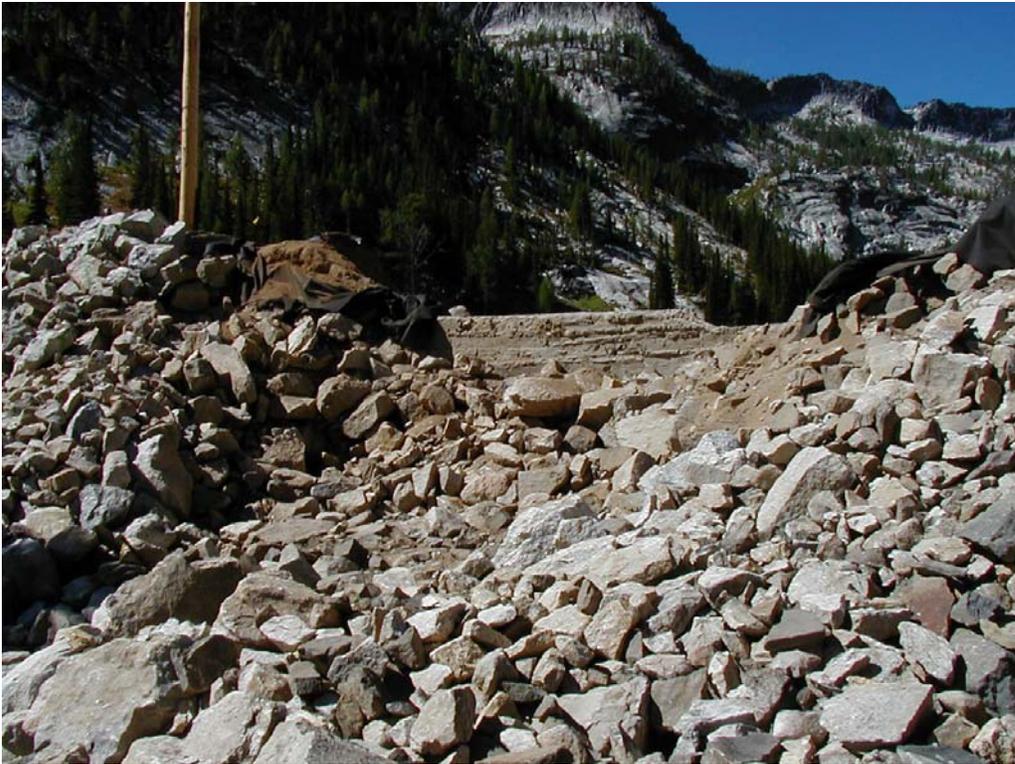
Canyon dam removal (8/25/03)

The dam repair has caused minimal disturbance to the portion of Canyon Creek downstream of the dam. There was not any visual sediment loading or indication of any increase in sediment at all. Water flow was low, but appears to be the natural flow amount for late August.
