Proposed Action for William Kent Campground BMP Retrofit and Administrative Site Redevelopment

US Forest Service Pacific Southwest Region
Lake Tahoe Basin Management Unit
Placer County, California

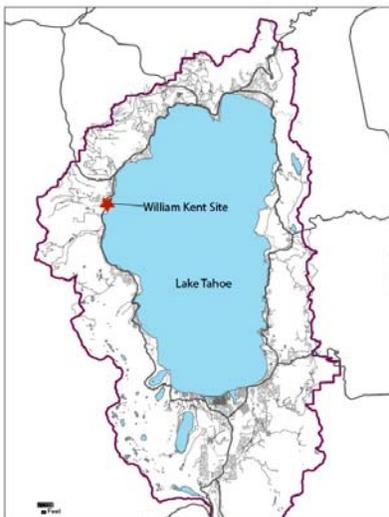
Figure 1:

Phase I (See Figure 1):

- Remove approximately 80% of the paved surfaces within the SEZ totaling approximately 36,700 square feet of asphalt removed.
- Construct a minimal amount of new roadway surface outside of the SEZ to maintain the vehicular circulation pattern and to create new spurs and yurt sites to offset the loss of the campground spurs from the SEZ.

- Construct all new spurs to meet FSORAG accessibility requirements; 16' wide by approximately 40' long.
- Widen the existing road in locations where turning radii are not wide enough to accommodate large vehicles and emergency vehicles.

- Reduce campground spurs from 95 to 92 sites in Phase I.
- Relocate the entry kiosk to within the campground to ease congestion near the Hwy 89 intersection. The existing kiosk will be decommissioned or repurposed elsewhere.

- Relocate the RV dump site to an area that is not within the SEZ and allows for easier vehicular circulation.
- Retain existing restrooms and water system.

- Construct small infiltration basins and vegetated swales along the roadways and in areas where water flows from paved surfaces into the SEZ to prevent any campground pavement runoff from contributing to the water volume of the stream.

- Restore and re-contour the SEZ and stream channel in areas where the paved surfaces are removed to permit the water to spread out over the SEZ and allow for infiltration and to reduce the flow volume and velocity.

- Plant native vegetation in eroded and disturbed areas.
- Stabilize slopes in the campground with boulder placement and revegetation where needed.
- Stabilize the beach slope with boulder or log terraces where needed.
- Replace the signage along Hwy 89 and in the campground to improve wayfinding for vehicles and pedestrians.
- Install electrical hookups in the eastern campground loop.

The US Forest Service facilities at William Kent are located approximately one mile south of Sunnyside-Tahoe City on Hwy 89/W Lake Blvd, Section 24, Township 15N, Range 16E. The property covers 22 acres and consists of the William Kent Campground, the William Kent administrative site that currently contains the William Kent House and Garage, and the William Kent day use beach area. The administrative site is just west of the campground visitor check-in building on the north side of the campground road. Refer to **Figure 1** for the project area location.
