FACT SHEET

Sunchief Mill Site Tonto National Forest

March 2012

ENGINEERING EVALUATION AND COST ANALYSIS (EE/CA)

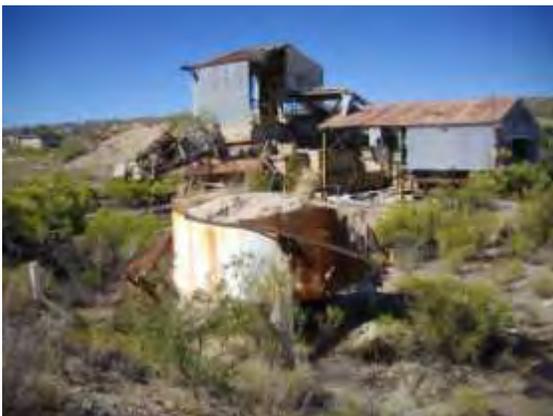
Sunchief Mill Building

Demolition of on-site buildings and continued site access restriction (fencing) is recommended in all evaluated alternatives. The buildings, in their current condition, represent a safety hazard and a community eyesore.

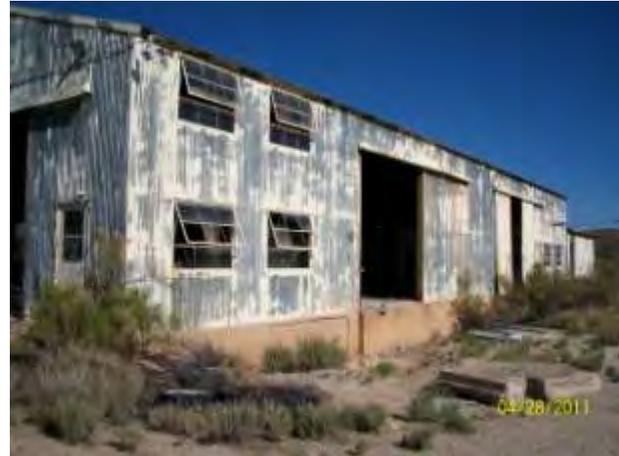
Sunchief Warehouse Building
