United States
Department of
Agriculture

Environmental Assessment

William Kent Campground BMP Retrofit and Administrative Site Redevelopment

Region 5, Lake Tahoe Basin Management Unit
Placer County, CA

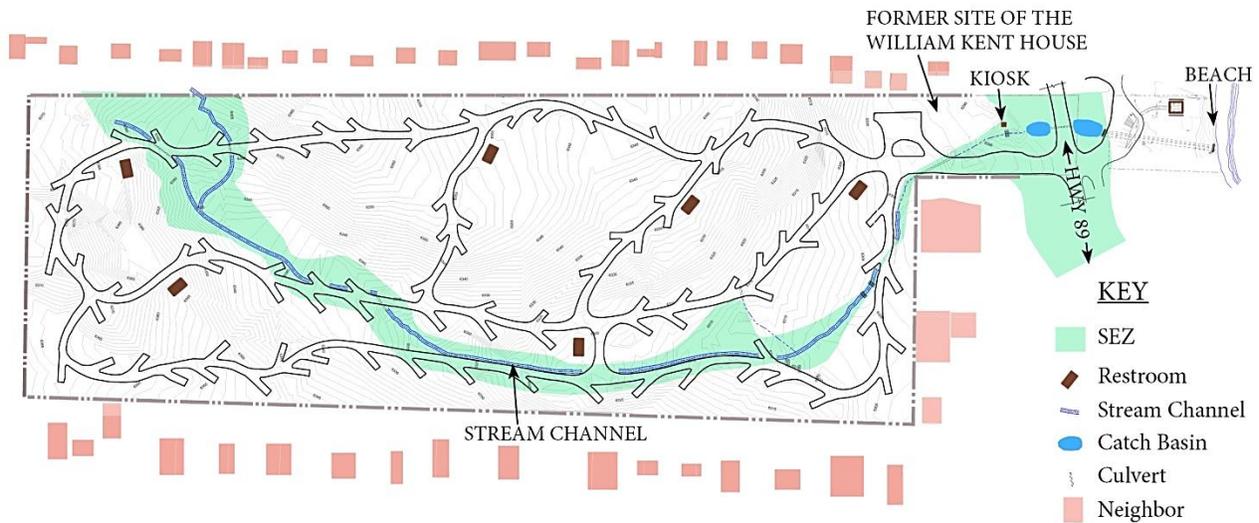
Figure 1-3. Existing condition of William Kent campground, administrative site, and beach day use site.

The William Kent campground was originally constructed in 1924. The current road and camping spur design was implemented in 1963 with 95 spurs (see Figure 1-3). Six flush toilet restroom facilities were constructed in 1969. No major upgrades to the facilities have occurred since that time.

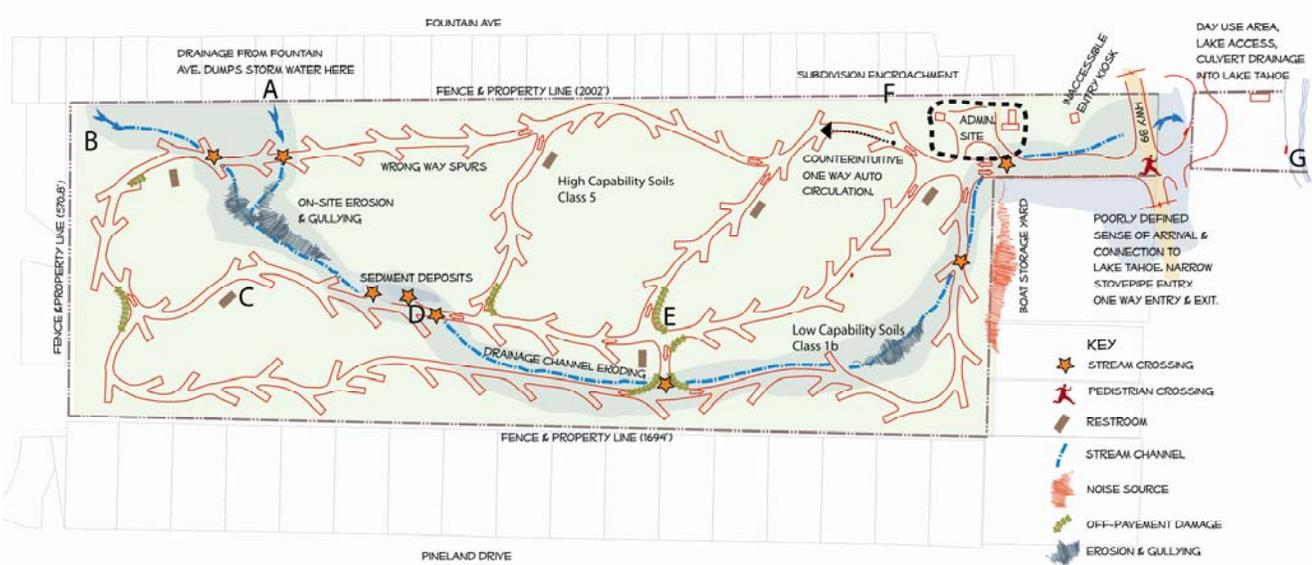
Figure 1-4. Existing site challenges.

Map Designation	Existing Site Challenges Legend
A	Stormwater from the subdivision drains via a ditch onto USFS property.
B	Sheet flow from the subdivision drains onto USFS property.
C	Non-universally accessible restrooms (typical throughout).
D	The stream has been diverted under camping spurs and the road numerous times via culverts (indicated as stars on the map above).
E	Small turning radii and small campground spurs have resulted in off-pavement resource damage.
F	The fence along the property border is damaged seasonally by bears.
G	The stormwater pipe outlet drains directly into Lake Tahoe.

The restroom facilities do not meet current building codes or universal accessibility standards for guidelines such as threshold height, door clearance, surface type, etc (Figure 1-6). The camping spurs do not meet Forest Service accessibility guidelines for standards such as surface type, maximum slope, and spur width (Figure 1-8). The small paved footprint of the camping spurs has led to off-pavement vehicular traffic and parking in areas where physical barriers are not present, resulting in destruction of vegetation, soil compaction and erosion. Visitor use patterns at campgrounds have changed over the last 50 years and now include the use of larger vehicles and camping trailers, which contribute to site impacts. The small turning radii and confusing circulation patterns on the site sometimes results in vehicles driving the wrong way on the one way roads, traffic congestion, and damage to trees along the roads. See Figure 1-4 for a map of site challenges.

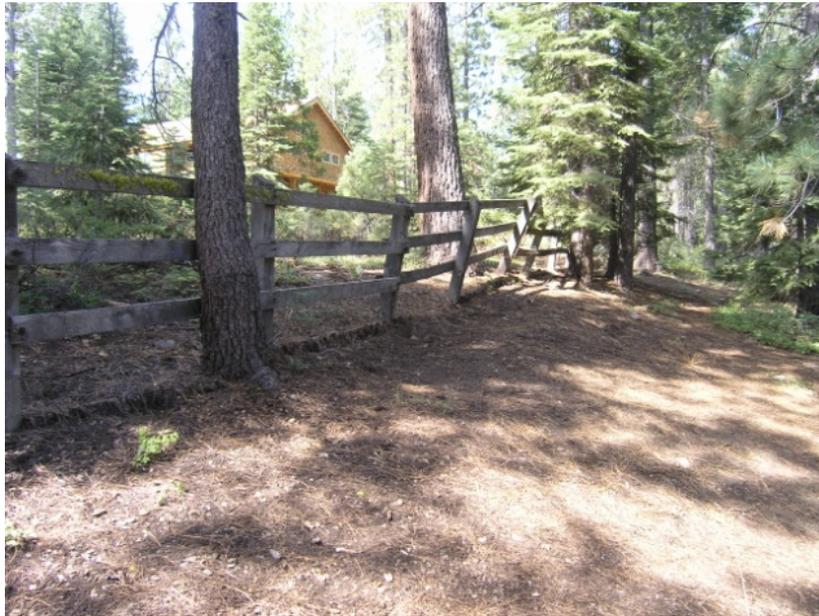
Figure 1-5. Evidence of sheet flow (water flowing evenly over a surface) from the subdivision onto the William Kent campground site (point B on the map in Figure 4).

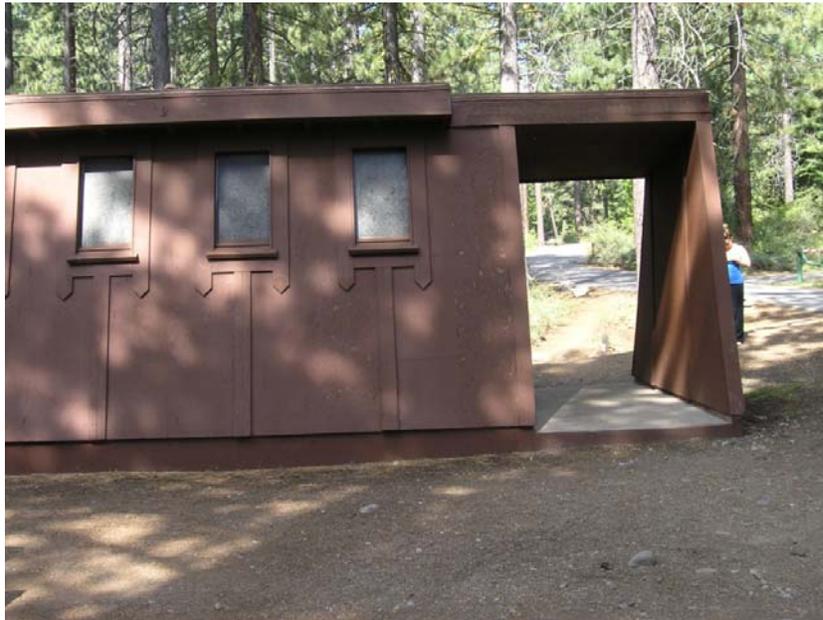
Figure 1-6. Non-universally accessible restroom facility with extensive deferred maintenance.

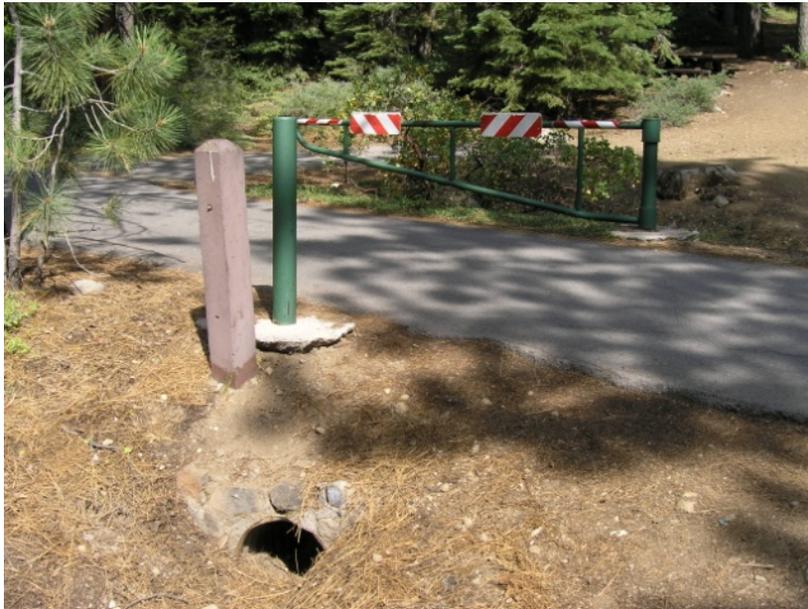
Figure 1-7. Camping spurs and the roadway were constructed over the top of the ephemeral stream using culverts in 8 locations on the site (indicated as stars on Figure 4).

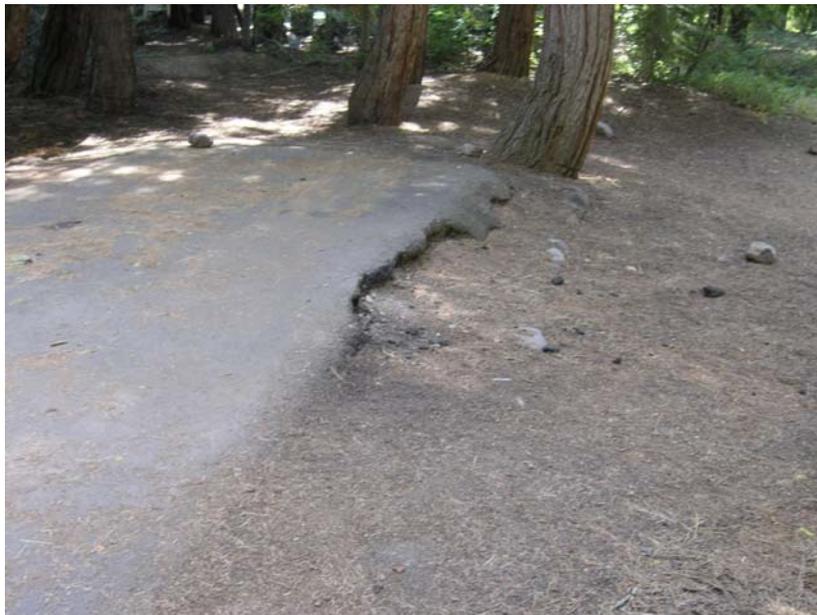
Figure 1-8. The camping spurs are very small and of variable sizes. The constrained size results in off-pavement parking and subsequent soil compaction and resource damage.

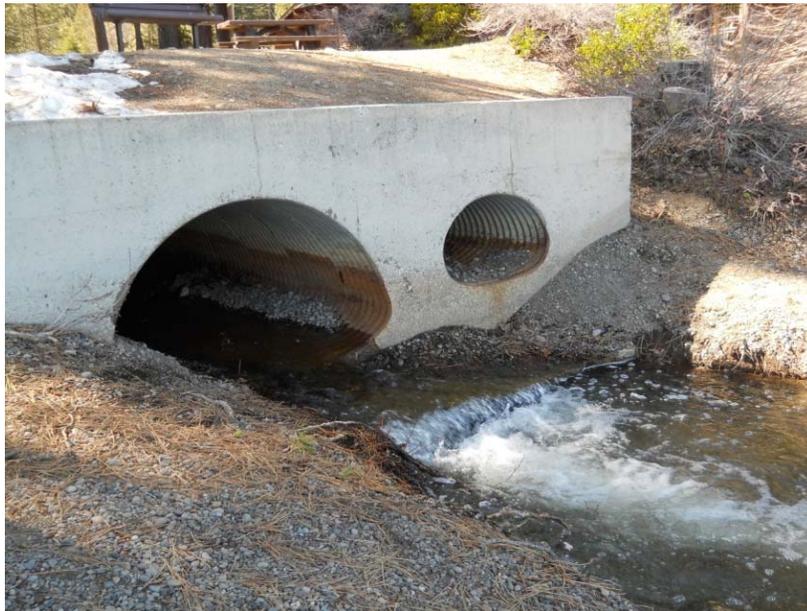
Figure 1-9. The stormwater pipe on the beach day use site flows directly into Lake Tahoe. This photo was taken during the spring snow melt. The depth of the scour area below the outfall is approximately 3 feet deep (point G on figure 4).

The beach day use site would be re-contoured and excavated to shorten the stormwater pipe on the beach to expose the flow (“daylight” the stream), as well as to stabilize the resulting slope. This will increase the area for infiltration and reduce the pollutant/sediment loads of the stormwater before it enters Lake Tahoe. Stabilization of the slope may include riprap, boulder placement, retaining walls, structural walls, and vegetation. Bridges, footpaths, and safety rails would be installed where needed to ensure navigability, safety, and efficient use of the site by visitors. An accessible path would be constructed to access the beach from the picnic area.

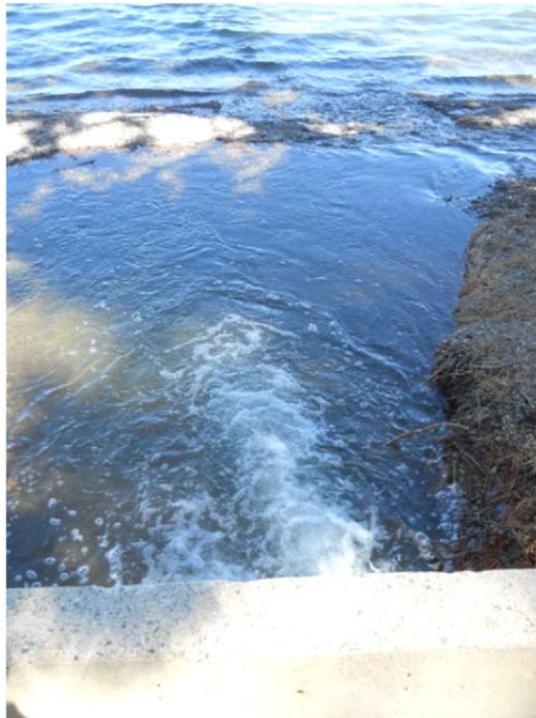
Figure 1-10. The stormwater pipe at the beach day use site, as viewed when standing on the outfall wall and looking towards the lake during spring snowmelt (point G on the map in Figure 4).

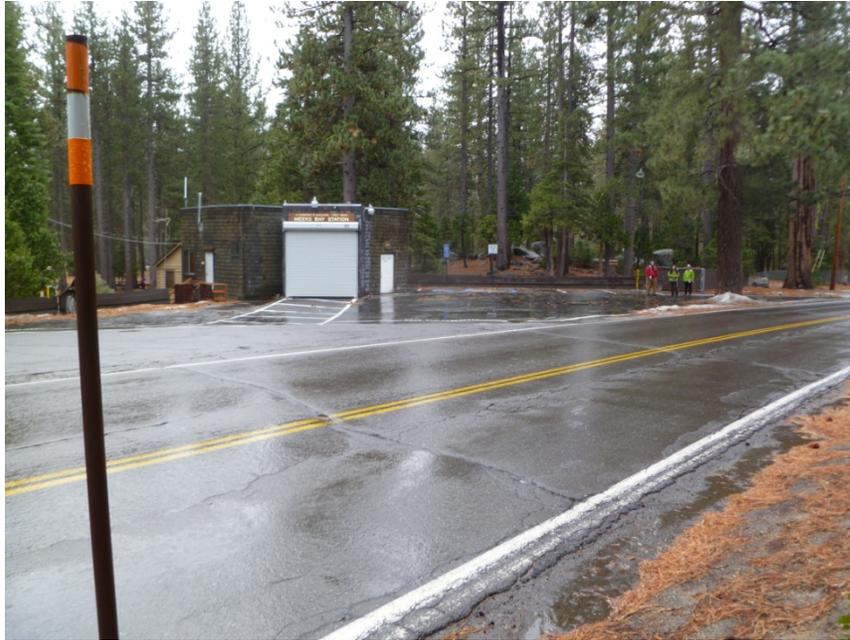
Figure 1-11. Meeks Bay Fire Station when viewed from across Hwy 89. The structure is extremely small and does not meet the needs of the fire crew stationed there.

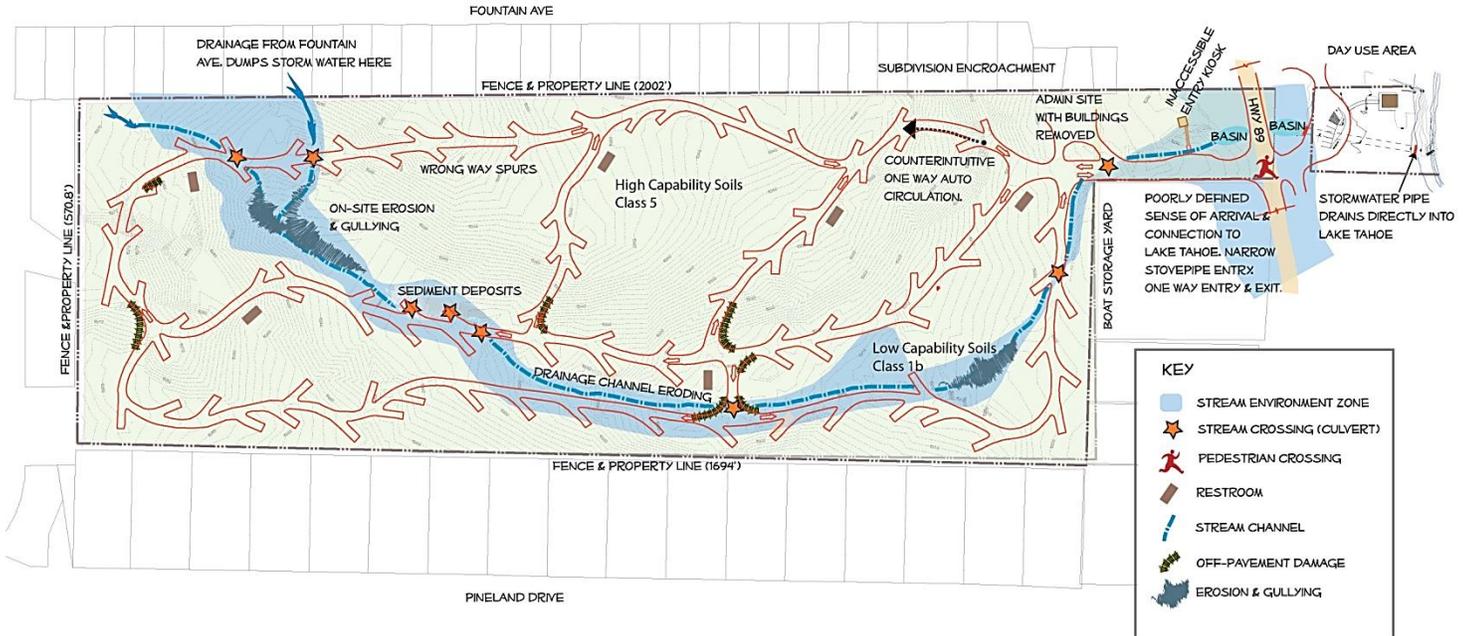
Figure 2-1. No Action Illustration.

ALTERNATIVE 1 - NO ACTION ALTERNATIVE

The campground would remain open and continue to be operated by the campground concessionaire. The restroom facilities would continue to degrade, resulting in more frequent repair and maintenance effort and costs. The road system within the campground will continue to be maintained at the present level. Parking and access to the beach area will continue at its present location and condition.

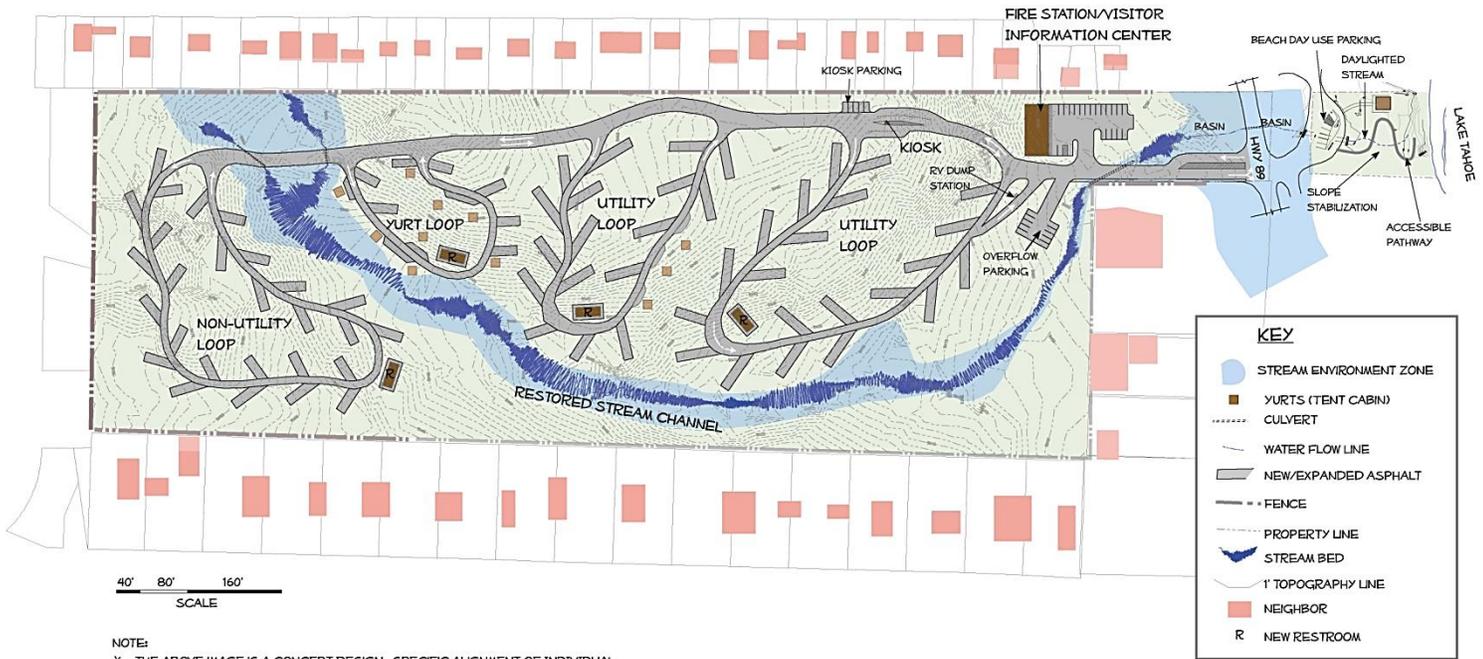
Figure 2-2. Alternative 2 Concept Design.

ALTERNATIVE 2 - PROPOSED ACTION
CONCEPT DESIGN

NOTE:
 ✘ THE ABOVE IMAGE IS A CONCEPT DESIGN. SPECIFIC ALIGNMENT OF INDIVIDUAL SITE ELEMENTS MAY CHANGE BASED UPON SITE RESTRICTIONS AND TO MEET DESIRED GRADING REQUIREMENTS FOR ACCESSIBILITY.
 ✘ INDIVIDUAL BMP'S SUCH AS INFILTRATION BASINS AND SLOPE STABILIZATION ARE NOT SHOWN IN THIS ILLUSTRATION.

The William Kent site is planned for rehabilitation, which would include installation of water quality BMPs, control of vehicle circulation by redefining and paving travel routes and camping spurs, relocation of the kiosk, and removal of inadequate restroom buildings. New construction would include four new toilet/shower buildings in the campground and a new fire station/administrative building on the administrative site (Figure 2-2). The Meeks Bay Fire Station would then be decommissioned and the area rehabilitated.

8. Relocate the entry kiosk further into the campground on the two-way road to allow for drive-up traffic on both sides.
9. Construct small infiltration basins and vegetated swales along the roadways and in areas where water flows from paved surfaces into the SEZ to prevent any campground pavement runoff from contributing to the water volume of the stream.

10. Remove impervious surfaces from within the SEZ and re-contour the stream channel in areas where the paved surfaces are removed to permit the water to spread out over the SEZ and allow for infiltration and to reduce the flow volume and velocity.

17. Remove the six existing restrooms and replace with four accessible shower/bathroom facilities, one serving each loop.
18. Plant vegetation for screening in any areas where vegetation was disturbed or removed along the campground perimeter and intensively plant for screening around the administrative site.

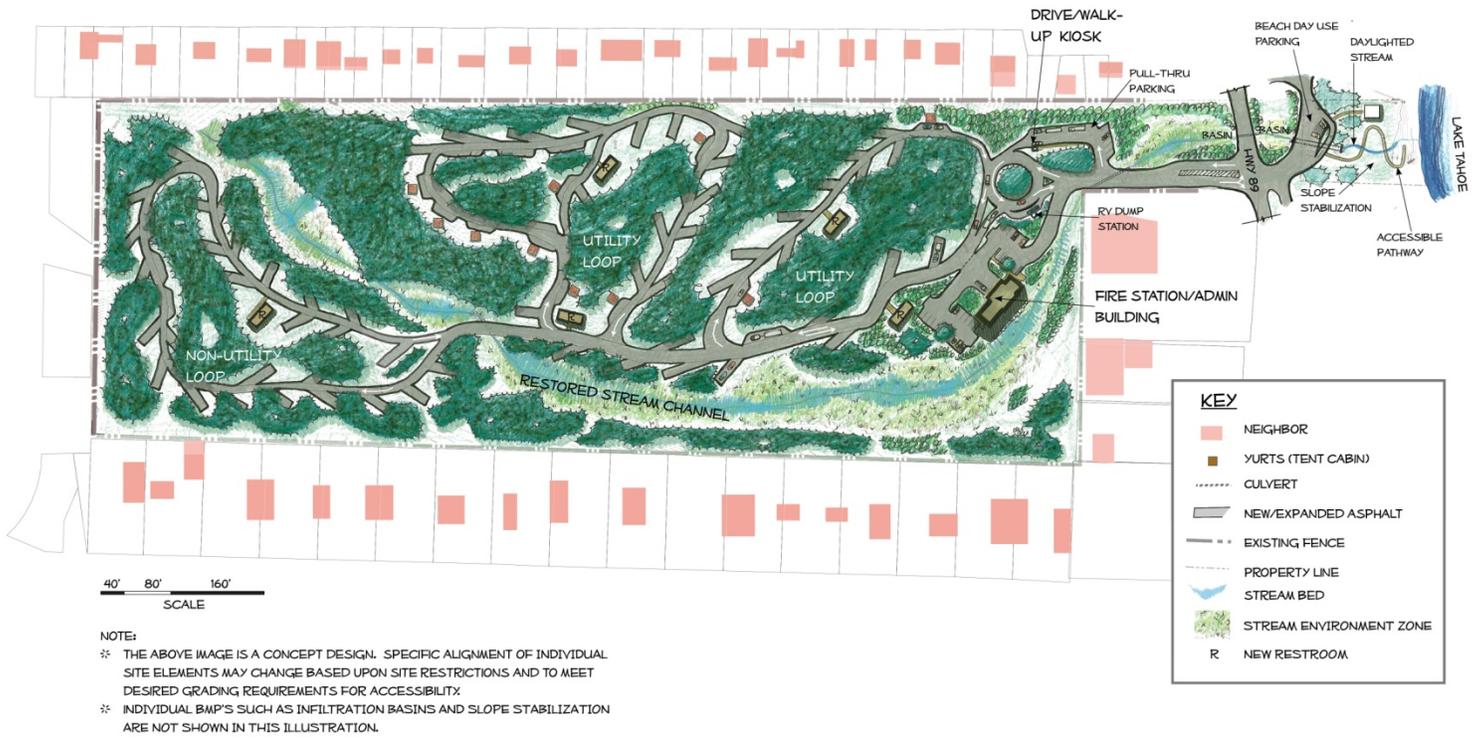
Figure 2-3. Alternative 3 Concept Design.

FIGURE 2-3
ALTERNATIVE 3 - CONCEPT DESIGN

9. Construct small infiltration basins and vegetated swales along the roadways and in areas where water flows from paved surfaces into the SEZ to prevent any campground pavement runoff from contributing to the water volume of the stream.

10. Remove impervious surfaces from within the SEZ and re-contour the stream channel in areas where the paved surfaces are removed to permit the water to spread out over the SEZ and allow for infiltration and to reduce the flow volume and velocity.

17. Remove the six existing restrooms and replace with five accessible shower/bathroom facilities.
18. Create seven overflow parking sites on high capability lands outside the SEZ.
