# Soil and Water Question 2a Appendix

## Best Management Practices Implementation and Effectiveness Monitoring Petersburg Ranger District Recreation Trip Report - Lake Trail and Cabin September 14, 2012

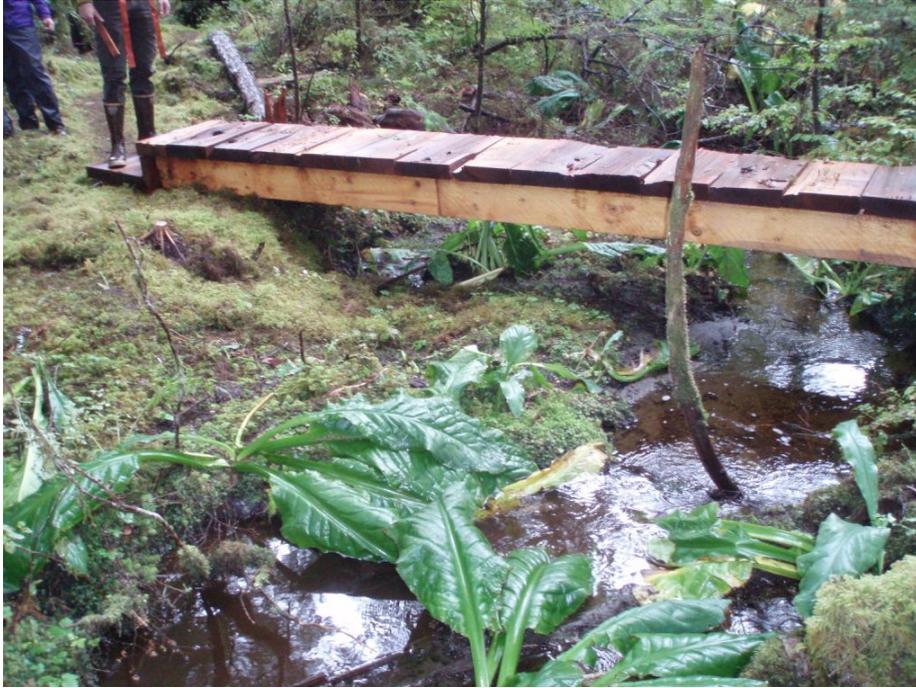
The implementation questions evaluate practices used to minimize water quality impacts. All applicable BMPs were implemented at the cabin and on the trail. A review of the trail project file documented aquatic specialist review and recommendations. Cedar puncheon was installed to avoid mud and minimize water diversion. One suspected fish stream (un-mapped, un-catalogued at the lat/long point shown on the form) was treated by re-routing the trail and constructing an elevated puncheon bridge that spanned the stream (picture 1). No work was performed within ordinary high water, so no Title 16 concurrence was required from the State of Alaska. Although not required, the trail crew routinely works and travels on old boardwalk as it is removed, in order to minimize disturbance. They also have a standard practice of placing local moss on bared soil to protect it from erosion (picture 1).

**Picture 1.** Suspected fish stream crossing. Note placement of moss and minimal disturbance.

No adaptive management actions were noted for other cabins. The use of old boardwalk and placement of moss as mulch are reasonable practices that should be applied on similar trail projects.

No adaptive management actions were noted for other cabins. The trail crew's use of old boardwalk as a working / traveling surface during construction is effective at minimizing disturbance. The placement of moss as mulch is effective at protecting bare soil from erosion.

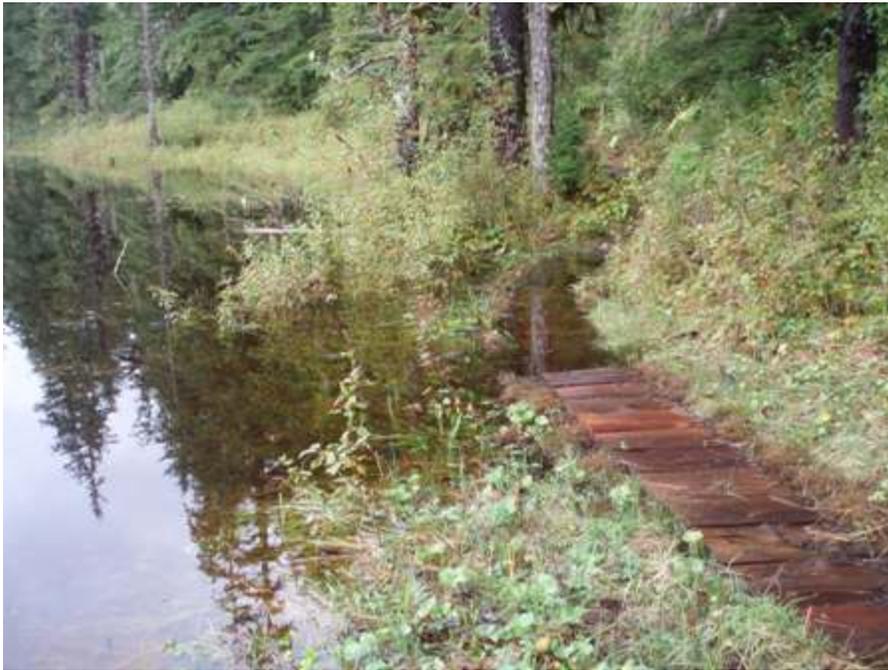
**Picture 2.** Flooded trail where puncheon had floated.

- As a result of the high lake level, some sections of puncheon had floated or shifted off the trail (picture 2). We recommended fastening the puncheon in place with long rebar stakes.
- At the location of the re-route, three boards had been left in place. The last board (in the stream) should be removed next year to ensure fish passage is not impaired in this suspected fish stream.

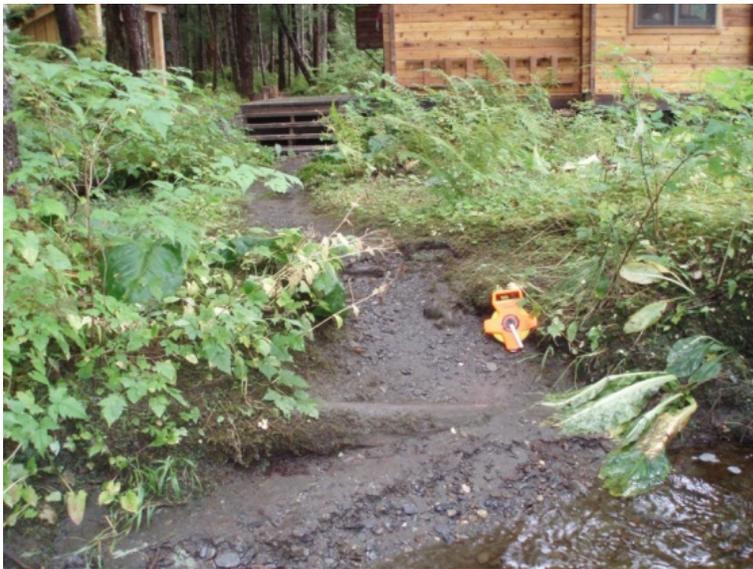
The effectiveness questions evaluate evidence of potential or current impacts to water quality. At the cabin, we found a small area (less than three feet wide) of trampled streambank where the trail from the cabin intersects the adjacent stream (picture 3). We did not consider this a concern since it is not unstable and is commensurate with the level of use we would expect where cabin users enjoy accessing the stream.

**Picture 3.** Small trampled stream bank near cabin

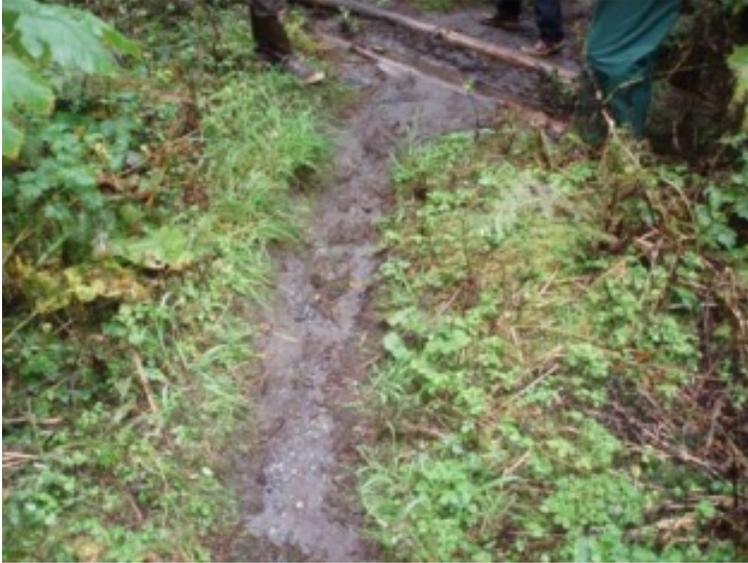
On the Petersburg Lake Trail, we found trace evidence of soil erosion and sediment transport caused by recent heavy rains on a sort section of bare ground. Sediment was detained by a log prior to entering a Class IV stream (picture 4).

**Picture 4.** Trace erosion and sediment deposition on trail
