2300 Recreation  
October 2002  
0223-2821P-MTDC

# Managing Degraded Off-Highway Vehicle Trails in Wet, Unstable, and Sensitive Environments

**Kevin G. Meyer**, *Environmental Specialist/Soil Scientist*  
*National Park Service, Alaska Support Office*  
*Rivers, Trails, and Conservation Assistance Program*

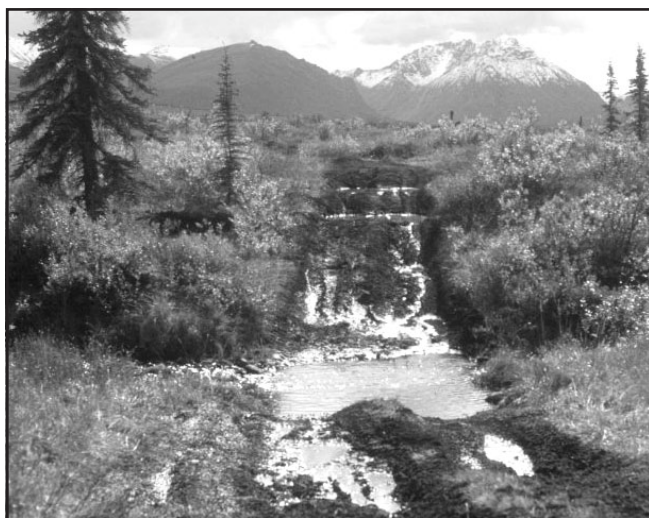
Figure 1—A degraded trail in interior Alaska. Heavy use has stripped surface vegetation and exposed permafrost soils to accelerated melting, resulting in muddy, rutted trail surfaces, erosion, and deep muck holes.

For land managers, degraded trails are a significant environmental problem because of their direct effects on vegetation, soils, and site hydrology. In addition, degraded trails may have indirect effects on wildlife, site esthetics, and other resource values. For trail users, degraded trails reduce the utility of trail systems and lead to a less enjoyable ride. Unfortunately, with increased use of backcountry resources by OHV enthusiasts and other trail users, the miles of degraded trails are increasing rapidly (figure 1).

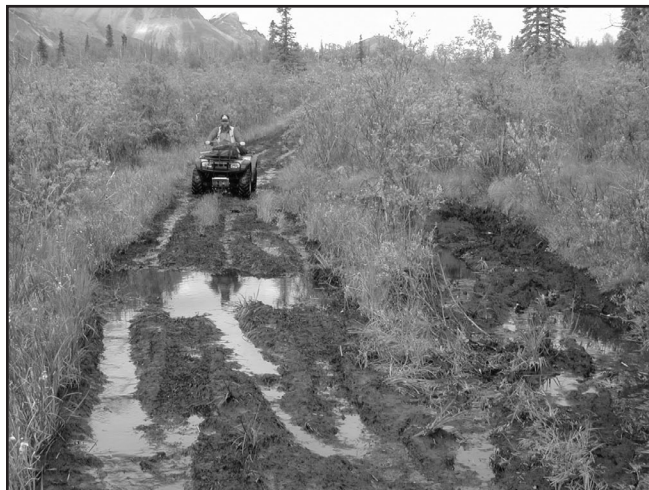
Figure 4a—Ponded water in ruts and muck holes prompt riders to pioneer new routes in adjacent undisturbed areas.

The first consequences of pioneering a trail across a virgin landscape are the stripping of surface vegetation, the abrasion of roots, and the compaction of surface soil layers. These impacts destroy soil structure, reduce water infiltration, and break bonds between soil particles. Soil particles are more vulnerable to displacement and loss from wind or water erosion. Soil compaction also leads to surface subsidence—the lowering of the trail relative to the adjacent ground surface. Trails become entrenched. This lower surface intercepts and drains water from adjacent surfaces and channels that flow along the trail. This dramatically increases the risk of water erosion on sloped areas and the pooling of water in low-lying sections. As trail surfaces degrade due to rutting or the formation of muck holes, users widen the trail and seek new routes, usually on adjacent soils where environmental conditions are identical to the original impact site. As this new route degrades, it is abandoned. A third route is pioneered, and then a fourth—until finally the area is scarred with a number of routes in various stages of use and abandonment. This condition is called trail braiding. Trail braiding significantly expands the environmental impacts of trail use. Trail braiding occurs because trail use levels repeatedly exceed the carrying capacity of soils to support that use. Figures 4a and 4b illustrate the process.

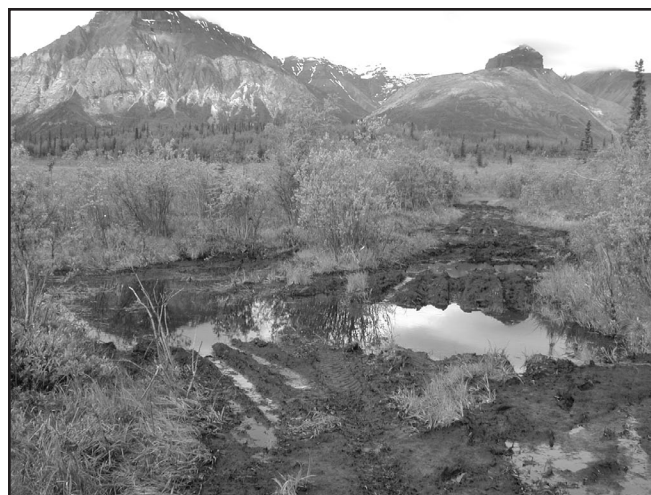
Figure 4b—Results are an adjacent degraded alignment and the development of a braided trail.

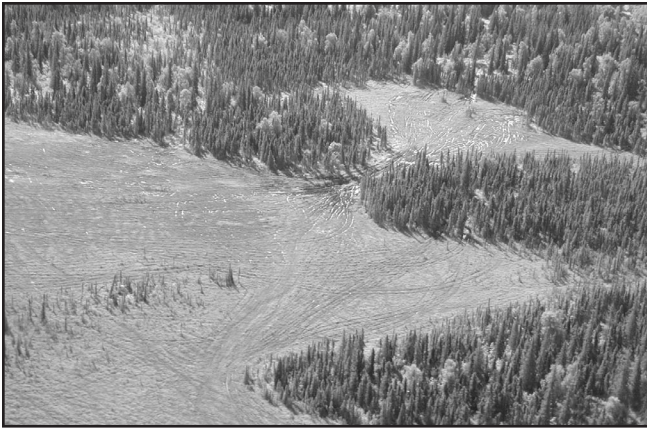
Figure 5—A braided trail in Alaska. More than a dozen separate routes have been pioneered in this section crossing a wetland. Note the wet trail conditions and numerous potholes. At this site, trail impacts affect an area more than 250 feet wide. Braiding significantly extends the area of impact by modifying vegetation cover, surface hydrology, and soil characteristics.

The impacts associated with braiding are a major concern for land managers because they dramatically increase the area of impacts associated with trail use (figure 5). Studies conducted in one area of Alaska documented that the average OHV trail had an impact area 34.6 feet wide (Connery 1984)—that's four times the width necessary for a single OHV track. Using that average width (34.6 feet), each mile of trail affects 4.2 acres. A single-track trail (8 feet wide) of the same length would affect just 0.97 acre per mile. Braided trail sections more than 200 feet wide are not uncommon within Alaska. For resource managers, the increase in area affected by braiding is significant in terms of resource destruction, habitat loss, and esthetics.

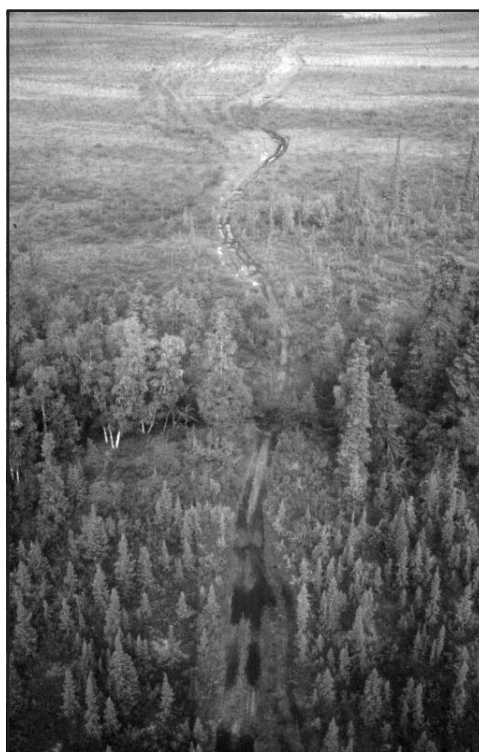
Figure 7—A heavily used OHV trail in Alaska crosses two distinct soil types. In the foreground, the trail passes through a mixed forest ecosystem where the soils support use along a single track. In the background, the trail crosses degraded wetland soils where users have created a braided trail. Managers should consider rerouting the trail to stay within the forest system.

In some cases, moving a trail or segment may be an effective method of responding to trail degradation. For example, moving a trail from a foot slope to a side slope may significantly reduce trail wetness. Moving a trail from an open wetland to an adjacent woodland may stop trail braiding. Figure 7 shows an example where rerouting should be considered.

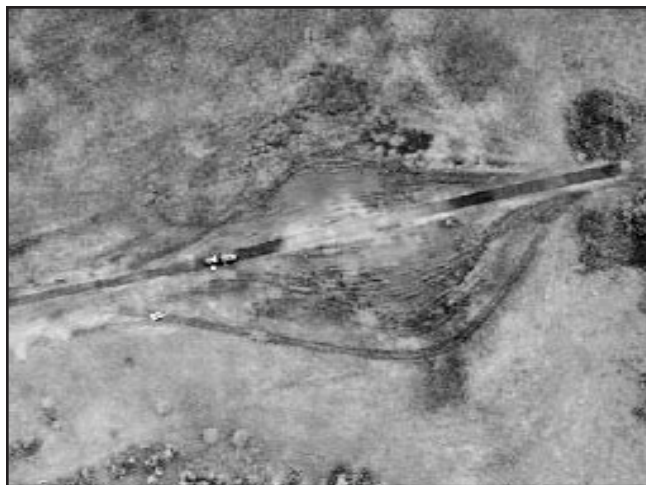
Figure 8—This aerial image shows a recently installed section of hardened trail crossing a wetland in southcentral Alaska. The new trail alignment defines a single route of travel that will prevent the continued development of braided trails.

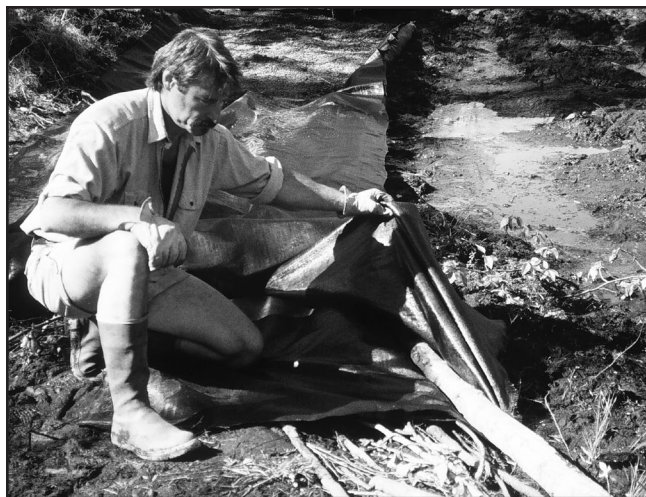
Figure 11—The author installing woven geotextile around a rim log in the geotextile gravel-capping test installation at the Yukon-Charley Rivers National Preserve in Alaska. The rim log held the gravel cap on the installation.

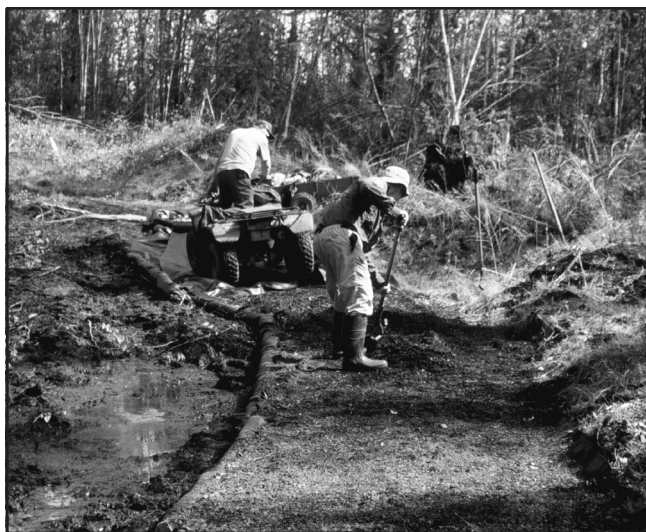
Figure 12—A geotextile and gravel-cap installation over permafrost-degraded soils in Yukon-Charley Rivers National Preserve in Alaska. Use of geotextile and a gravel cap on this trail allowed the National Park Service to construct a 6-foot-wide OHV trail over a 3- to 4-foot-deep muck hole.

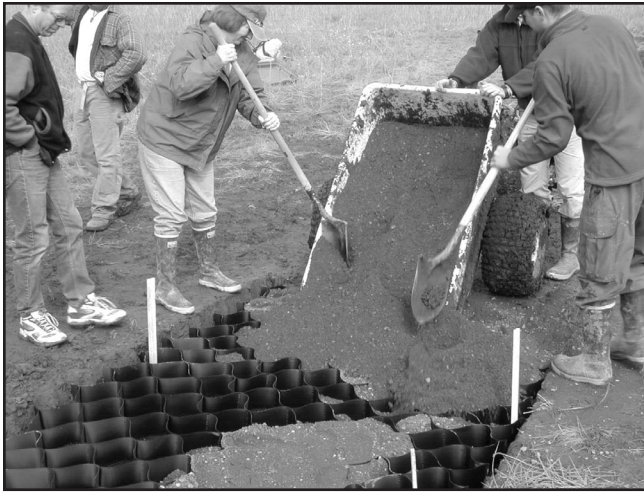
Figure 13—A cellular confinement system being installed on an experimental trail in southcentral Alaska. Four-inch-deep cells were formed by expanding the cellular product accordion style, then backfilling and compacting with a suitable fill material—in this case, sandy gravel. The sides of the installation were confined by a 6-inch-deep trench.

**Cellular Confinement Systems**—Cellular Confinement Systems (CCS) are three-dimensional, web-like materials (figure 13) that provide structural integrity for materials compacted within the cell. They are engineered so cell walls limit the transfer of shear forces within the soil. Employed worldwide for a wide variety of uses, cellular confinement systems are a well-accepted soil engineering tool (Ron Abbott 2000). In Alaska, these systems have been used with success on military runways and remote radar sites, Arctic tank farms, construction sites, and boat ramps (Joseph Neubauer 2000). The systems also have been used when

A cellular confinement system consists of a surface-aggregate wear surface, the cell membrane, fill material, and an optional separation fabric (depending on site characteristics). Fill material is usually imported gravel, but onsite material can be used in some circumstances (the use

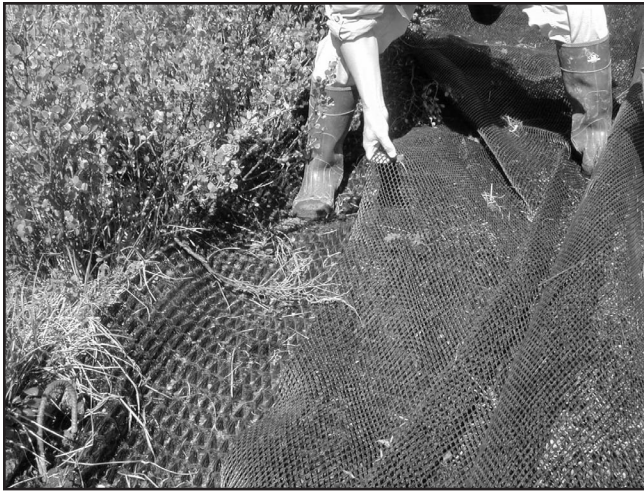
Figure 14—Polynet over Pyramat was used in this National Park Service installation to test the addition of a synthetic turf reinforcement mat. The Polynet, with its more durable wear surface, was installed over the less durable Pyramat.

The manufacturer had extensively tested Pyramat as a soil-reinforcement product. The company had documented significant increases in resistance to erosion and shear stress after vegetation regrowth (Synthetic Industries 1999). The National Park Service tested both turf reinforcements to see whether they would support existing roots and cushion soil bodies from direct impact. Polynet provided a wear surface, while the open weave of Pyramat allowed for active plant growth and eventually was integrated into the soil surface layer.

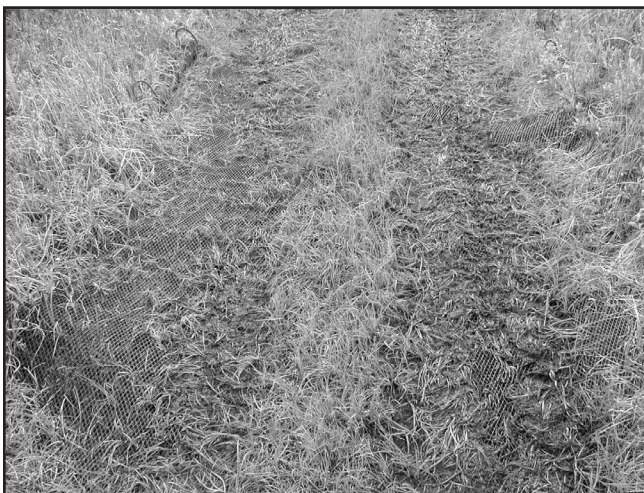
Figure 15—A Park Service Polynet/Pyramat test installation after 3 years in a wetland area with a high percentage of sedge. By the third year, sedge had become well established and its roots well entwined with the Pyramat matting.

The Park Service field tests were encouraging because the materials appeared to protect the underlying soils from impact. They stabilized degradation and provided a durable wear surface for OHV use. Vegetation regrowth on the sites increased from 54-percent cover at installation to 79.5 percent 3 years later (figure 15). On sites with a high percentage of sedge and cotton grass, the materials were well integrated into the root mass by the end of the second year.

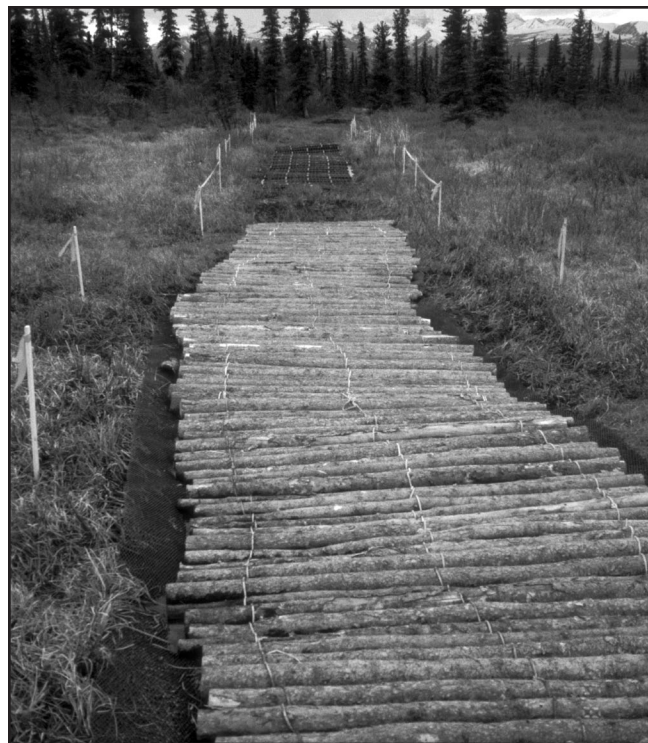
Figure 16—Spruce pole corduroy laid across permafrost soils in Alaska. These poles were imported to the site and secured by weaving them with three strands of  $\frac{3}{8}$ -inch nylon line.

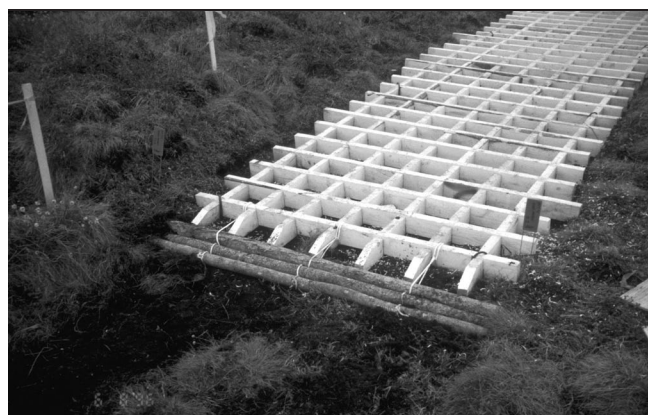
Figure 17—Wood matrix after installation in the Wrangell-St. Elias National Park and Preserve in Alaska. The wood matrix provided a suitable surface for OHVs, but had several characteristics that limited its suitability for future field applications.

**Wood Matrix**—Wood matrix was another trail-hardening method tested by the Park Service in the Wrangell-St. Elias study (figure 17). The wood matrix was a wooden grid structure constructed of rough-cut, 2- by 4-inch timbers that were notched and fitted to form an 8- by 8-inch open grid. The surface of the grid formed the wear surface. The interlocked timbers carried and distributed the load across the soil surface. The technique was adapted from an approach developed in Britain (Shae 2000).

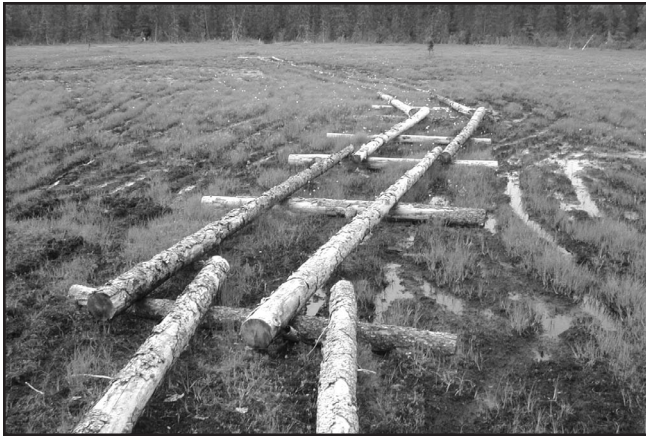
Figure 19—Rough layout of the sill and stringer timbers for puncheon trail construction over a wetland area in southcentral Alaska. Stringers are laid with tops meeting tops and butts meeting butts.

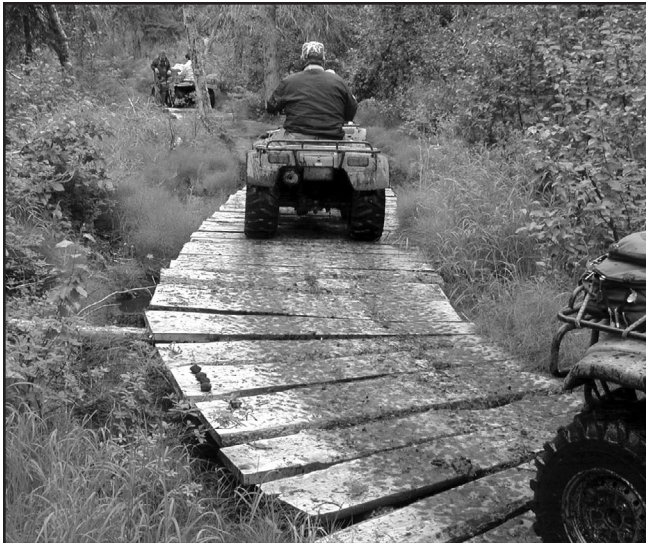
Figure 20—A finished puncheon trail. Note the placement of the plank taper to accommodate the curves along the trail.

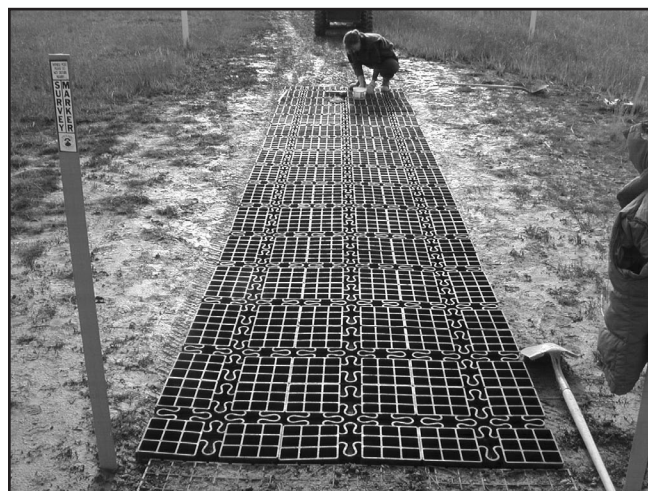
Figure 24—Test installation of SolGrid at the Palmer Hay Flats State Game Refuge in Alaska. Note the U-shaped flex joints between sub-panel sections. The SolGrid was tested without Polynet PN-3000 to test the characteristics of the product when installed on a soft, silty substrate.

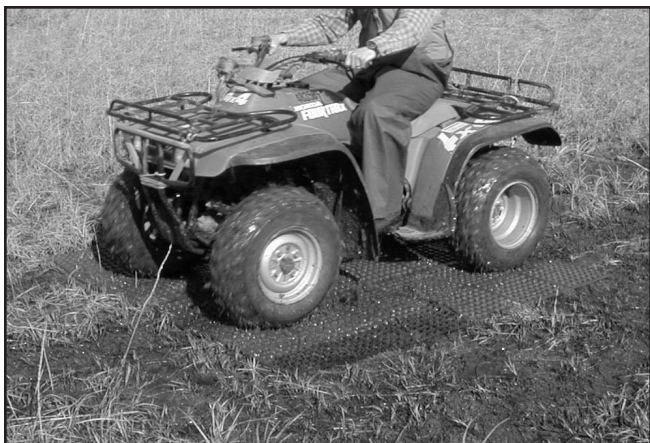
Figure 26—A section of rubber antifatigue mat undergoing preliminary field trials at the Palmer Hay Flats State Game Refuge in Alaska. The large panels install quickly, but the rubber's flexibility limits the panels' ability to transfer lateral loads.

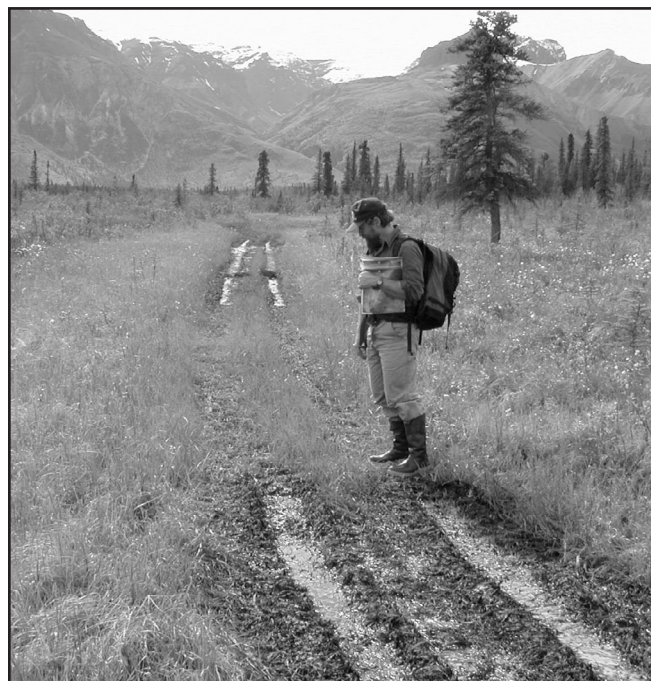
Figure 27—A hardened, protected section of trail 4 years after installation.

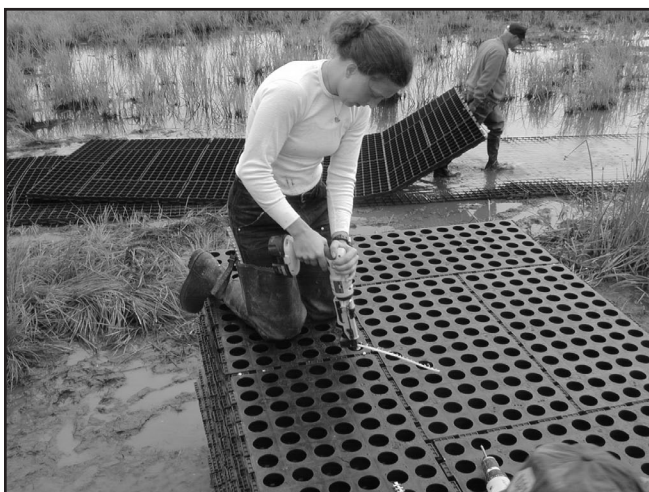
Figure B4—Assembling the subsections with the Quik Drive drill system. Using this tool and a standard 18-volt cordless drill, two people can assemble 32 six-panel subsections in 1½ hours. In the background, a worker drags a three-section assembly along an installed trail segment.

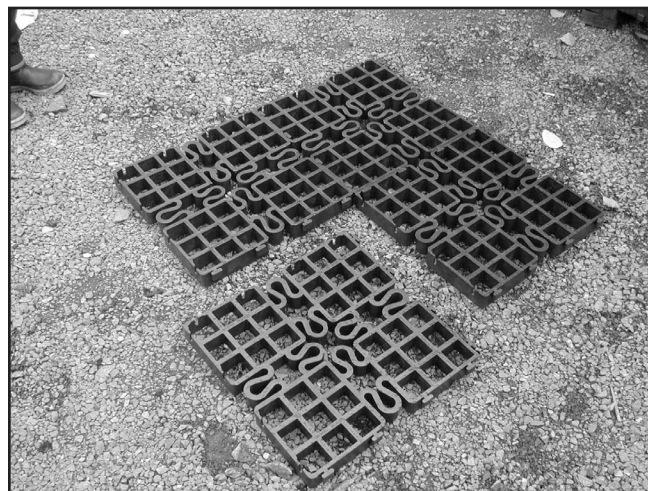
Figure B5—Two SolGrid panels. Note the slot and tab fasteners along the edges and the integrated U-shaped expansion components.

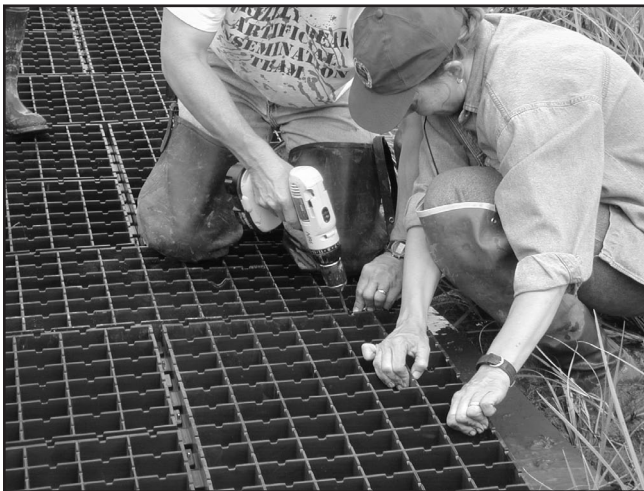
Figure B7—Joining the sections using a screw gun. Note the underlying plywood.

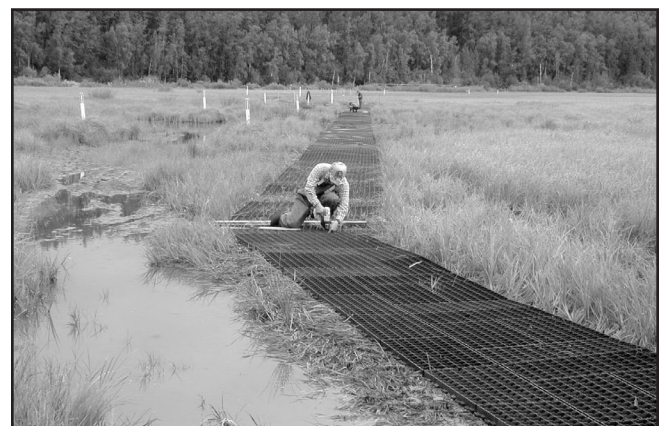
Figure B8—Angular cuts in the panel sections help form the turns in the trail.
