Forest Service  
U.S. DEPARTMENT OF AGRICULTURE

Southwestern Region | PR-R3-16-24 | August 2024

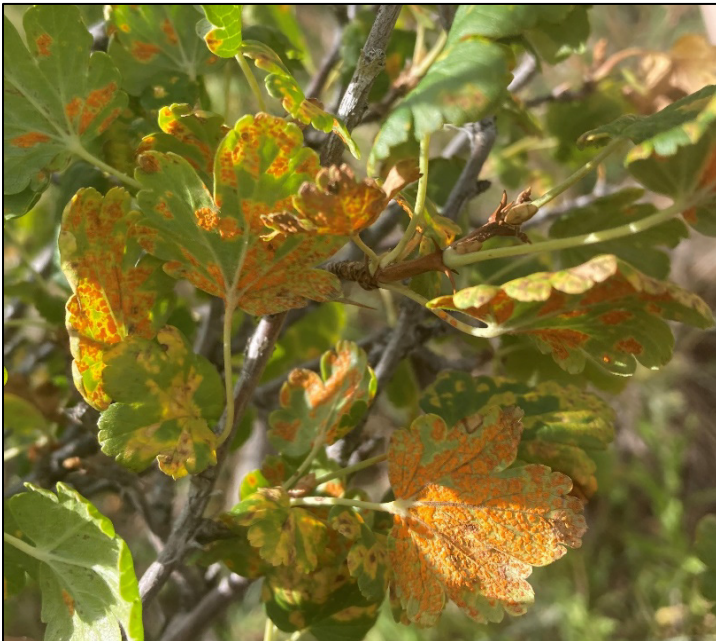
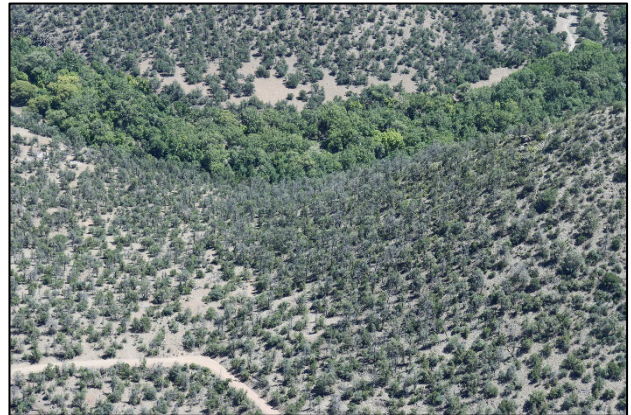
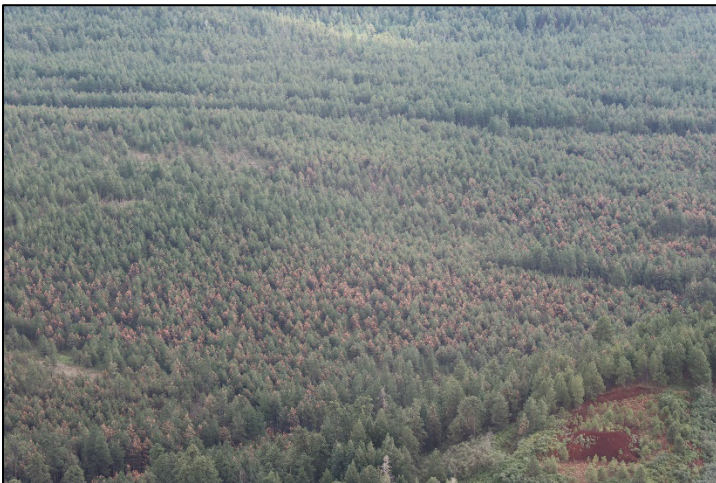
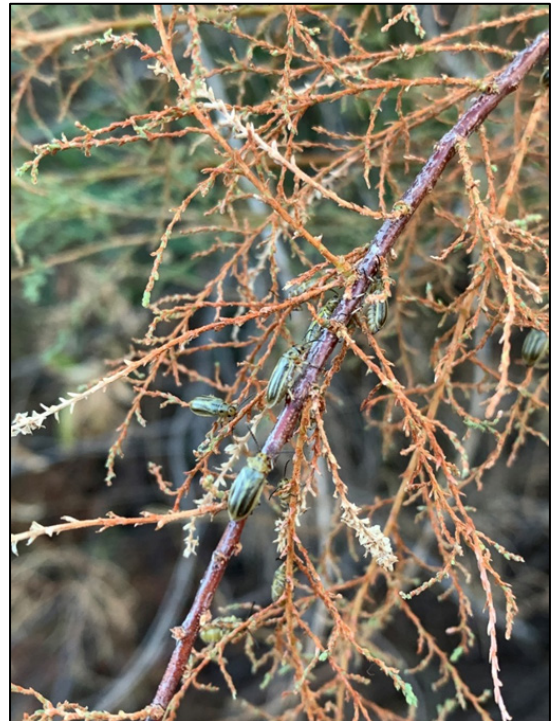
In accordance with Federal civil rights law and U.S. Department of Agriculture (USDA) civil rights regulations and policies, the USDA, its Agencies, offices, and employees, and institutions participating in or administering USDA programs are prohibited from discriminating based on race, color, national origin, religion, sex, gender identity (including gender expression), sexual orientation, disability, age, marital status, family/parental status, income derived from a public assistance program, political beliefs, or reprisal or retaliation for prior civil rights activity, in any program or activity conducted or funded by USDA (not all bases apply to all programs). Remedies and complaint filing deadlines vary by program or incident.

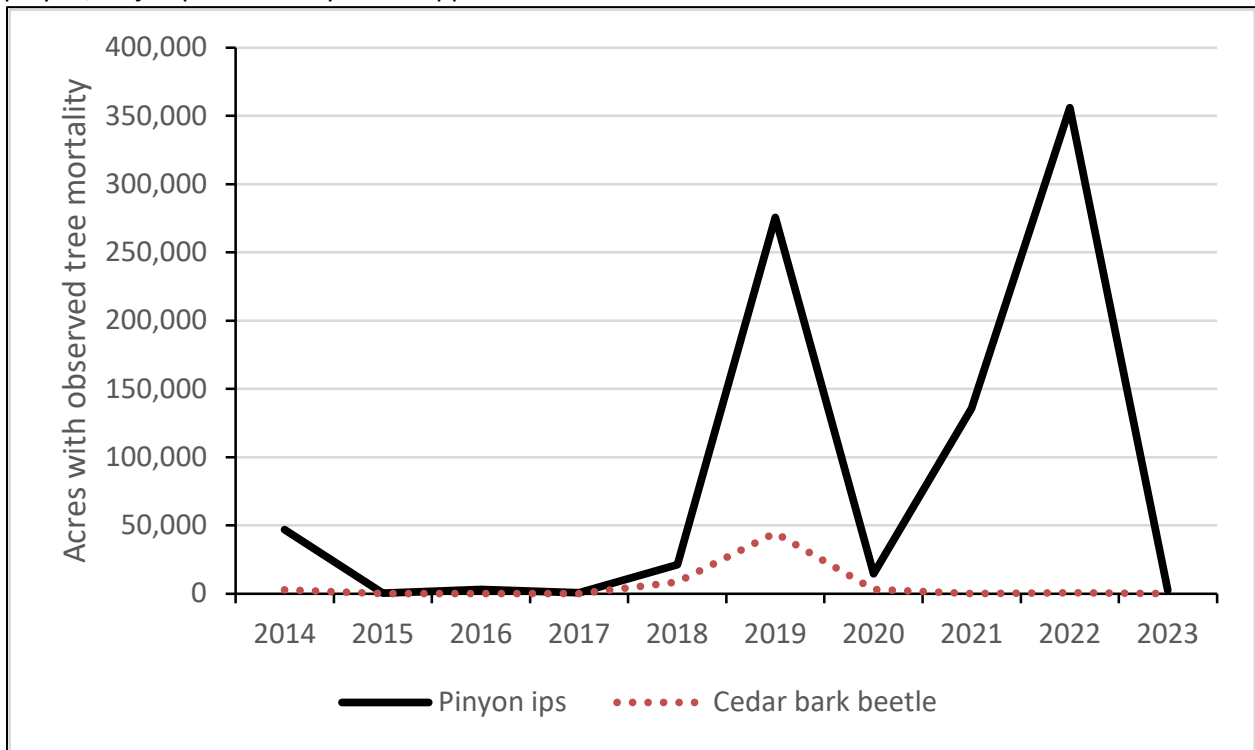
Figure 5: Pinyon-juniper mortality associated with pinyon ips and cedar bark beetles in the Southwestern Region over the last ten years.

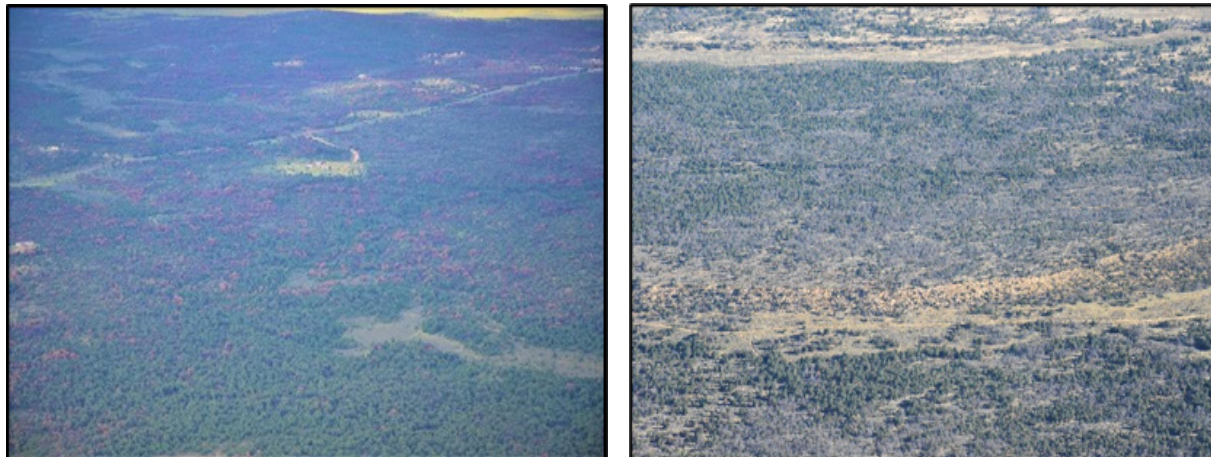
**Figure 6: Severe pinyon mortality was widespread on the Navajo Nation in 2022 (left) while dead pinyon persists (gray appearance) in 2023 (right).**

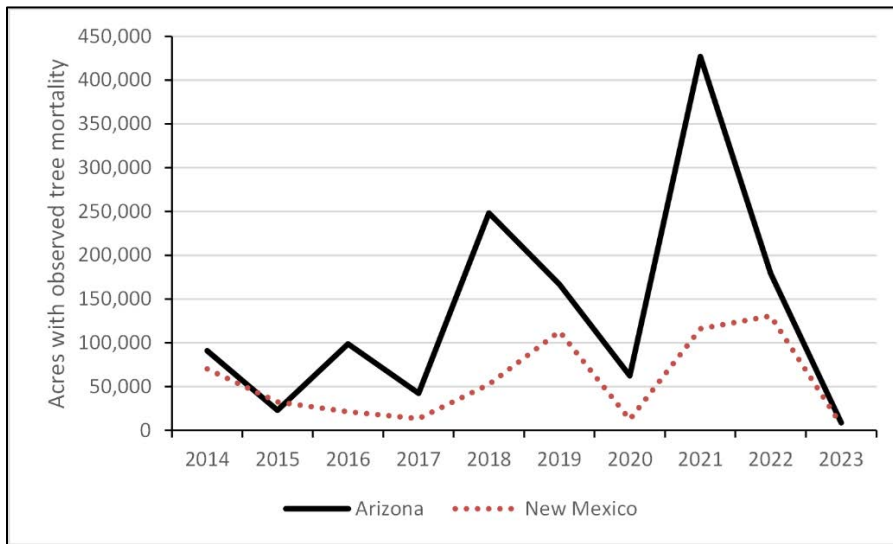
**Figure 7: Ponderosa pine mortality attributed to bark beetles in the Southwestern Region over the last ten years.**

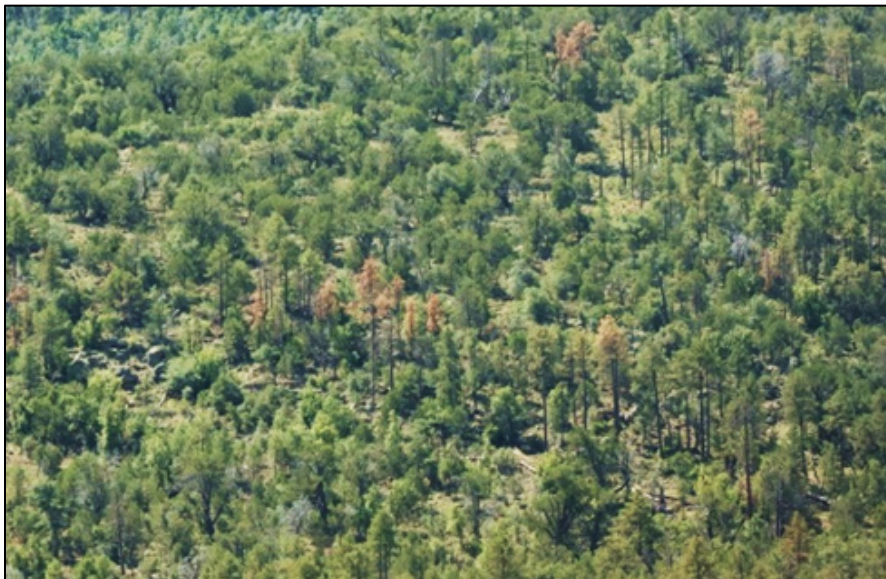
**Figure 8: Ponderosa pine mortality observed on San Carlos Apache Tribal Lands, Arizona in 2023.**

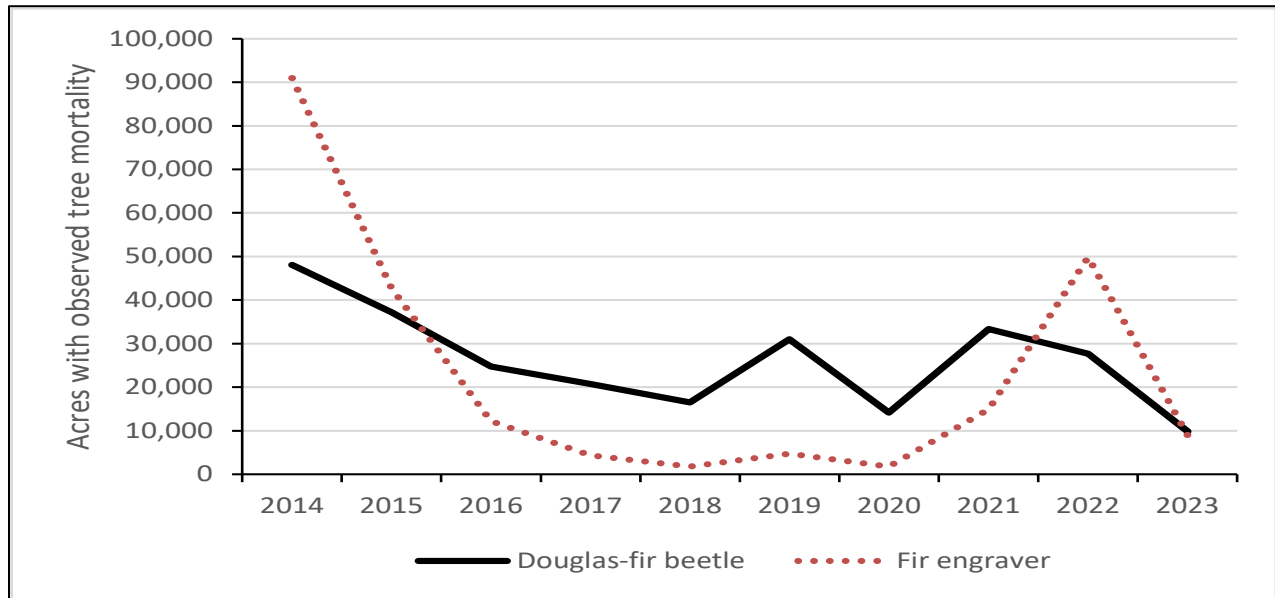
Figure 9: Mixed conifer mortality associated with Douglas-fir and fir engraver in the Southwestern Region over the last ten years.

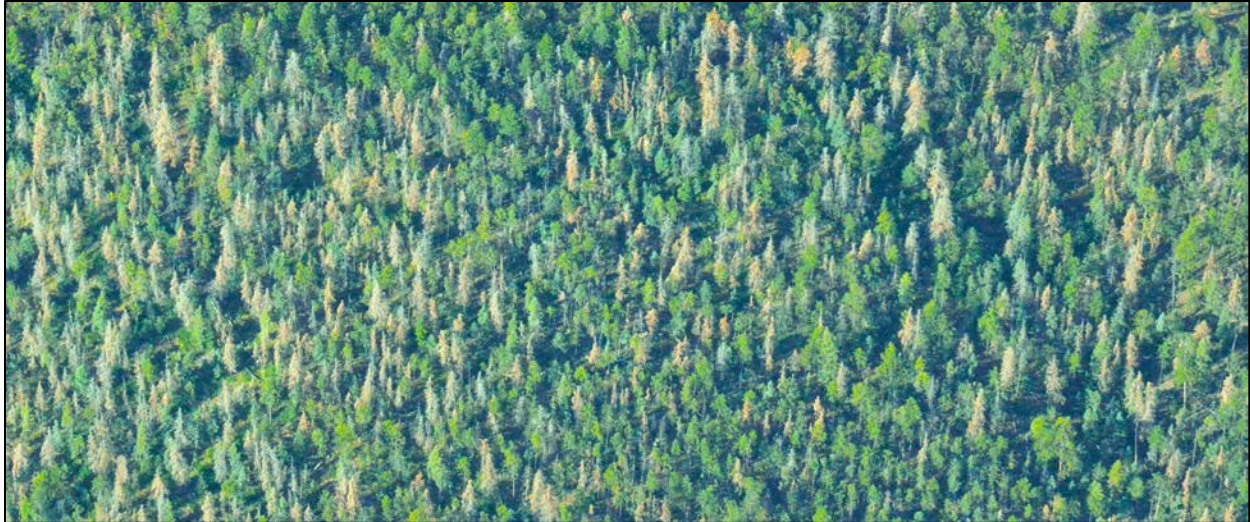
**Figure 11: White fir mortality (yellow trees) in the Pecos Wilderness on the Santa Fe National Forest, New Mexico, the scattered distribution of killed trees is characteristic of attack by fir engraver beetles.**

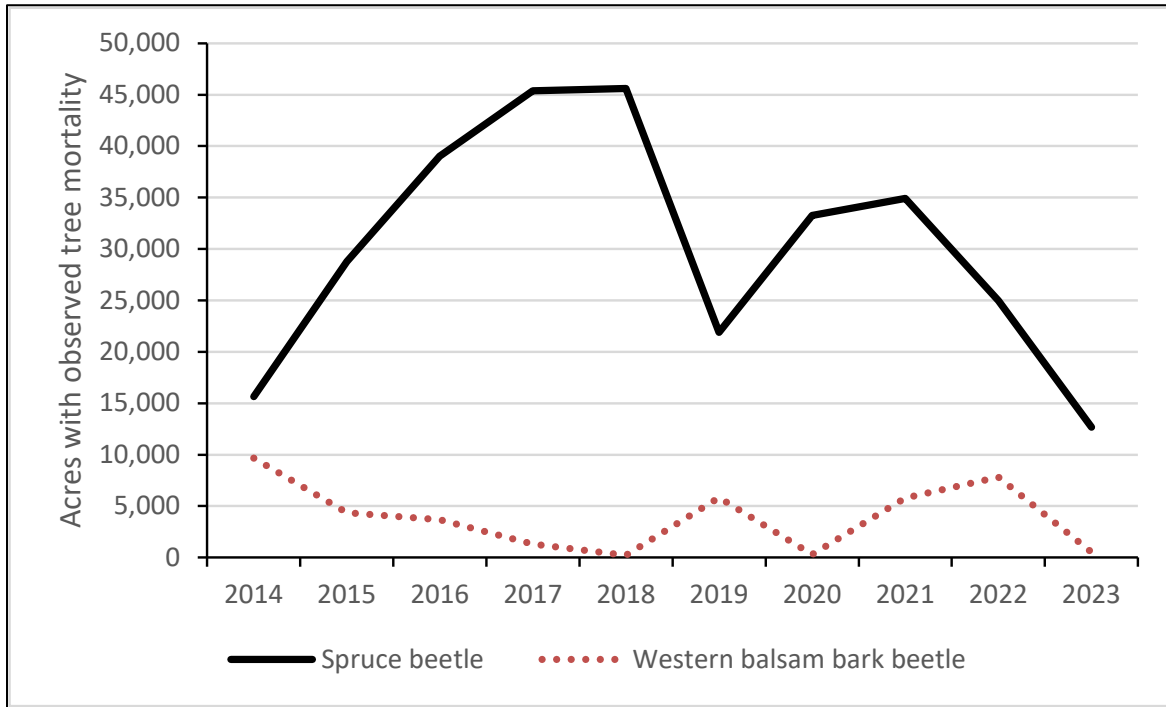
**Figure 12: Tree mortality in spruce-fir forests attributed to spruce beetle and western balsam bark beetle in the Southwestern Region over the last ten years.**

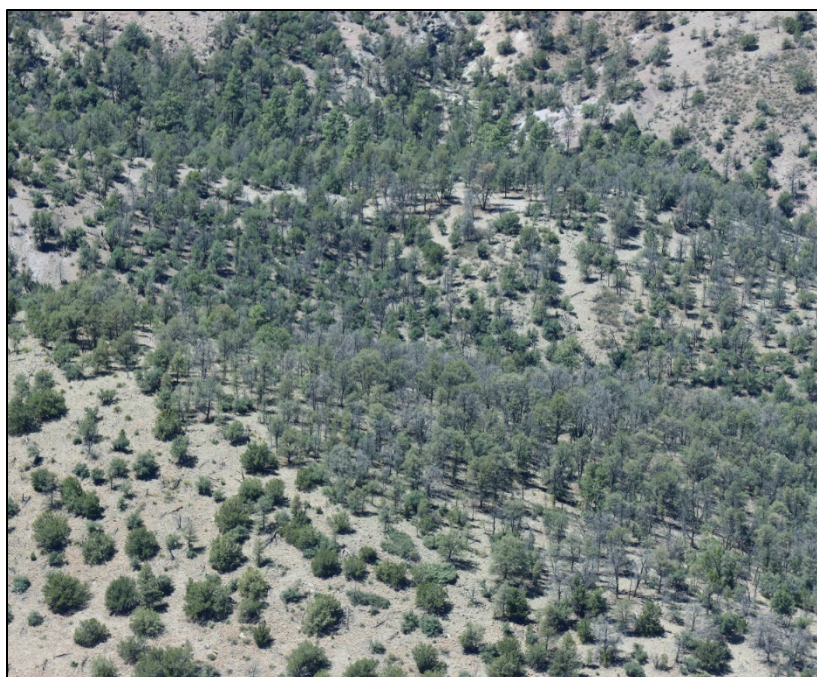
**Figure 13: Chronic pinyon needle scale and drought caused thin crowns resulting in widespread pinyon stress and mortality on the Clifton Ranger District, Apache-Sitgreaves National Forests, Arizona.**

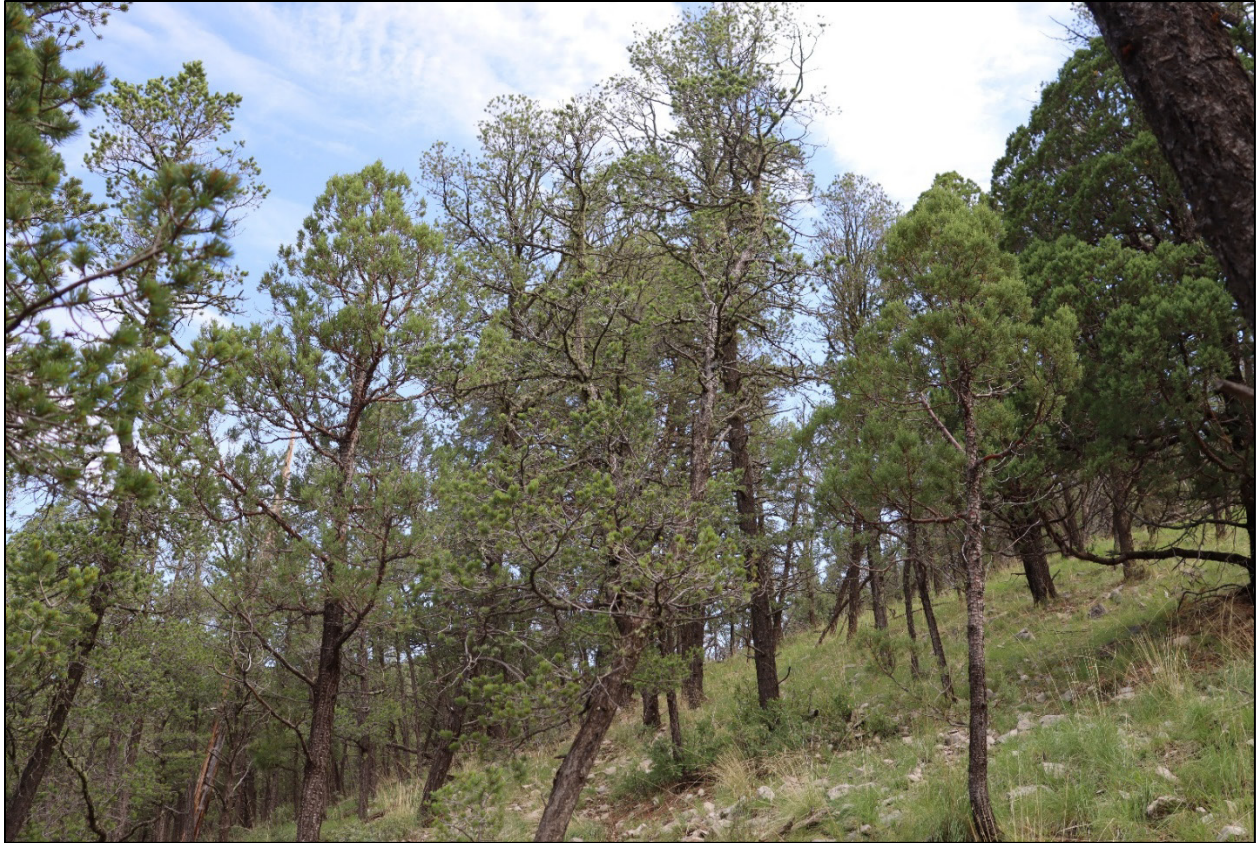
Figure 14: “Thinynon” symptoms characteristic of pinyon stands across Mescalero Apache Tribal Lands and Lincoln National Forest in New Mexico due largely to pinyon needle scale.

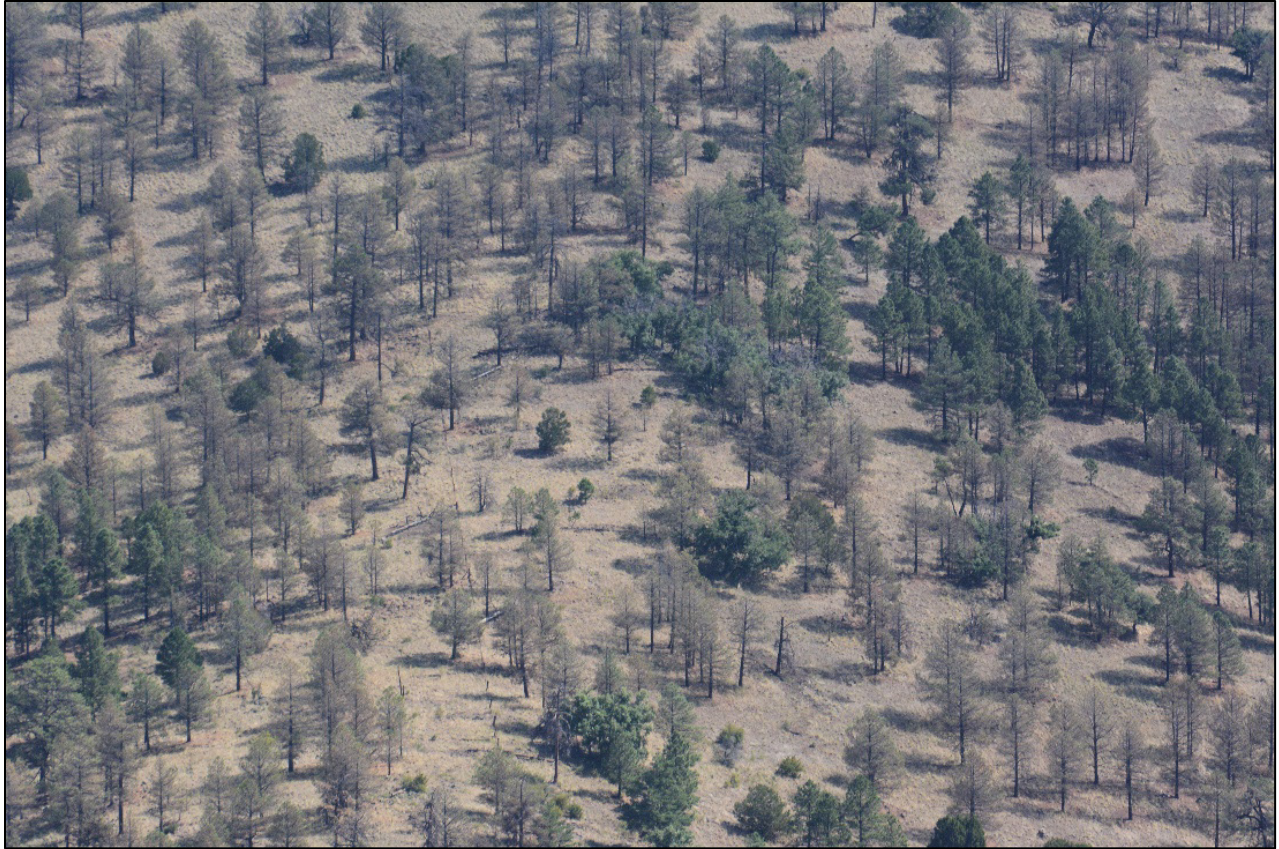
**Figure 15: Defoliation of ponderosa pine from suspected sawfly activity (gray/green trees) on Elk Mountain, Reserve Ranger District, Gila National Forest, New Mexico.**

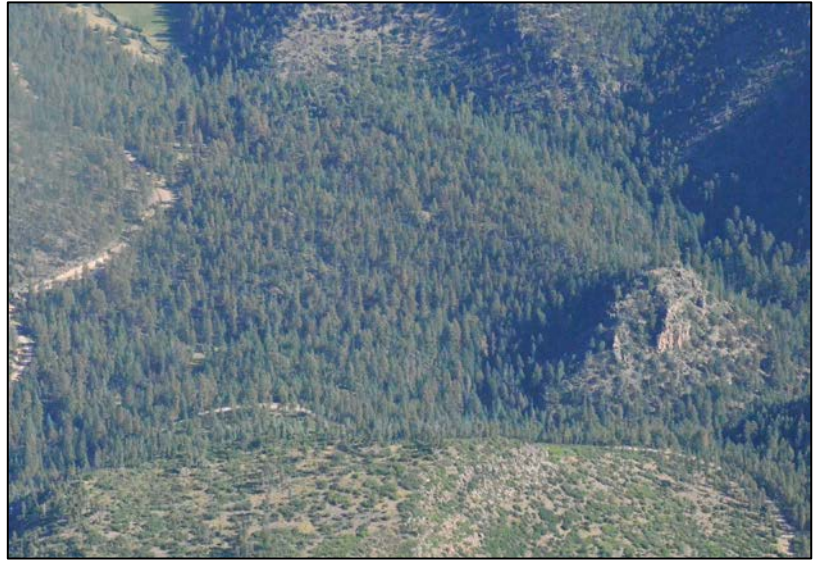
**Figure 16: Needleminer damage in a ponderosa pine stand on the Jemez Mountains, New Mexico.**

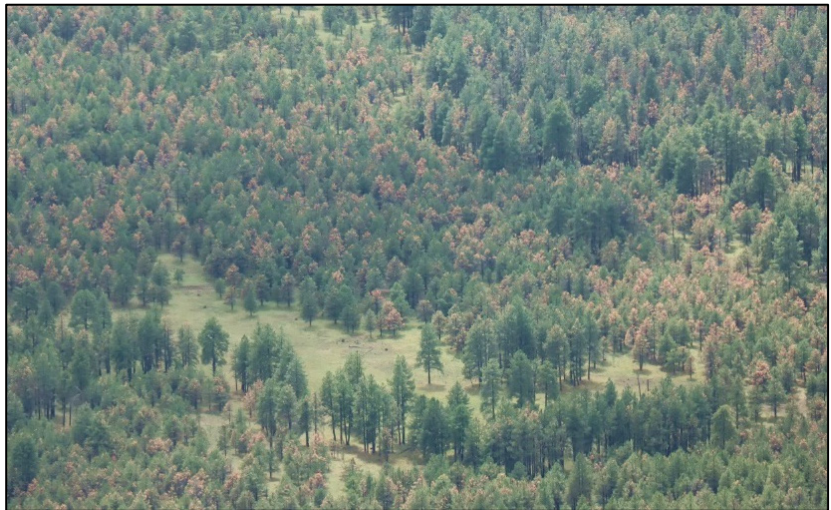
**Figure 17: Branch flagging (trees with branches with red foliage) in ponderosa pine caused by the Prescott needle scale on White Mountain Apache Tribal Lands in Arizona.**

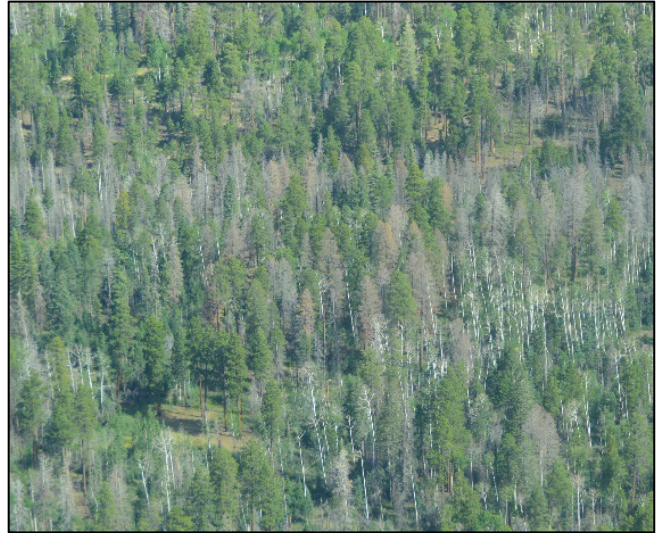
**Figure 18: Mixed conifer mortality and aspen damage observed on the North Rim of the Grand Canyon National Park, Arizona in 2023.**

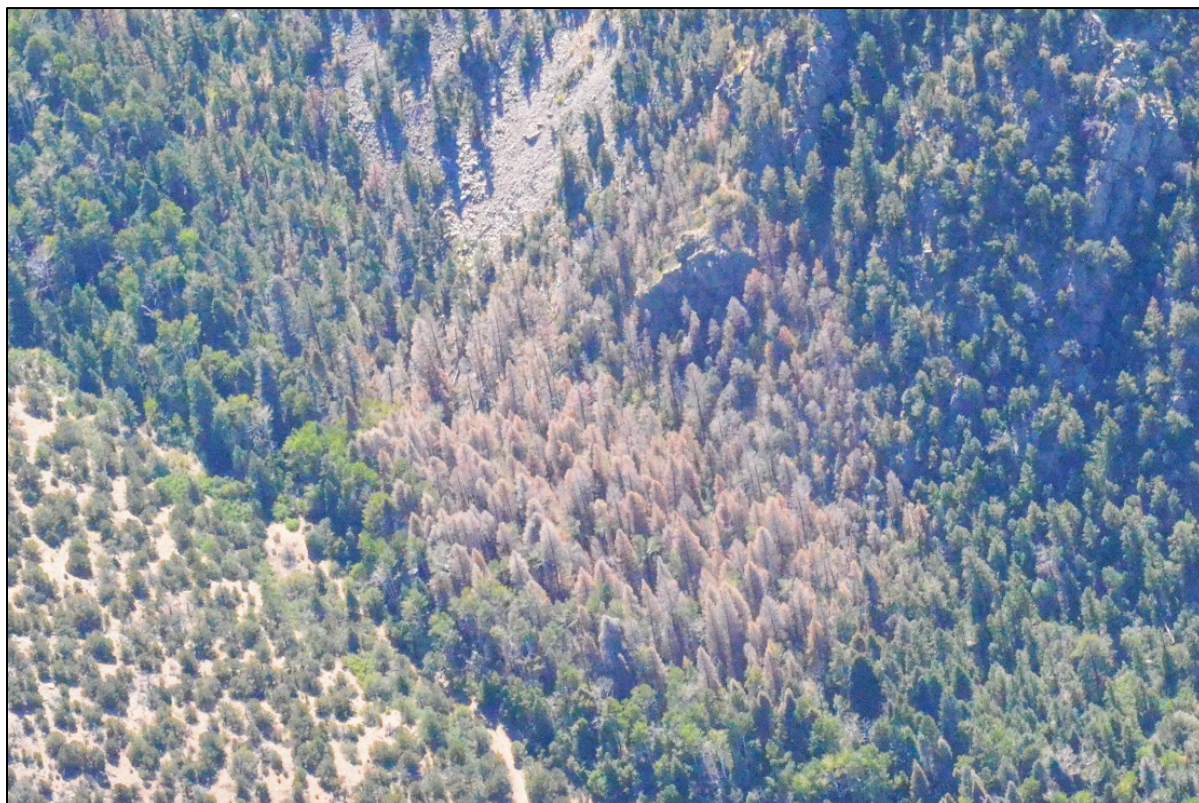
**Figure 19: Douglas-fir tussock moth affected 58 acres of mixed conifer (reddish grey) in Rito Premero, Rito del Medio, Latir Creek as well as Arroyo Seco of the Questa Ranger District on the Carson National Forest, New Mexico.**

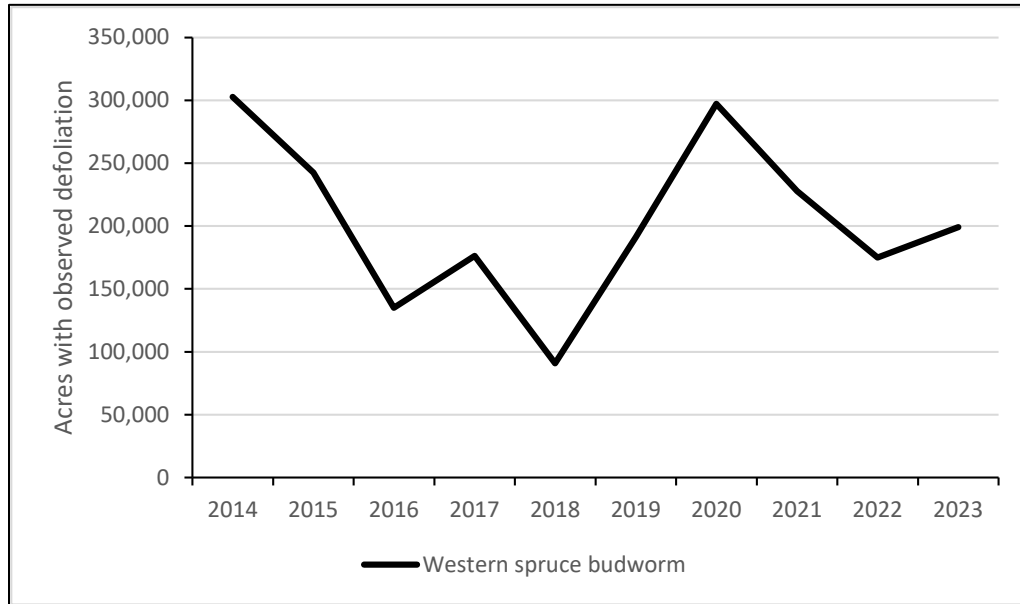
**Figure 20: Defoliation attributed to western spruce budworm in the Southwestern Region for the last ten years.**

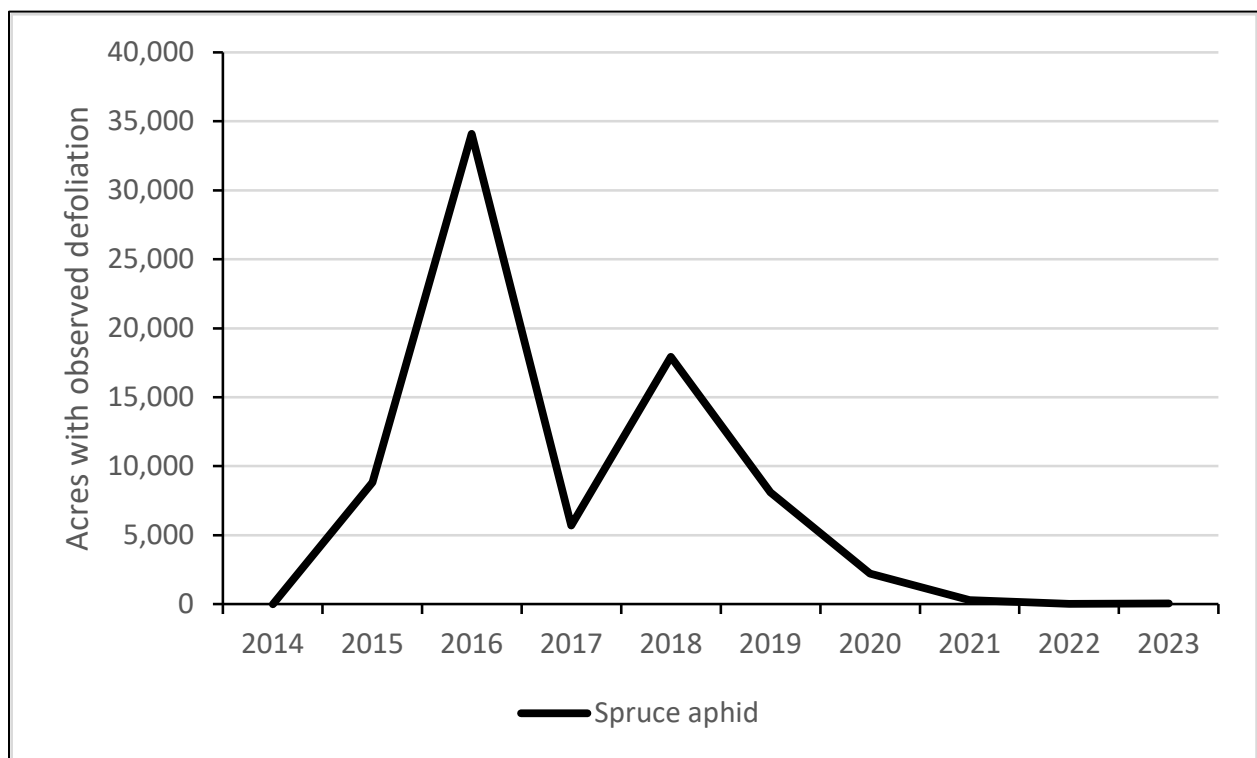
Figure 22: Defoliation attributed to spruce aphid in the Southwestern Region over the last 10 years.

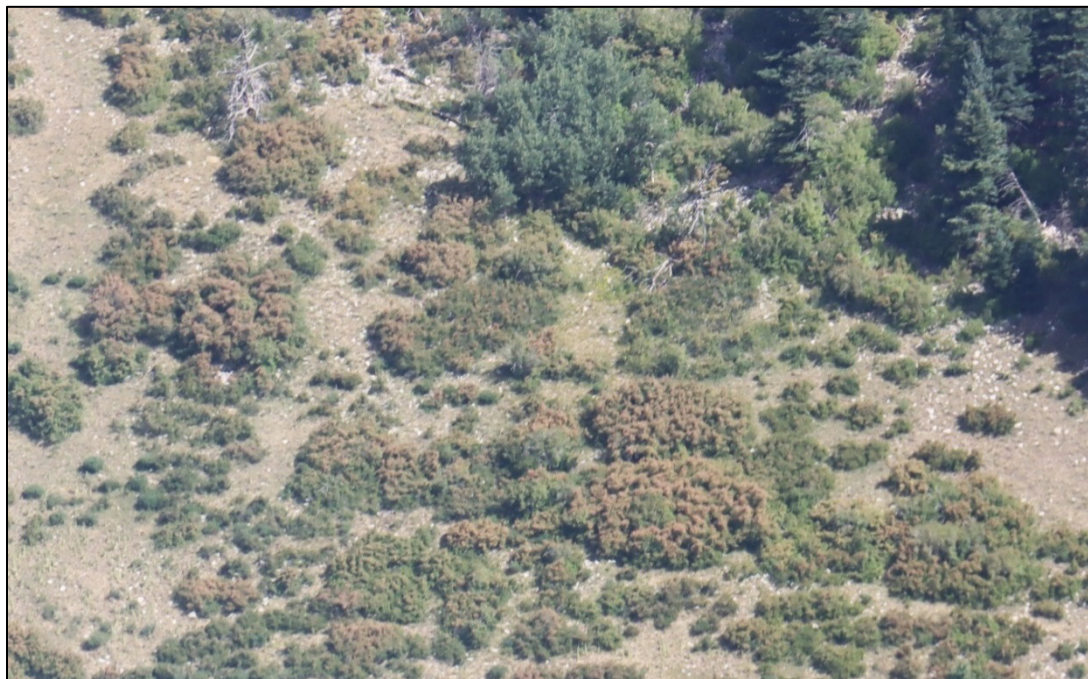
**Figure 23: Oak defoliation (yellow gray tops) in Nogal Canyon, Lincoln National Forest, New Mexico.**

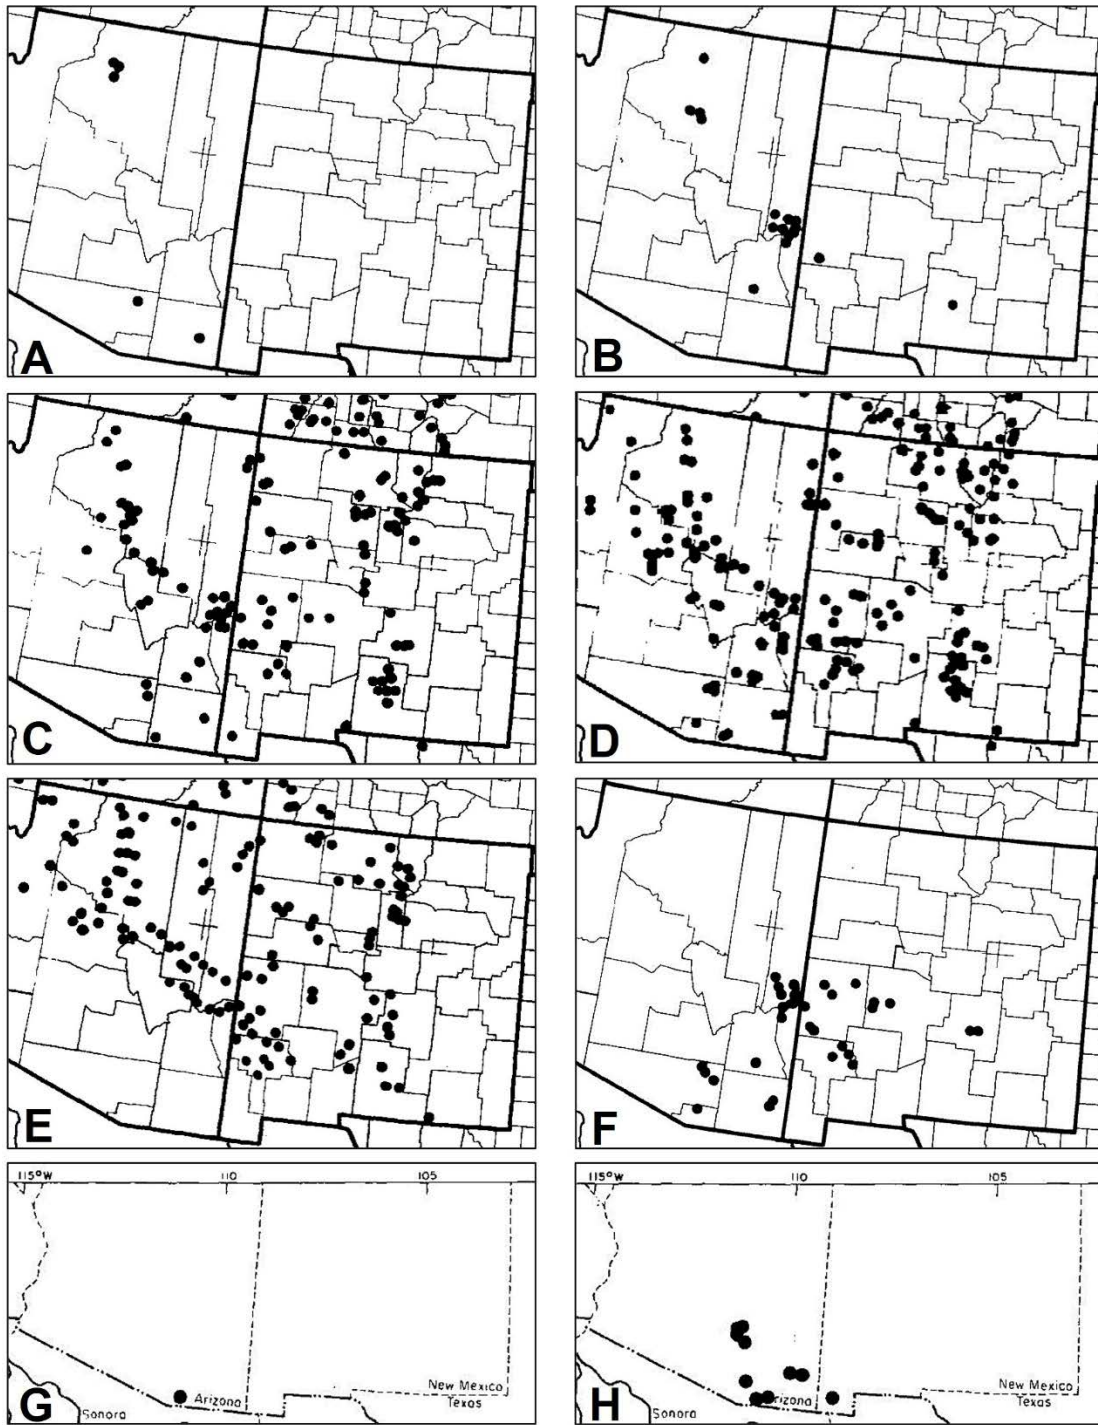
Figure 24: Distributions of dwarf mistletoe species in the Southwestern Region principally infecting white fir (A, *Arceuthobium abietinum* f. sp. *concoloris*), spruce (B, *A. macrocarpum*), Douglas-fir (C, *A. douglasii*), ponderosa pine (D, *A. vaginatum* subsp. *cryptopodum*), pinyon pine (E, *A. divaricatum*), southwestern white pine (F, *A. apachecum* and G, *A. blumeri*), and Chihuahua pine (H, *A. gillii*). Maps are adapted from Hawksworth and Wiens (1996).

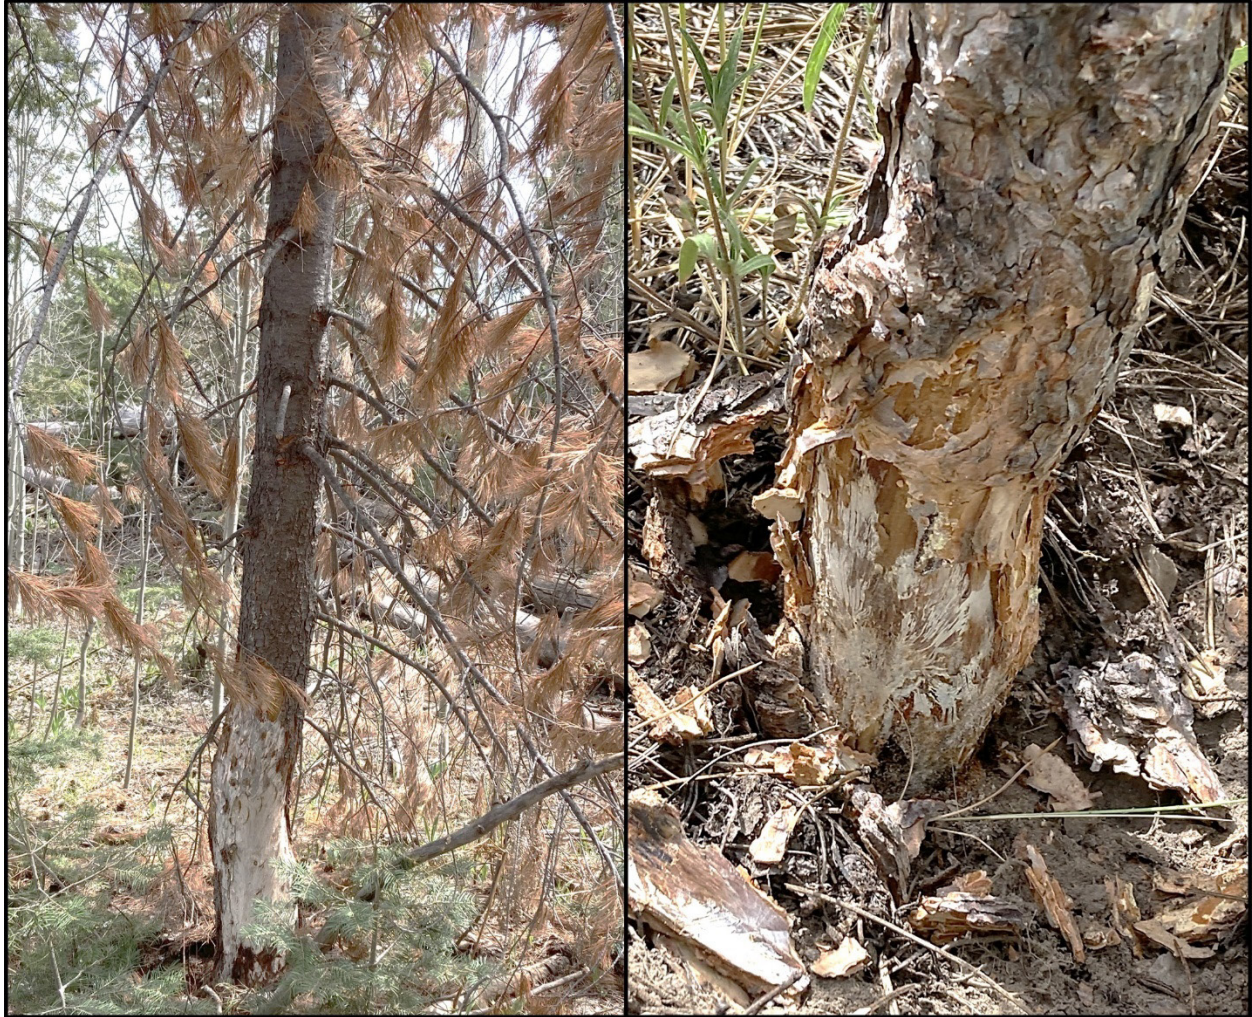
**Figure 26: Recent Southwestern white pine mortality with severe *Armillaria* root disease as indicated by the white mycelial fan (left). Ponderosa pine with *Armillaria* root disease displaying diagnostic white mycelial fan (right).**

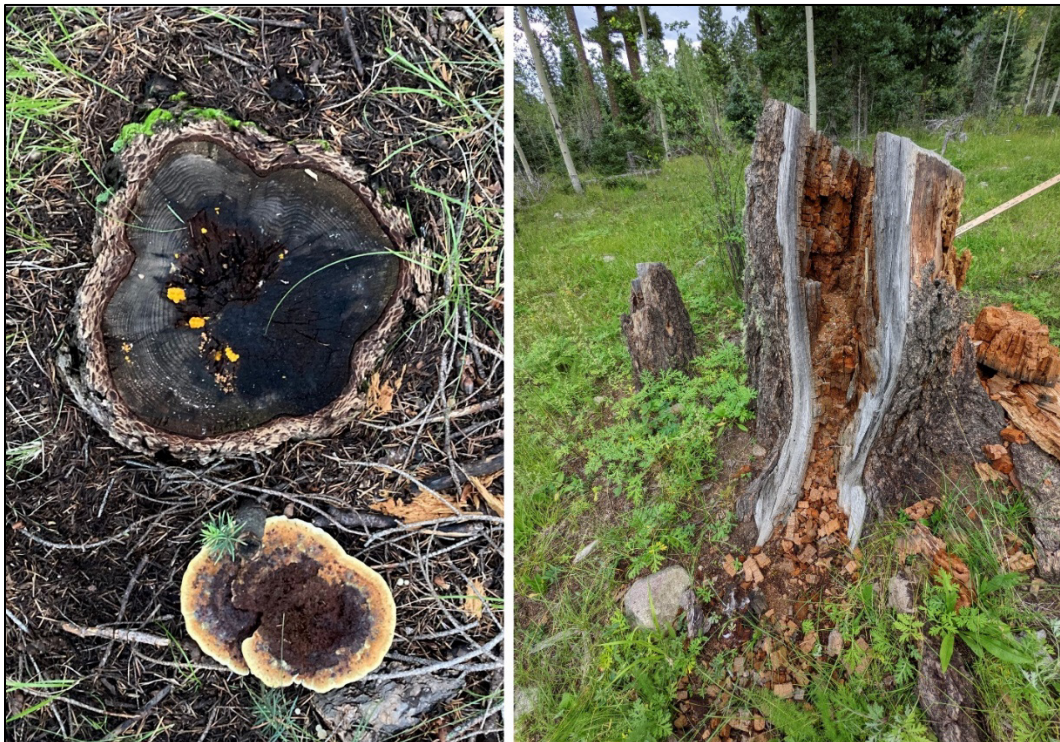
Figure 27: *Phaeolus schweinitzii* fruiting body next to an infected cut stump (left) and the characteristic brown rot caused by this root disease pathogen (right).

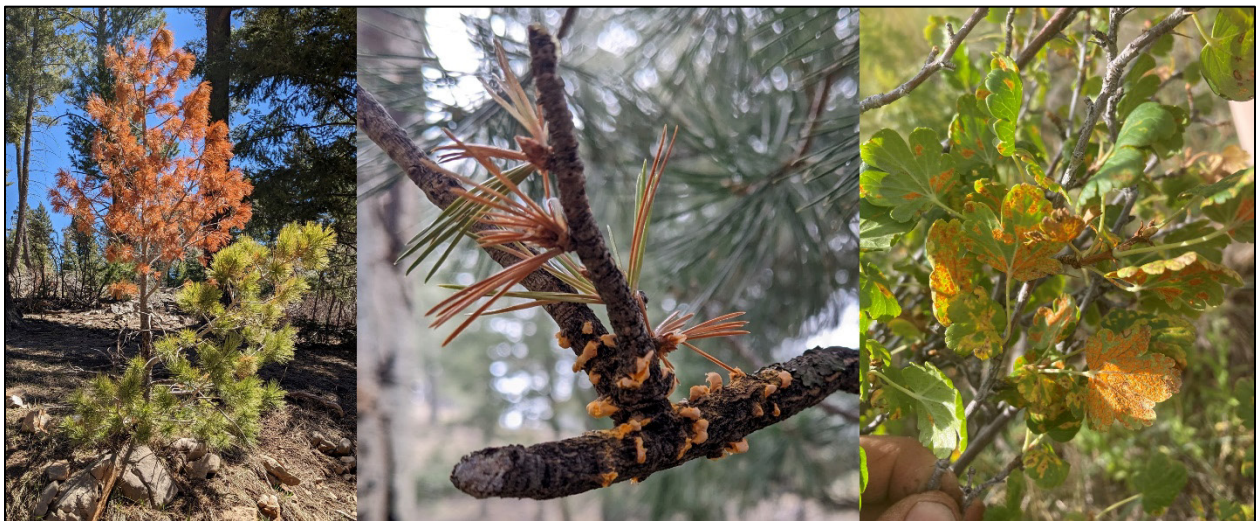
**Figure 28: White pine blister rust-caused topkill on a southwestern white pine in the Sacramento Mountains, New Mexico (left), aecial spore sacs on an infected branch in the Zuni Mountains, New Mexico (center), and heavy production of uredospores on *Ribes*, an alternate host of this invasive disease (right).**

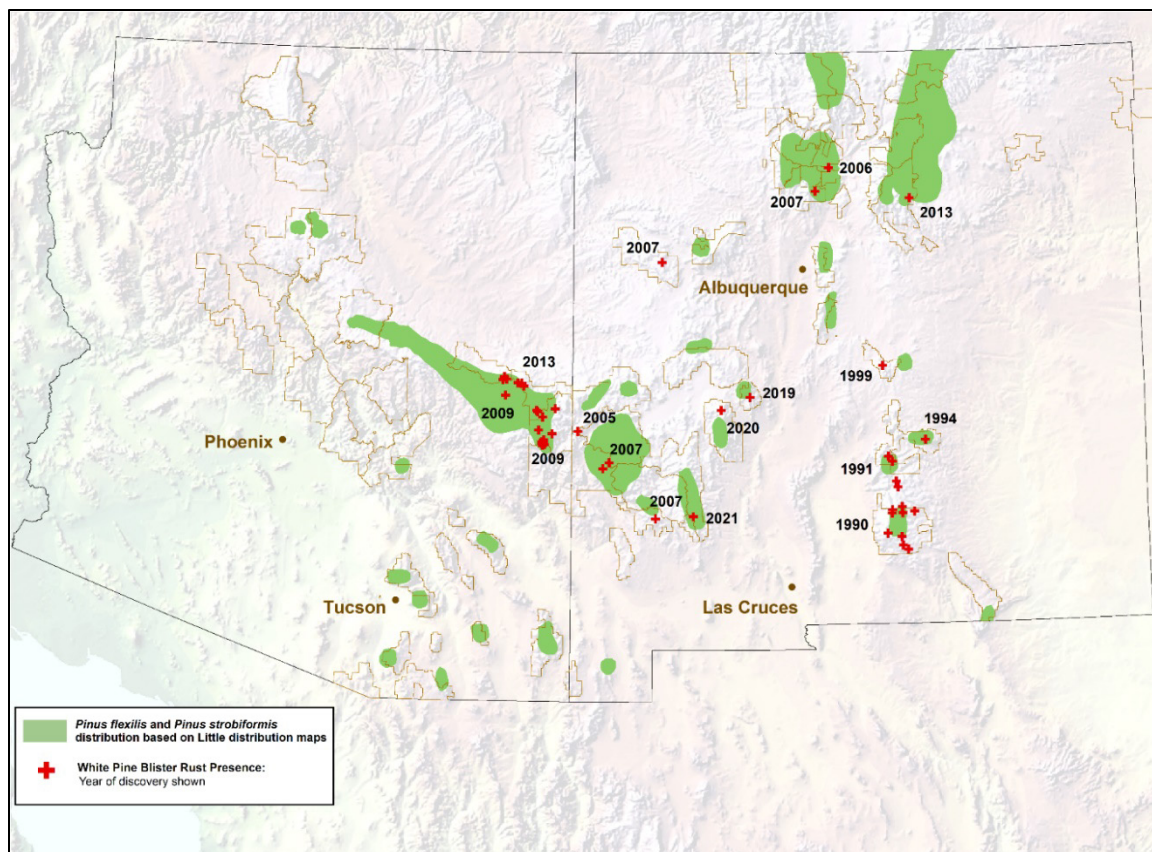
**Figure 29. Distribution of known white pine blister rust infection centers within the Southwestern Region and the year in which they were discovered. USDA Forest Service image.**

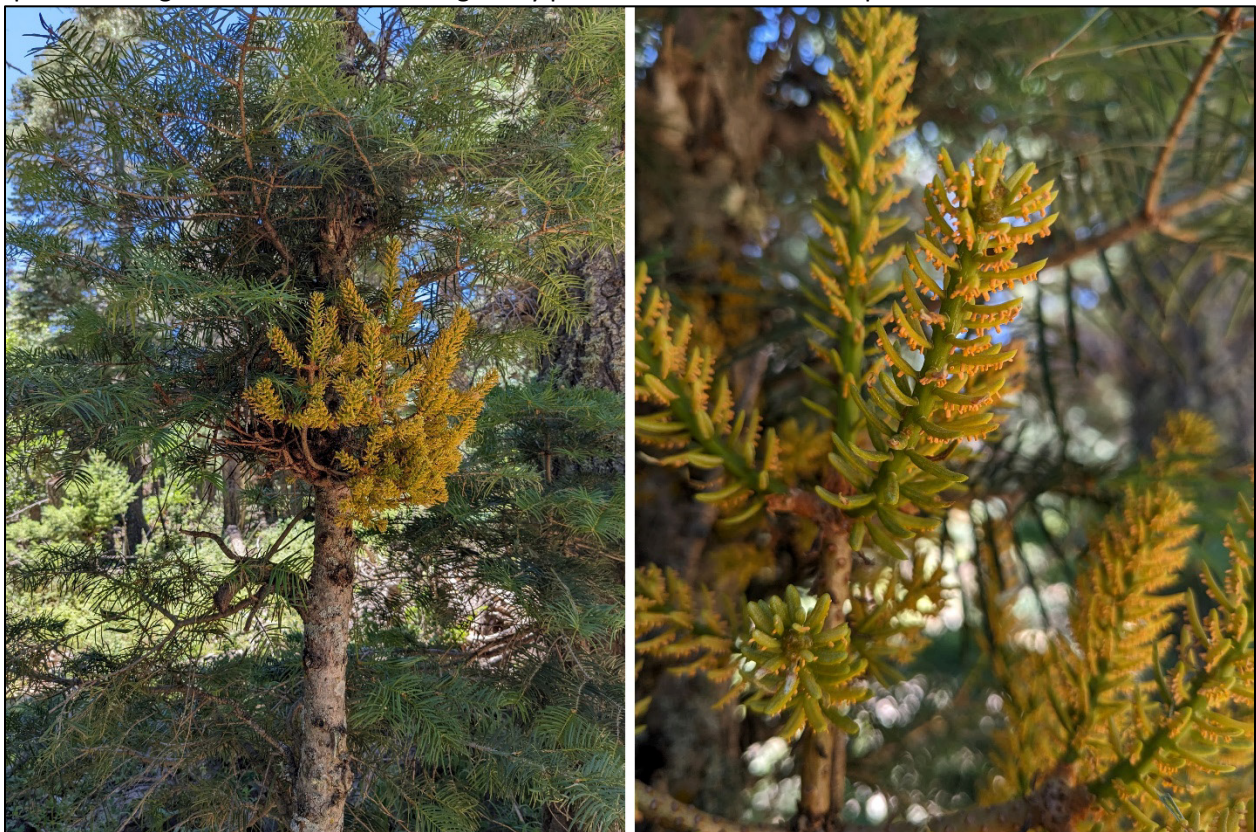
**Figure 30: Fir broom rust symptoms on a white fir in the Sandia Mountains, New Mexico (left) and the aecial spore sacs on needles within the broom (right).**

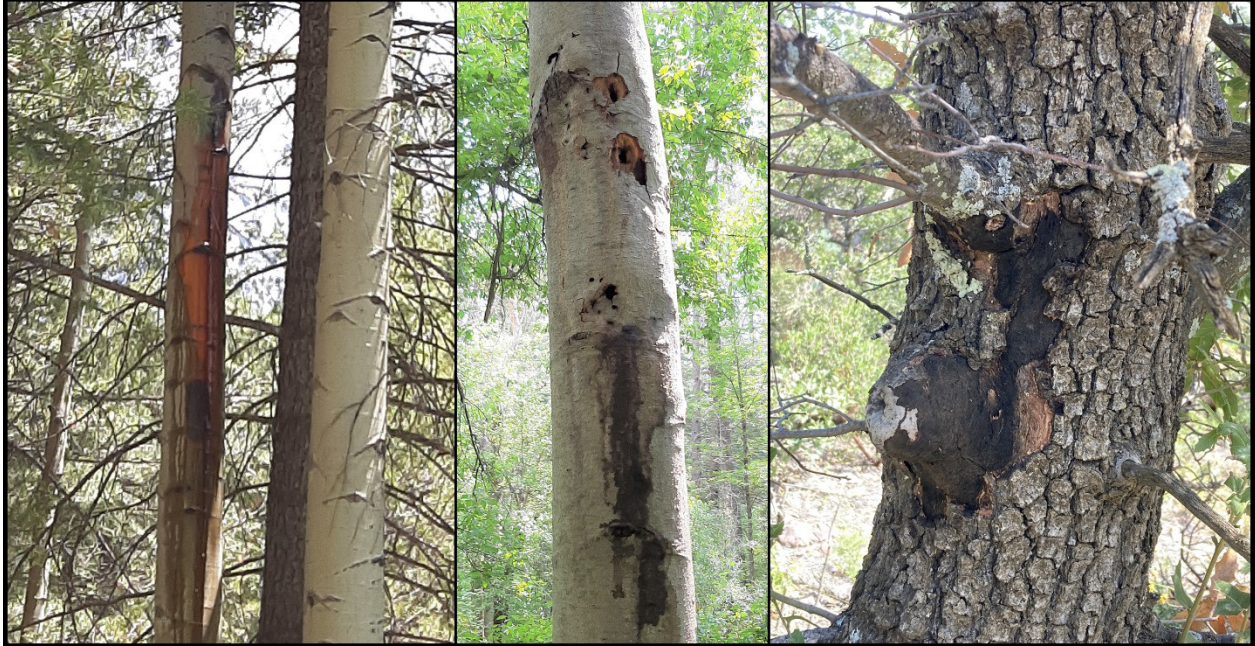
**Figure 31: Orange discoloration, oozing, and diffuse pattern associated with cytospora on aspen (left). Sunken tissue and diffuse pattern associated with alder heat canker; note the beetle and woodpecker activity which is commonly associated with this canker and alder dieback in Arizona (middle). Flat, dark fruiting body of *Biscogniauxia* spp. And associated canker on Emory oak.**

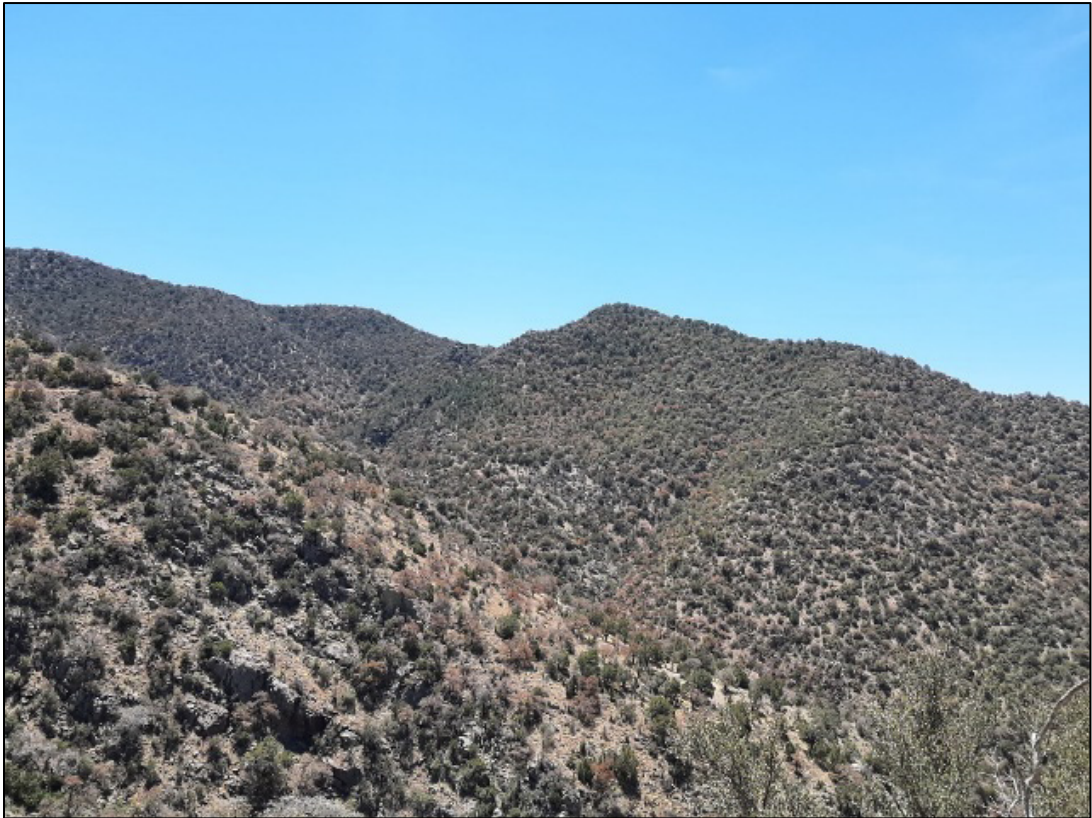
**Figure 32: Damaged and discolored oaks on the Coronado National Forest likely due to *Biscogniauxia* spp.**
