Forest Service  
U.S. DEPARTMENT OF AGRICULTURE

Southwestern Region | PR-R3-16-24 | August 2024

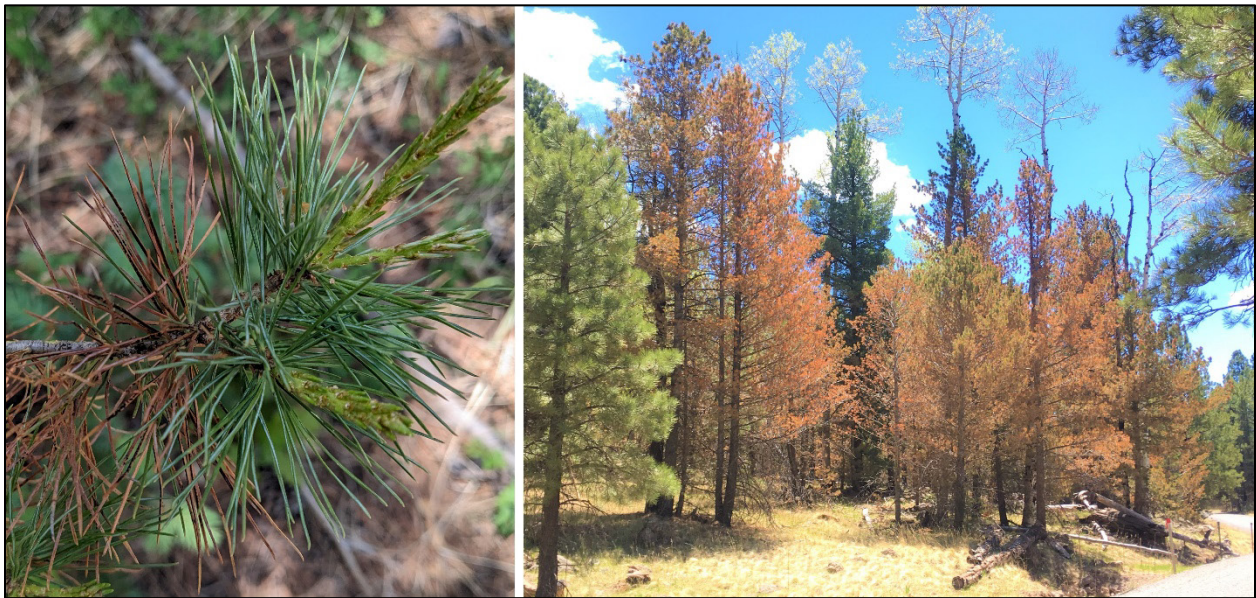
**Figure 33: *Bifusella* needle cast symptoms and elongated black fruiting bodies on older needles killed by the disease in an understory southwestern white pine on Mescalero Apache Tribal Lands in New Mexico (left), and southwestern white pine exhibiting red crown discoloration due to *Lophodermella arcuata* infection on the Coconino National Forest in Arizona (right); note the dark green ponderosa pine which is not susceptible to this disease.**

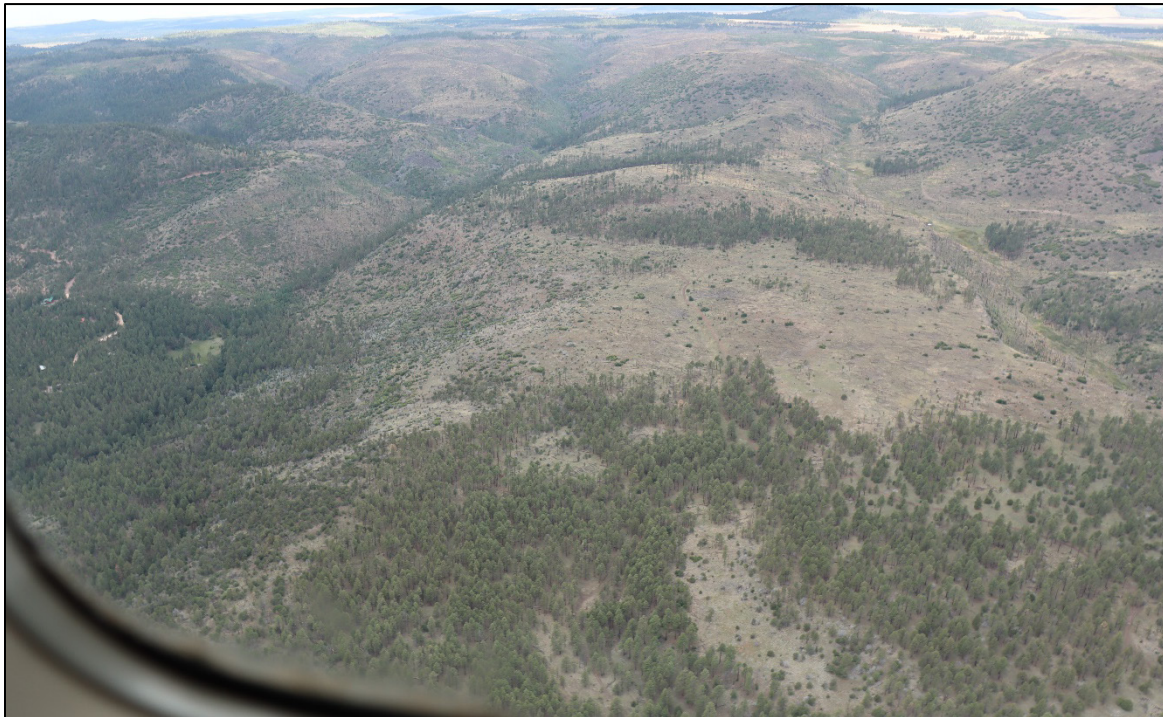
**Figure 34: Drought-stressed, discolored ponderosa on White Mountain Apache Tribal Lands in eastern Arizona, August 2023.**

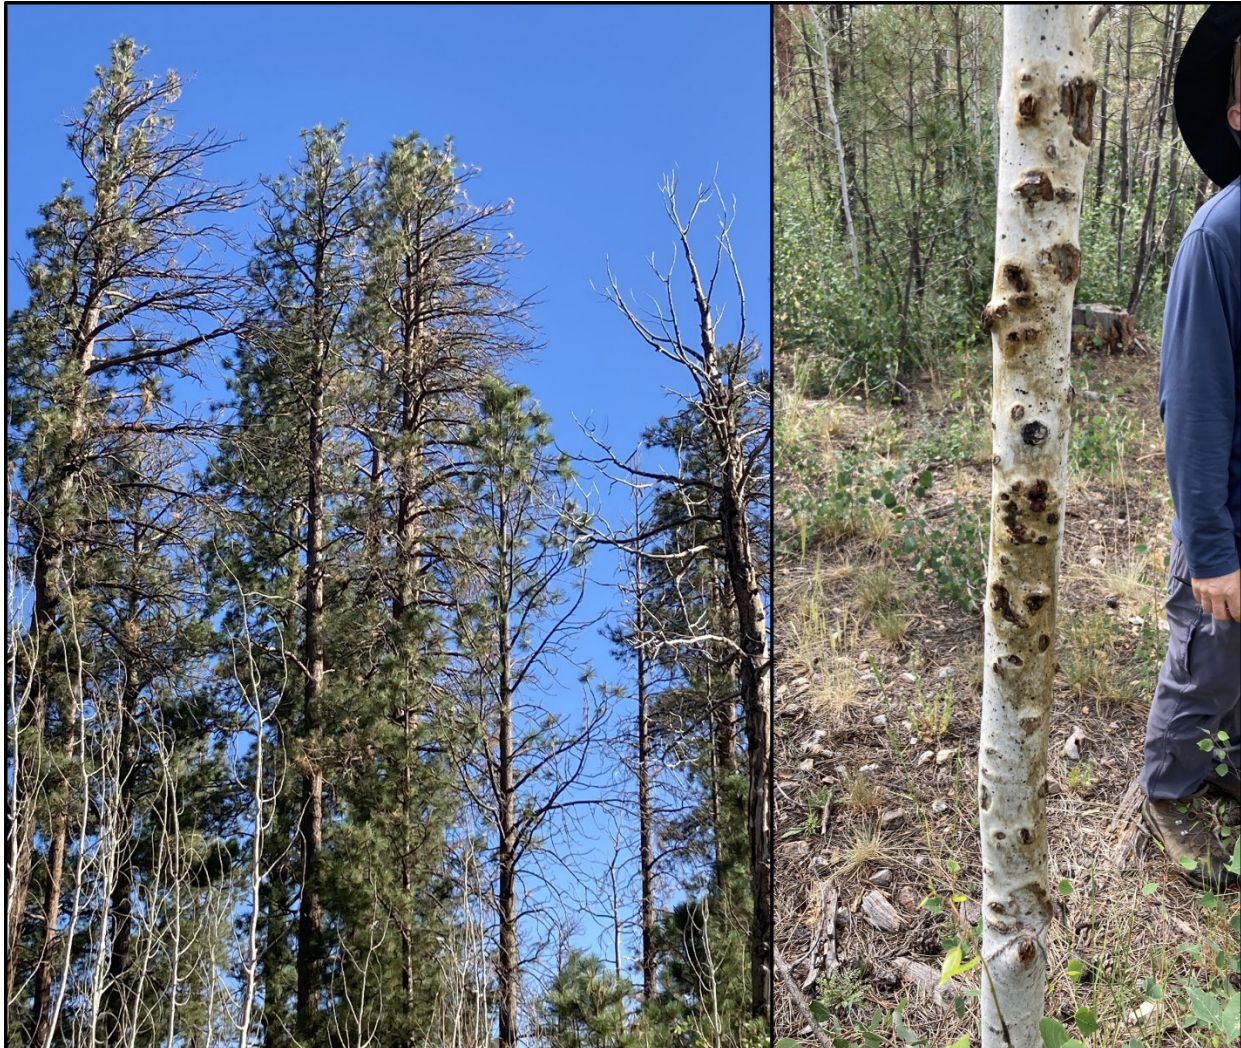
**Figure 35: Ponderosa pine exhibiting thin, hail damaged crowns with damage most severe on the south side (left). Aspen displaying mechanical damage from hail and subsequent cankers. Damage was most severe on the south side of the stem (right).**

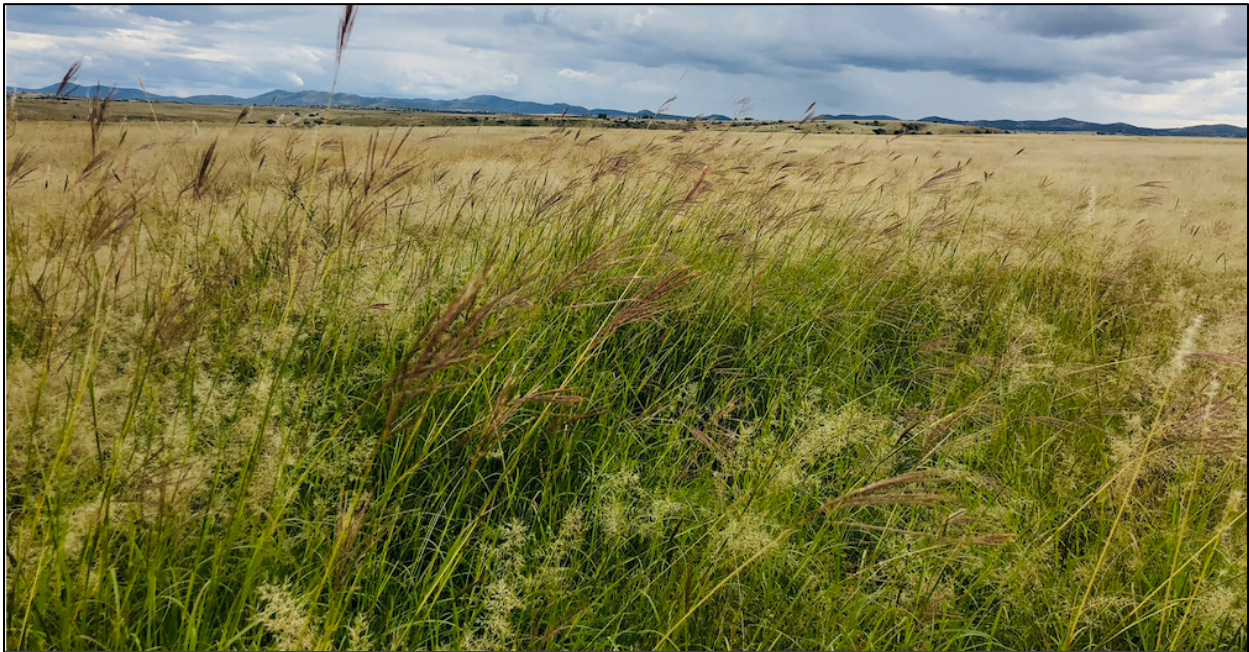
Figure 36. Yellow bluestem near Algin, Arizona. Borderlands Restoration Network photo.

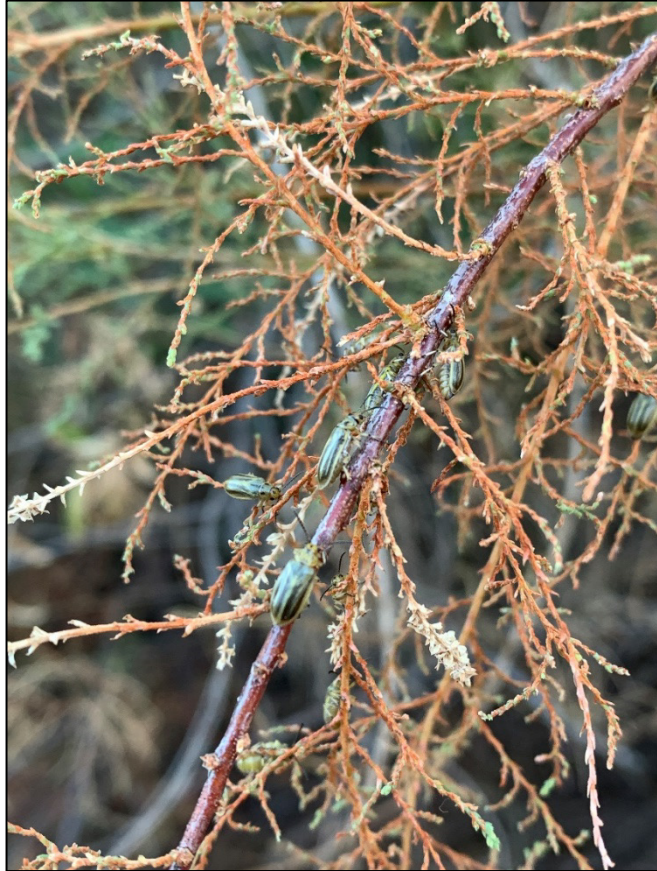
Figure 37. Tamarisk leaf beetle. USDA Forest Service photo by Camden Bruner.

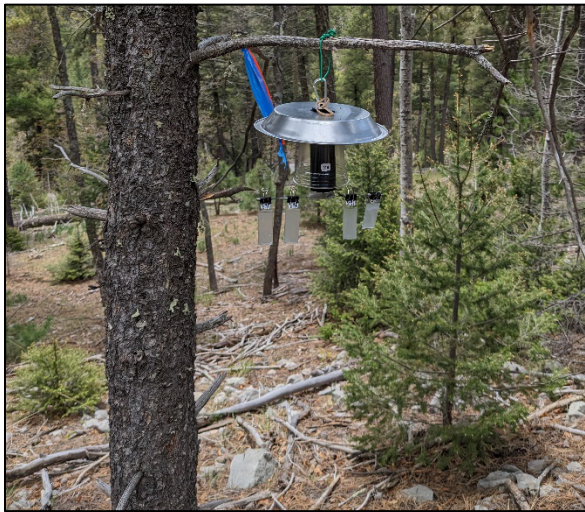
**Figure 38: A motorized, rotating spore trap used to monitor airborne spores of *Cronartium ribicola*, the cause of white pine blister rust; spores are intercepted on microscope slides coated with petroleum jelly and quantified weekly using qPCR.**
