Monitoring the Viers Creek Wetland Improvement Project July 27, 2007

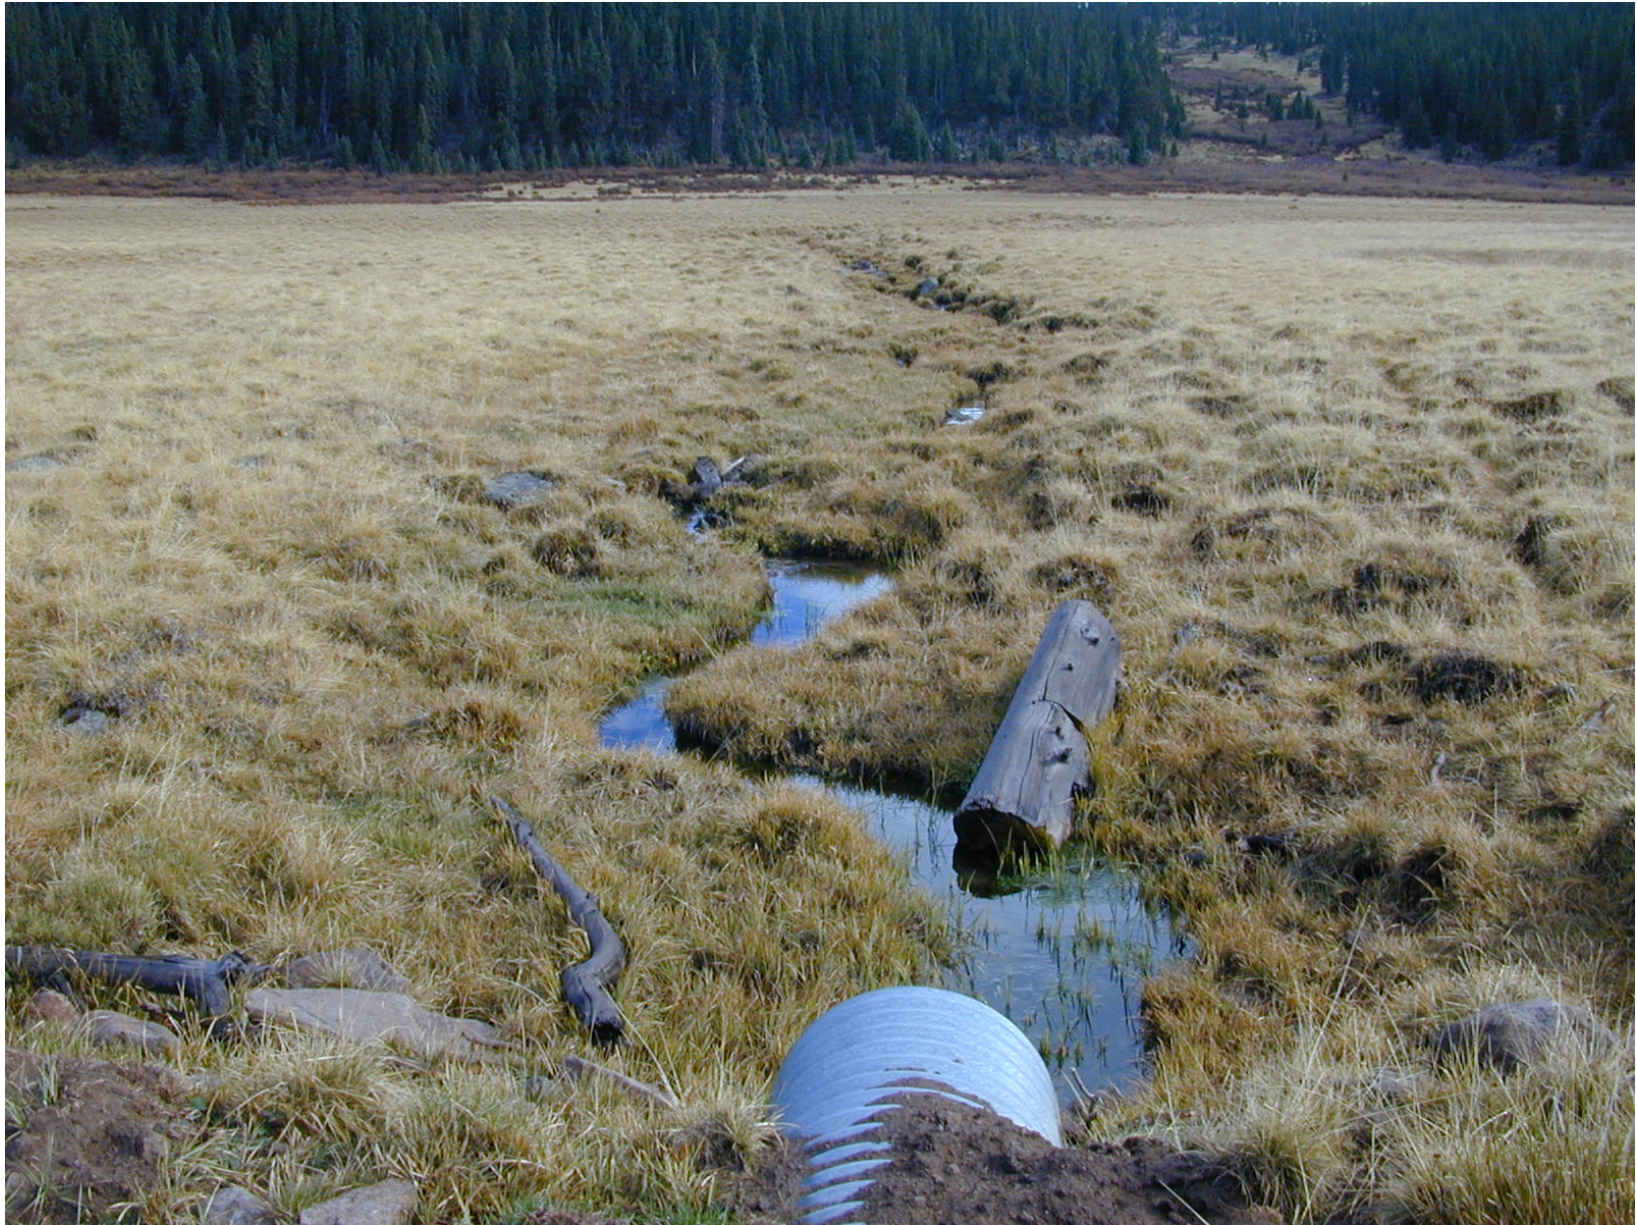
In 2000, a wetland improvements project was undertaken to restore a de-watered wetland. The project occurs along a FS system road where Viers Creek crosses. The original culvert installed de-watered the wetland by lowering the flow point. Cutbanks were caving and vegetation was losing sedges in favor of drier species. The first photo was taken before the project in 2000.

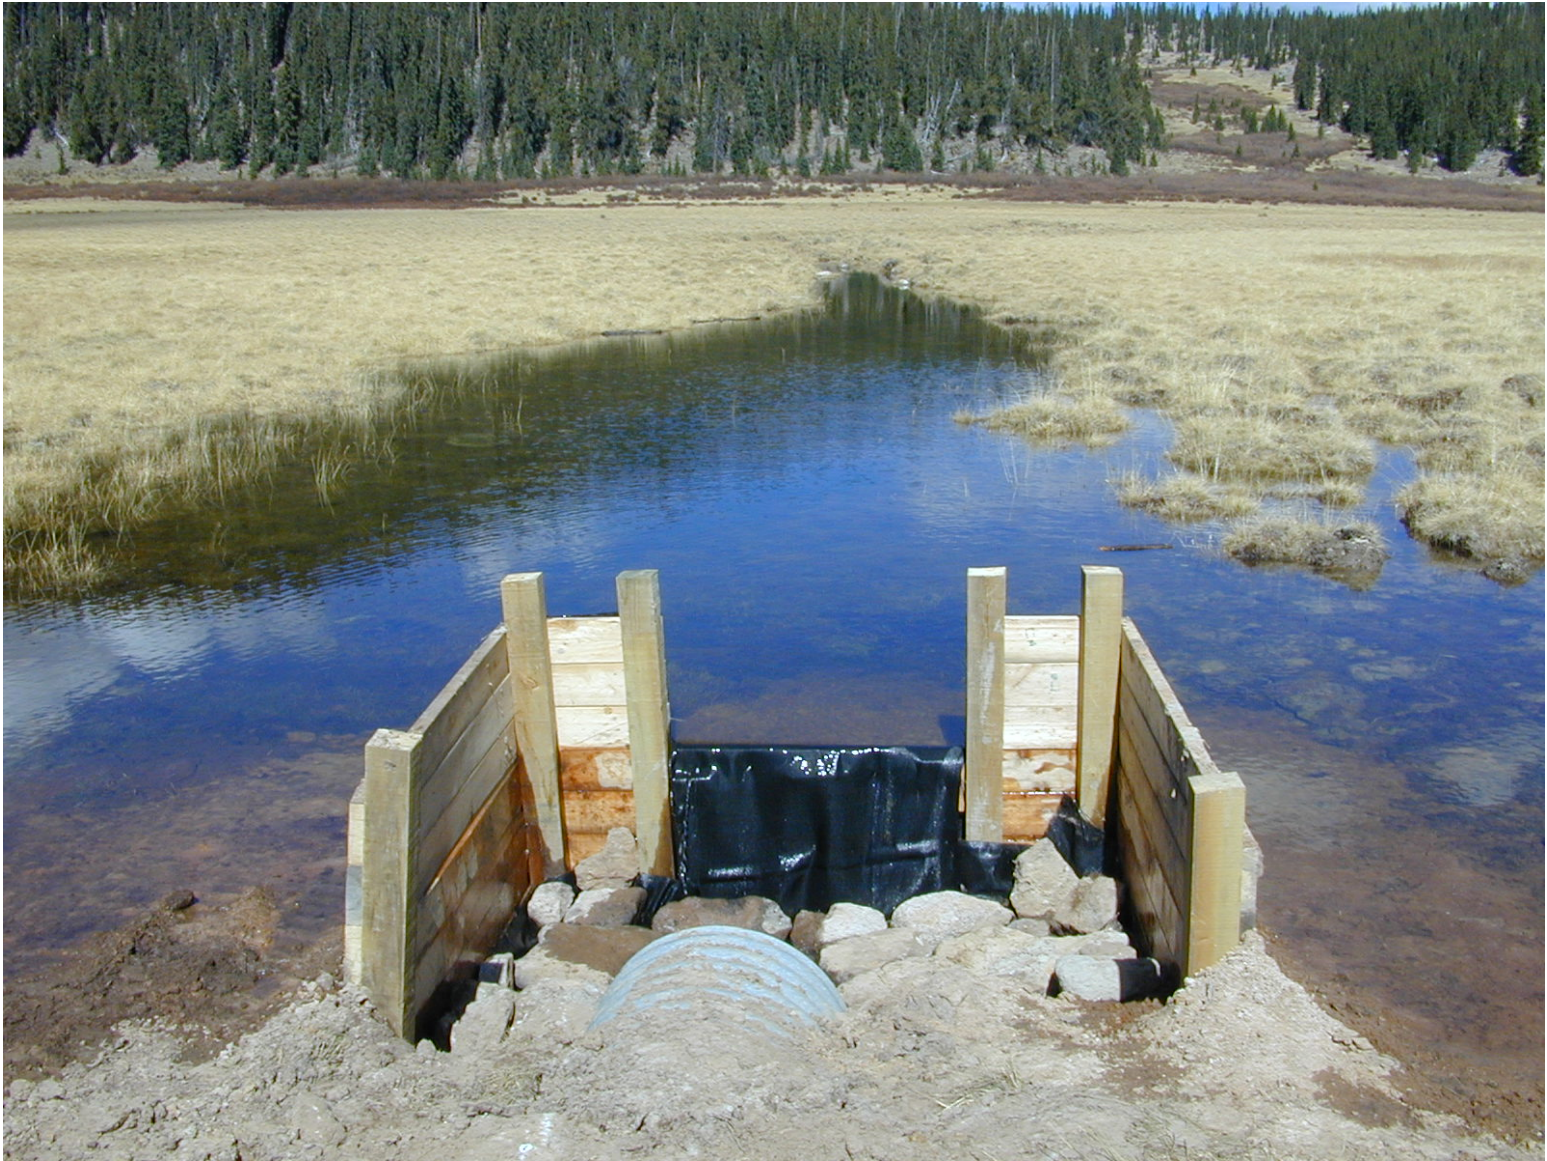
In 2000, a wetland restoration structure was built to raise back the water table. We used treated lumber and crude materials. The second photo shows the area after construction.

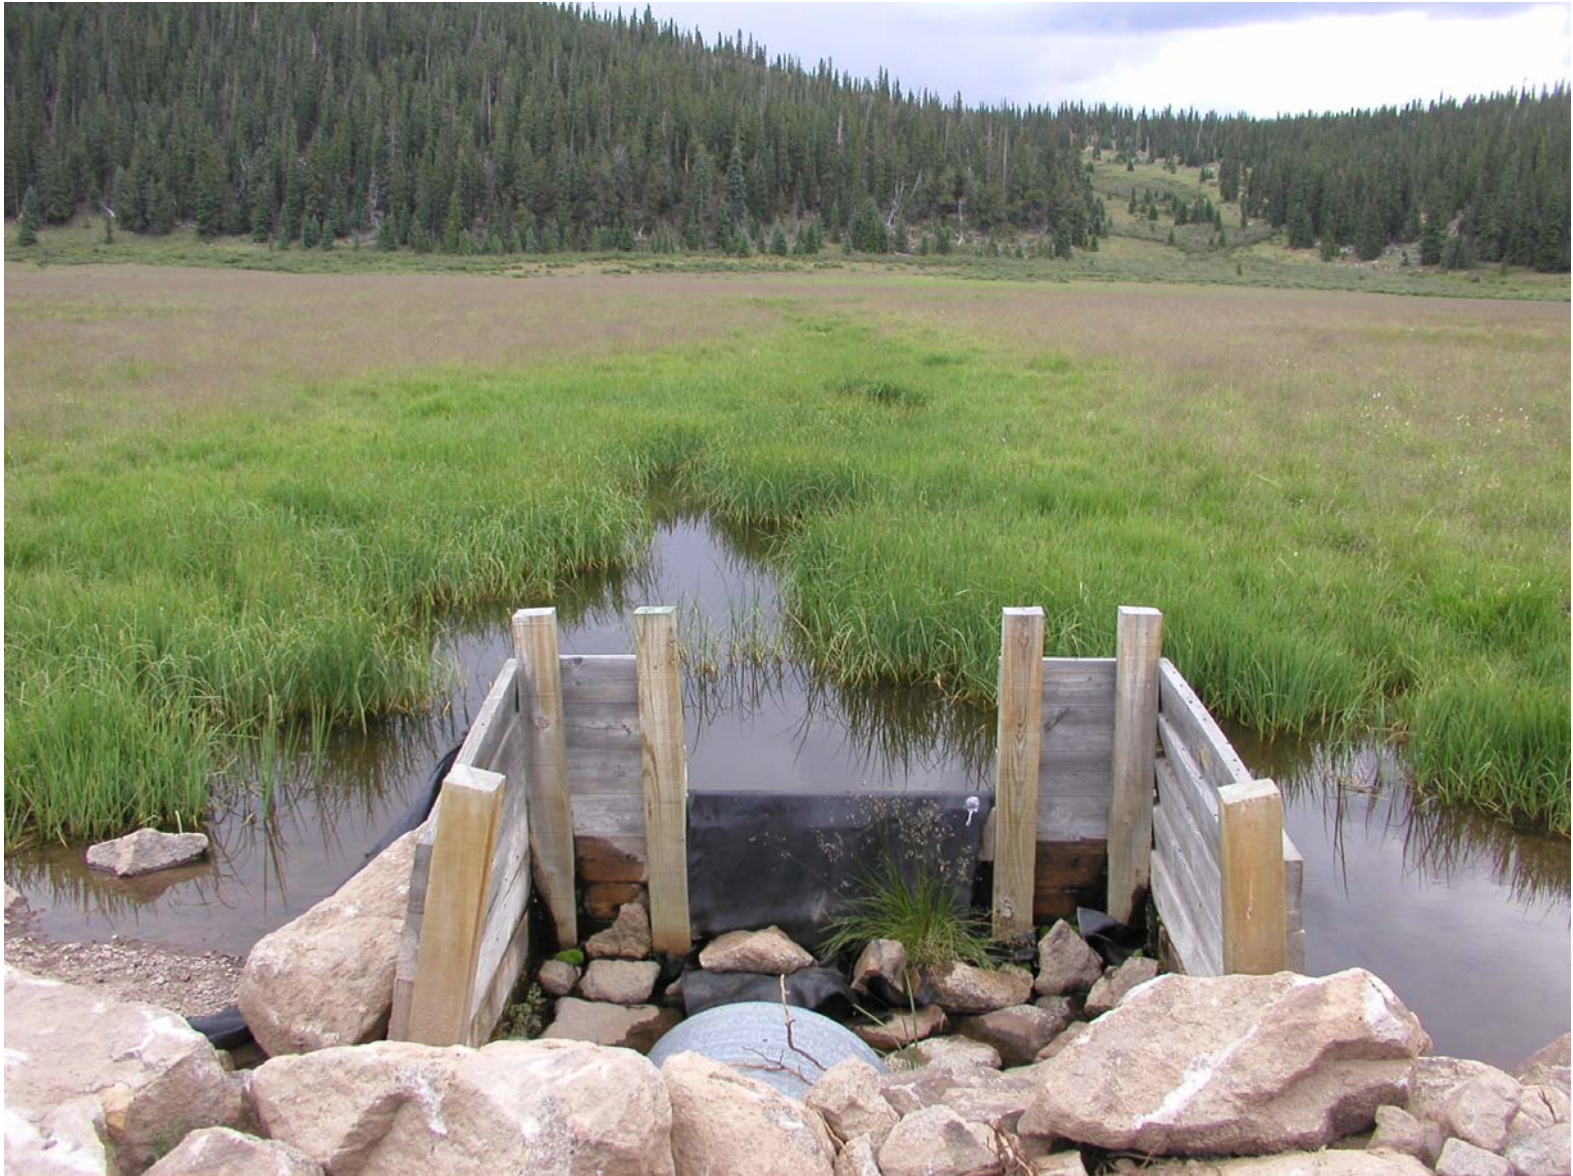
In 2007 (third photo), monitoring shows that the watertable has been raised about 2 feet from the previous level. Wetlands and sedges seem to have re-developed even some ways away from the channel. Soils have a restored water table and are responding with more vigorous sedge vegetation. The channel which was once wide seems to have narrowed considerably as soils have built up in the system.
